REPAIRS TO A LIVE SEWAGE PUMP STATION

M G Perry, NZCE (civil) REA

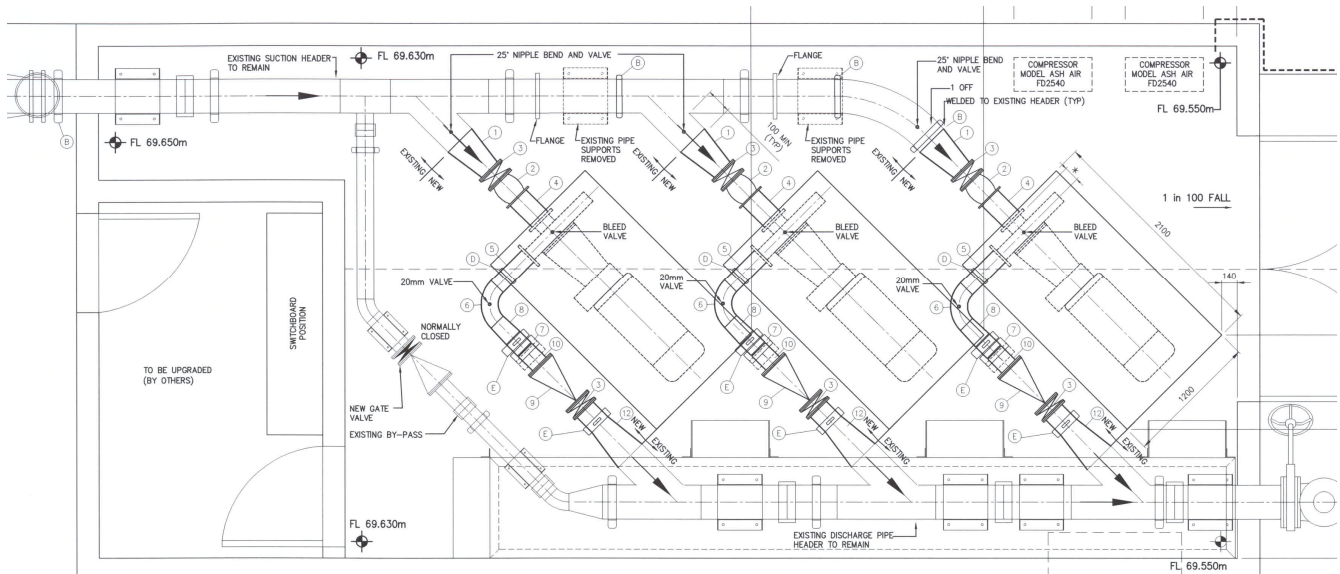
Figure 1: Pump station configuration

A view of the pump station layout is shown below to assist in visualisation of what happened, with pumps 1 to 3 from left to right.

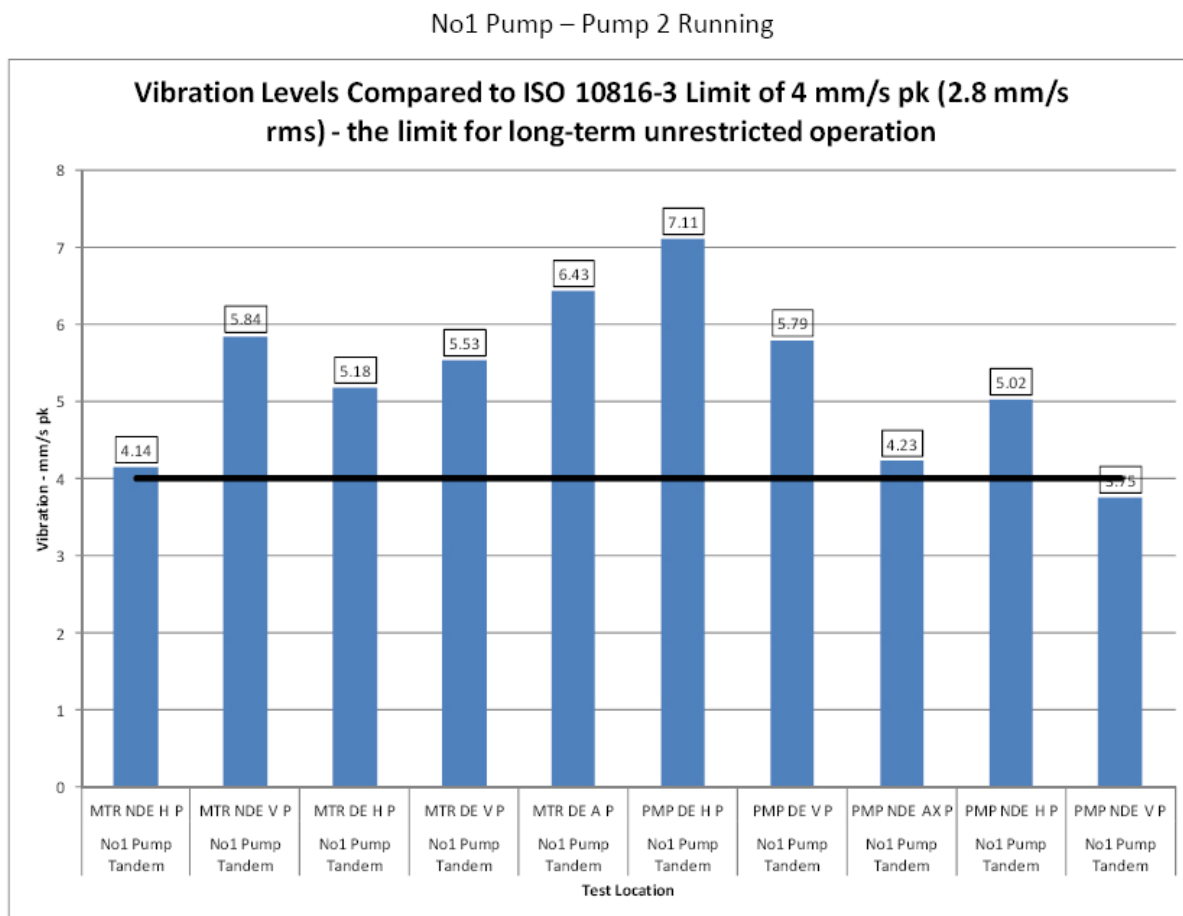
Figure 2: Sample vibration level graph Pump 1

A sample of the type of graph supplied in the vibration reports is shown below showing the positions and levels of vibration experienced, the highest levels in this case being the pump drive end bearing (7.11 mm/s pk) and motor drive end bearing (6.43 mm/s pk).

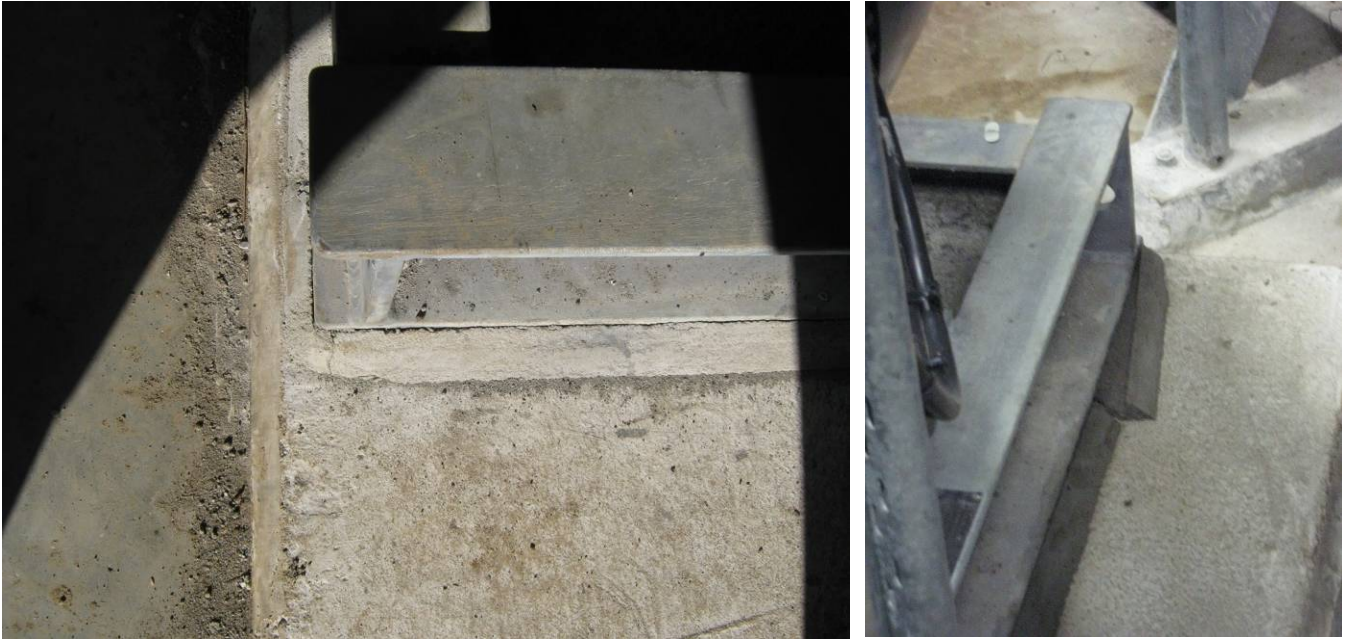
In addition, the mortar under the pump chassis became cracked and started to vibrate loose (photograph 1). It was later found that air voids created behind this dry pack were a partial cause as the web of the chassis channels was largely unsupported.

Photograph 1: Loose and cracked dry-pack at Pumps 1 and 2 motor ends

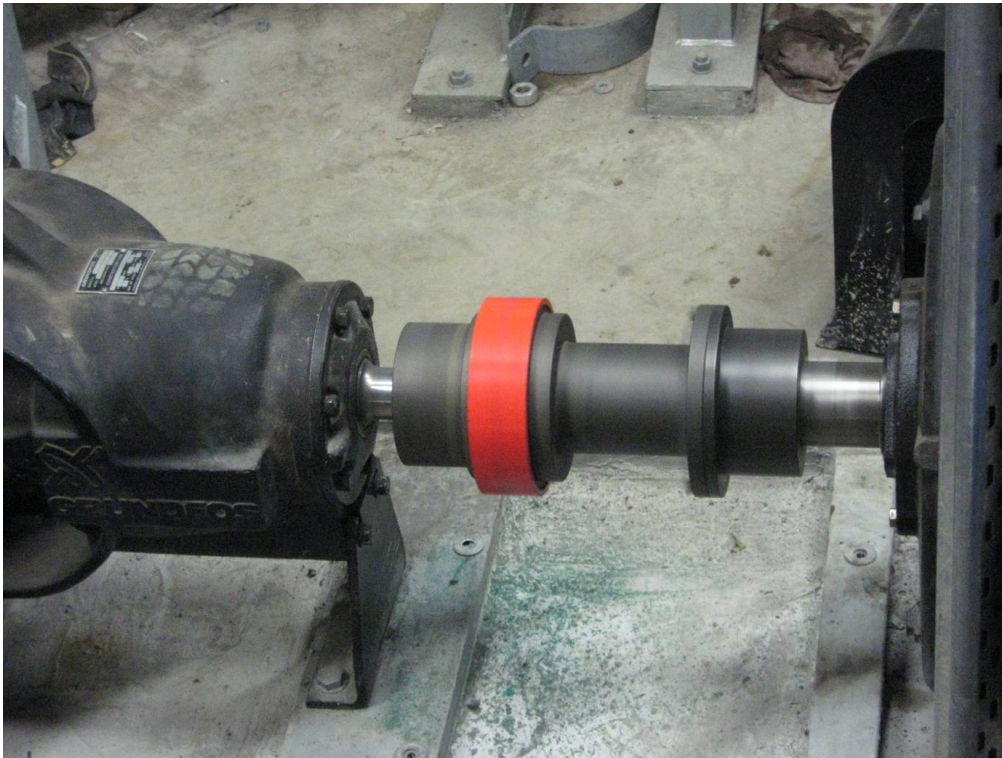
The pump sets when supplied were fitted with coupler elements which proved too soft and these suffered excessive wear which was attributed to misalignment and vibration (photograph 2).

Photograph 2: Motor coupler showing green powder from deteriorating element below unit

The initial coupler elements used between the motors and pumps were apparently of the wrong grade and initially suffered excessive wear (photograph 2). These were replaced with harder elements after the first vibration test and realignment was done and there have been no further issues apparent with these elements.

It was acknowledged by the pump supplier that an error had been made and these elements were replaced and no further failure of this type has been evident.

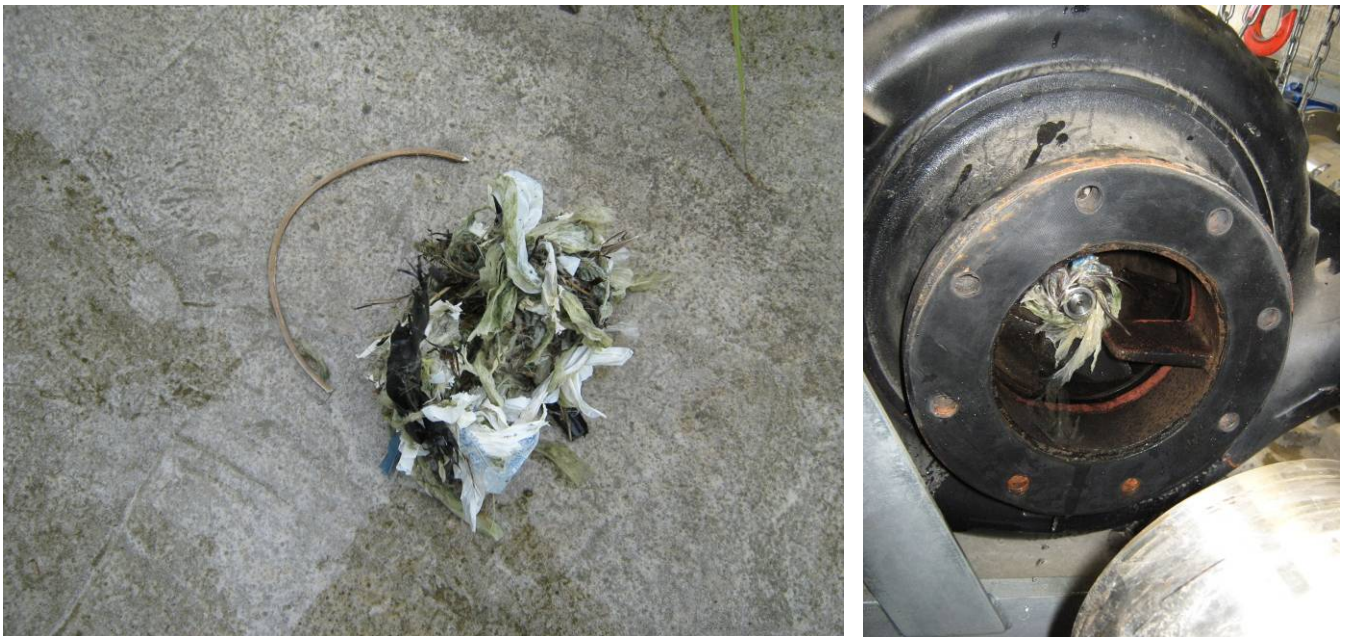
During commissioning, no swirl was observed, thus the screens were not installed. Unfortunately this allowed plastic bags (mainly wind-blown) which had not been caught by the primary screens at the plant inlet, and feathers from the swans inhabiting the ponds which had negotiated the pond outlet baffles, to enter the pumps, causing issues with jamming of the impellers (photograph 3). Screens were fitted to this MH to alleviate this problem. Subsequently however, problems have occurred with these screens blocking and bending with feathers as the manhole is in the order of 4 metres deep and feathers are difficult to rake from the screens.

Photograph 3: Debris including part of a valve seal removed from the impeller of Pump 1

Issues have arisen with the knife-gate valves on the pump suction pipes. In spite of manufacturers data indicating that these valves are suitable for the location used, and for the velocities encountered, these seals in all three valves have failed and in one instance have been sucked into the pump (photograph 3).

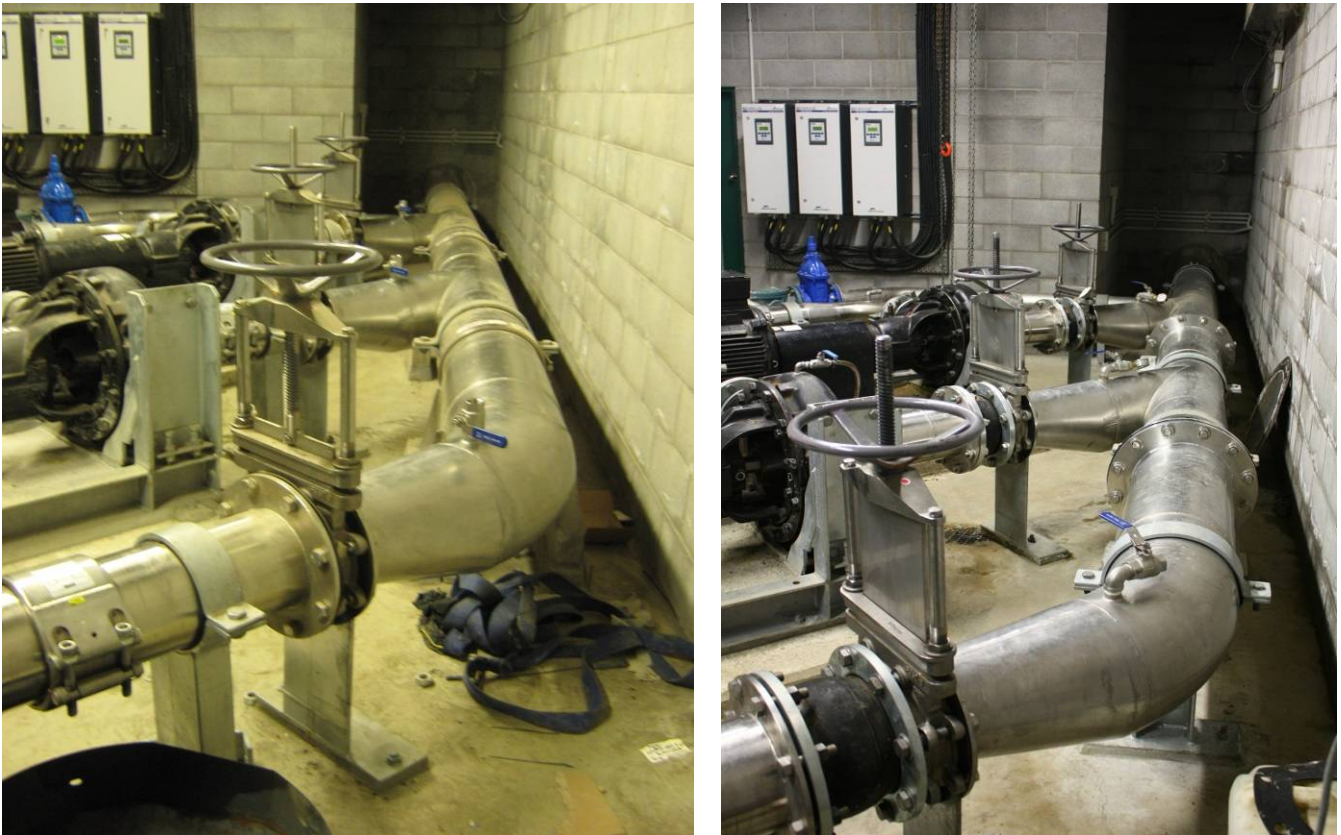
Photograph 4: Before and after header pipework configuration

Principally, the configuration has less than optimum distance between the pump inlet and the tee from the main header pipe, the design originally had no isolation mechanism between the pipework and the pump, and the configuration of the delivery side pipework meant that the pumps were mounted with a side delivery, rather than a vertical delivery.

As can be seen from photograph 4, there was also minimal isolation between the pipework and the pumps with the only movement available being that permitted by the Straub couplers.

Extra rigidity was added to this pipework by replacing the couplers with flanges and the folded supports with galvanised steel brackets (photograph 4).

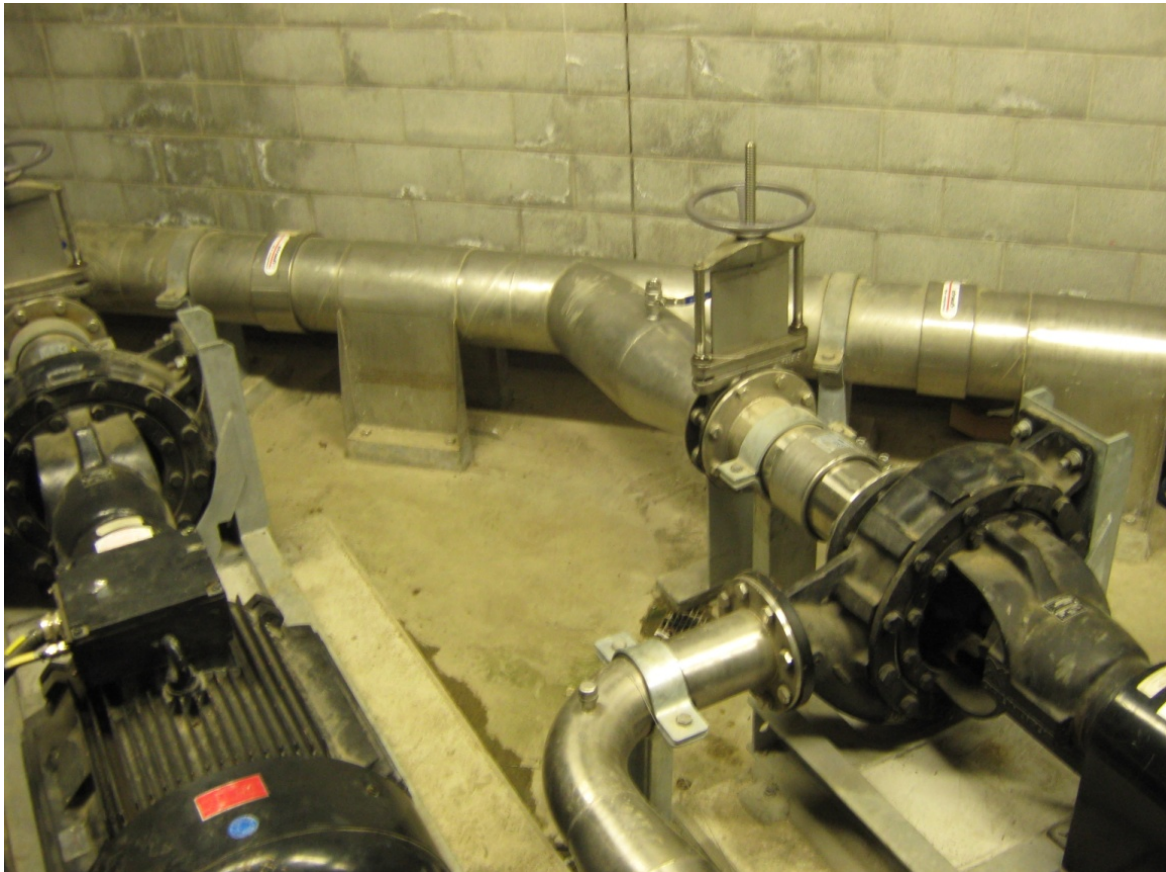
The existing pipework used in this installation is light walled stainless steel, spiral welded tubing secured to the floor with a combination of bolted galvanized steel brackets and light stainless steel supports folded and welded to the pipe, joined using semi-rigid straub couplers (photograph 5).

Photograph 5: Pumps 1 & 2 showing original supports and couplers

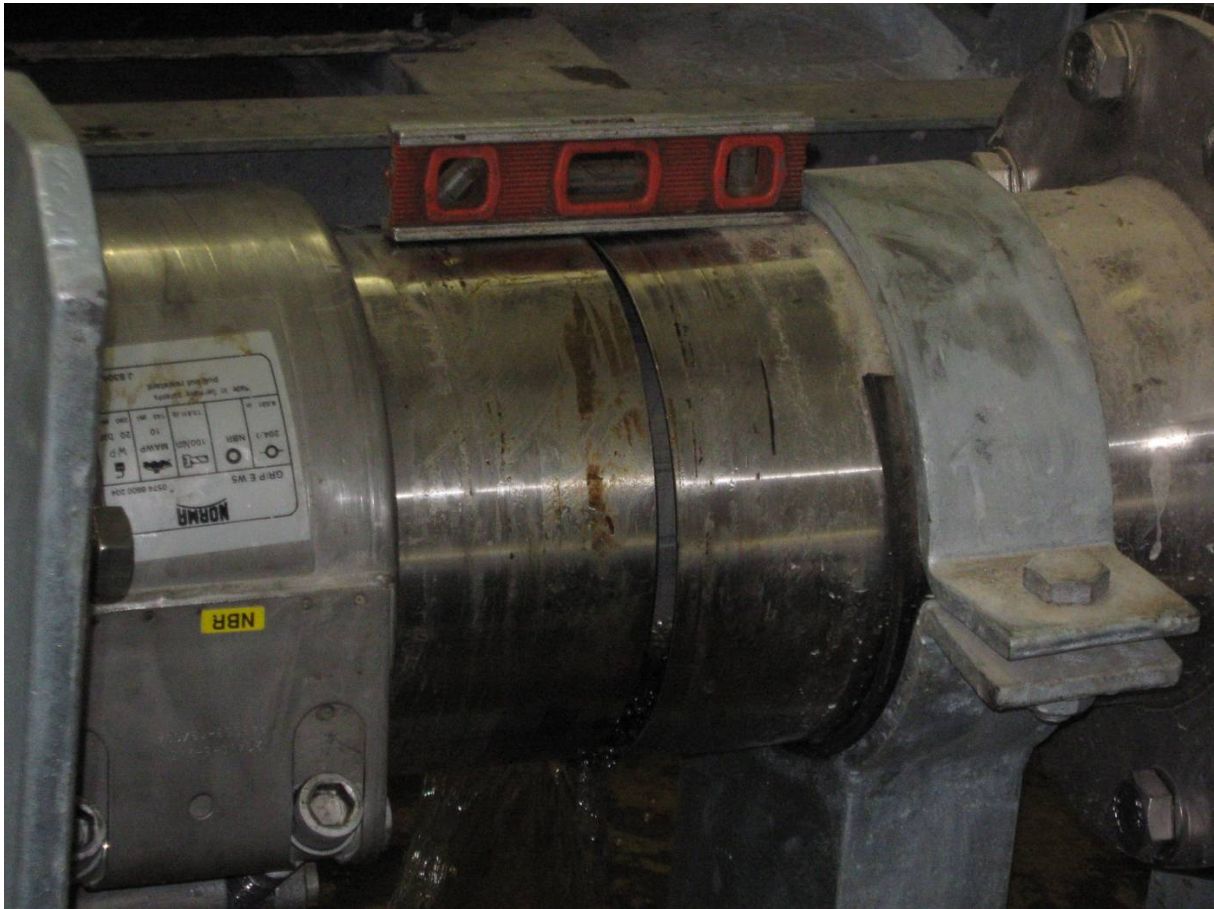
There was marked angular and lateral (both vertical and horizontal) misalignment in the existing header pipework at the Straub couplers. This was particularly noticeable at the joint between pumps 1 & 2 (photograph 7) where the displacement was between 6mm and 10mm depending where it was measured.

Photograph 6: Misalignment in the 200 mm pipework at Pump 2

This misalignment was corrected by removing the Straub couplers and pipe supports and fitting flanges at the joint before reinstalling the supports. The folded stainless steel supports were also replaced with galvanised units of greater rigidity.

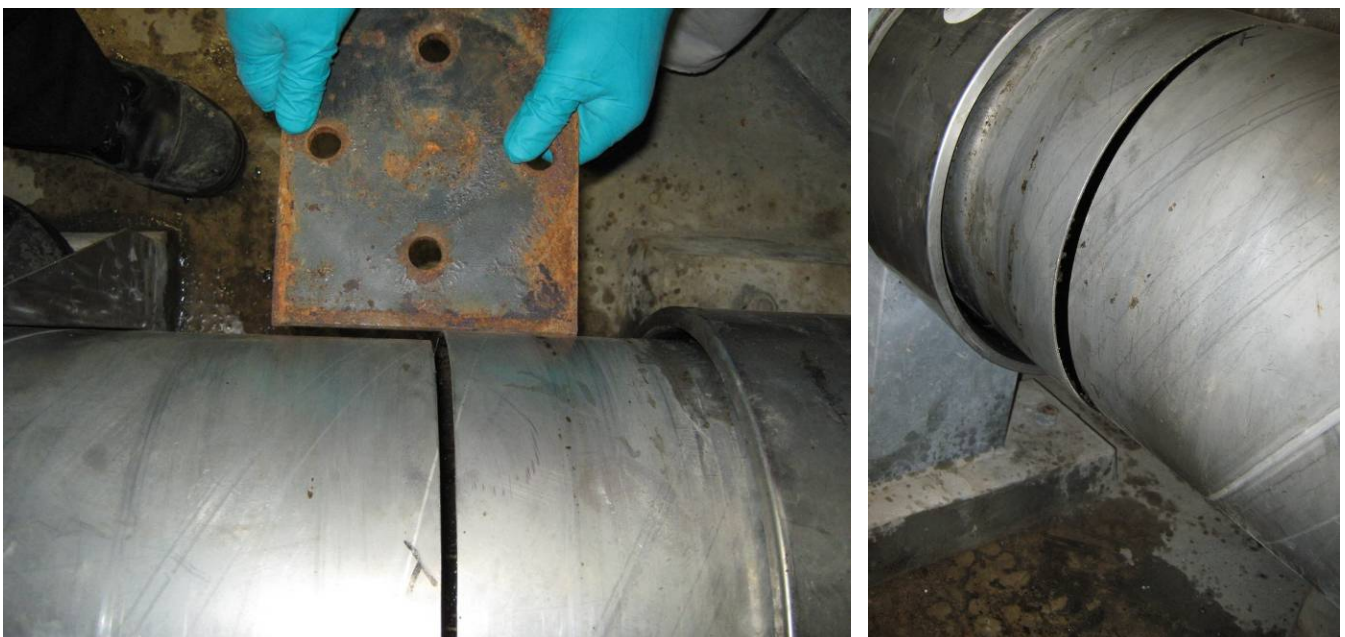
When the Straub couplers were removed the pipework sprang sideways and the end of the downstream pipe was noticeably out of round. This was difficult to photograph, but some of the misalignment shown in photograph 7 was due to this.

This distortion was probably due to the Straub couplers being used to force the pipework into alignment at the joints against slightly out of position pipe supports, but any uneven pressure from any source on such thin walled tube would be sufficient to cause this distortion.

Photograph 7: Lateral and angular misalignment at Straub coupler in 300dia header pipe

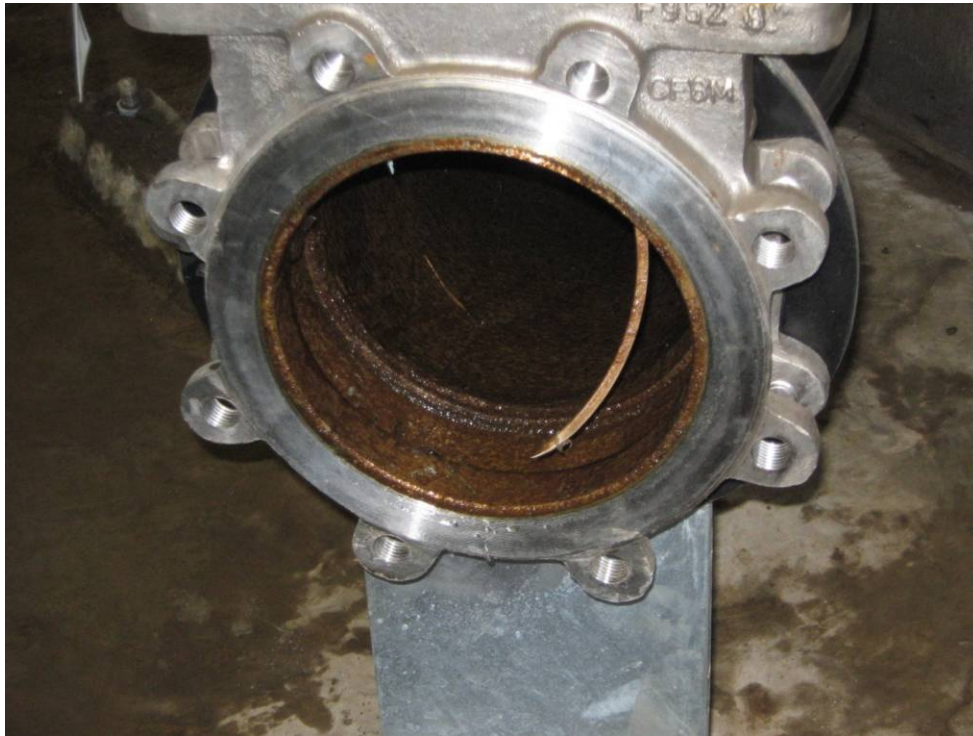
In other instances the valve seal has become dislodged and protruded into the flow with the likelihood of also migrating to the impeller (photograph 8).

Photograph 8: Loose and broken valve seal Pump 3

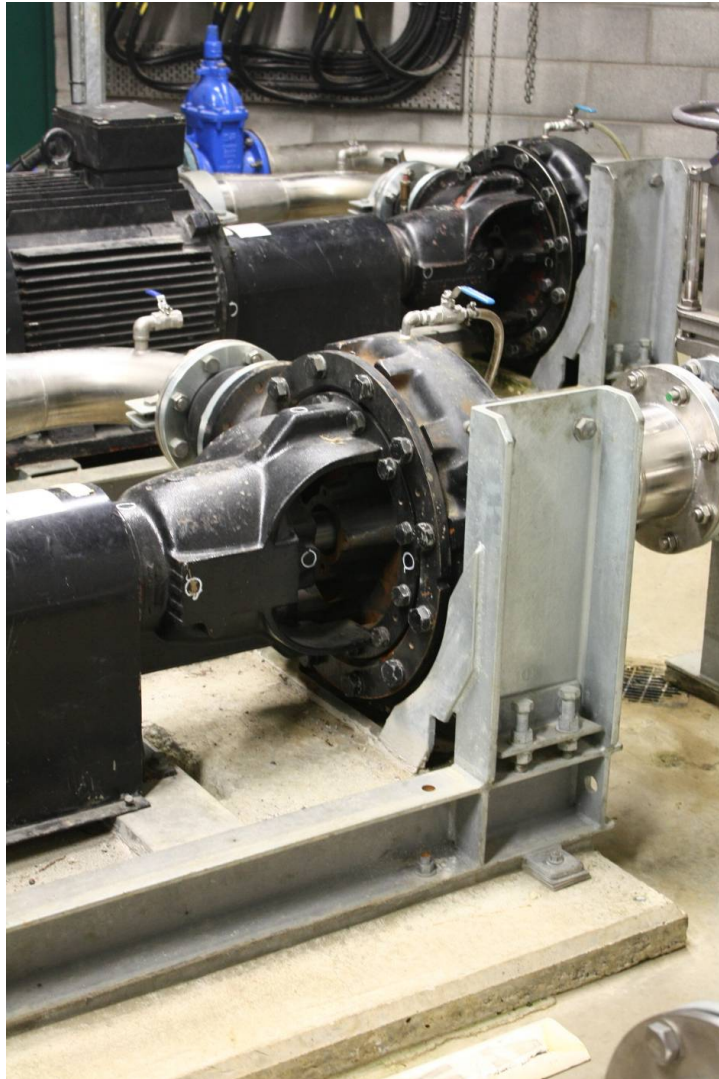
Holding down of these pumps was a contentious issue from the time of the first vibration report, with the pump supplier unwilling to accept that the holding down detail was inadequate. The reason being that similar pump sets elsewhere used a similar detail with no apparent vibration issues. However the mounting of the pump on a vertical strut (photograph 9) does introduce a marked increase in rotational moment at the holding down bolt position compared to a vertical delivery installation with the pump bolted directly to the base frame.

Photograph 9: Pump mounting detail

Vertical adjustment of the pump was possible using adjusting bolts (photograph 9); however horizontal adjustment relied on slotted holes and friction which made it easier for units to vibrate out of line.

The final solution adopted was to install three bolts on each side of the chassis, drilled directly through the flanges into the floor.

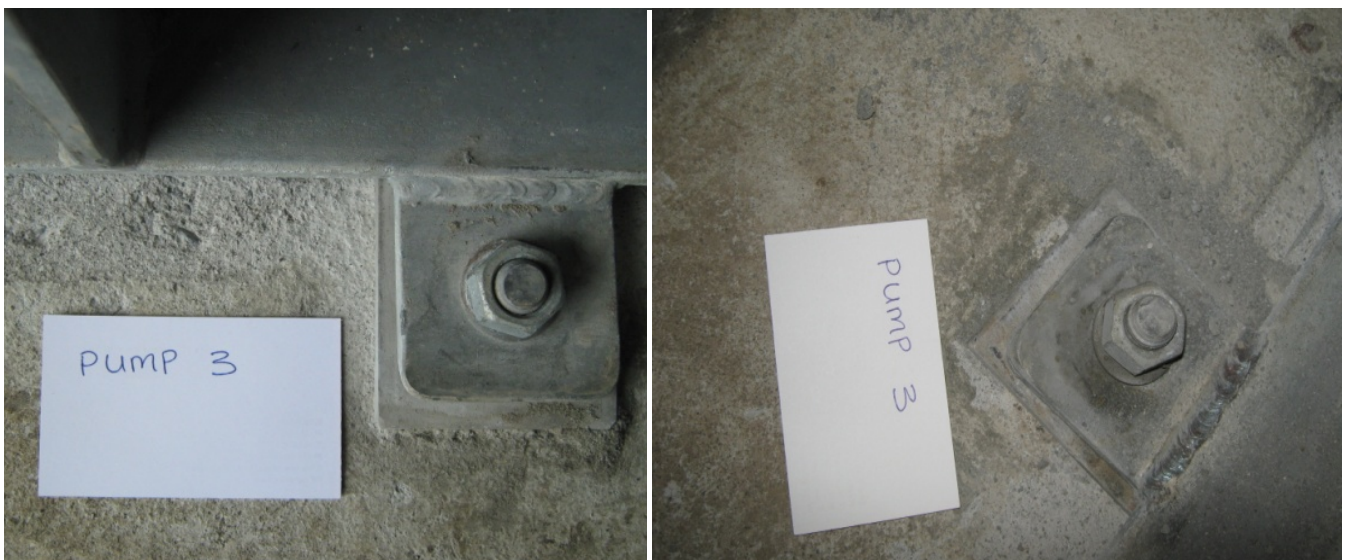
It was also noted that the four bolts used in the original installation of each pump set were of different sizes (photograph 10). Possibly a support on the delivery side pump flange may have assisted these bolts to resist the forces imposed, and this was given serious consideration, but due to the other problems encountered and resolved this was found to be not required.

Photograph 10: Different size HD bolts Pump 3

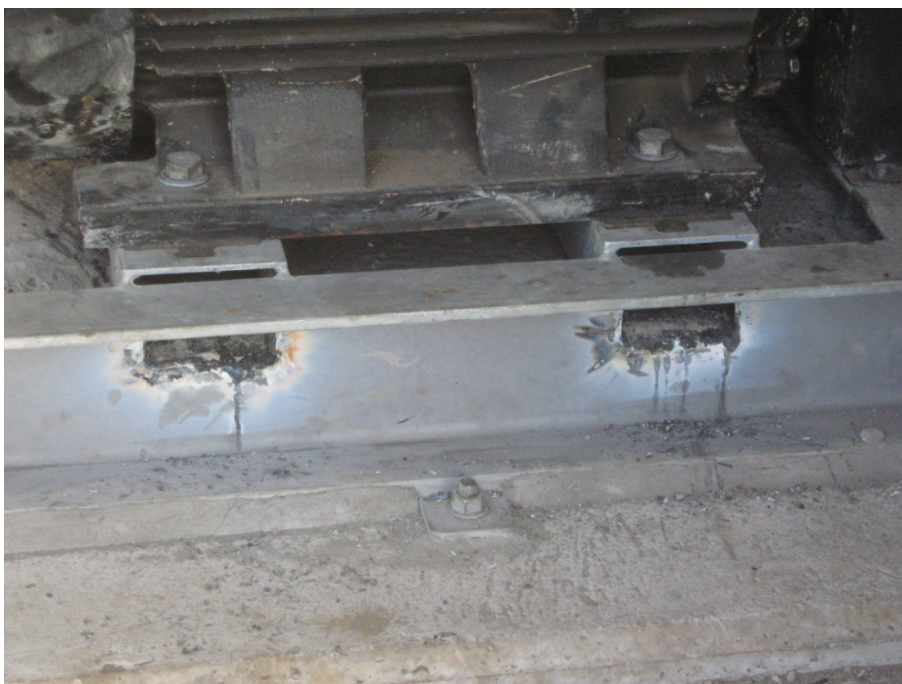
In order to achieve accurate alignment, the mounting bolts for the motor first had to be made accessible and the holes slotted to allow movement for horizontal alignment (photograph 11) and the shims under the motor itself had to be changed to achieve accurate vertical alignment.

Photograph 11: Pump 3 chassis showing access slots cut to enable motor adjustment.

The hold down bolts for the motors were made inaccessible by the level of concrete poured into the base frame (this can be seen in photograph 2). This meant that slots had to be cut in the main chassis members to enable access to the motor bolts (photograph 11).

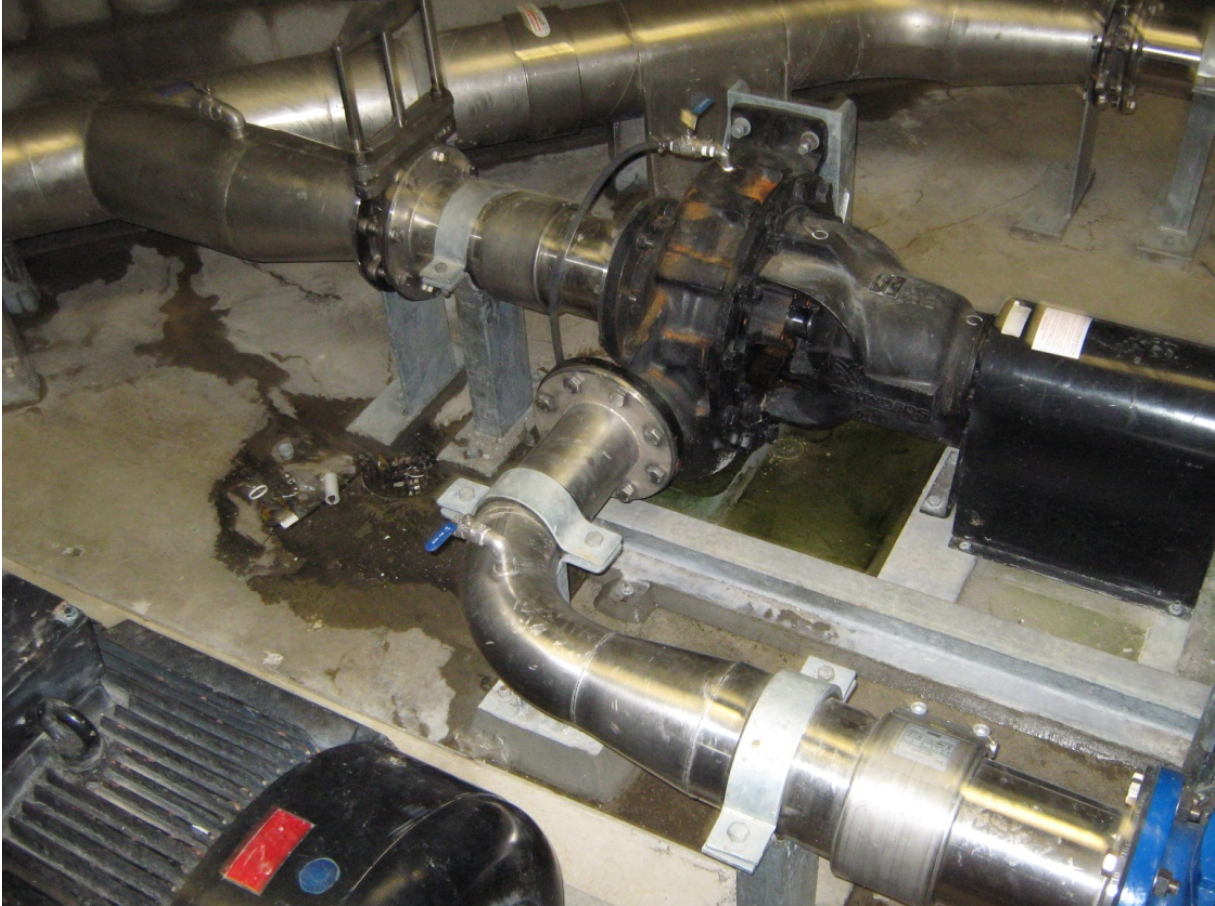
On at least two occasions pump seals were observed to be leaking after the pumps were reinstalled (photograph 12). These issues were largely resolved by applying correct torque to the mounting ring.

Photograph 12: Pump 2 seal leak after reinstallation

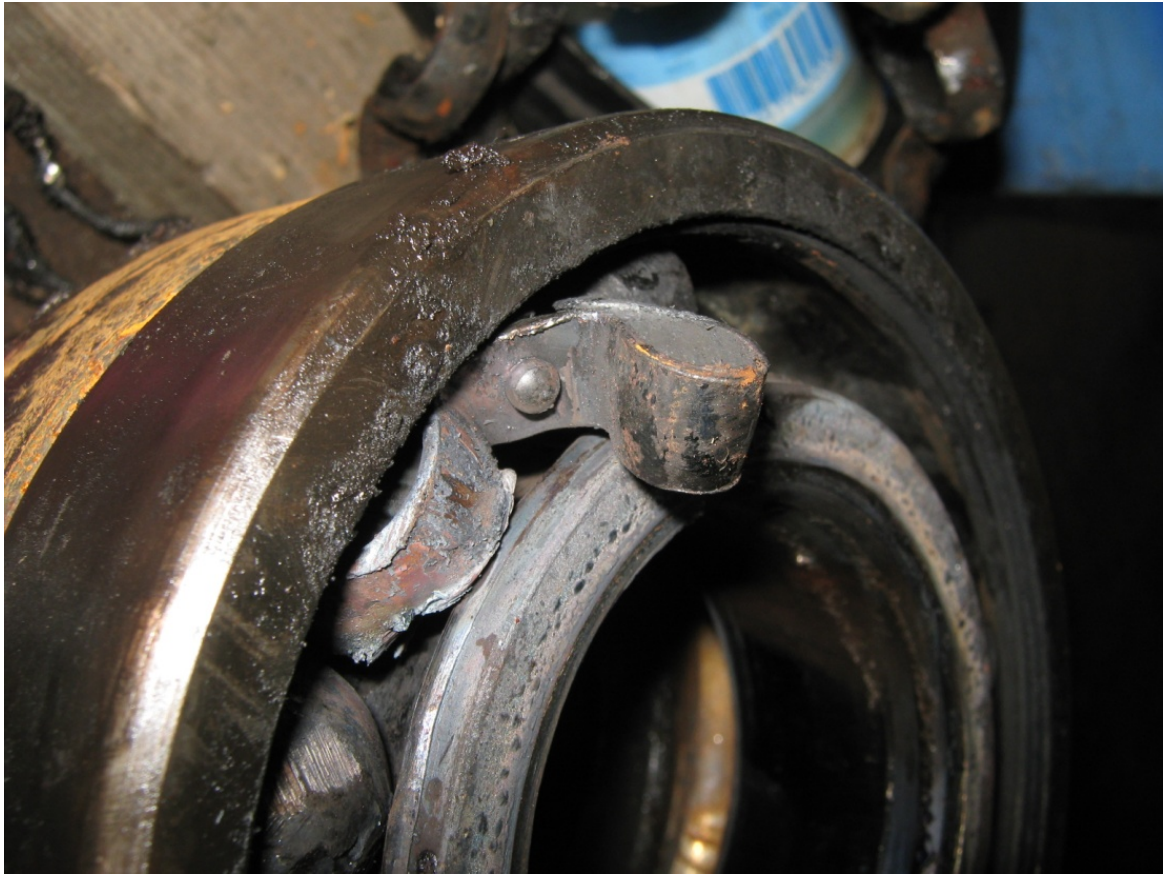
The bearings in pump 2 also failed catastrophically in September 2010 (photograph 13). This pump had shown lower levels of vibration than pump 1 so was being used as a duty pump in preference to pump 1, notwithstanding that it had been noted as hard to turn. From the shaft and housing damage noted after the failure, it is likely that the bearings had been rotating on the impeller shaft, and also possibly in the bearing housing. This was probably the reason this pump was hard to turn. It is also possible the impeller had been touching the housing to cause this.

Photograph 13: Bearing from Pump2 showing typical damage.

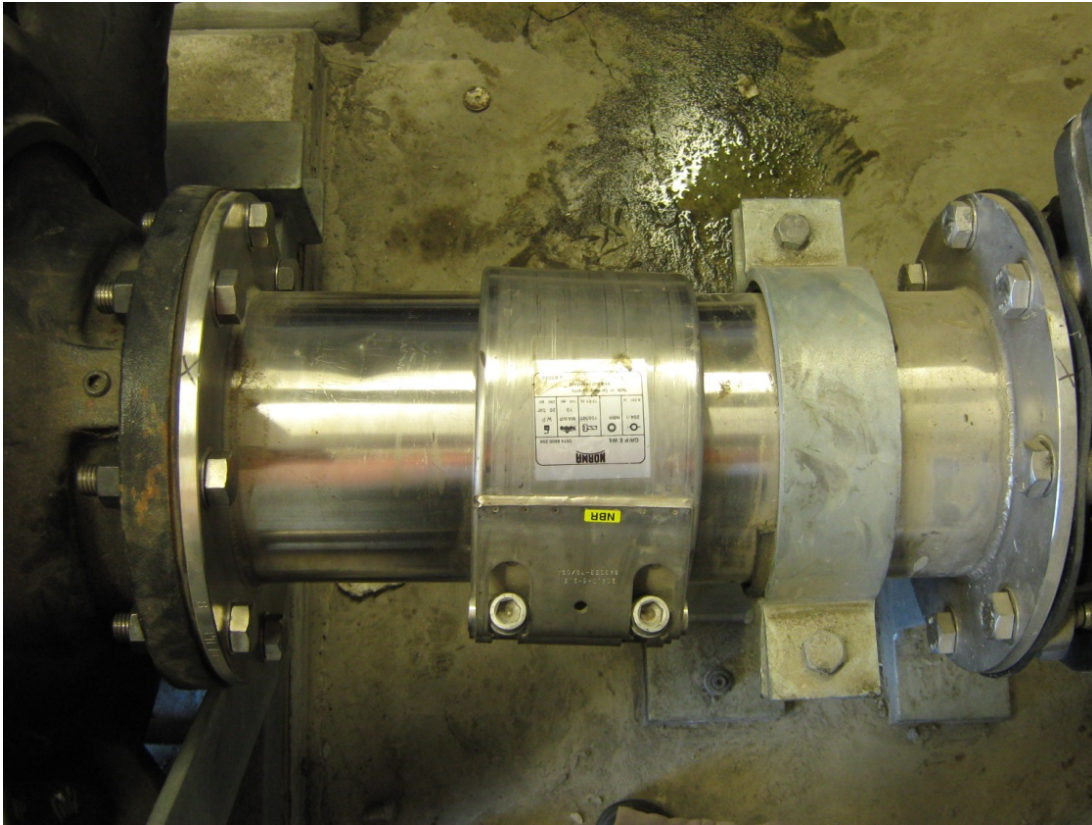
A varying degree of misalignment was discovered in the modified pipework between the new knife-gate valves and each pump, both angular and lateral being present to varying degrees (photograph 6). This was worst at pump 3, where there was both angular and lateral misalignment as well as an excessive gap but lesser degrees of misalignment were present at all pumps with Straub couplers being obviously out of parallel with the pipe (photograph 14).

Photograph 14: Pump 2 Straub coupler not parallel

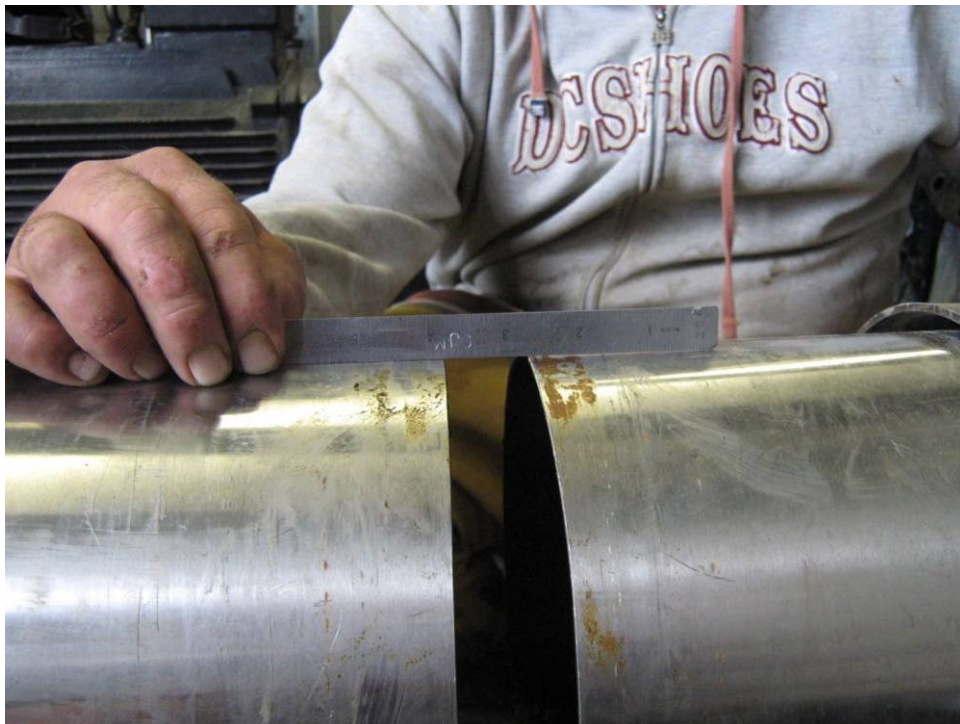
At Pump 3, it was discovered that the gap between the ends of the pipework in the coupler was excessive, with a gap of approx 25mm at one side of the coupler increasing to approx 35mm at the other. It is probable that the removal of this gap was a large contributor to the reduction in average vibration levels shown at this pump, the only point where the pipework changes did show a marked improvement in level experienced.

Photograph 15: Angular misalignment/ excessive gap at 200dia Straub coupler pump 3

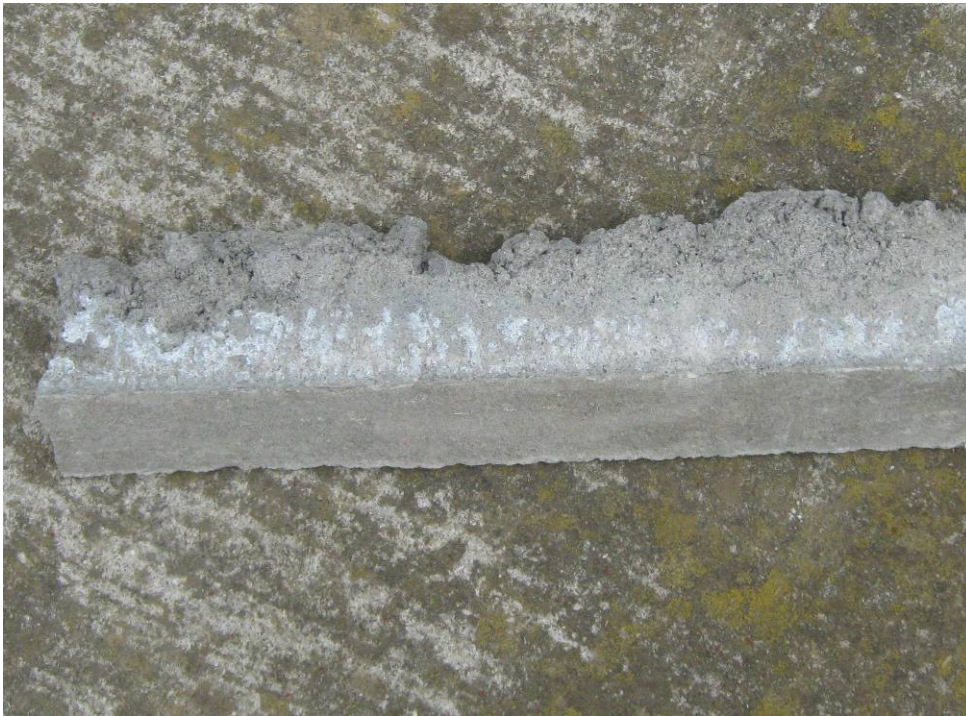
The “Sika 212” non-shrink dry pack under the pump chassis showed uneven compaction, with air voids evident once inside the outer 15mm or so (photograph 16). The penetration of the dry pack was also uneven, in spite of staff stating that the material was rodded into place against a timber form placed at the back of the chassis member. It is clear that the method employed to place this material was not effective. When the pumps were initially installed, dry pack was placed under all 4 sides of each chassis, and then a free-flow concrete grout poured into the inside.

Photograph 16: Sample of original dry pack from under pump 3

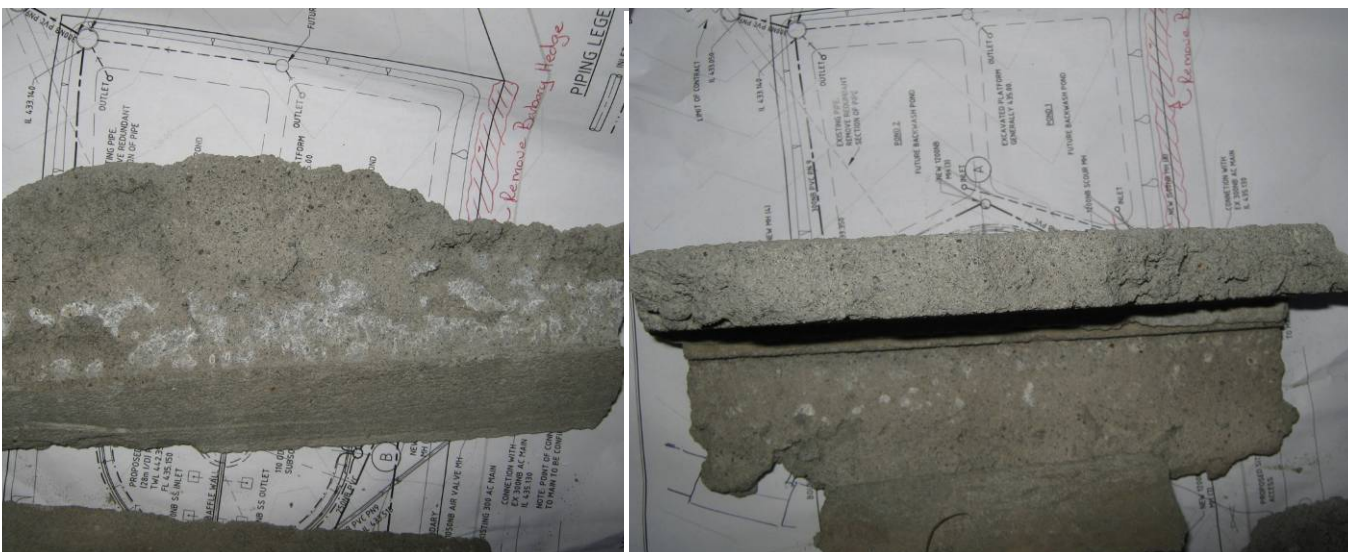
Examination of textures visible in samples of the dry pack removed (photograph 17) strongly suggest that this methodology resulted in pockets of air being trapped under the inner (web) side of the main chassis members. It is likely that the resulting lack of support for the web of this channel contributed to the issues arising from the lack of holding down discussed in item 3.3.1 above.

Photograph 17: Sample of original dry pack from under pump 2 plan view and edge view

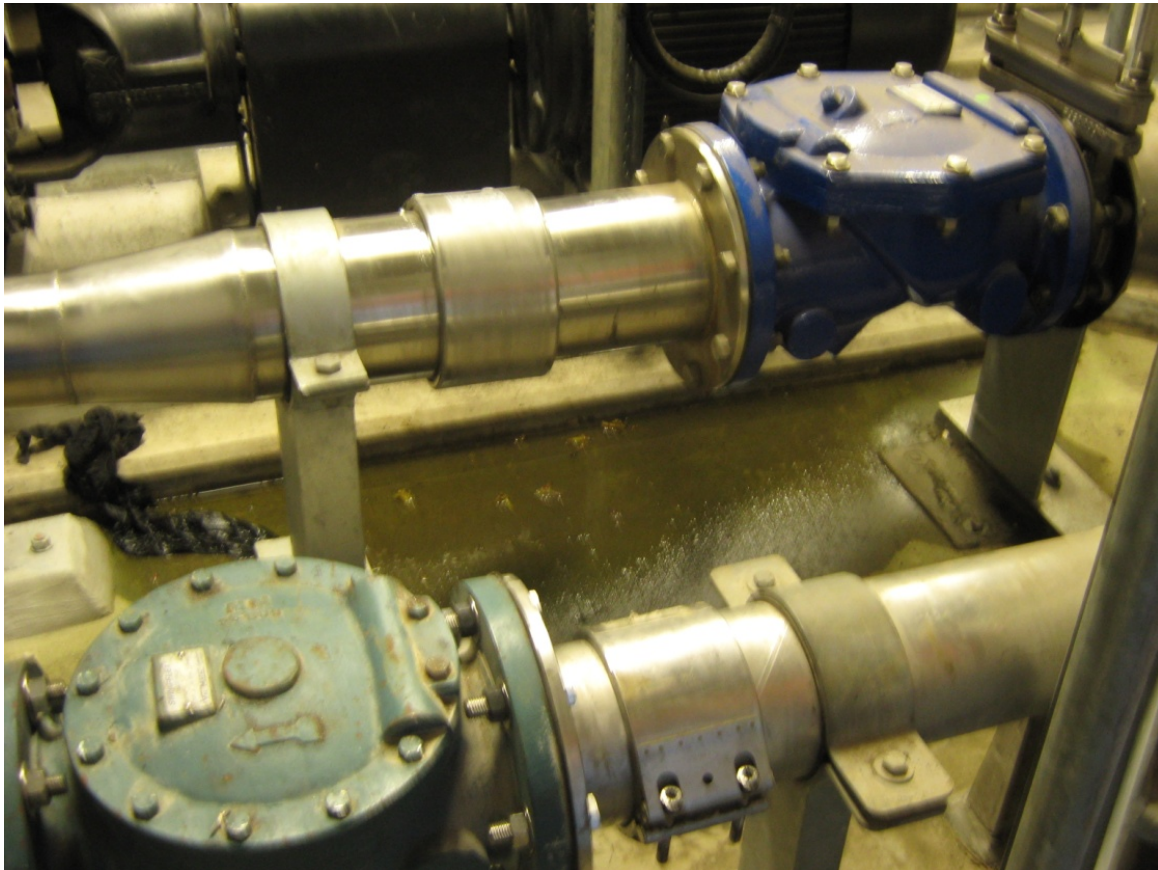
The result of this was side pressure on the affected pipework with potential to pull the pumps out of alignment when this was coupled with even moderate levels of vibration. It is difficult to see this in photographs but an example is shown below (photograph 18).

Photograph 18: Support on delivery pipework out of plumb

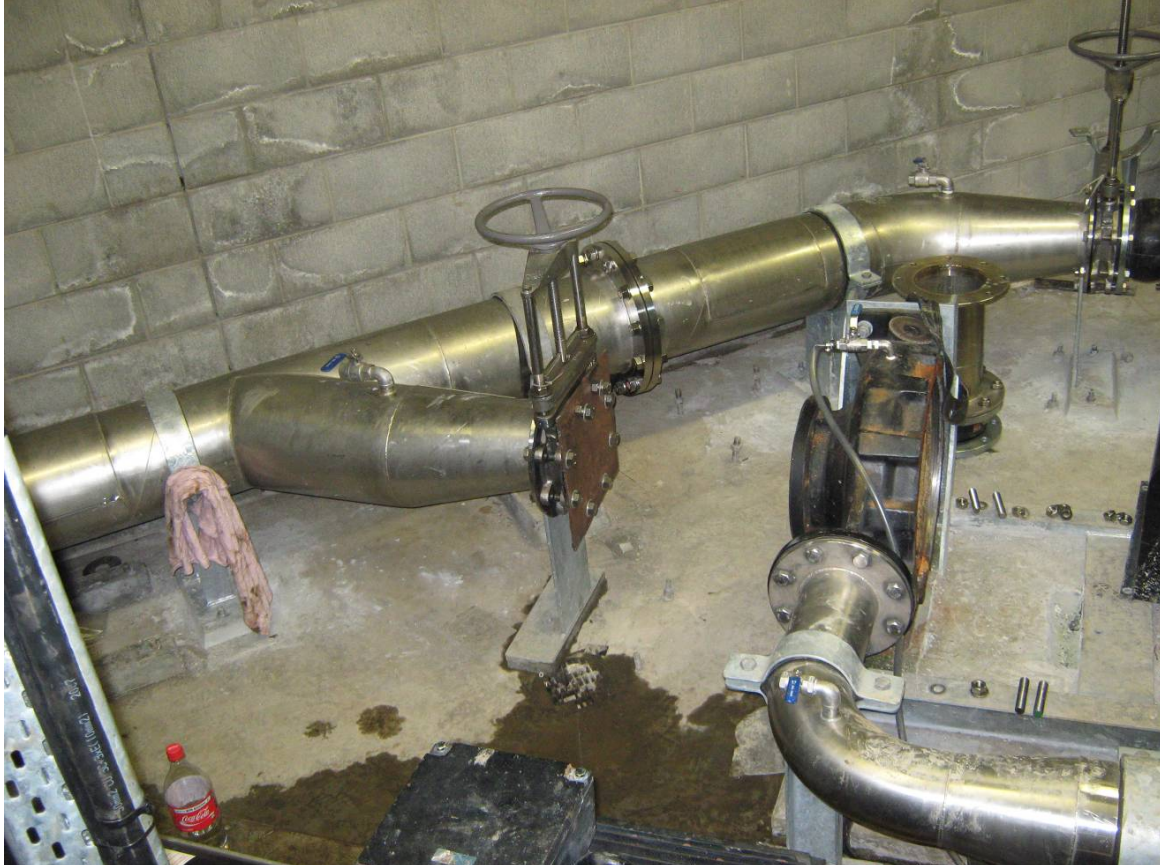
This became an issue when the knife gate valves would not seal and in the end the pipes between the pump and valve were removed and a temporary blanking plate was installed to prevent air being sucked into the other pumps (photograph 19).

Photograph 19: Work on pump 2 showing pump & pipework removed
