FIBREGLASS PUMP STATIONS: 10 YEARS EXPERIENCE IN NEW ZEALAND

Holyoake, K.M.; ARMATEC Environmental Ltd, and Guthrie, B.C; ITT Water & Wastewater NZ Ltd

ABSTRACT

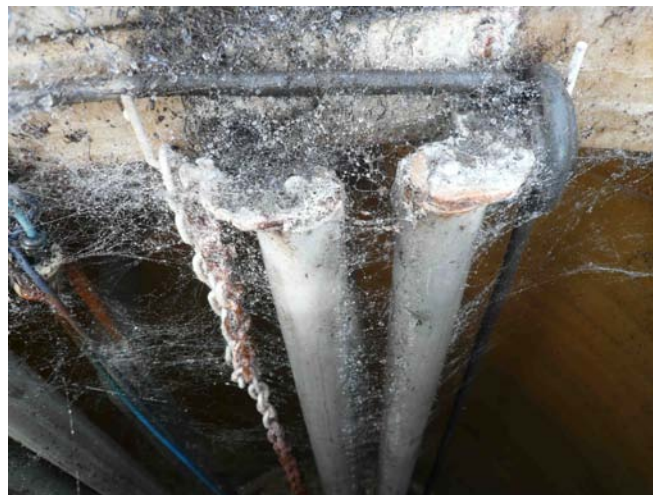
A fibreglass pump station was installed in the Mangaroa Prison in Hawkes Bay in 2005. After 6 years operation, it is in excellent condition. The load is intermittent, with low-level buildup of hydrogen sulphide gas. Non-stainless steel parts within the pump station have corroded, and will need maintenance in the future.

Site personnel advised that the pump station is hardly ever touched, other than being cleaned out every 3 to 4 months. Management of the prison changed in 2010, and servicing had possibly been neglected in the past. The spider webs present (Photograph 11) confirm there has been minimal servicing. The fibreglass pump station itself has not suffered as a result of infrequent service.

Photographs 11. Fibreglass pump station at Hawkes Bay prison handling wastewater is in excellent condition, despite minimal servicing. Non-stainless steel metal parts are being corroded by hydrogen sulphide gas.

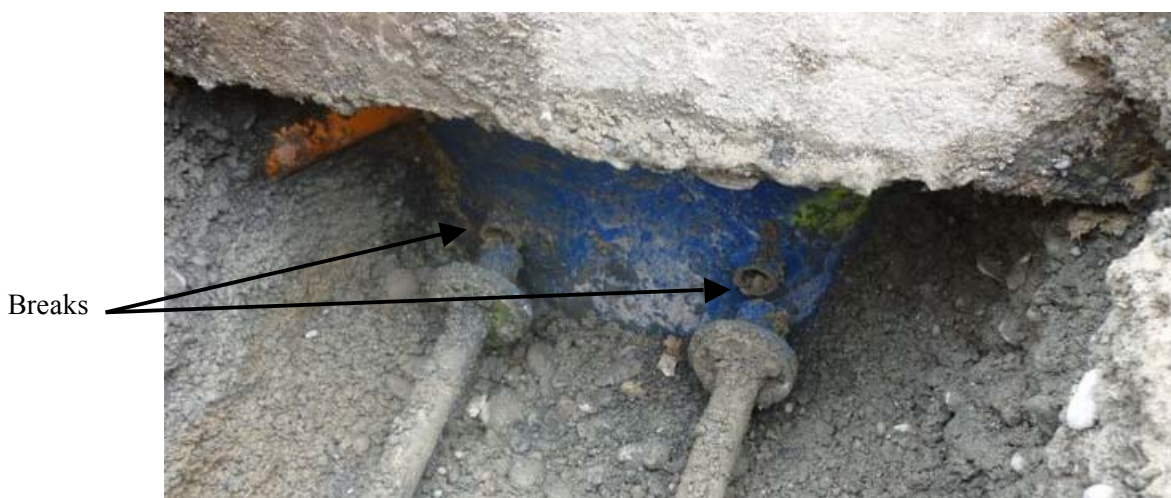
The Birchgrove pump station (PS97) was installed in 2009. It is located to the east of the city centre, closer to the area worst affected by the 2010 and 2011 earthquakes. The two 50mm diameter pump station discharge pipes include flanged fibreglass spools at the pump station wall, followed by a ductile iron pipe to the valve chamber. During the 22 February 2011 earthquake, both discharge pipes sheared immediately outside the pump station in the fibreglass spool section (Photograph 13). The liquid tight envelope of the fibreglass vessel itself was not broken.

An unusual aspect of the Christchurch earthquakes was the significant vertical acceleration that occurred, in addition to the normal horizontal acceleration. A significant amount of the damage to Christchurch City buildings, and pump stations, was a result of this vertical acceleration component.

When excavated, the pipes were found to be displaced both horizontally and vertically by 20mm to 50mm. It is likely the pump station and valve chamber moved during the earthquake, and that the backfill around the discharge pipes compacted downwards. As the discharge pipes were rigid ductile iron, there was no flexibility to take up any movement, and the breakage resulted.

Photograph 13: Birchgrove Pump Station, Christchurch (PS97): Discharge pipes broke during 22 February 2011 earthquake at fibreglass spool just outside pump station wall.

Repairing the breaks in these fibreglass pipe spools was relatively straight forward, as the break was outside the pump station. The rigid ductile iron pipes have been replaced with HDPE piping, and trial 'Carrier Pipes' were

installed. This provides more flexibility and room for movement of the pipe connecting the pump station and valve chamber. The 'Carrier Pipes' are fibreglass, with a diameter between 4 and 6 times the discharge pipe diameter. They also provide protection to the HDPE piping during any future excavation.

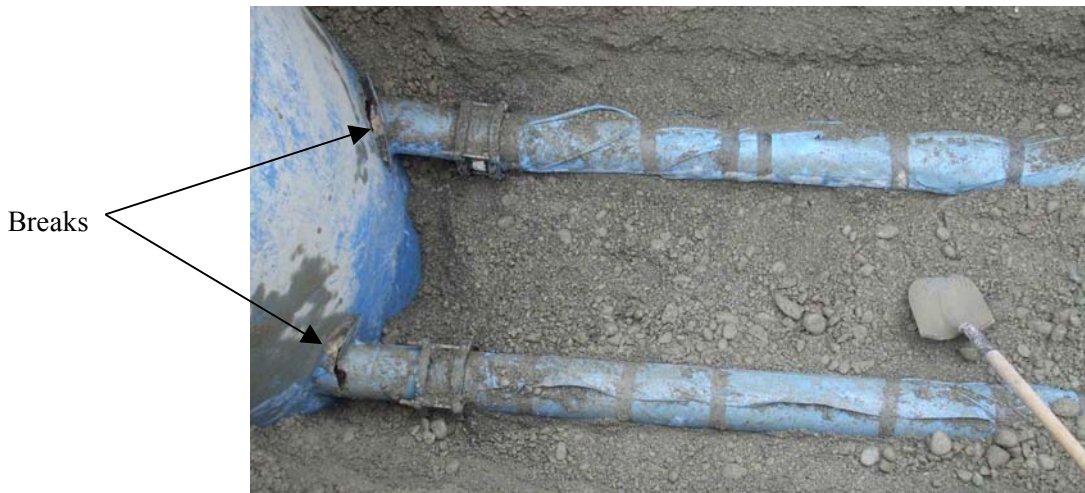
The Wigram pump station was installed in 2011 in a new subdivision. The pump station and valve chamber are 4 metres apart, and 150mm diameter ductile iron discharge pipes connect the two. The pump station was commissioned immediately prior to the series of earthquakes in June 2011. The earthquakes fractured the discharge piping just outside the pump station in the fibreglass spools (Photograph 16). The liquid tight envelope of the fibreglass vessel itself was not broken. Again, there was both vertical and horizontal displacement of the pipes; the maximum vertical displacement measured was 80mm downwards.

Photograph 16: Wigram Pump Station, Christchurch (PS101): Both 150mm diameter discharge pipes to the valve chamber fractured in the fibreglass pipe spool at the pump station wall.

It appeared that the ductile iron pipes (and not the pump station) were forced downwards by the earthquake, and as a result the fibreglass pipes fractured. The pump station and valve chamber were subsequently surveyed, but no significant movement vertically of either was found. It appears the earthquakes compacted the backfill around the pump station, forcing the discharge pipes downward, with the observed result.

The fibreglass spools were strengthened and gusseted (Photograph 17), so that the weakest point is further out from the pump station wall and more accessible if damaged in the future. HDPE discharge piping was installed, and is now the standard for this work in Christchurch. It is not possible to totally stop earthquakes causing damage, but the measures taken will minimize any future damage and make subsequent repairs easier.
