EFFECT OF THE RECENT EARTHQUAKES ON SELWYN INFRASTRUCTURE

Tim Ure – SDC Wastewater Engineer

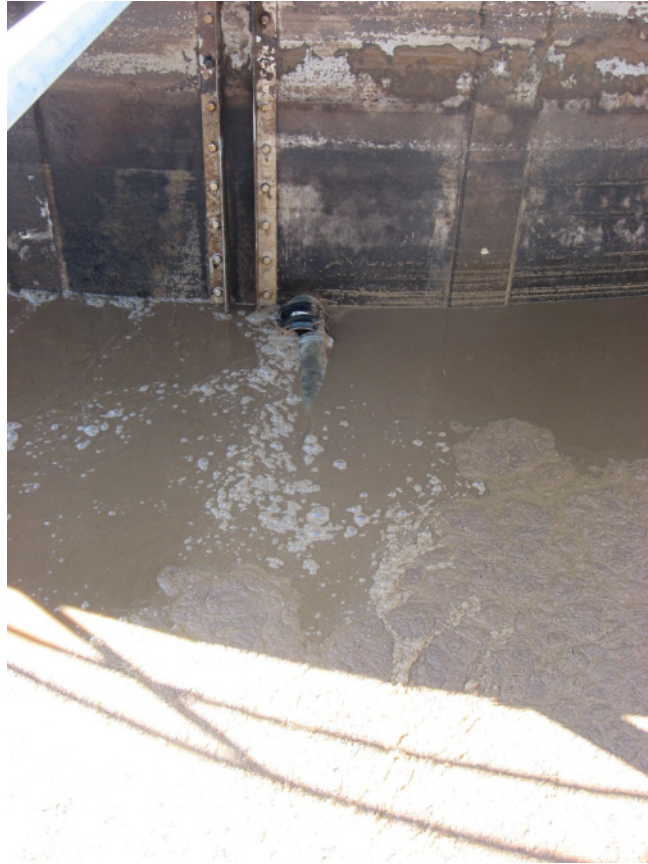
When staff first arrived at the Pines (Rolleston) Wastewater Treatment Plant (WWTP), it became apparent that serious damage had occurred. The most noticeable effect was that 250m³ of wastewater had disappeared from the bioreactor and first impressions were that a massive structural failure had occurred resulting in partially treated wastewater disappearing into the Rolleston gravels. After a good look at the remainder of the plant, it became apparent that wastewater from the bioreactor had somehow entered the irrigation wet well and had been pumped out into the centre pivots. It became evident that the pipe carrying supernatant from the overflow weirs in the clarifier, through the bioreactor into the UV disinfection unit had separated, allowing water from the bioreactor to enter the irrigation pump station. The centre pivots nozzles had blocked with hair and sludge and had limited capacity to dispose of the wastewater without removing and cleaning all the nozzles individually.

Photograph 1: Photographs of the Pines Wastewater Treatment Plant 4 Sept 2010

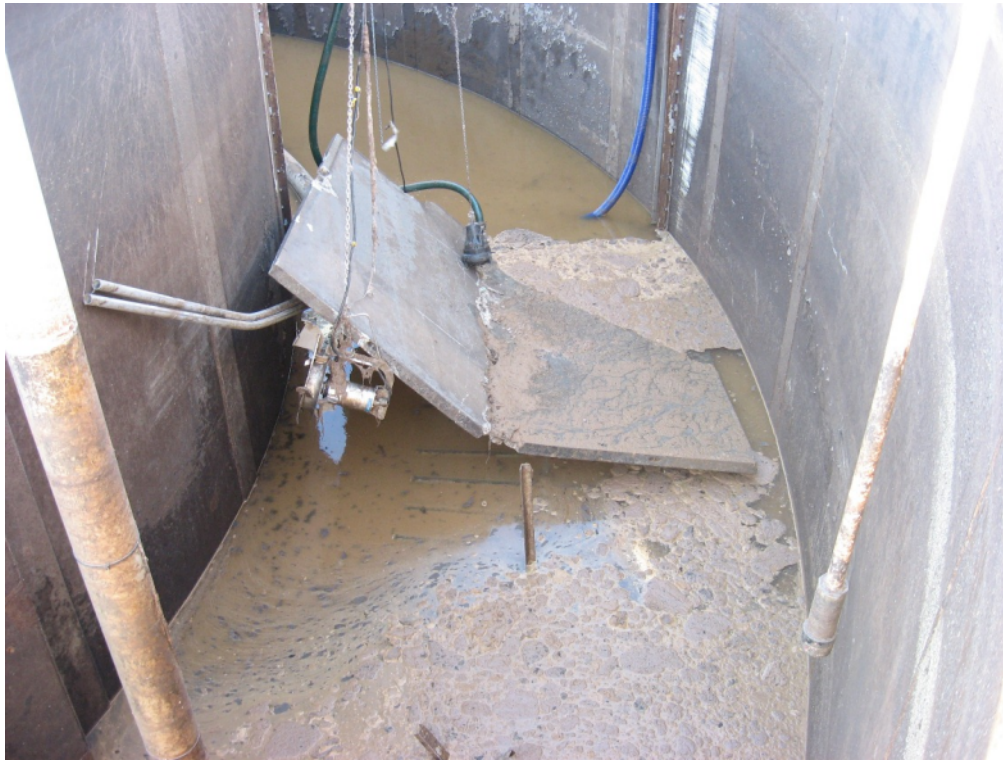
Concrete panels within the bioreactor which were used to separate the anoxic and aerobic zones had split down the middle, allowing the panels to fall on to the mixers and diffusers beneath. Generally these are below the water level and therefore it was only during the emptying of the bioreactor that the extent of the damage could be assessed. The panels, around 4m x 5m in dimensions were broken in the east-west alignment, but in the north south alignment, there was minimal damage, indicating that the effects of the earthquake were more prominent in the alignment of the earthquake. This is due to the earthquake producing waves that caused differential water pressure in a north-south direction. The mixers were damaged beyond repair, with the panels taking out the guide rails, and bending the impellers out of shape. Aeration equipment located in the base of the bioreactor had been damaged and disconnected and required prompt replacement from Australia. One of the panels had also dropped onto the sludge recirculation (RAS) system effectively blocking the recirculation process.

Photograph 2: Broken Bioreactor Panels - Pines Wastewater Treatment Plant 4 Sept 2010

In the following week, new panels were poured, and installed, new diffusers and mixers were imported and installed and the weirs and scum arm were repaired and replaced. An overall inspection showed no significant structural damage to the tanks. This was primarily due to the site conditions at this location with well founded structures in Rolleston gravels, a groundwater table at a depth of 12m below ground level and a flat site mitigating the risk of lateral spreading.. The treatment plant started to accept sewer flows on six days after the earthquake, and was compliant within resource consent conditions 15 days after recommissioning. During the whole emptying operation all downstream monitoring bores remained compliant for faecal coliform and total nitrogen testing.

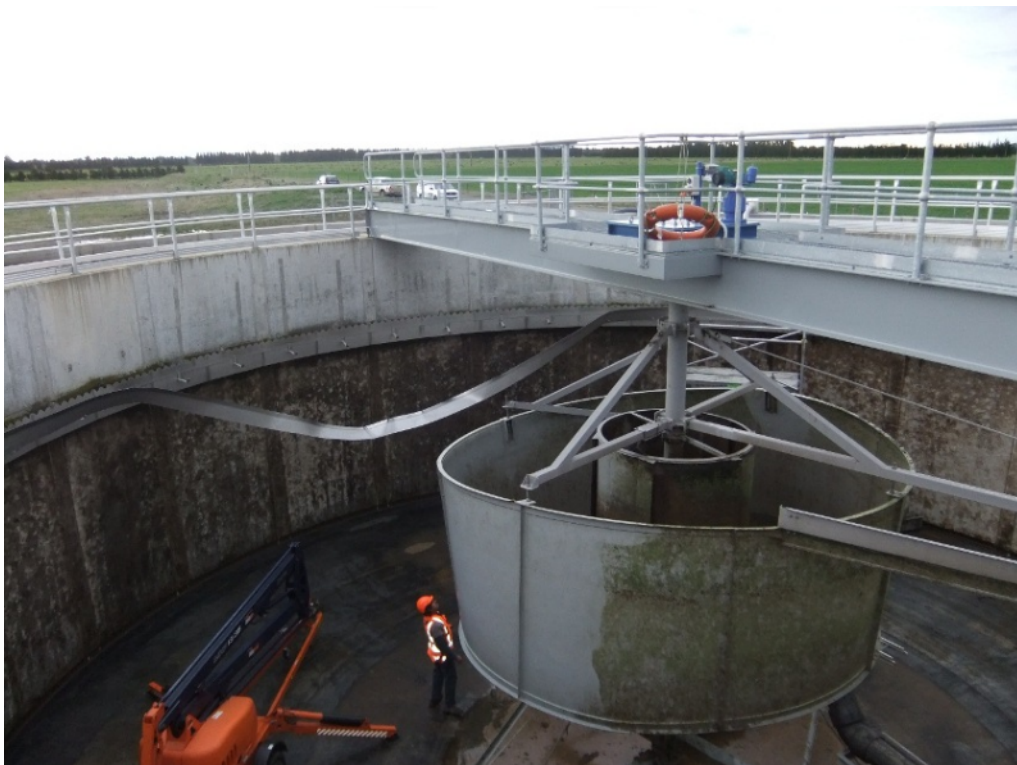
In the clarifier, around a third (15m) of the overflow weir had come away from the wall as a result of the scum collection arm support breaking, shearing off at the welded interface. The UV system was covered in around a foot of water from the bioreactor, and wastewater from the initial quake had obviously caused a tidal wave (or “poonami” as it was so elegantly described) that had allowed the water within the plant escape up and over the 1.2m high wall.

Photograph 2: Emptied Clarifier - Pines Wastewater Treatment Plant - 5 Sept 2010

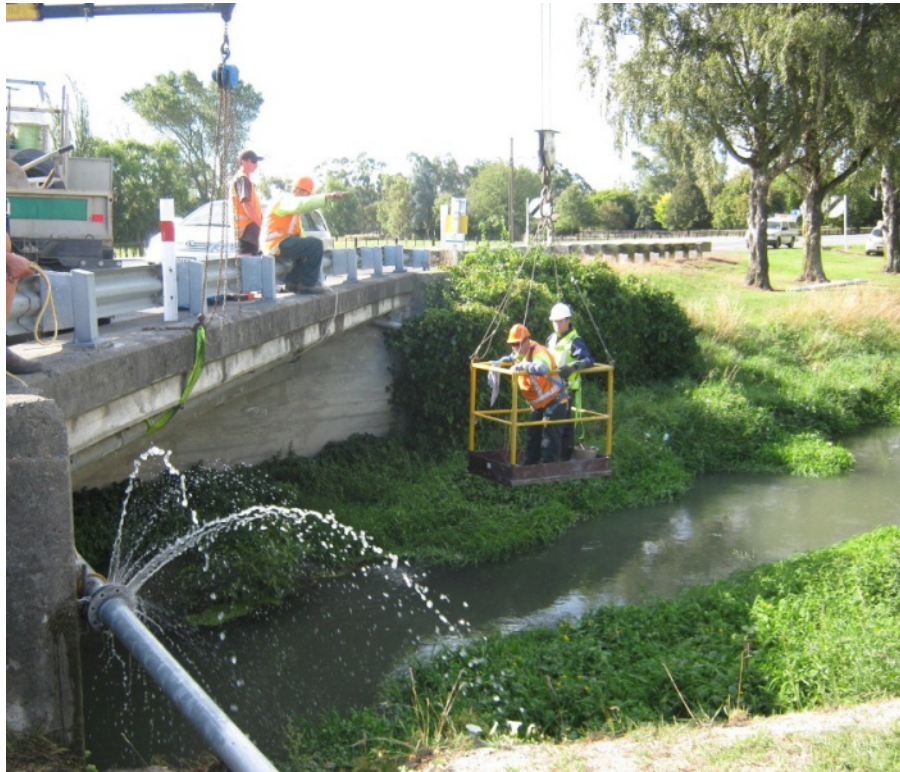
Photograph 3: Breaking Pipe at Tai Tapu
