NATIONAL ASBESTOS CEMENT PRESSURE PIPE MANUAL

Volume Two

TECHNICAL/SUPPORTING DATA

Second Edition | February 2017

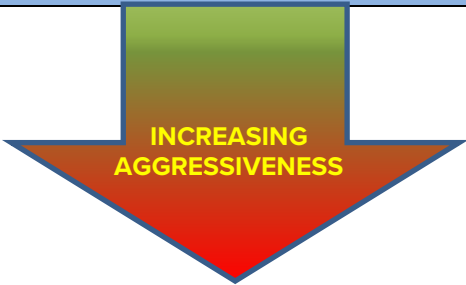
Figure 2-2 Relative Aggressiveness of Soils⁴

Figure 2-2 has been adapted from a CIRIA Report³. It shows the relative aggressiveness of soils typically found in pipeline trenches and as pipe bedding.

Grain Size Criteria	Aggressiveness (Low to High)
Gravelly soils

Sand	
Silt	
Clay	
Peat & other Organic soils	
Aggressive fill or contaminated materials

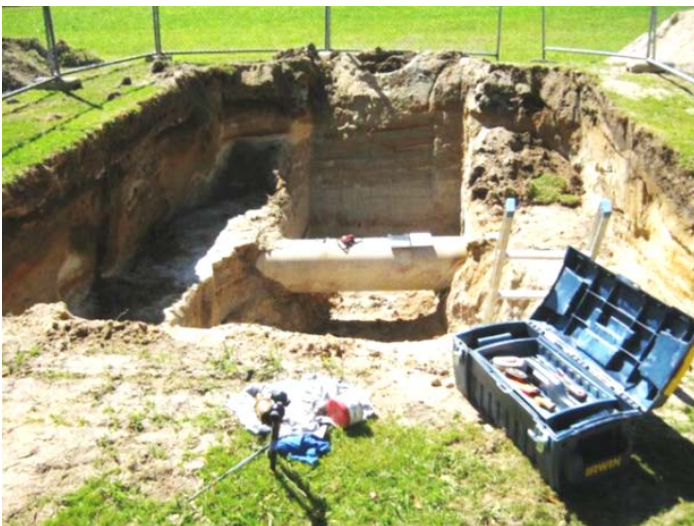
Figure 3-1 Shows a Well-Planned Excavation

During excavation, take care in exposing the pipe, so the pipe bedding can be observed and recorded, the presence of rocks or other deleterious materials and / or voids under the pipe can be observed and photographed.

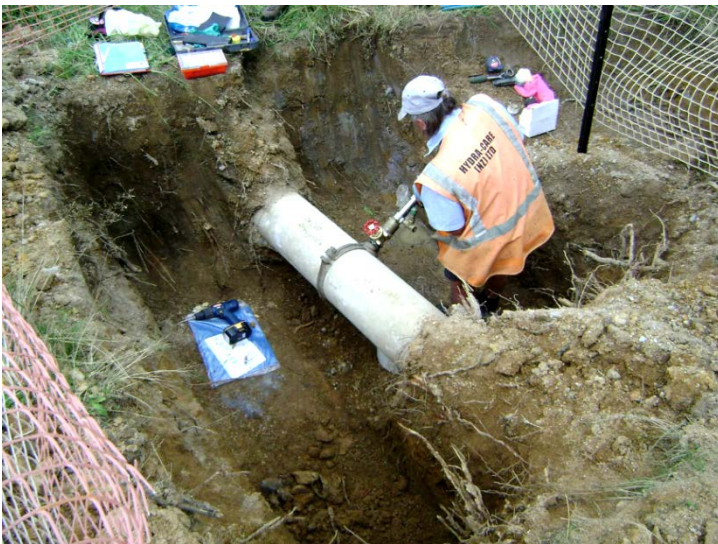
Figure 3-2 Recovery of an AC Core Sample

- Carefully clean the pipe exterior to remove any native soil, bedding material or other debris. Take care not to damage the surface of a softened pipe or to remove any manufacturer's markings that may still be visible.
- Accurately measure and record the circumference (OD) of the pipe barrel to the nearest 0.5 mm preferably using a diameter tape (π tape). The pipe circumference can be measured with a flat steel tape and the OD calculated by dividing by π . The pipe OD is particularly important when recovering a core sample.
- Core samples should (preferably) be at least 40 mm in diameter. Care is required to avoid causing the core to delaminate during recovery.
Note that core samples can fall out of the hole saw and be lost inside the pipe, the risk of this happening can be minimised by fixing the take-off clamp or tapping band horizontally or at 45° (see Figure 3-2).

- Mark the location for cutting the pipe (if taking a full sample) or, fit a stainless steel off-take clamp or tapping band¹⁴ (refer to Figure 3-2) in preparation for the recovery of a core sample.

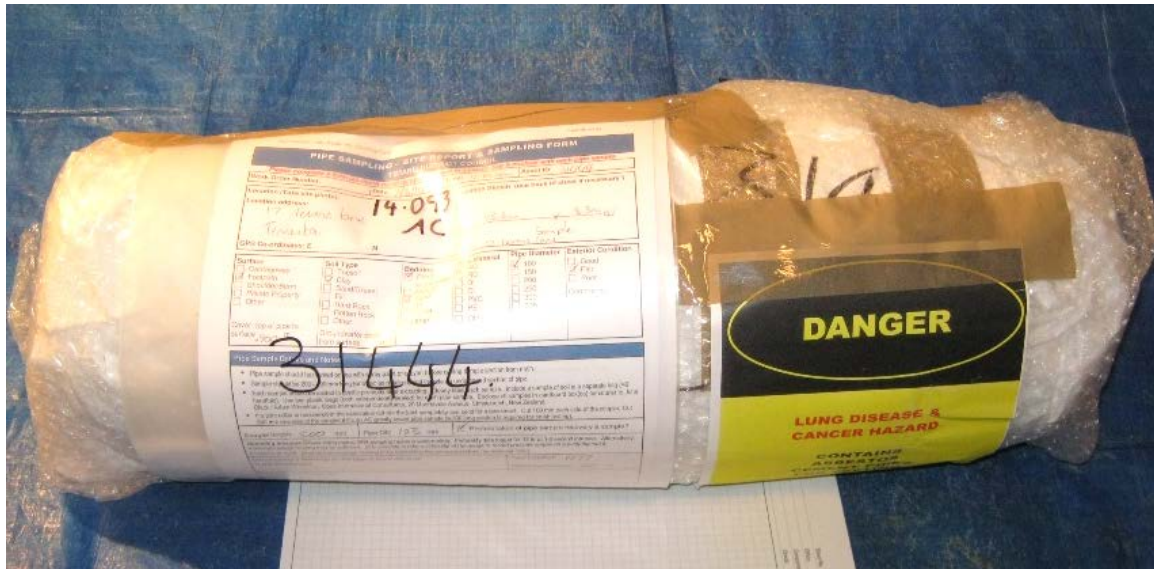
This is an example of a well wrapped AC pipe sample. The asbestos warning label is clearly visible as well as the pipe sample recovery report and Asset ID. Note also the bubble wrap at the pipe sample ends.

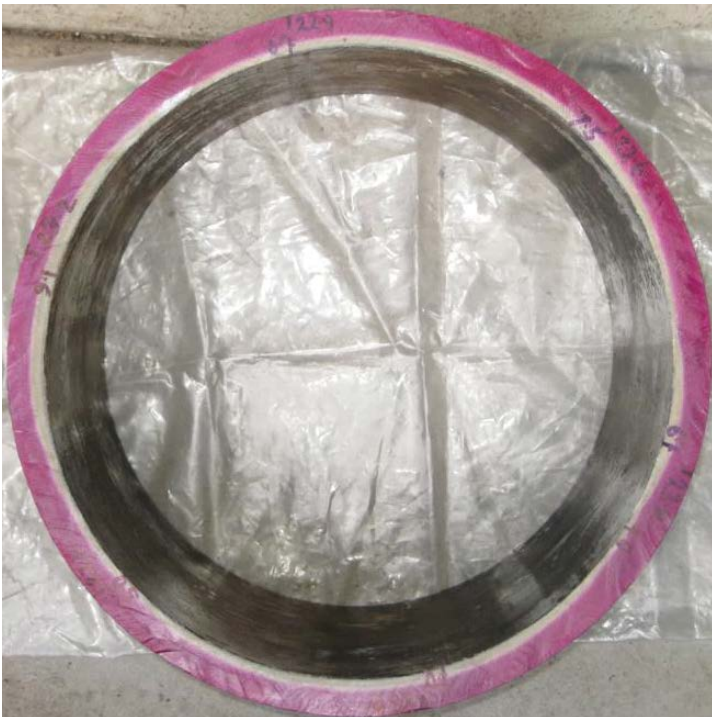
Figure 3-4 Phenolphthalein Solution Applied to a Freshly Cut Pipe Sample End

Phenolphthalein is a chemical powder that is dissolved in alcohol and is mixed with water to produce a colourless liquid that changes to a magenta colour (refer to Figure 3-4) when applied to sound cementitious material that has a pH > 8.3.

The phenolphthalein solution is best applied as a fine spray. To avoid potential running of the solution and migration of any remaining asbestos cement surface dust, the prepared surface should be laid flat and no more spray than necessary applied.

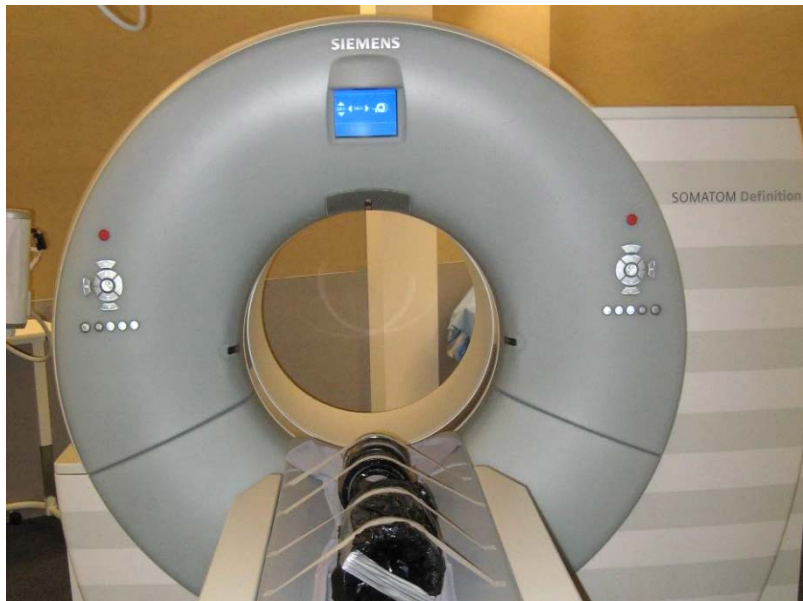
Figure 3-5 CT Scanner (Siemens SOMATOM) Loaded with AC Pipe Samples

Figure 3-5 shows some pipe samples loaded on the scanner table prior to being scanned.

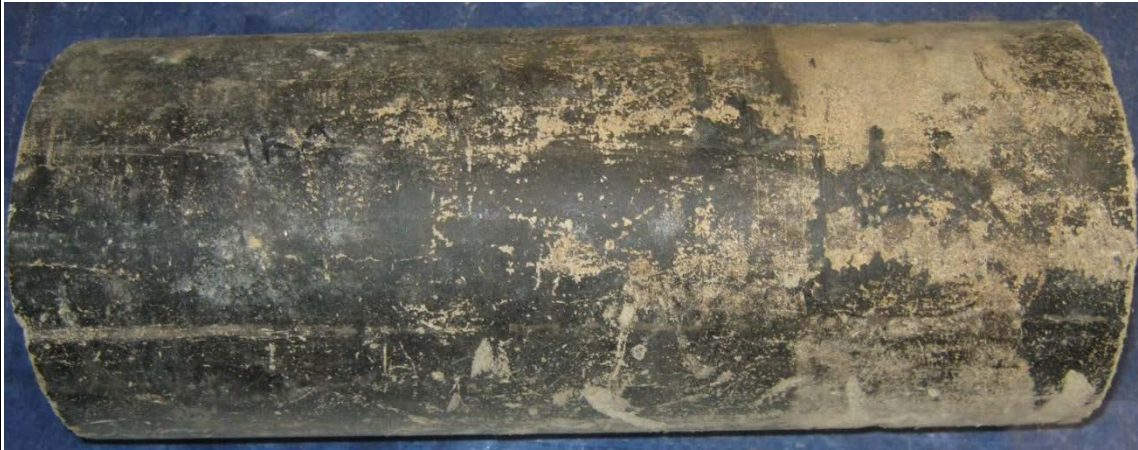
B1-1: Typical external view of an Everite pipe. Approx 50% of the bitumen coating is remaining, however, the CT scan confirmed that it was providing little to no protection against deterioration.

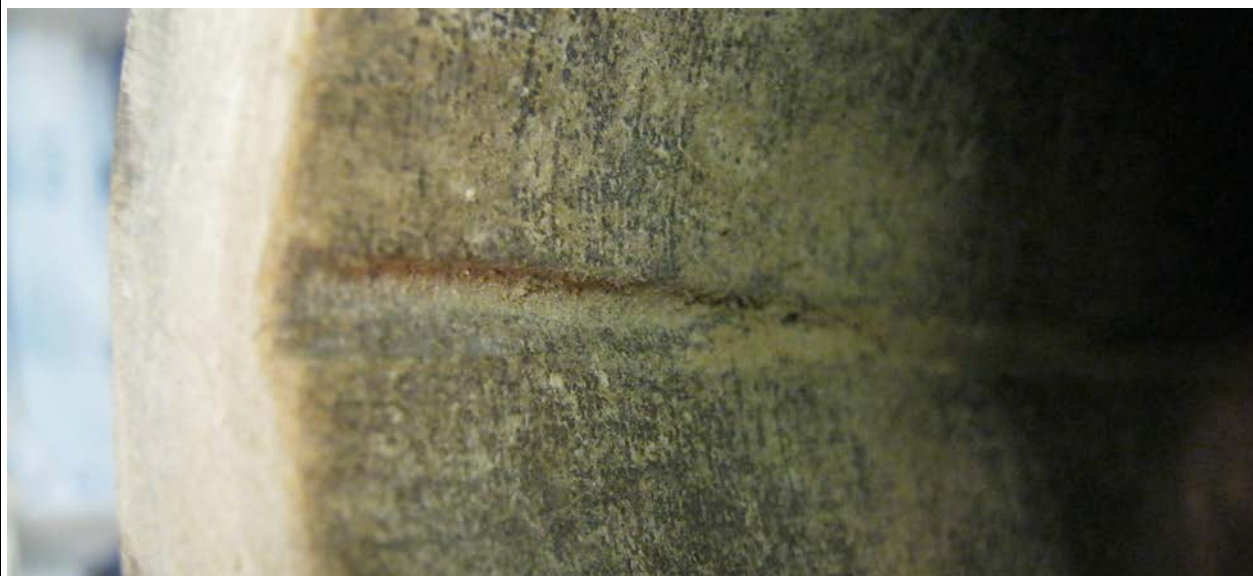
B1-2: Internal view of an Everite pipe, the bitumen lining is still visible. The longitudinal seam from the mandrel joint is clearly visible.

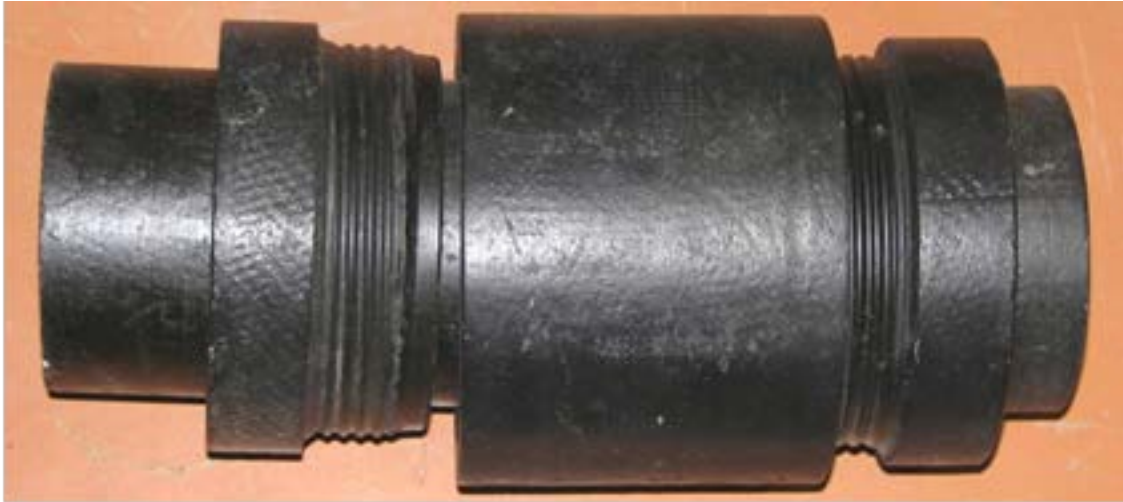
B1-3: Photograph of Everite screw joint disassembled.

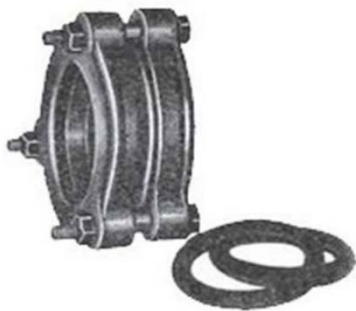
B1-4: Photograph of a Cast iron detachable (gibault) joint.

Used in NZ from 1937 to approx. 1957 for nominal bore pipes $\geq 6''$ (150 mm), consists of the following components:

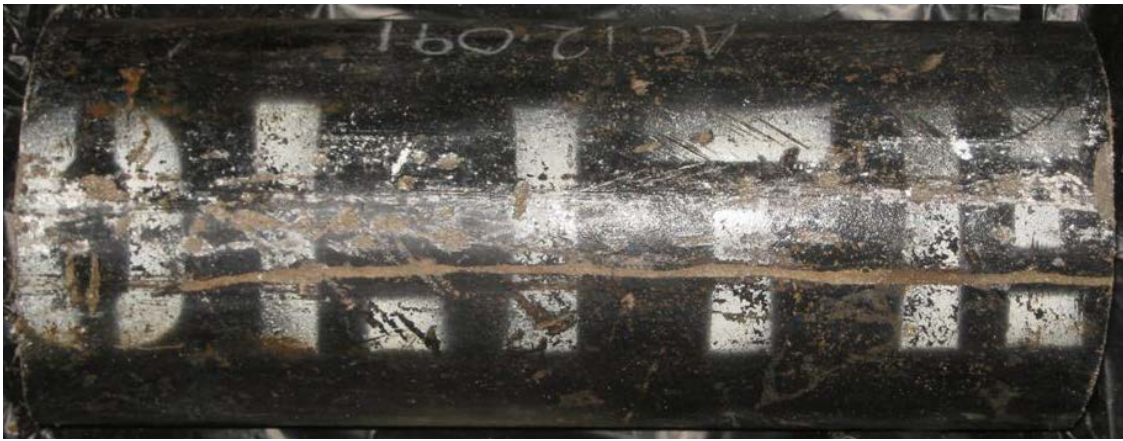
B2-1: Early Fibrolite pipe (circa 1954), bitumen dipped: - White stencilling reads “Fibro**OLITE** pressure pipe”.

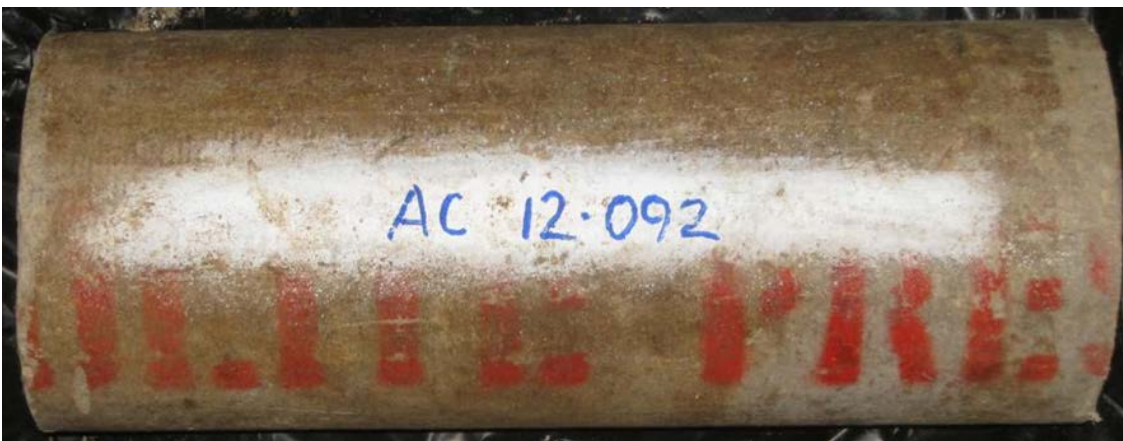
B2-2: Fibrolite pipe, circa 1961, - Red stencilling reads “Fibro**OLITE PRES**sure pipe”.

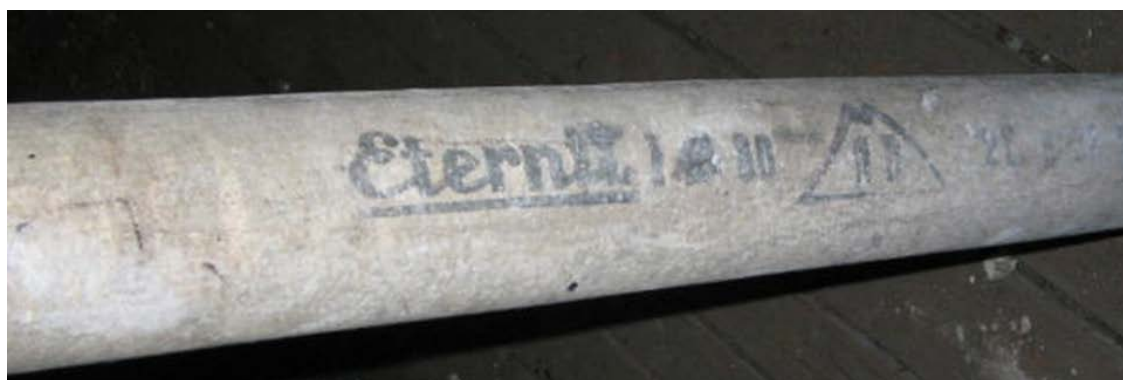
B3-2: Eternit wastewater pipe, installed in an above ground application.

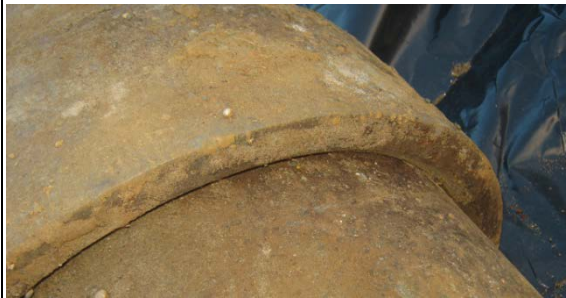
B3-5: DN 500 Simplex joint from a trunk watermain.
