OKARA PARK PUMP STATION UPGRADE

E W Thorn and F Richter Opus International Consultants Limited

ABSTRACT

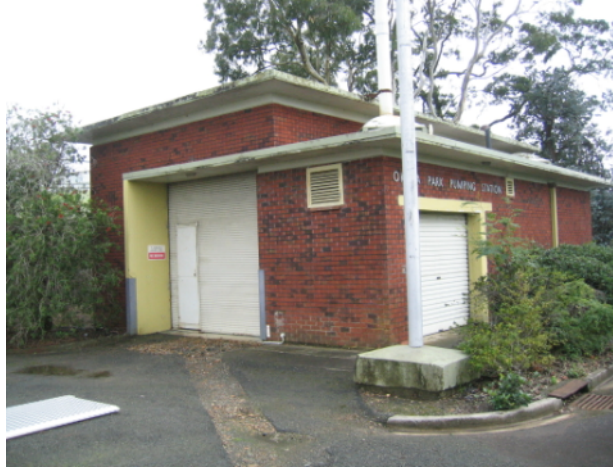
Photograph 1: Original pump station building

Until 1967 sewage from Whangarei flowed to a large septic tank at Okara Park, from which the treated effluent flowed to the Whangarei Harbour. In 1966/67 a pump station was built on the site to pump flow to a new treatment plant about 1.6 km away in Kioreroa Road. The pump station was connected to the treatment plant with a 600 mm diameter reinforced concrete rising main. The pumping station had a separate wet well where the incoming sewage entered and a drywell in which the pumps and valves were installed. It had four J. J. Lee Howl pumps installed, two of 60kW, and two larger pumps of 100kW. The pump station had a claimed maximum pump capacity of 570l/s, however the actual maximum capacity was probably less than this figure.

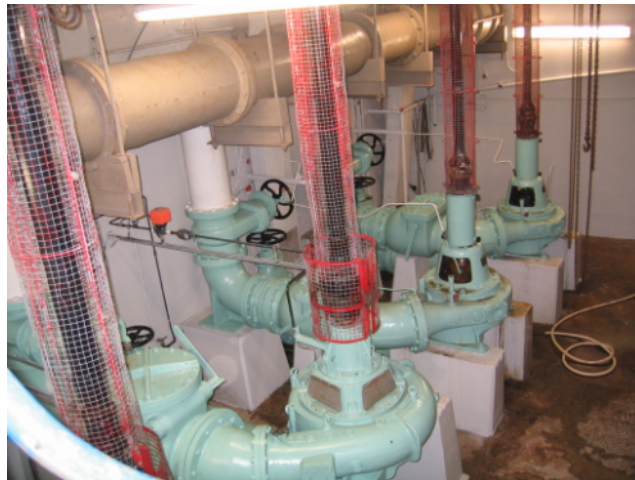
Photograph 2: Original pump station dry well

In 1990 the two smaller pumps were replaced with two 250 kW pumps, installed on the original suction pipework. The fluid velocities in the inlet pipework were about 8 m/s which was the likely cause of cavitation problems that the pumps suffered from. Opus measured the actual capacity of the pump station at 630 l/s with these pumps installed prior to any upgrading works.

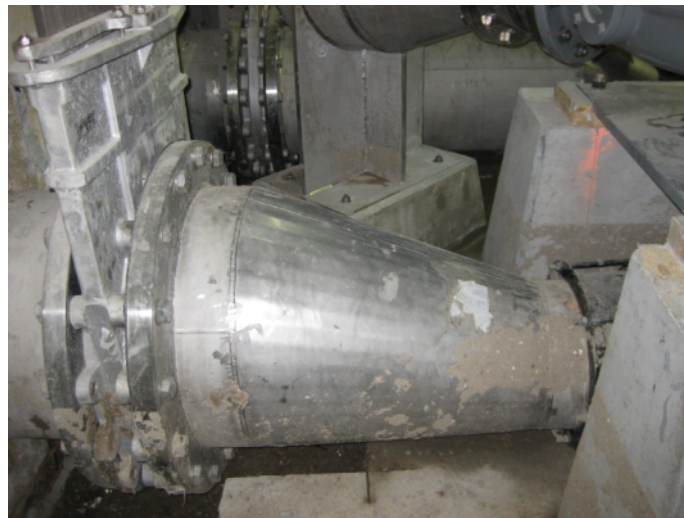
- Cutting the suction pipework flanges slightly into the pump station floor to gain about 1cm.
- Using eccentric reducers on the connection from the suction pipework to the pump flange to keep the pump inlet as low as possible.

Photograph 3: Eccentric taper and flanges cut into floor

The selected pumps were chosen not just for their adequate performance but also because they were shorter by a few cm than the other pump manufacturers could provide. But even with the more squat pumps a number of other measures were necessary to enable the pumps to be installed. These included:

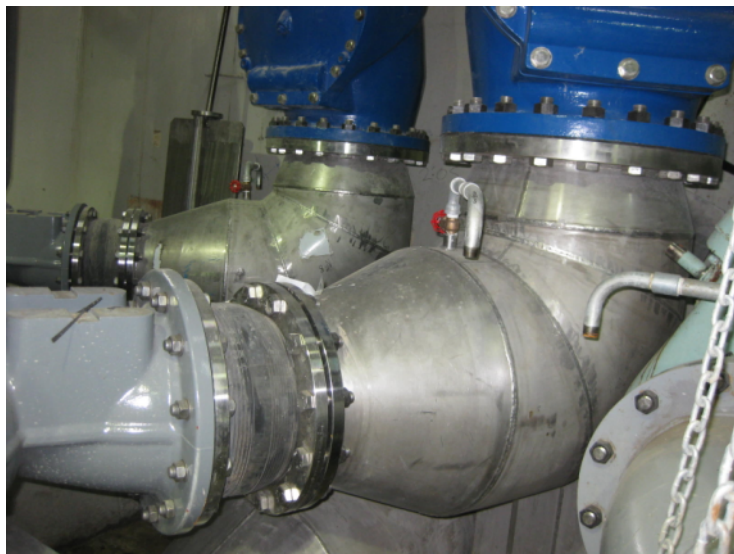
New discharge pipe was installed to serve the two larger pumps. The space available to install the second rising main within the station made it necessary to specifically design every taper, bend and tee. The bends and tapers were combined into one fitting to enable them to be built shorter; it was also necessary for the bend radius to be less than desirable because of the limited space.

The discharge pipework had to be installed clear of the existing rising main to allow the station to remain operational while the new pipework was being installed.

Photograph 5: Discharge Bends off pumps

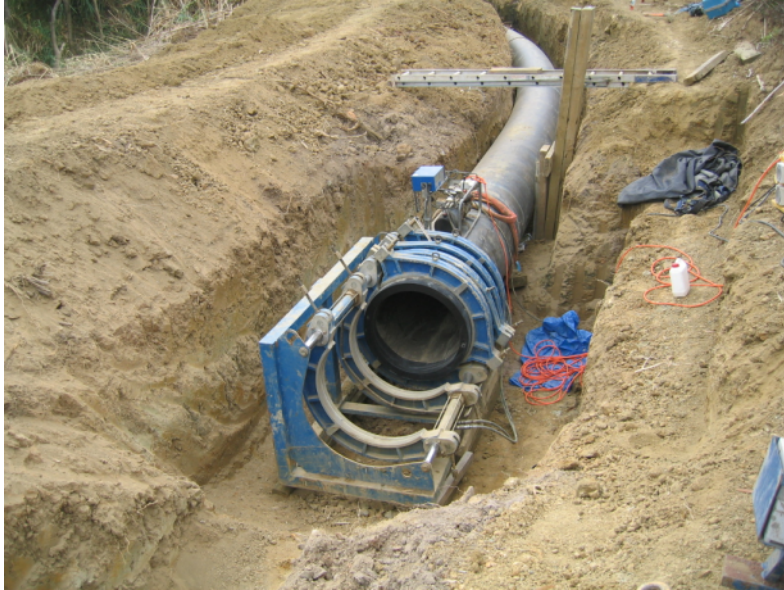
A new duplicate DN800 PE100 SDR13.6 rising main was designed and installed from the pump station to the treatment plant. For most of its length the rising main follows a different route from the existing rising main, which lessens the risk of one single event causing the failure of both rising mains.

Photograph 6: Rising main under construction

The existing rising main was already at its maximum capacity. It was originally a 1,600m long 600mm diameter RCRRJ pipe, which had suffered from a number of failures. In 2002 385m of the pipeline was replaced with a DN630 SDR21 polyethylene (PE) pipe. A further 330m of pipeline was replaced with PE in 2008. Increasing the pressure to get more flow through the existing pipeline was not a viable option. The pipeline would almost certainly have failed if the pressure in the pipeline was increased significantly.

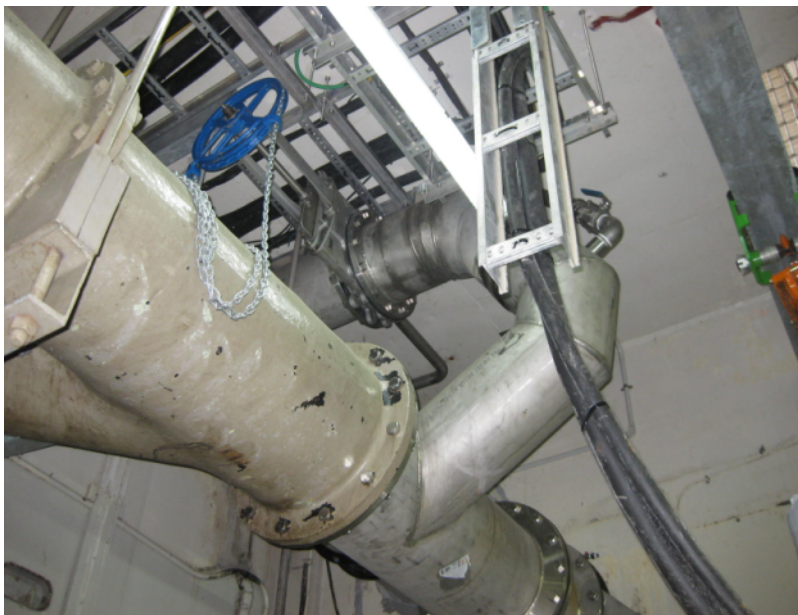
For general day to day operation the two larger pumps pump through the newer, larger rising main and the two smaller pumps pump to the old rising main. A cross connection between the two mains within the pump station enabled the flow from all pumps to be diverted to one rising main if required.

Photograph 7: Cross connection between rising mains

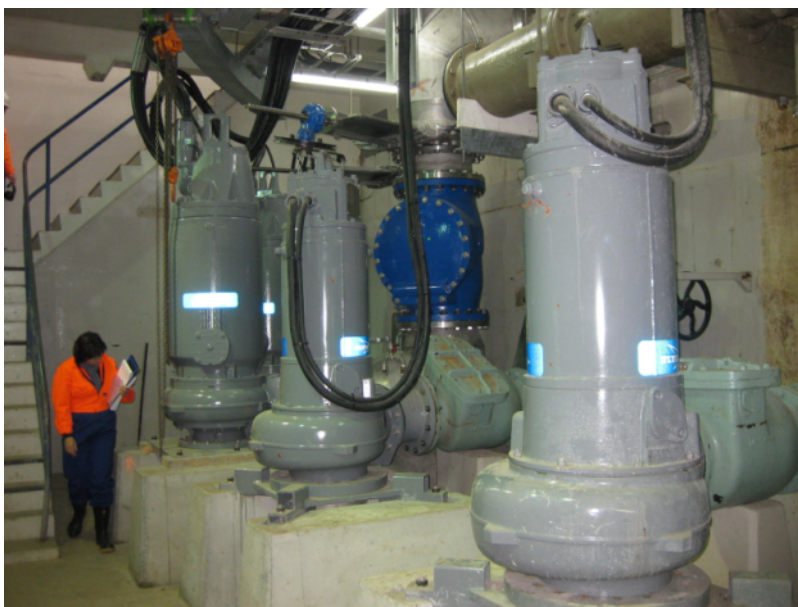
A number of pump and rising main options were investigated and the final chosen pumps were two Flygt NT3306/665 (curve 53-670, 445mm impeller) dry-mounted submersible pumps with 75kW motors and two Flygt NT3312/835 (curve 53-670, 585mm impeller) dry-mounted submersible pumps with 250kW motors.

Photograph 8: New installed pumps

The two smaller 75kW pumps can each pump about 270 L/s (Range 225 – 325 L/s) into the older rising main or, with both pumps running on a duty/assist basis, they can pump up to about 380 L/s (range 335 – 475 L/s).

The two larger 250kW pumps can each pump about 630 L/s (range 530 – 670 L/s) into the new rising main. This is about the same flow as the four previously installed pumps could pump if all were operating together. With both 250kW pumps running on a duty/assist basis, they can pump about 950 L/s (range 800 – 1,020 l/s). Again the exact flow is dependent on wetwell level and pipe friction.
