THE CHRISTCHURCH OCEAN OUTFALL - FROM DESIGN TO COMMISSIONING

Ron Fleming – URS New Zealand Ltd, John Moore – Christchurch City Council, Ian Campbell – McConnell Dowell Constructors Ltd, Cliff Tipler – URS New Zealand Ltd

ABSTRACT

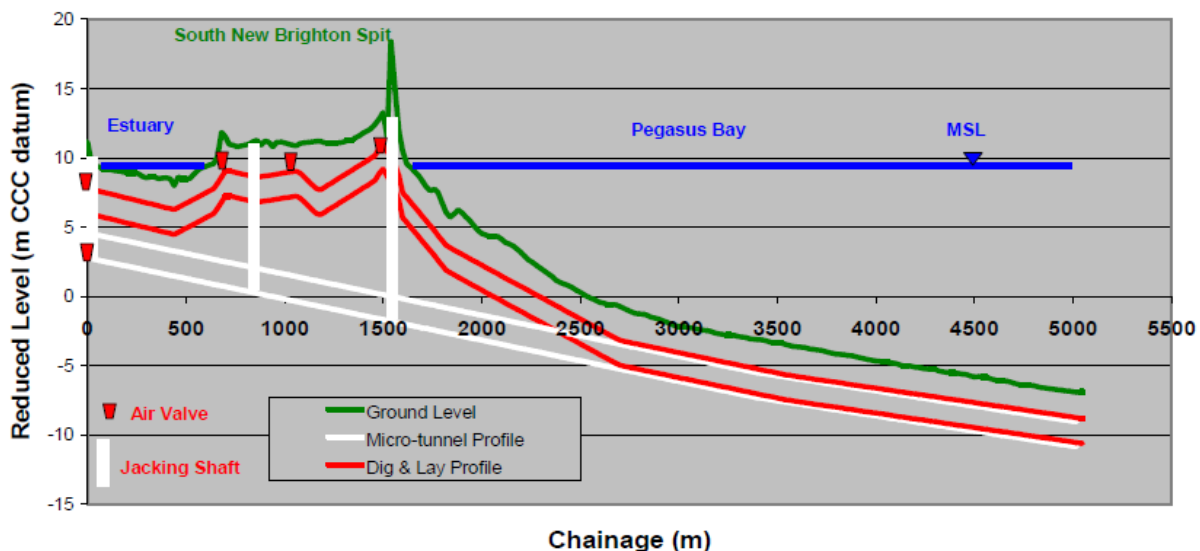
Figure 2: Microtunnel and Dig and Lay Pipeline Profiles

Dig and Lay with the proposed pipeline invert generally laid at between 3.0 and 5.0 m below the current ground surface, following the topography, with increased depths at the pump station location and within the South New Brighton Beach fore-dune deposits. This dig and lay construction was expected to be undertaken using a trench up to 5 m depth. The off-shore pipeline would lie between 2.0 and 4.0 m below seabed level.

Microtunnel/Pipe Jacking with the proposed pipeline laid at a constant gradient from the oxidation ponds to the South New Brighton Beach fore-dunes where depth to invert would be

about 11.5 m below ground level. From the fore-dunes to the diffuser, the pipeline would be constructed in a dig/dredge and lay operation with the depth to invert level reducing off-shore to about 4.0 m at the diffuser.

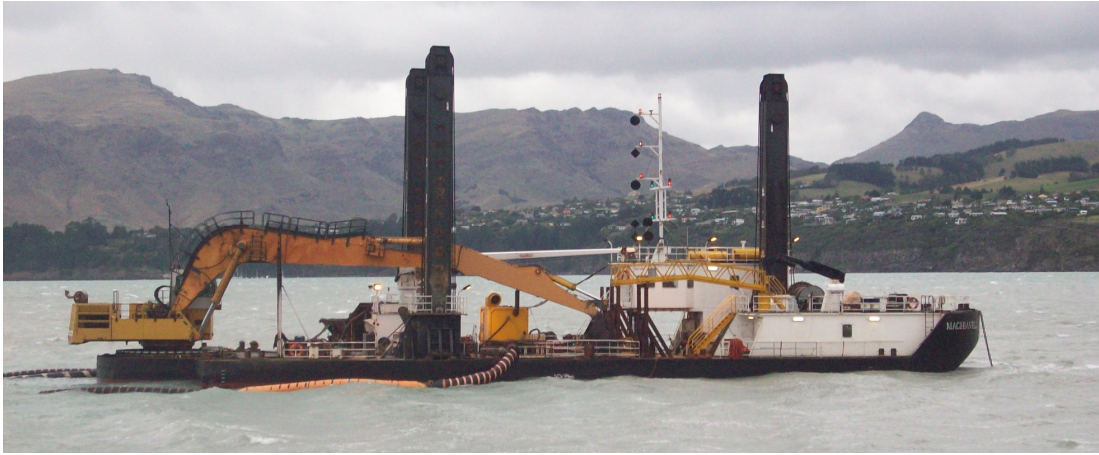
Figure 4 – Machiavelli Dredge

Dredging was commenced by MacDow in November 2007 using the spudded dipper dredge Machiavelli, owned by sub-contractor Heron Construction Ltd, a NZ dredging company. The 53 m barge is fitted with a Liebherr P994 excavator using a 5 m³ bucket with a maximum dredging depth below water of 20.8 m. The Dredge stayed on station by deploying three 30 m long and 60 T spuds and achieved the desired excavation with a DipMate RTK GPS bucket positioning system to dredge a 4 m deep trench, 4 - 6 m wide at the bottom with 1V:3H batters. As each section of trench was completed, a 360 m long pipe string was towed into Pegasus Bay from the storage area in Diamond Harbour to be sunk into the trench and joined together prior to being backfilled.

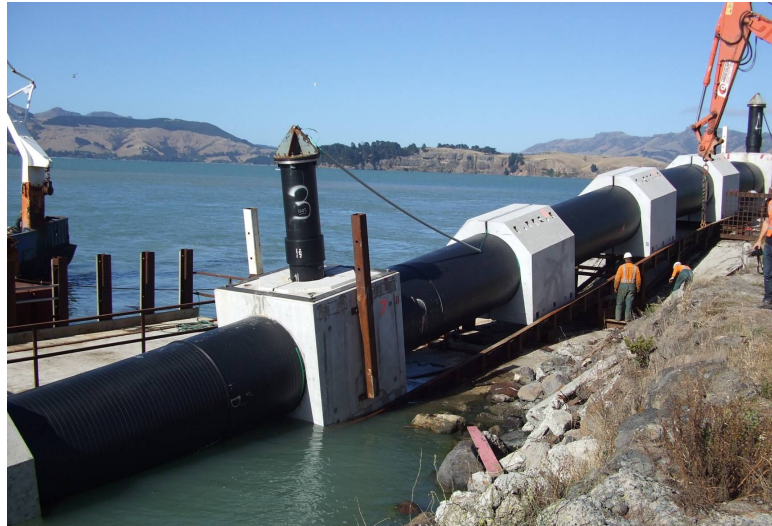
Figure 5 – Launching diffuser section on slipway at Lyttelton CMA

The seven 360 m pipe strings were assembled on a 400 m long slip way construction area at the Lyttelton CMA. After capping and testing to 4 Bar, the completed pipe strings were launched and sunk into a temporary storage area in Diamond Harbour. Pipe strings were refloated, towed out and sunk into position whilst maintaining up to 35T axial tension with a 50T winch on board the Tug and winches on board the Flexifloat crane barge, both on anchor.

The last pipe string installed was the diffuser section, which incorporates the 13 risers each with eight duck bill valves that will discharge the wastewater into the ocean environment. Each diffuser riser was then fitted with a pre-cast concrete over-trawl protection structure to prevent damage from trawlers.

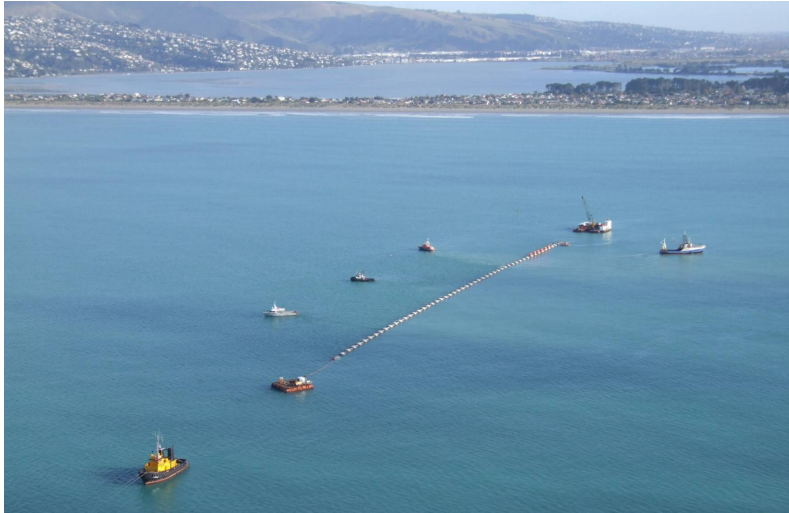
Figure 6 – Pipe string held in position in Pegasus Bay prior to sinking

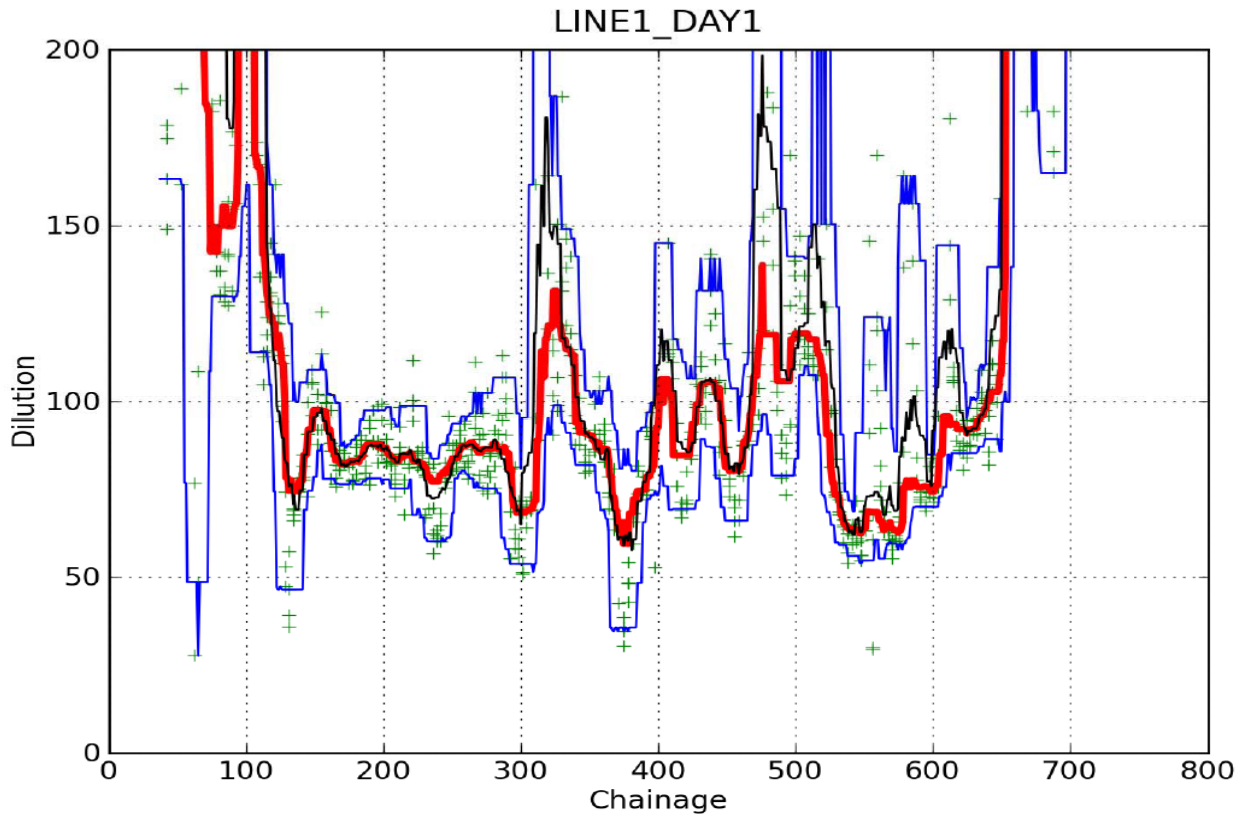
Figure 7: Measured dilutions on Line 1 – Day 1

Six separate transects were sampled away from the centreline of the diffusers. Line 1 represents a distance 200 m to the north of the diffuser (at the edge of the mixing zone). On the first day of testing, the dilutions as measured along that transect are shown on Figure 7 following. This shows that while individual measurements show dilutions less than 61 times, the median of the dilutions along the diffuser is greater than the required minimum of 61 times.
