FLAT SHEET MEMBRANE BIOREACTOR OPERATIONAL EXPERIENCES – A NEW ZEALAND PERSPECTIVE

Coordinating Lead Author: Simon Mason (AWT)

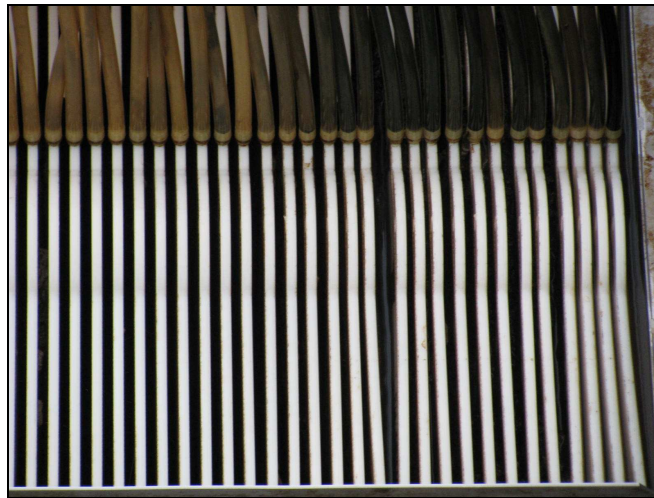
The sludge caking at its worst was extremely thick and well compacted, forming an almost brittle cake, which completely filled the void between the sheets. In slightly less severe cases the space between the sheets was filled but the level of compaction was less, leaving the caking with more typical sludge characteristics. In Photograph 1 below it can be seen that the sludge cake between the sheets is sufficiently thick in places to displace the neighbouring sheet. Photograph 2 provides examples of some of the more severe sheet fouling observed. Finally, Photograph 3 provides three examples of the spectrum of lesser degrees of sludge caking witnessed, including an example of a sheet with no fouling.

Photograph 1: Sludge caking between membrane sheets causing displacement of neighbouring sheets (Te Aroha 24/05/2010)

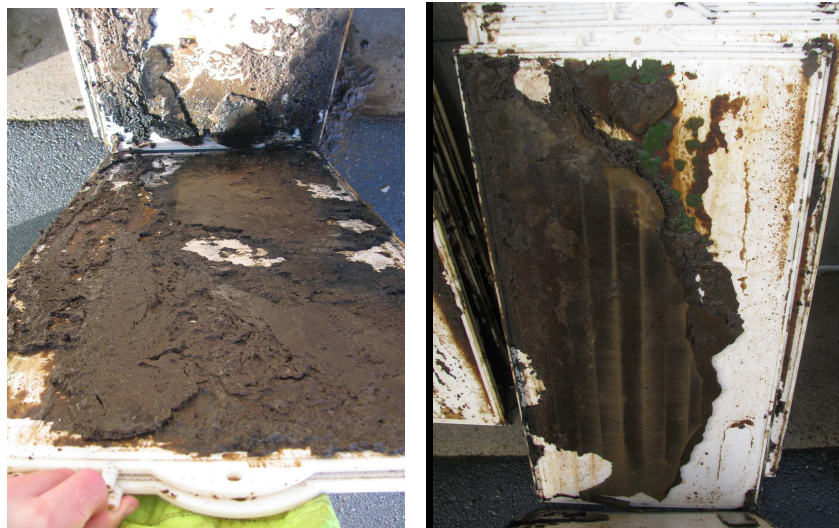
Photograph 2: Examples of severe sludge caking [from left; Te Aroha WWTP (26052010), Te Aroha WWTP (27052010)]

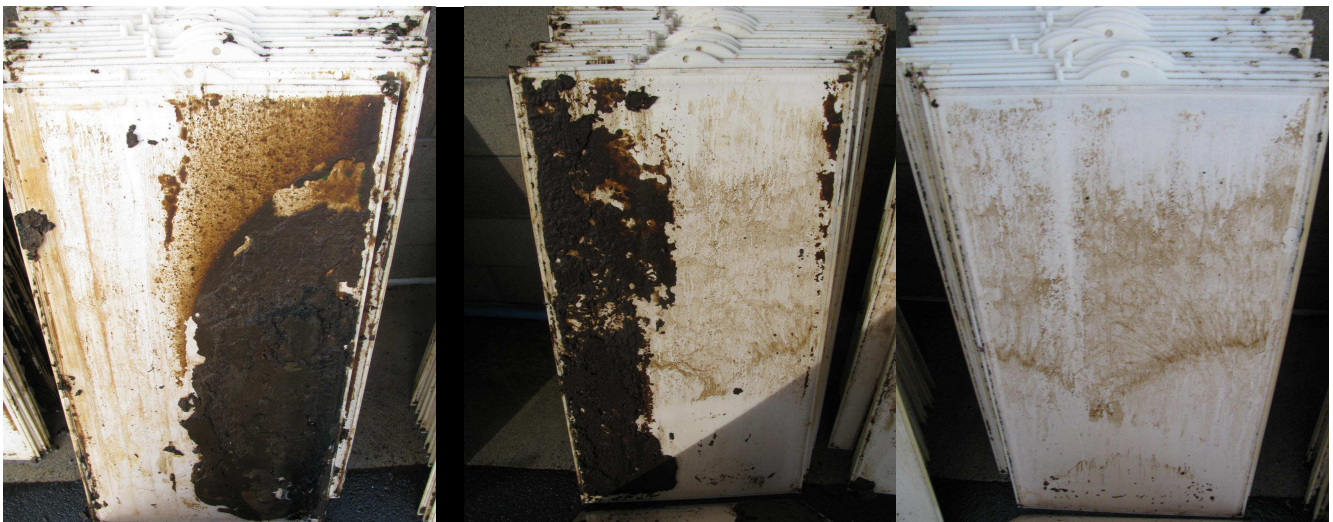
Photograph 3: Examples of spectrum of sludge caking observed

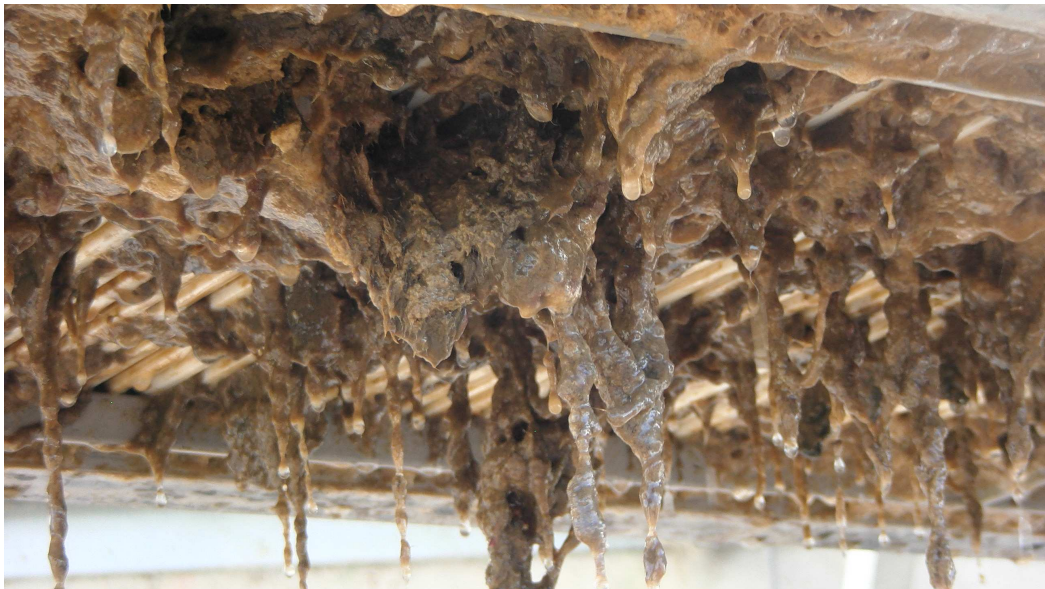
However, from observation it appears the inlet screening is required to do more than simply protect the membrane sheets from physical damage. The inlet screening stage must also adequately remove lint and hair from entering the reactors as the presence of this fibrous material was observed to interfere with the uniformity of the coarse bubble aeration. This is caused by a build-up (agglomeration) of lint and hair at the base of the membrane banks and around the permeate tubes of the lower bank restricting the free passage of airflow between the sheets above the lint agglomerations. Photograph 4 illustrates an example of severe lint/hair agglomeration at the base of a membrane bank. Significant sludge caking was observed between the membrane sheets above.

Photograph 4: Example of lint/hair agglomeration at the base of a membrane module (Turangi WWTP)

It is recommended that screening equipment capable of removing this fine fibrous material is utilised, either in addition to or in place of other types of screening equipment. For example fine aperture rotary drum or band screens which induce a 90° flow direction change through the screening element and a backwash in the reverse direction of flow to remove the screenings from the screening element are significantly more effective in capturing hair and fine fibres.

It also appears that the greater the screenings capture rate the better the performance of the plant. As such benefits are likely to be seen from utilising a fine screen aperture size. It is recommended that a 1 mm screen aperture is preferable for MBR plants. Further still due to the criticality of the influent screening and the severe effects inadequate screening can have on the downstream process, it is recommended that wherever feasible a standby screen of equal specification is provided.

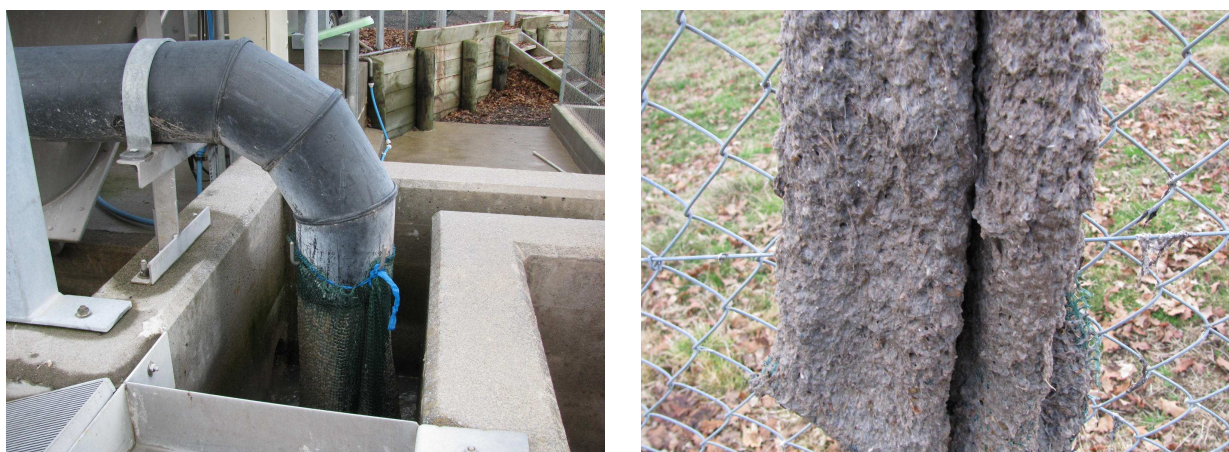
At the Tirau WWTP the operators have employed a low cost, innovative approach to reduce the quantity of lint build up within the reactor tanks. The operators are using 'Copasac' sacks on the discharge of the screen and grit removal to provide additional screening. Currently the sacks are replaced weekly. The plant has been operated in this manner for over a year and a significant decrease in lint build up was noted at the plants most recent inspection (undertaken April 2010). Photograph 5 illustrates the system in place and also displays the quantity of lint captured on a used sack.

Photograph 5: Crude additional screening provided at the Tirau WWTP to reduce quantities of ling entering process

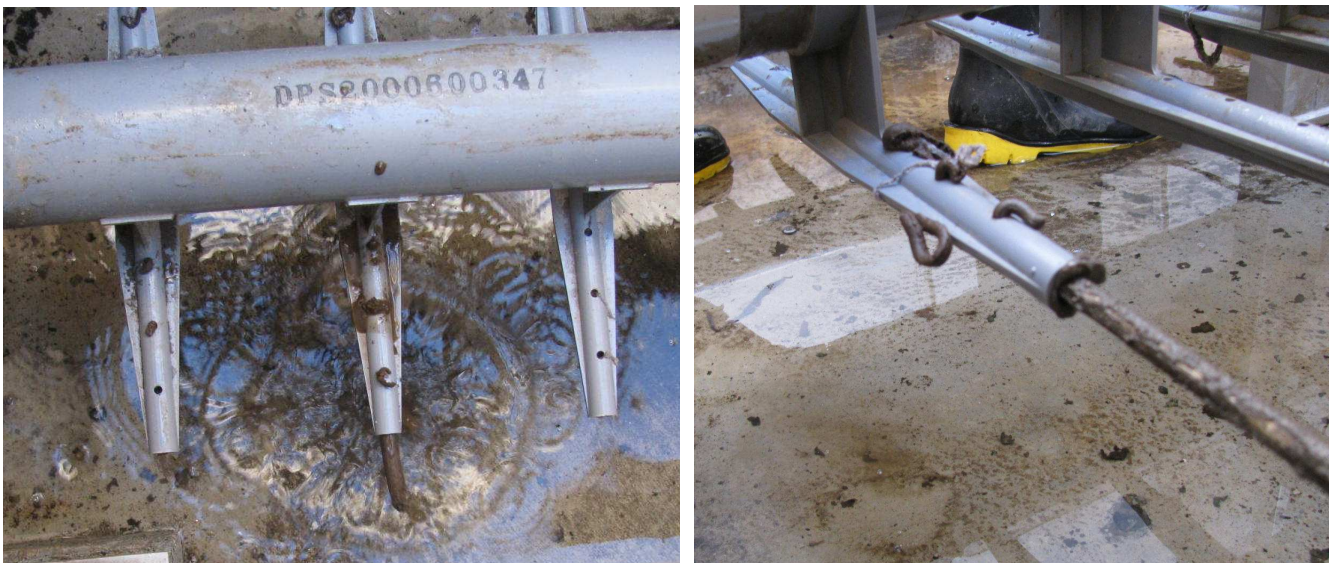
Inspection of the coarse bubble aeration diffusers at both the Turangi WWTP and the Te Aroha WWTP showed significant blockages in both the lateral diffuser pipes and the diffuser nozzles. Steel rods were used to dislodge the sludge from within the lateral pipes and high pressure water was used to remove blockages from the nozzles. A significant amount of sludge was extracted from the majority of the diffusers, however, the areas of poorest air flow were not obviously more significantly blocked than the other areas. Photograph 7 illustrates the diffuser cleaning process.

Photograph 7: Coarse Bubble Aeration Diffuser Cleaning [Te Aroha WWTP]

The degree of coarse bubble diffuser blockage noted during the plant inspections identifies potential deficiencies in the effectiveness of the current diffuser cleaning method. Two alternatives are suggested that may provide more agreeable results:

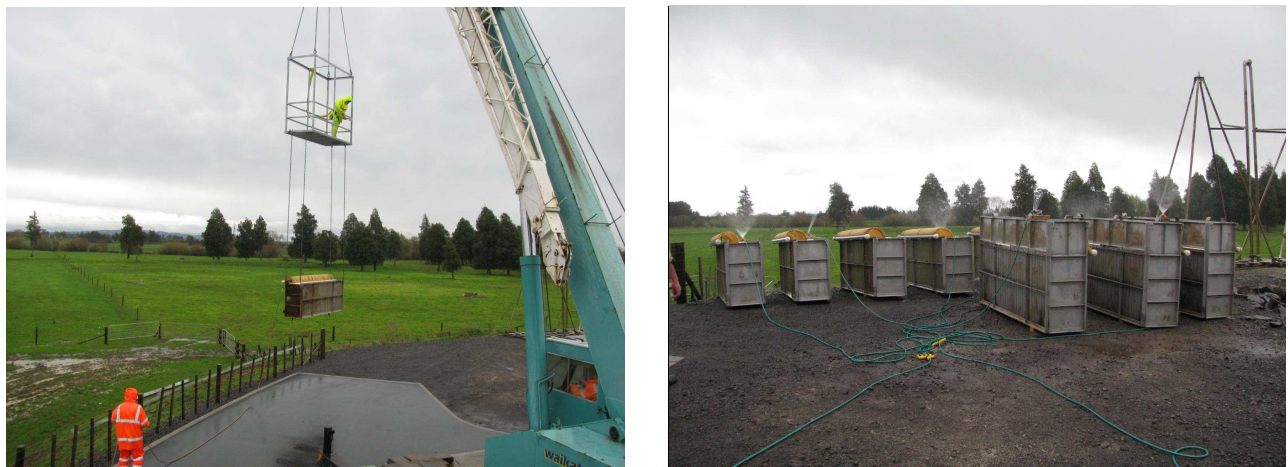
Photograph 8 below presents the man cage in operation, with one of the upper module banks attached in the left hand photograph and on the right the configuration of temporary sprinklers can be seen ensuring the membranes remain wet.

Photograph 8: Membrane Module Removal and Temporary Storage
