LARGE SCALE SEWER OBSTRUCTION – REAL STORY AND IMPLICATIONS EXPLORED

*Timothy Preston, GHD Ltd
Christopher Mance, Christchurch City Council*

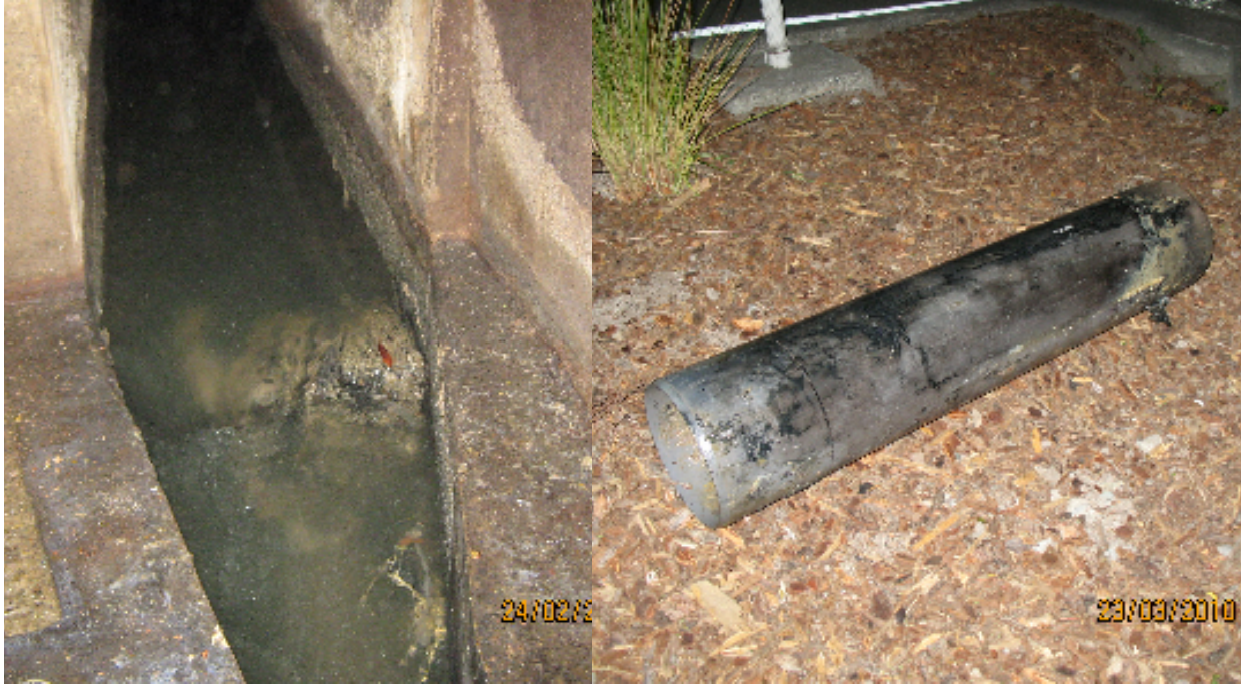
Photographs 1&2: Blocked Flume (AWT 3:35am), Obstruction Removed

City Care, CCC's maintenance contractor was instructed to remove the blockage, and on the morning of the 23rd March 2010, a length of DN225 PVC pipe was removed from the throat of the flume (Photo 2). Immediately, the water level upstream of the flume dropped by approximately 150mm, and the process of getting the Riccarton Interceptor back to operating as originally designed started.

The hydraulics of the trunk sewer literally changed overnight, with velocities improving, and surcharging of the lower reaches dramatically reducing, to the point that previously wet benching in some manholes became noticeably dryer. Jetting of the downstream manholes followed, improving the hydraulics of the line, before a significant wet weather event at the end of May 2010, may have cleared the trunk sewer still further. Photos of the flume after clearance have not been obtained due to the confined space entry requirements for access.

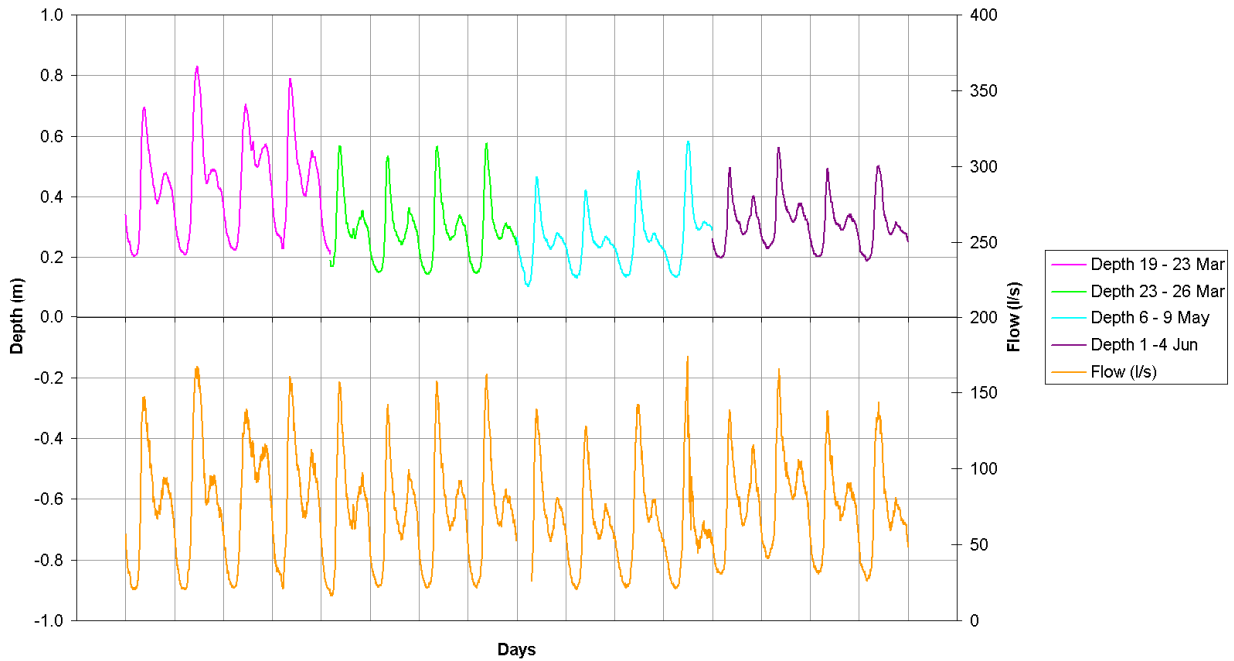
Figure 4: Gauged Depth and Flow Time-series

Depth and flow data from four periods of the Division St flow gauge are presented in Figure 4 below.

This illustrates the dramatic reduction in flow depth that was achieved due to removal of the blockage on March 23rd and the more subtle improvement that was achieved during subsequent jet cleaning on June 6th, against a background of reasonably consistent daily flow patterns.

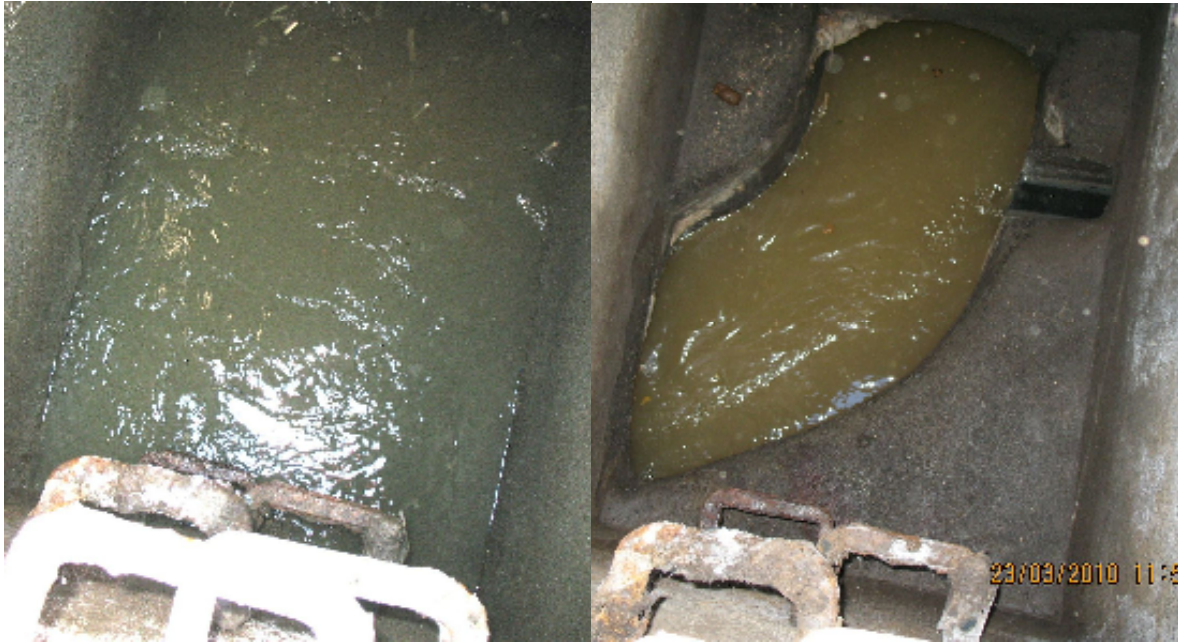
Photographs 3 & 4: Before (10:50am) and after (11:58am) at manhole 2819795, 450m upstream

After removal of the obstruction, previously unseen benching and pipe soffits became visible. The extent of the historical surcharging became evident from signs such as debris on the benching, ragging of the step irons and water marks higher up the manhole walls, but there was now no evidence of recent high level surcharging that had in the past been associated with the Riccarton Interceptor.

Photographs 3 and 4 below show 'before and after' conditions in manhole 2819795, located 450m upstream of the flume. Photo 3 was taken at 10:50am many days before blockage removal. Photo 4 was taken at 11:58am on the morning when the blockage was removed. Model predictions for this manhole are presented in Figure 10 (refer later section 4.3.2).

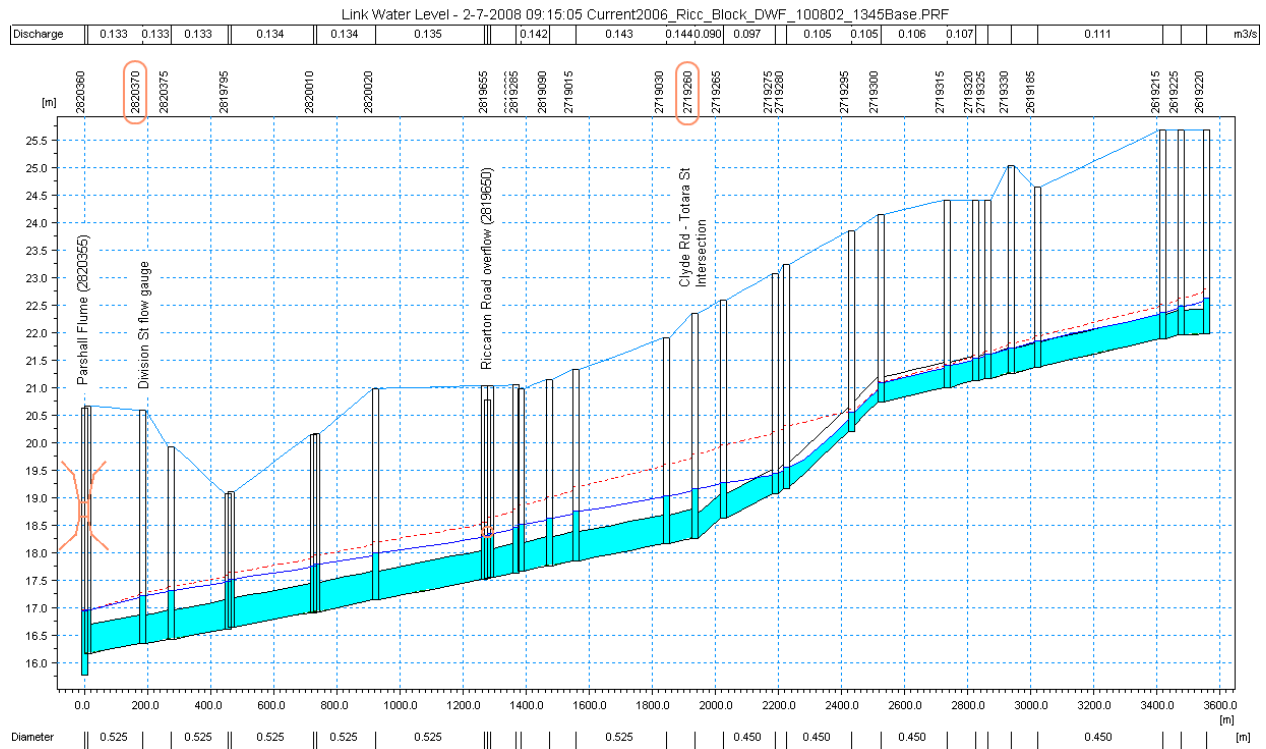
Figure 7: Clean Flume Model Long-section

Model predicted sewer performance upstream of the Parshall Flume for the blocked and cleaned conditions at model time 9:15am is illustrated in the following two figures. This flow condition was selected as it demonstrated the most dramatic difference between blocked and clean sewer performance.

These two figures illustrate the significance of the blocked flume in the 2,000m of sewer upstream of the flume, under conditions somewhat less than peak dry weather flows (blue lines). Pipe full and some minor surcharging are evident in this lower section of the sewer when the flume is in its normal clean condition, but significant surcharging is already evident for the same flows when the flume is in its blocked condition.

The interceptor long-section is presented in Figures 6 & 7 (refer later section 4.3.1) with the location of key features described annotated.

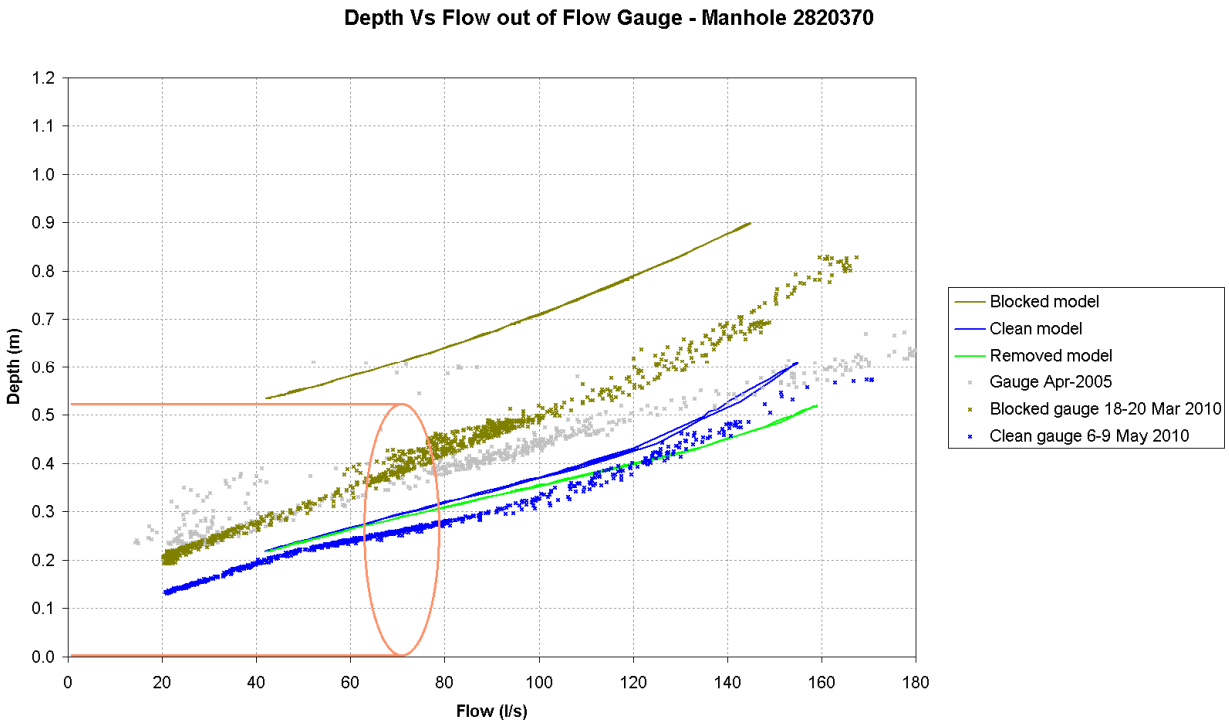
Figure 14: Flow Vs Depth at Division Street Gauging Site 180m upstream (modelled and measured)

Figure 14 illustrates the model predicted distinction between performance of the blocked, cleaned and removed flume, with strong improvement predicted with cleaning of the blocked flume and more subtle improvement predicted if the clean flume was to be removed.

These relationships are also compared with the blocked and clean flume relationships determined from the flow gauging data. As is evident for the clean flume, the measured data (blue line) and model prediction (blue points), match reasonably well. The 25mm discrepancy is considered of minor significance and could reflect either gauge calibration accuracy (noting the field calibration has not been carried out since the March 23 change in hydraulic condition) or could suggest that a minor adjustment in model head-loss parameters could be appropriate.

Comparison for the blocked flume measured data (brown line) and model prediction (brown points), does not match. This difference is most likely caused by overestimating the magnitude of the blockage when determining how it would be represented for modelling. This result suggests that there was probably significant flow passing under and around the blockage which was not evident from visual inspection, thus the actual blockage is measured as having only about half the effect that was anticipated through the modelling work.

For further comparison, data from the April 2005 calibration data is shown to illustrate the possible condition of the flume during this period. Comparison of this data suggests with the 2010 data suggests that the flume was neither clean nor fully blocked during the 2005 calibration data period.
