# DE-SILTING THE HELENSVILLE RAW WATER DAM

*Dr Phillipa Chase, Downer Water.*

*Dr Peter Johnson, Monitoring Technologies Commercial Dive Limited.*

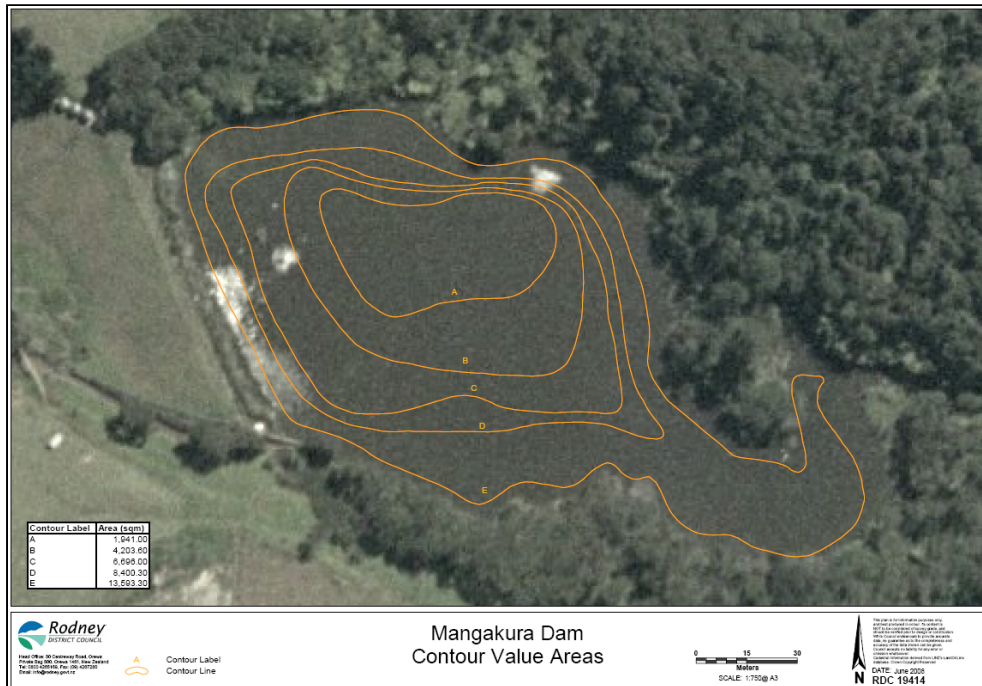
**Photograph 2: Silt Contours in Dam 1**

In the middle of 2008 RDC commissioned Pattle Delamore Partners Ltd to perform a “Silt Survey” of the Mangakura Dam (Dam 1)<sup>ix</sup> to determine the amount of silt deposit in the basin. This survey used a hand held GPS and a probe that was lowered into the dam to measure the top level and thickness of the silt in the dam.

From the survey an underwater contour of the silt layer was produced (see photograph 2) and based upon the silt survey it was determined that between 7,660 and 8,930 m<sup>3</sup> of sediment had built up in the dam. This volume represented approximately 10% of the total storage volume of the dam.

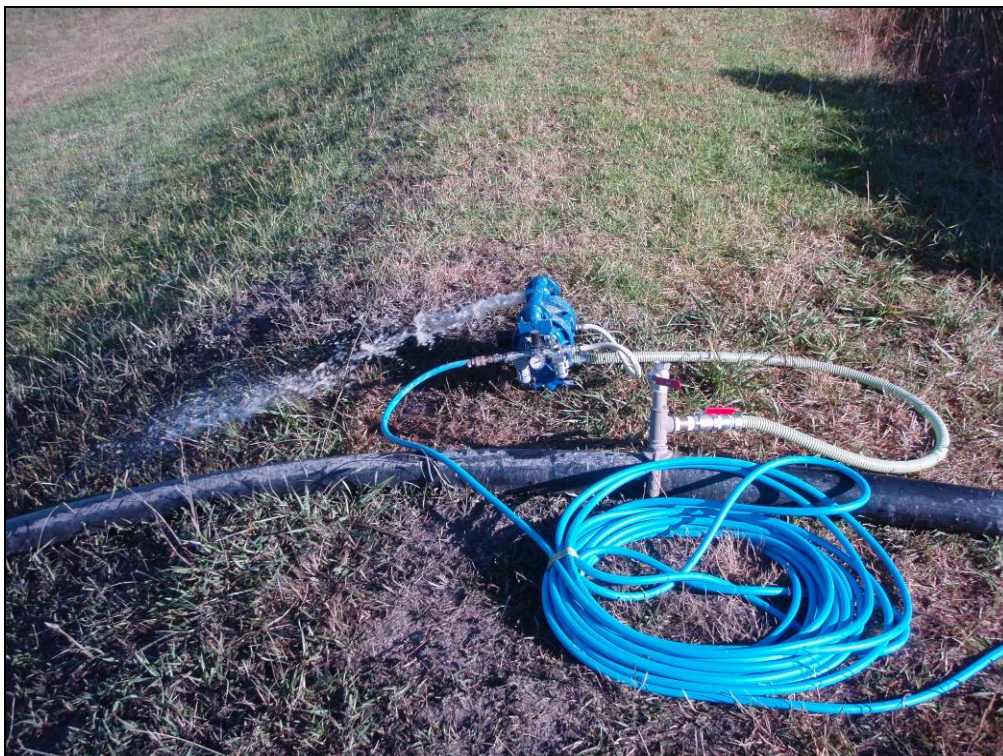
*Photograph 3: Siphon Priming System.*

The dredging and centrate return schematics are shown in Figure 1. The dredging was achieved with a siphon over the crest of the dam. A quick siphon break was used at the apex of the dam to allow the Dive Supervisor to break the siphon should the diver require it. The siphon break point was also used for priming of the dredge. Once the water had flowed through the geo-textile bags it was then allowed to flow to a closed culvert. A high lift diesel driven pump then sucked centrate out of the culvert and pumped it up over the crest of the dam. The centrate was then directed into a hay bale bund and then into the dam via raupo reeds.

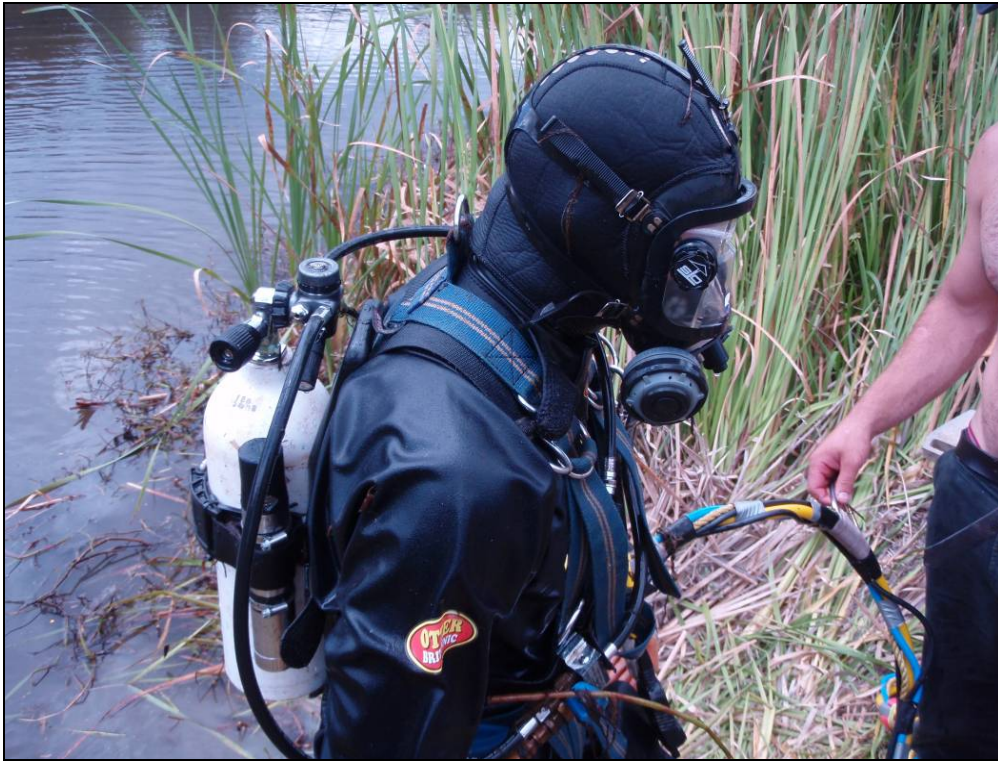
*Photograph 4: Diver on Surface Supply Entering the Water*

The methodologies called for divers to hand dredge the sediment from the Dam. To satisfy the requirements of the prevailing commercial diving standards (AS/NZS:2299:2007) it was necessary to have a minimum dive team size of three (one supervisor, one diver and one standby diver). As dredging was being used it was necessary to have the divers on surface supply and reliable hardwired communications.

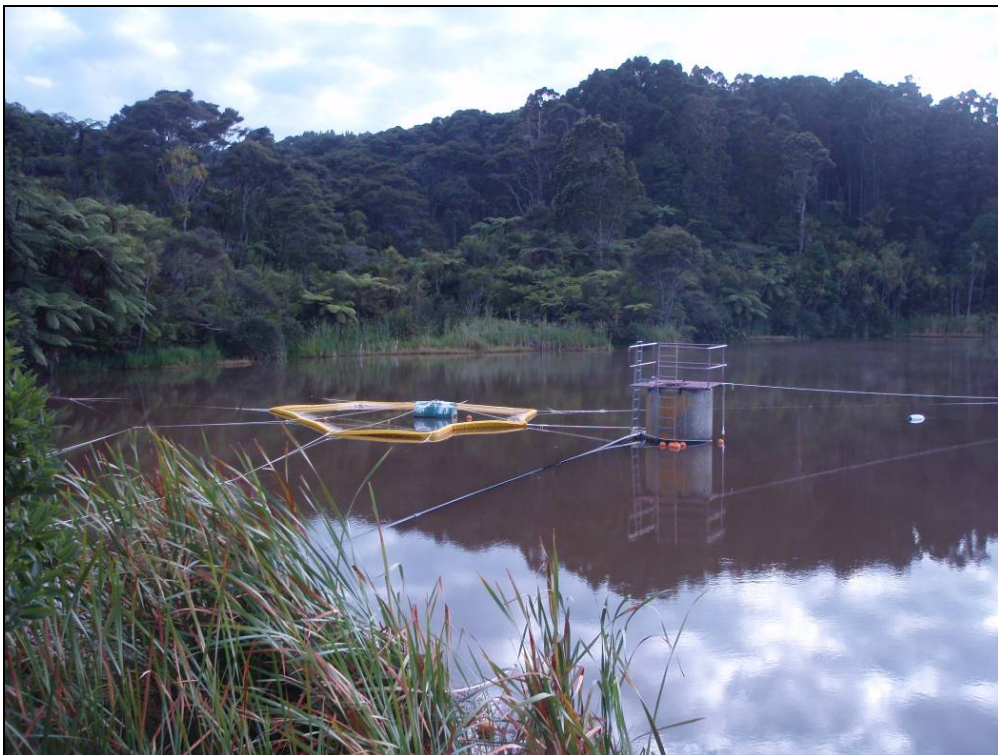
*Photograph 5: Floating Filter Cloth around Intake.*

The first component of the site setup was to isolate the intake by running a floating screen filter cloth around the intake point. This was achieved by using a spider lashing and warratahs to pin the bottom of the filter cloth to the bed of the dam. As the job progressed, the filter cloth was sucked in towards the intake screen. It is recommended that at least a 5m setback is used between the filter cloth and the intake for a project of this duration. Should a longer dredging operation be considered then a greater setback or two sets of floating filter cloth (so one set can be changed with a clean set) should be used.

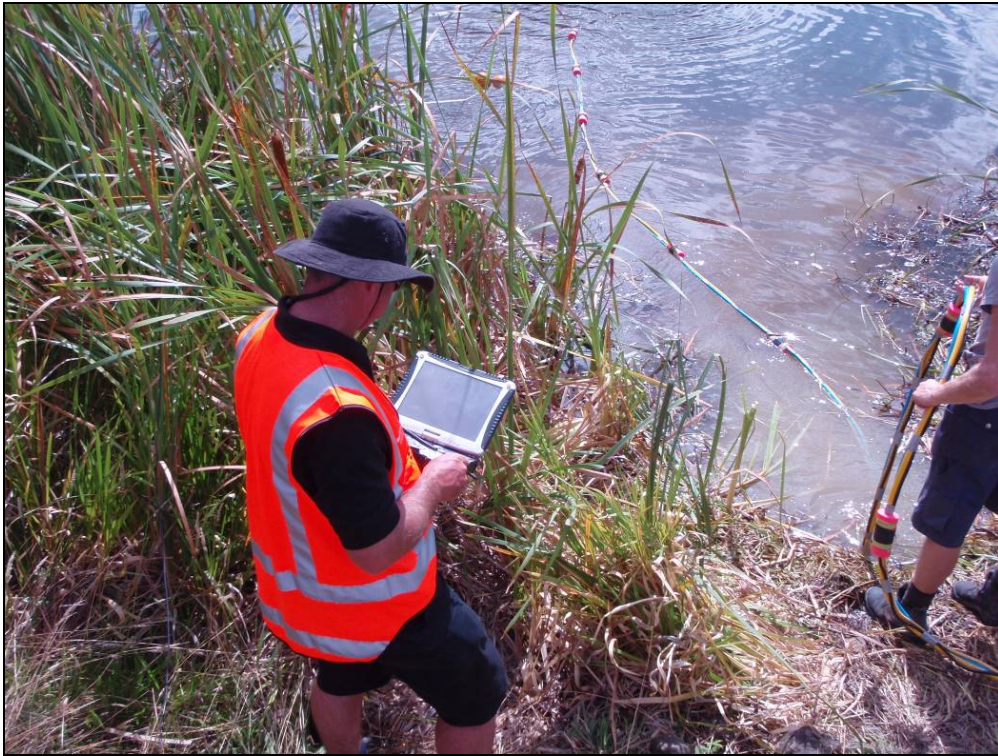
*Photograph 6: Computer Monitoring of Divers in Zero Visibility*

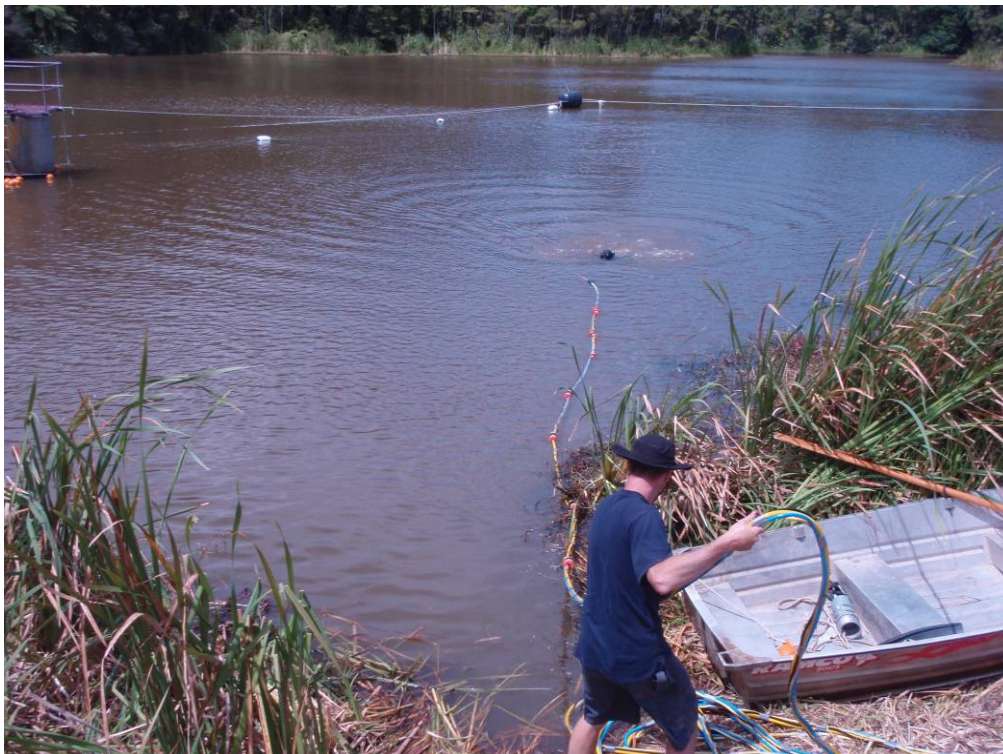
*Photograph 7: Diver on Surface Supply Swimming to Dredge Face.*

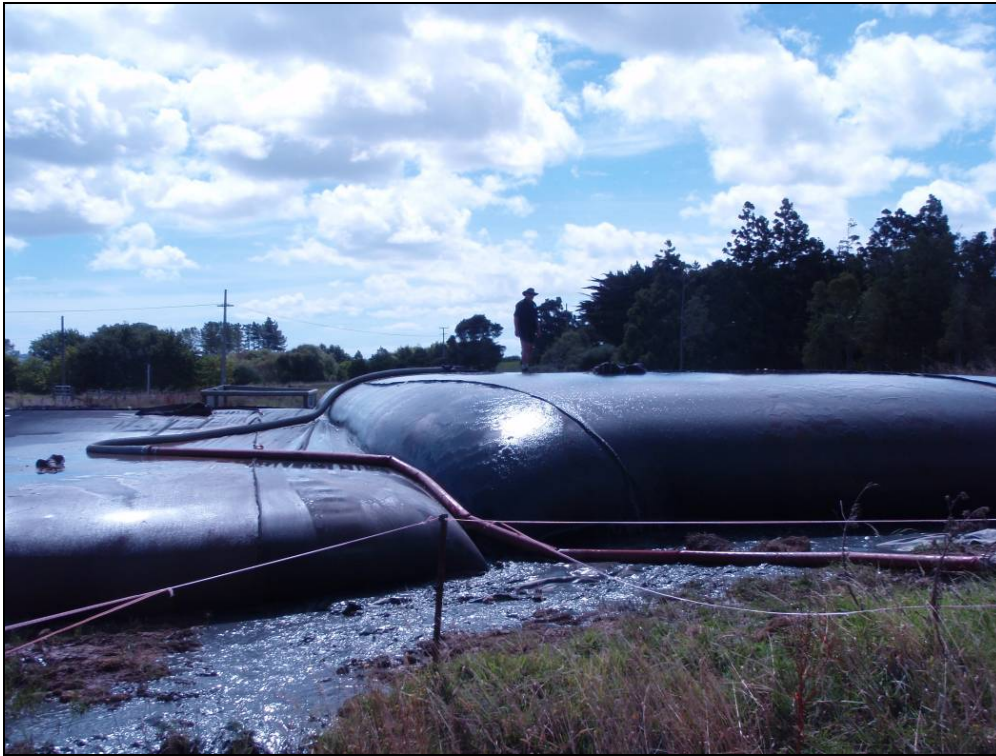
*Photograph 9: Geo-Textile Filter Bags being filed.*

Two geo-textile filter bags were used as this allowed one bag to be filled in a single day of operation. The next day the bags would be swapped over and the first bag was allowed to rest. During the filling operation the geo-

textile bags grew to approximately 1,800 mm high by the end of the day and would shrink down to approximately 700 to 1,200 mm high after a day of rest.

During the operation the geo-textile filter bags inflated to a height in region of 1.8m. Once left to dewater for six months the geo-textile filter bags have settled to an average height of 400m. As the sediment is now very firm it is estimated that the water content is in the region of 20-30% solids, and this represents a total of approximately 80 m<sup>3</sup> of dry solids. The original estimate for the total amount of sediment in the dam was 89-135 m<sup>3</sup> of dry solids within the dam (assuming 8,930 m<sup>3</sup> of sediment at 1 – 1.5% solids). It is now believed that the initial survey had difficulty determining the top and bottom layers of the sediment and as such underestimated the total amount within the dam.

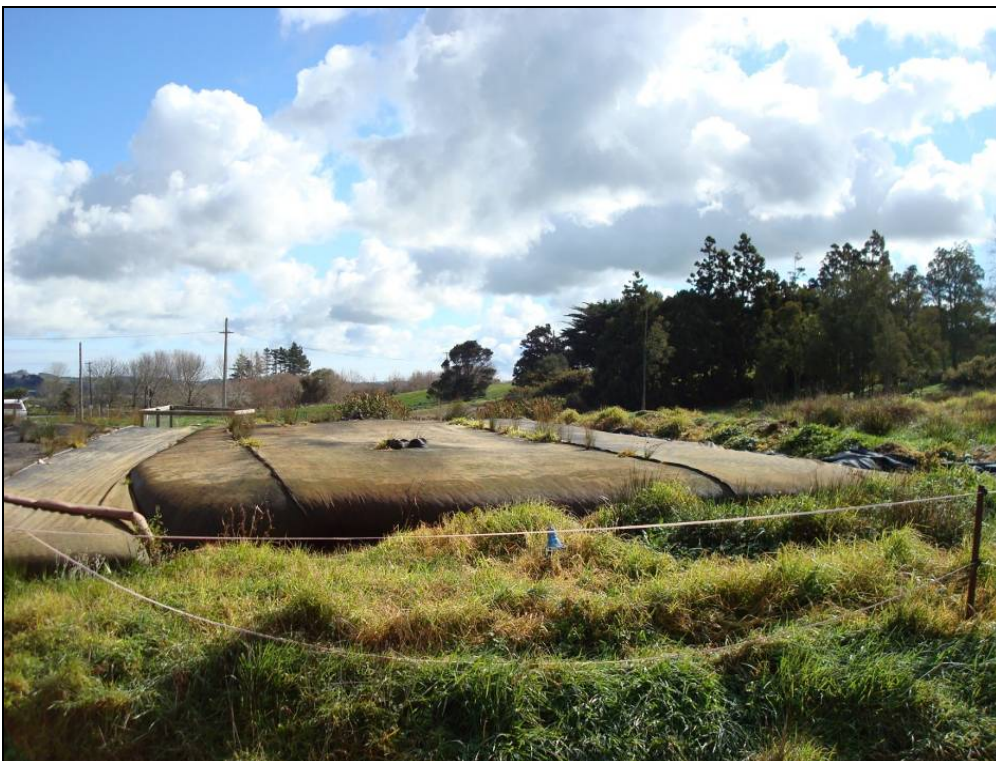
*Photograph 10: Geo-textile filter bags after 6 months of dewatering.*
