TIME IS OF THE ESSENCE TO A COLIFORM REDUCED PRESENCE

O'Dempsey, B. M. (CH2M Beca Ltd) and Kuyl, V. L. (South Taranaki District Council)

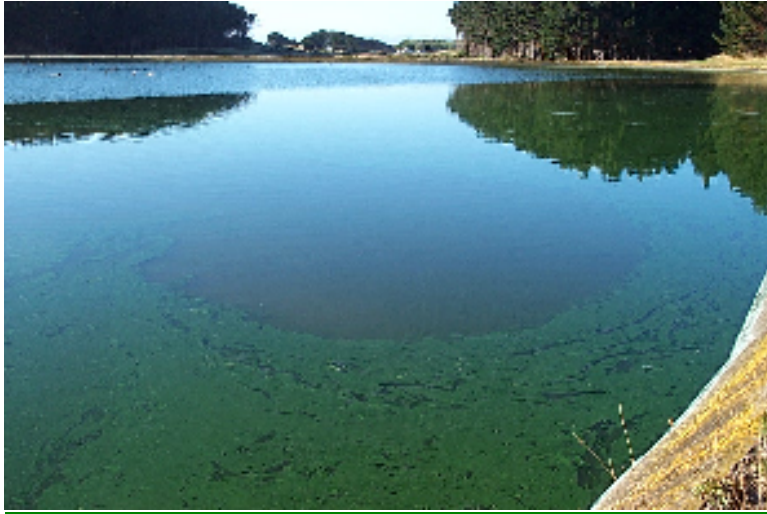
Photograph 1: Oxidation pond before the upgrade, showing inflow welling up in centre of photo

In 1973, an oxidation pond was constructed on a terrace 20m above the river, to treat the raw wastewater before discharging into the tidal reach of the river (see Photographs 1 and 2). A pump station near the comminutor was used to lift the wastewater up to the WWTP. The pond had an area of 2.33 ha and a design capacity of 2,900 population equivalents.

The effluent quality was typical of a single oxidation pond and as such was highly variable, particularly for pathogen indicators (faecal coliforms and enterococci), due to short circuiting (see Table 1). Raw wastewater typically has a faecal coliforms concentration of 10^6 to 10^8 cfu/100 ml. A small amount of wastewater travelling directly from the inlet to the outlet, with a shorter than usual retention time, can result in very high effluent concentrations.

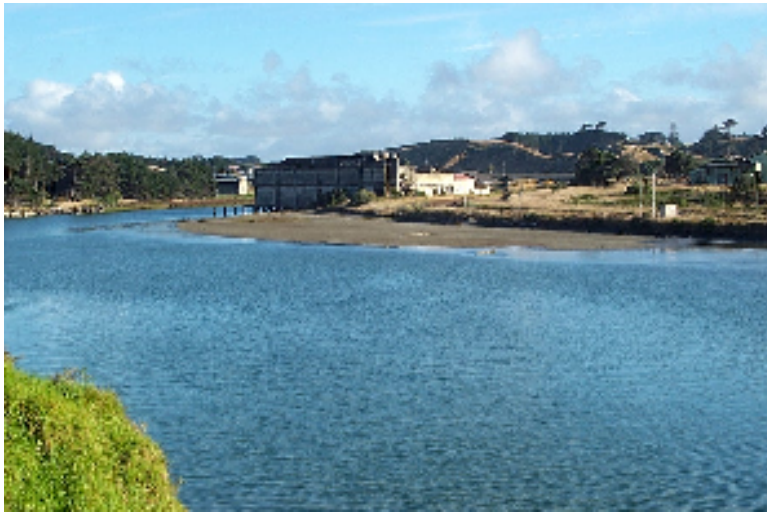
Photograph 2: Patea River, looking upstream from Patea WWTP

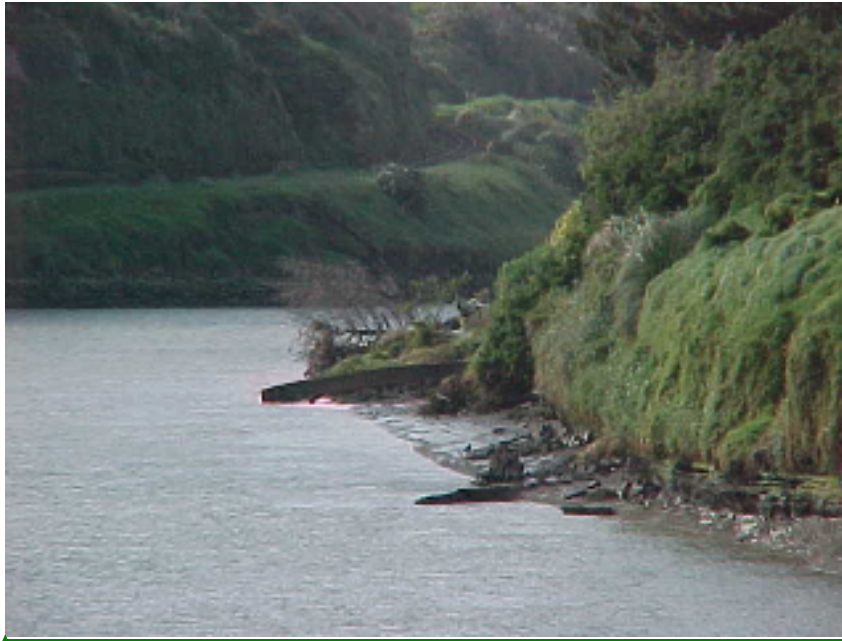
Photograph 3: WWTP outfall to Patea River at low tide, viewed from upstream (note pink Rhodamine WT dye from mixing and dilution experiment near bank from cracks in outfall pipe)

A simple estimate of mixing and dilution characteristics in the Patea River was made based on observations and measurements made during a single injection dye study at low tide (NIWA, 2003). It was observed that much of the discharge leaked through large cracks in the outfall pipe near the bank (see Photograph 3). The dye dispersed downstream in a long narrow plume entrained along the true right bank of the river. Near the outfall, the plume was approximately 5 m wide and broadened to approximately 30 m wide about 300 m downstream of the outfall. The study found a dilution rate of 284 at a distance of about 200 m downstream of the discharge (where downstream water quality is monitored by TRC). While different tide and river flow conditions would result in a different dilution ratio, it was considered that differing conditions would not result in dispersion patterns that were significantly worse for effects on lower Patea River ecological and recreation values.

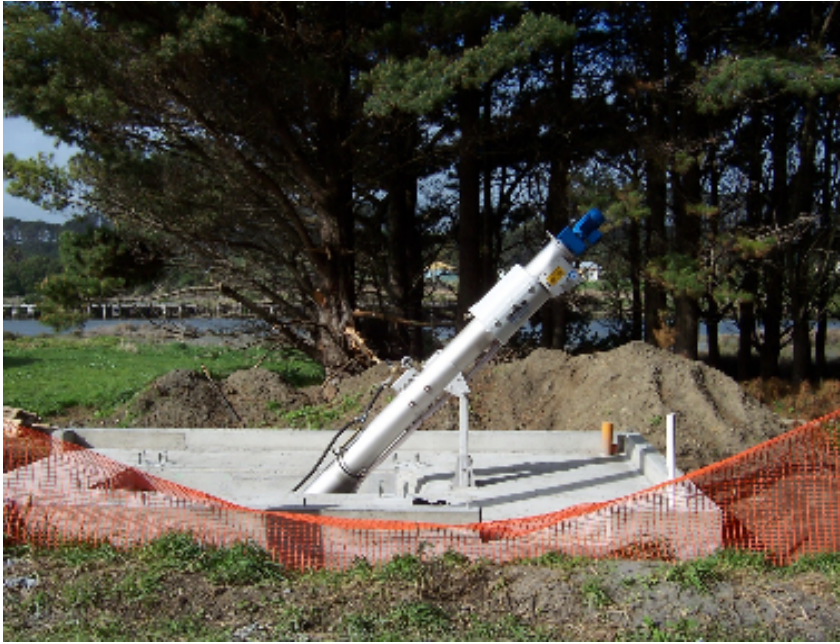
Photograph 4: Rotary auger screen (during construction)

A Huber rotary auger screen was installed upstream of the pump station. A new building was constructed to house the screen, as it was located at the end of a street and accessible to the public (see Photographs 4 and 5). The screen was located near the pump station as the WWTP is approximately 200 m from a power supply. A Parshall flume with a level sensor for flow metering was installed on the gravity line upstream of the screen and emergency overflow point. A flume was chosen over a magnetic flow meter as it was less expensive for pipe size.

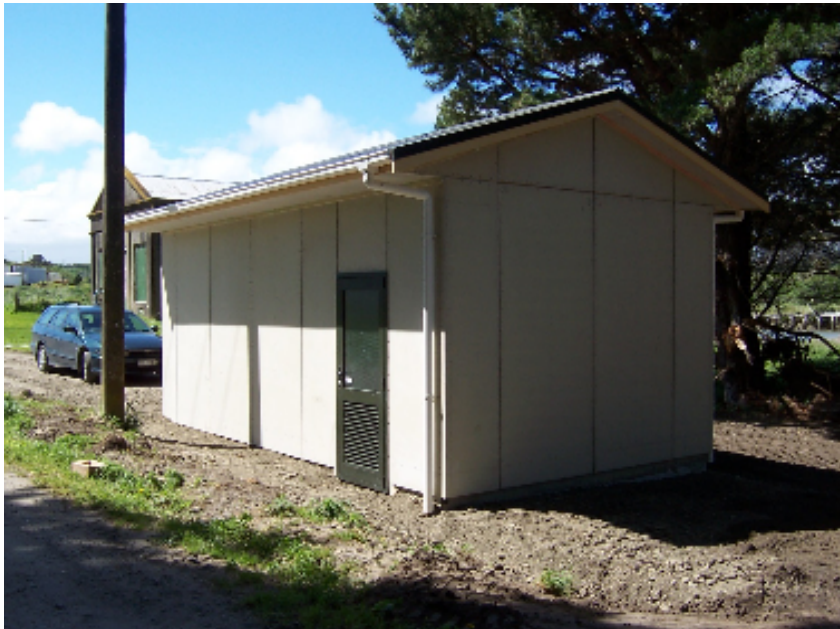
Photograph 5: Shed housing the rotary auger screen

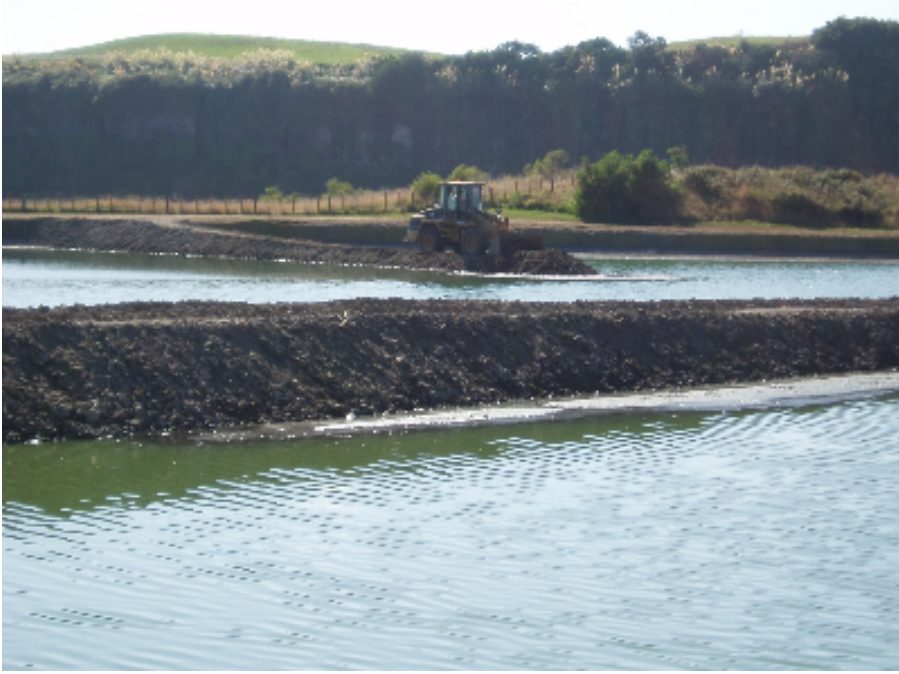
Photograph 6: End-dumping rock to create internal bunds

The inlet to Pond 1 was relocated to maximise the distance between the inlet and outlet locations. The pond operating level was lowered and the internal dividing bunds were constructed by end-dumping quarried rock to create three ponds in series (see Photographs 6 and 7, and Figure 1).

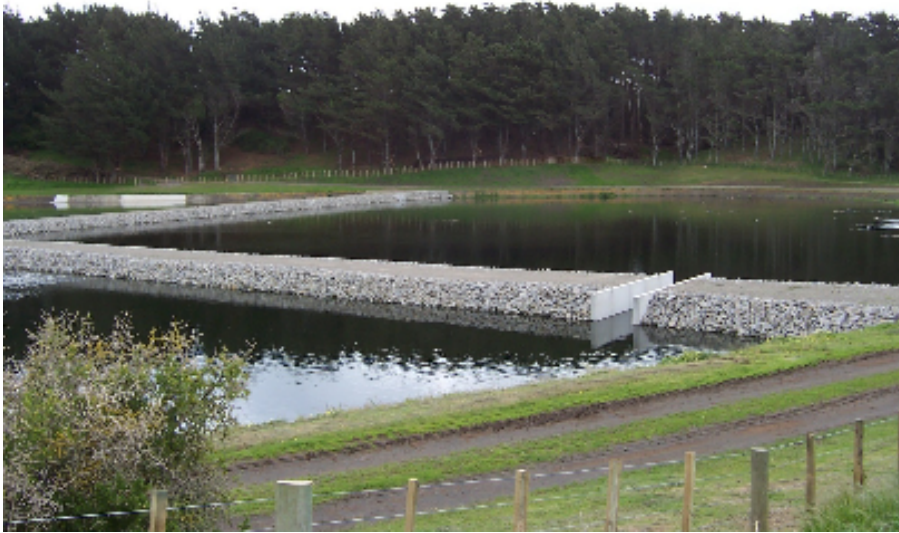
Photograph 7: Completed internal dividing bunds

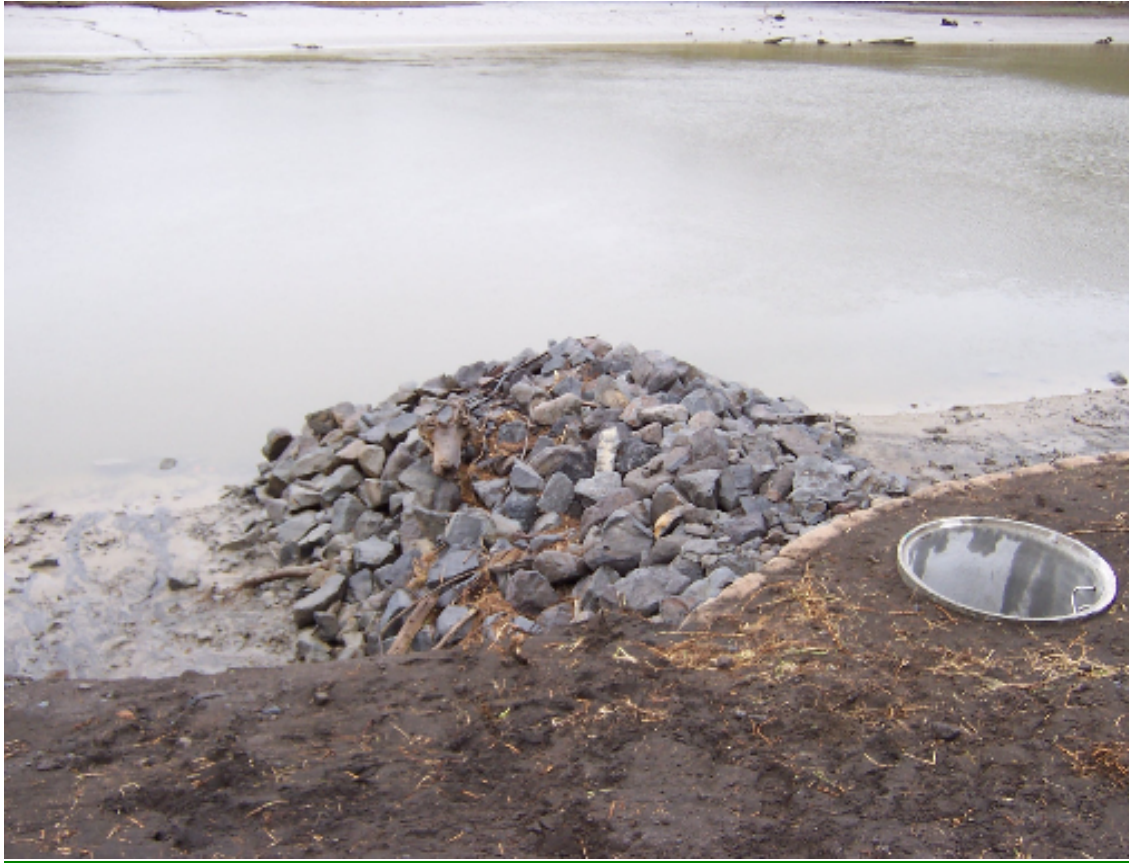
Photograph 8: In-bank rock diffuser

A v-notch weir and level sensor to monitor effluent flow were installed in the outlet chamber. The in-bank rock diffuser was constructed by surrounding the end of the outlet pipe with large rock above the low water spring tide level (see Photograph 8).

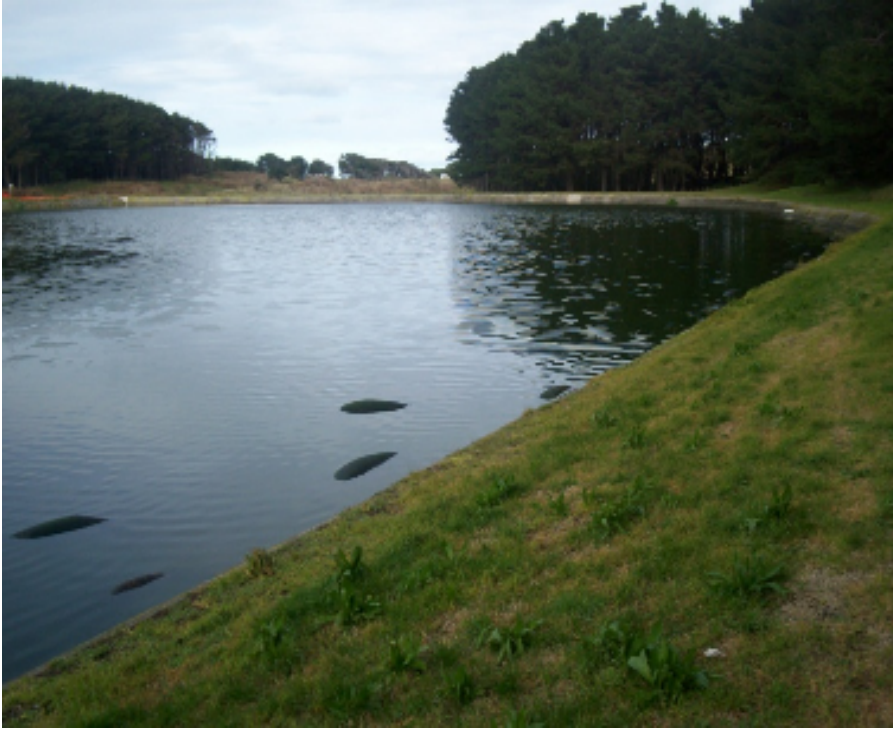
Photograph 9: Pond liner ballooning to surface, buoyed by biogas

It was proposed to line the pond with a 1.5 mm thick HDPE membrane liner. However, the sludge did not dry sufficiently to allow the liner to be welded. The liner was too large to be welded and pulled in segments into place over the sludge. A geotextile liner was therefore used. This quickly sealed with sludge, as evidenced by the liner ballooning to the surface in places, buoyed by biogas produced from the anaerobic digestion of the remaining sludge (see Photograph 9). The ballooning was dealt with by slitting with a knife and sinking with sand bags. Cutting slits in the fabric did not destroy the integrity of the liner because the fabric was laid with overlapping strips (not sealed) and was intended to provide "reinforcement" to the sludge layer in the event of a preferential seepage route developing through the sand base.

The third lesson is that all sludge should be removed from the base of a pond before placing a liner, even if the liner is supposed to be permeable. The sludge will continue to anaerobically digest and buoy the liner to the surface.
