# EDGECUMBE RANGITAIKI PLAINS FLOOD MITIGATION PROJECT

*Peter Askey, BE(Ag), CPEng, Opus Consultants*

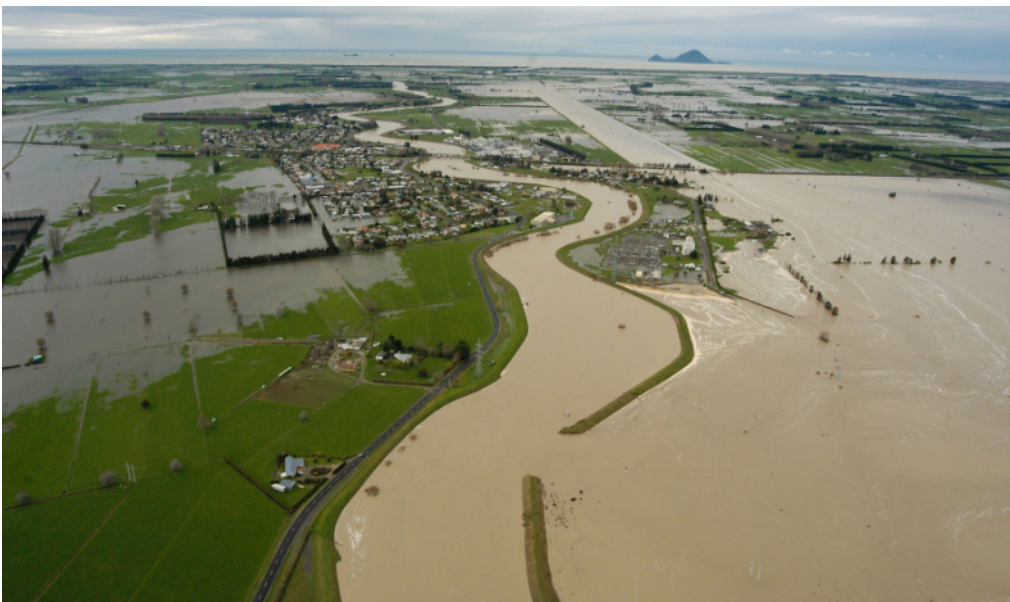
*Photograph 1: Flooding in Edgecumbe and on the Rangitaiki Plains following the stopbank breach (foreground) at Sullivan's Farm*

The Transpower substation was flooded and only quick work by BOPRC staff and contractors, assisted by the washout of the State Highway 2 bridge over Reids canal downstream, averted a disastrous loss of power to the entire Eastern Bay of Plenty. Such a failure would have also cut power for stormwater and sewer pumping at a critical time for Whakatane and Opotiki. The Fonterra site was flooded, fortunately without major damage, and lower lying houses on the east of Edgecumbe were severely flooded. While the west side of Edgecumbe was spared a river breach, the accumulation of local rainfall caused very extensive flooding which entered a number of houses. River erosion came dangerously close to breaching the stopbank at Kokohinau on the west side of the river upstream of Edgecumbe. Ground was heaving in Edgecumbe itself. The general opinion afterwards was that if the river had not breached when and where it did, it would have breached the bank at College Road within Edgecumbe with catastrophic consequences for the town.

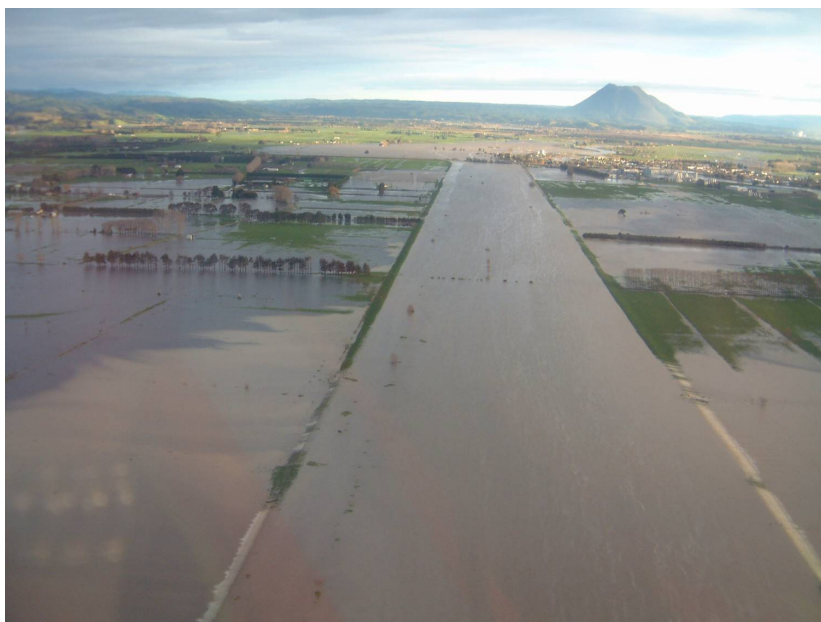
*Photograph 2: Reids Floodway looking south on Sunday 19<sup>th</sup> July with extensive overtopping both sides*

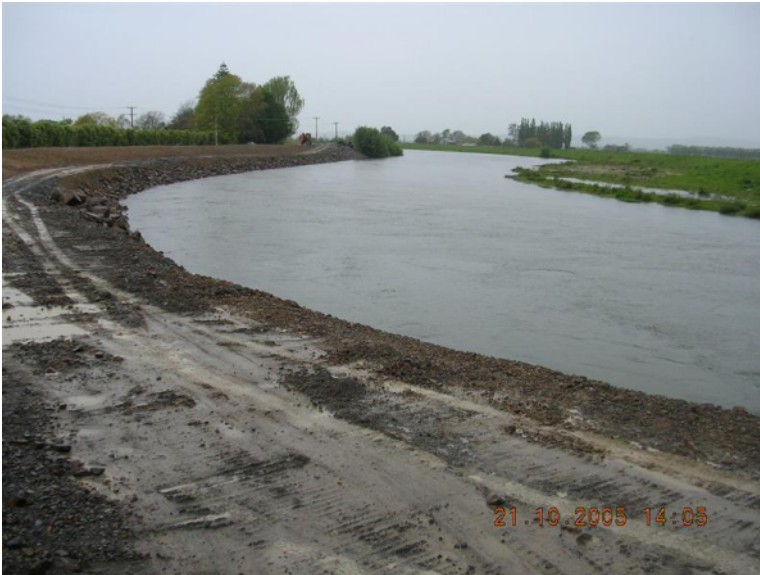
*Photograph 3: Reconstruction of river bank protection works at Laws bend following 2004*

Following the July 2004 flood event BOPRC undertook a detailed assessment of how the river bank protection works had performed. This identified several sites where additional rock work was required, such as at Kokohinau. This work was undertaken over the following 4 years, and is now complete. In total 7.6 km of river bank in the reach from Te Teko to the mouth received increased protection.

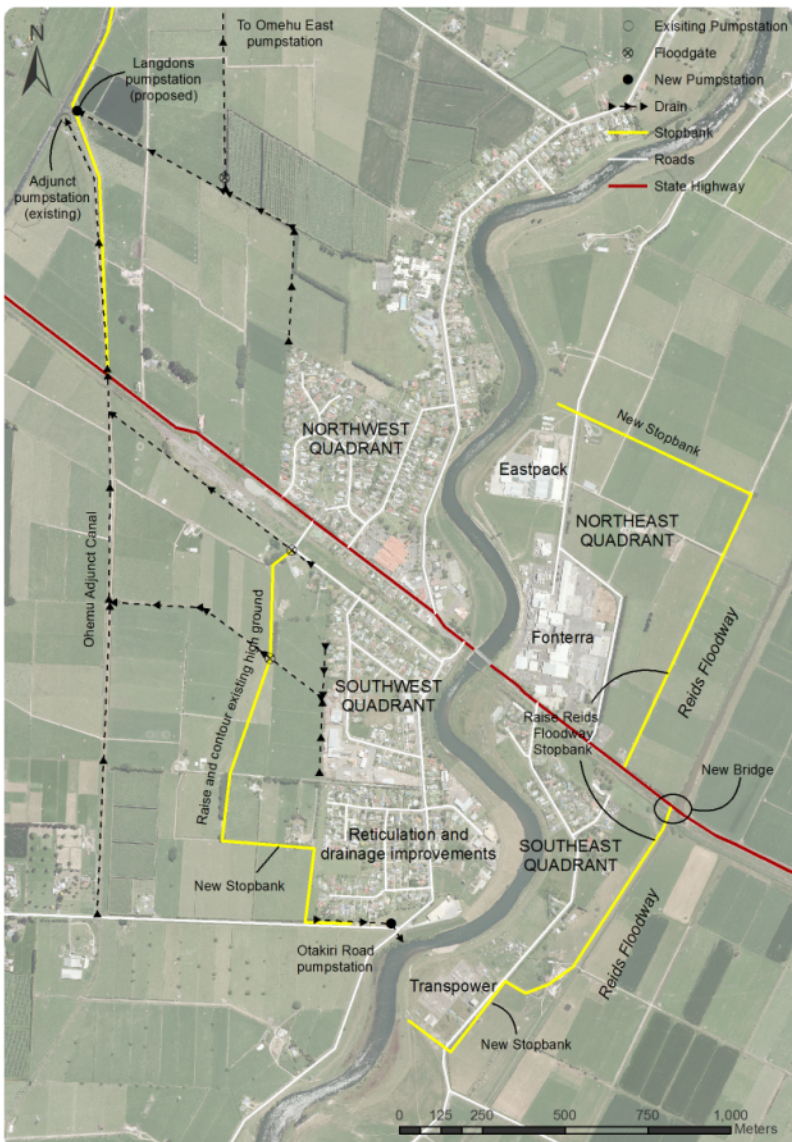
Figure 5: Edgcumbe Proposed Stormwater Improvements

Edgcumbe conveniently divides into four quadrants by the Rangitaiki River running north-south and Rail Embankment running east-west. Each has distinct problems and solutions (Figure 5).
