A NEW APPROACH TO STREAM RESTORATION TRIALED IN NORTH SHORE

Tom Mansell, Chris Stumbles
North Shore City Council

This paper case studies a new approach to designing and implementing an urban stream restoration and enhancement project that is currently underway in North Shore City.

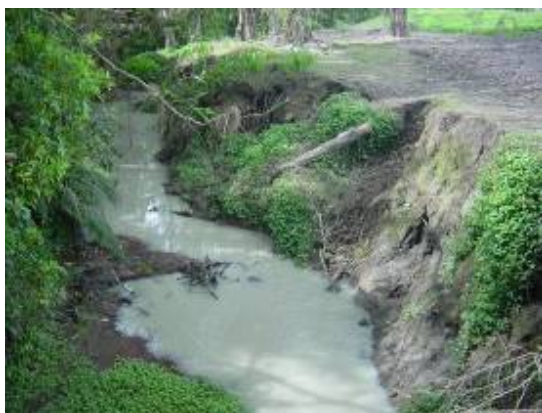
Figure 2: Stream bank erosion infestation

Increased stormwater runoff as a result of recent urban development has caused the channel to erode and widen to adjust to the changing flow regime. Currently during a 2 year storm flows in the order of $22\text{m}^3/\text{s}$ can be expected at the site, increasing to around $50\text{m}^3/\text{s}$ in a 10 year event. Figure 2 shows the severe bank erosion in the main channel running through Hooton Reserve. Figure 3 shows the how bank erosion gets covered up with invasive weeds

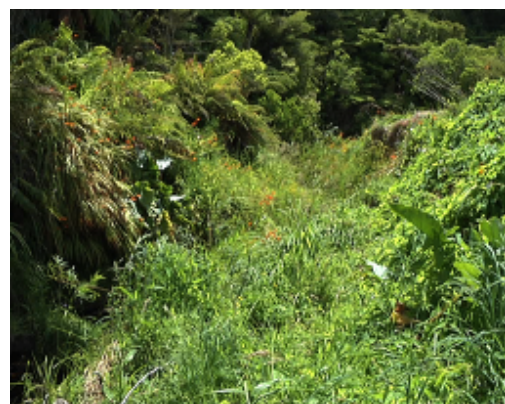
Figure 3: Invasive weed

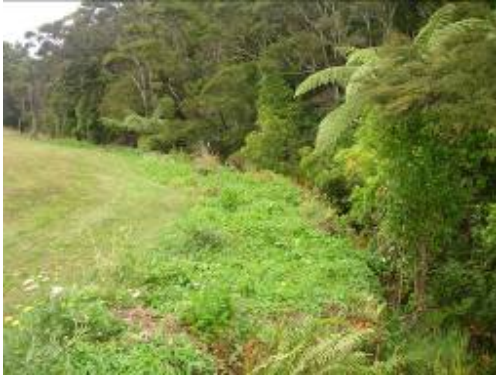
Figure 4: Before work

Throughout the entire reach we effectively double the wetted stream width. Development has increased impervious areas within the catchment resulting from increased peak flows. The channel in response has been undercutting causing severe erosion on the true left bank.

By flattening or reshaping the bank stabilizes the eroding stream bank by reducing the slope angle or gradient. The water velocity reduces by spreading the flow over a greater area. Once the channel has been widened pre-washed gap 20 gravel is spread over the exposed area as a form of sediment control. Over time some of this will eventually get washed away as the stream widens. The figures 4 to 7 show what the bank looked like before and after the reshaping. Figure 8 shows the constructed increase in stream width and profile of original bank. In July 2010 the area will be planted with appropriate native riparian vegetation.

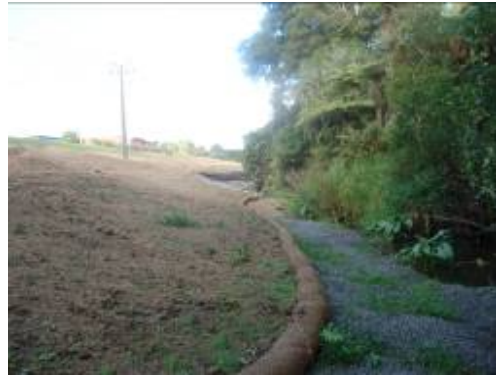
Figure 5: After

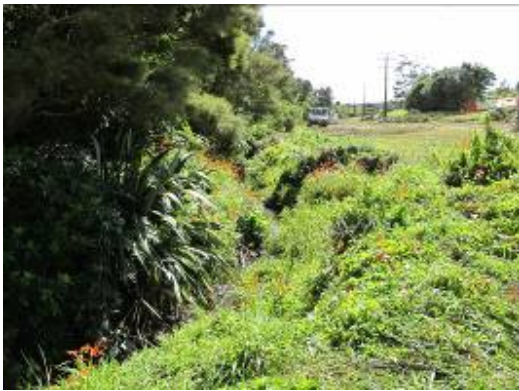
Figure 6: Before

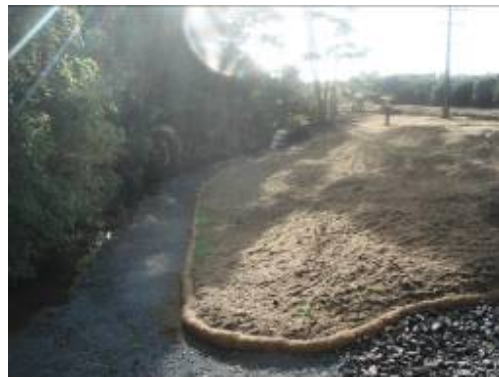
Figure 7: After

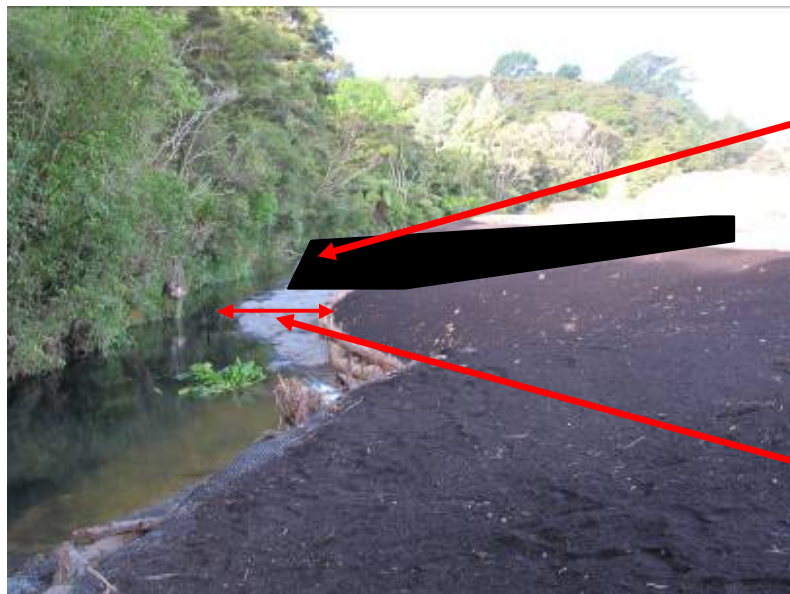
Original bank profile

Extended wetted width with pre-washed gravel protection layer

Figure 8: Widened stream section

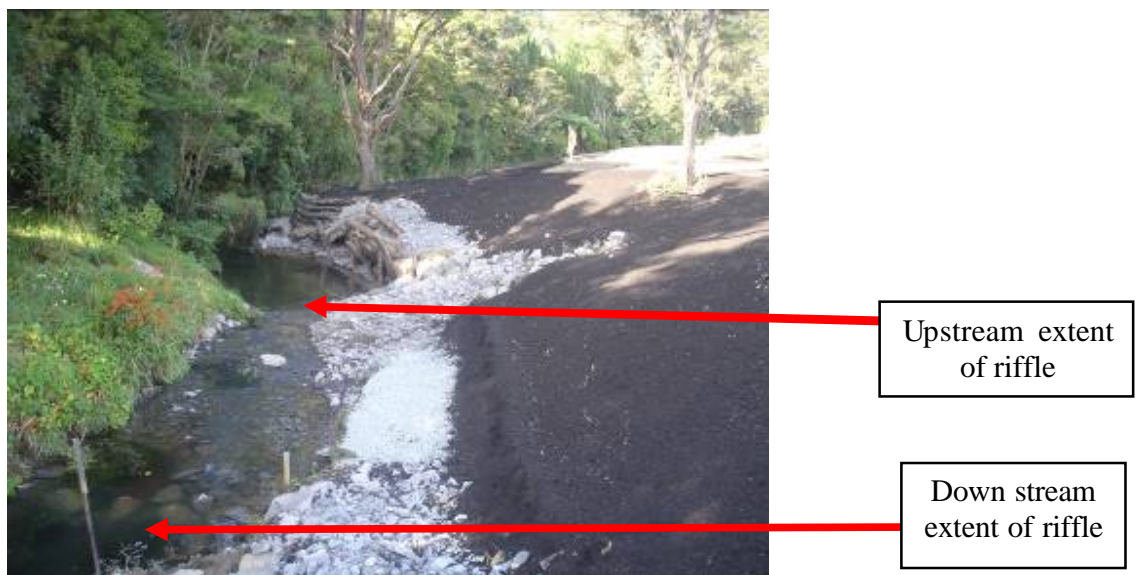
Newbury rock riffles are ramps with long aprons made from small rocks that are constructed at intervals along the channel approaching natural riffle spacing (5 to 7 channel widths). The riffles ranged from 10 to 15m in length. The structures are built by placing washed clean rock within the existing channel. Rock riffles are an environmentally-sensitive grade control structure that is used to ensure that future incision of Lucas Creek will be arrested. These structures also provide pool and riffle habitat, and are visual diversity in otherwise soft clay bottom sub-straight. These structures were placed in the long more uniform sections of the stream to reduce the undercutting. Larger boulders were placed on the down stream end to anchor the structure in place. Figure 9 shows a completed riffle.

Figure 9: Newbury rock riffle

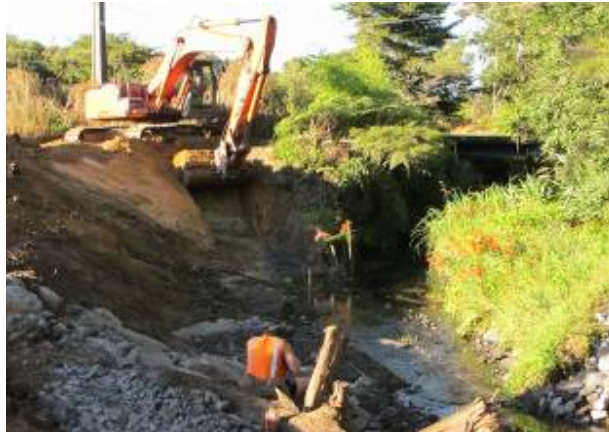
Figure 10: Rock vane under construction

Looking downstream at the outer bend in Lucas Creek just before it flows under a bridge (on right). The contractor is preparing the keyway for a flow redirecting Rock Vane. Rock Vanes point upstream at a 30-degree angle and dip from a high water elevation down to the stream bed.

Rock vanes are flow redirecting structures angled upstream at 20 to 30 degrees. The purpose of the structure is to redirect flows from the bank to the centre of the channel reducing bank erosion. Rock vanes can reduce the need for harder engineering options. Only one of these structures was constructed in this project situated just upstream of a vehicle bridge to protect its foundations. Figures 10 to 13 illustrate how the rock vane was constructed.

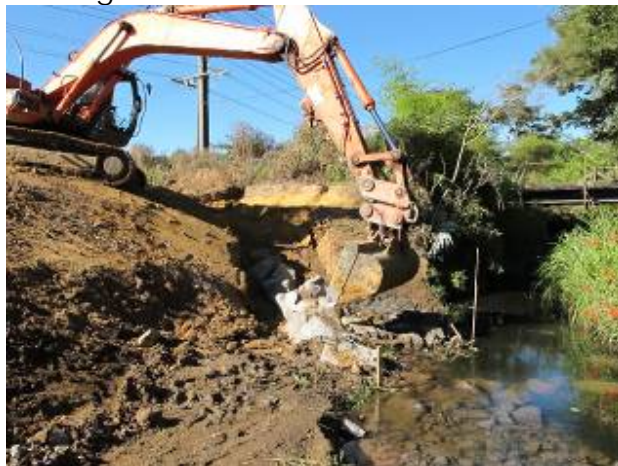
Figure 11: Rock vane under construction

Rock Vanes are best built of self-launching stone (poorly sorted, well graded) but placement of some big anchor stones is also recommended.

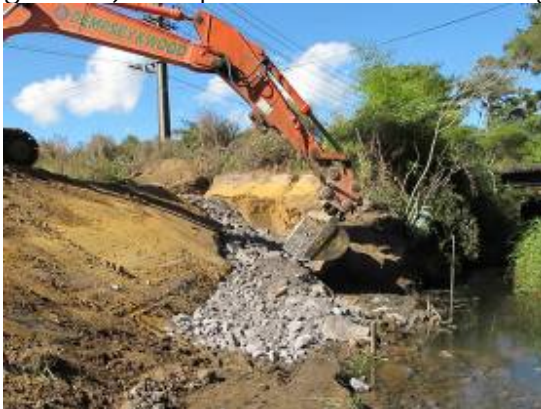
Figure 12: Placing rock

Next we placed the self-adjusting, self-launching stone. The average highwater here is expected to be as high as the excavator bucket. The area was then composted for stabilisation which will then be planted.

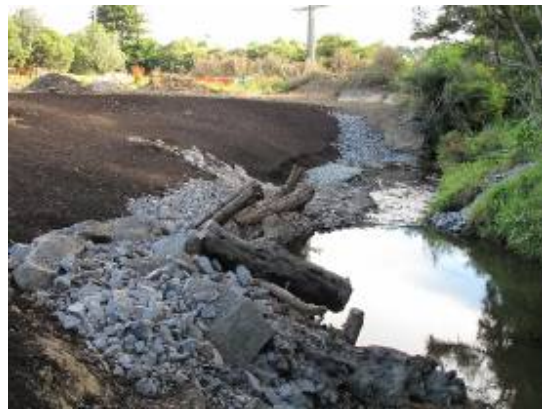
Figure 13: Rock vane completed

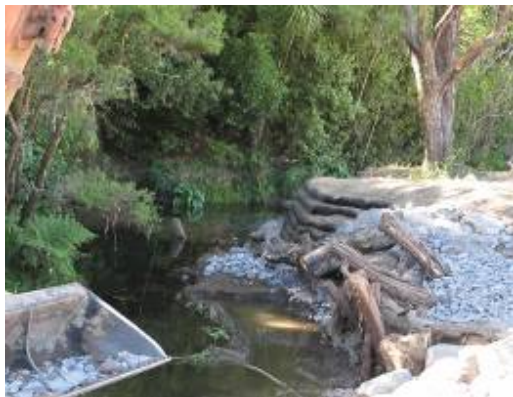
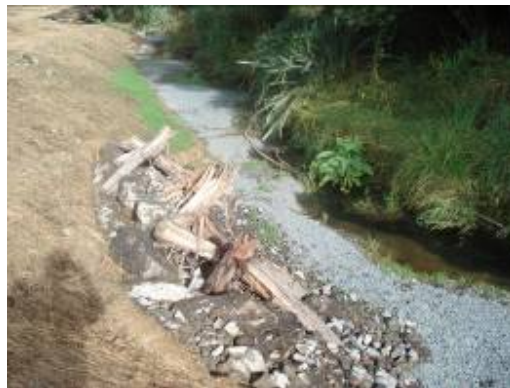
Lunkers are woody structures constructed from interlocking tree material. These structures are intended to mitigate erosive flows and are used on the outer bank of a meander bend. The lunkers were constructed from mature Tee Tree which was removed from the stream bank reshaping. They also provide habitat within the stream bank. Two of the lunkers that were constructed as part of this project are shown in Figures 14 and 15.

Figure 14: Lunker

Figure 15: Lunker

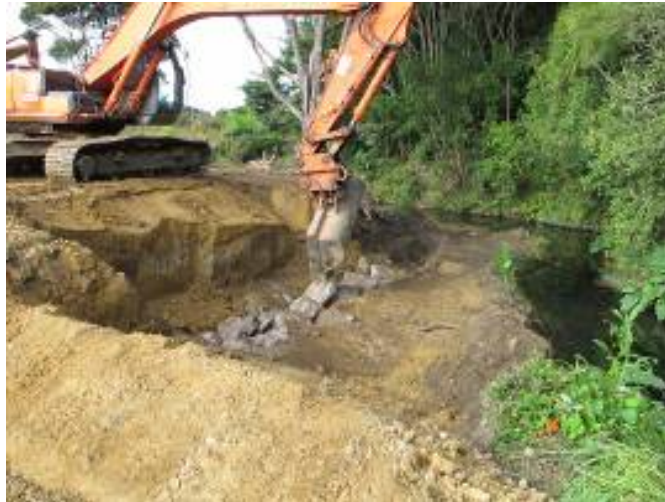
Figure 16: Rock toe under construction

Figure 16 shows the toe of the socks are constructed from poorly graded rock dug down 600mm by 600mm to protect the socks from being undercut from stream erosion.

Filtrex Living walls are basically socks filled with compost running along the bank which is planted into for long term stability. Planting is expected to succeed these materials over time as the principle method of soil stability and cohesion. Living walls were used in the steeper sections of the bank, either where the rock substrate was too hard to widen the upper banks or where there was limited space. They were also used to protect protected trees in the riparian margin. Figures 16 to 18.

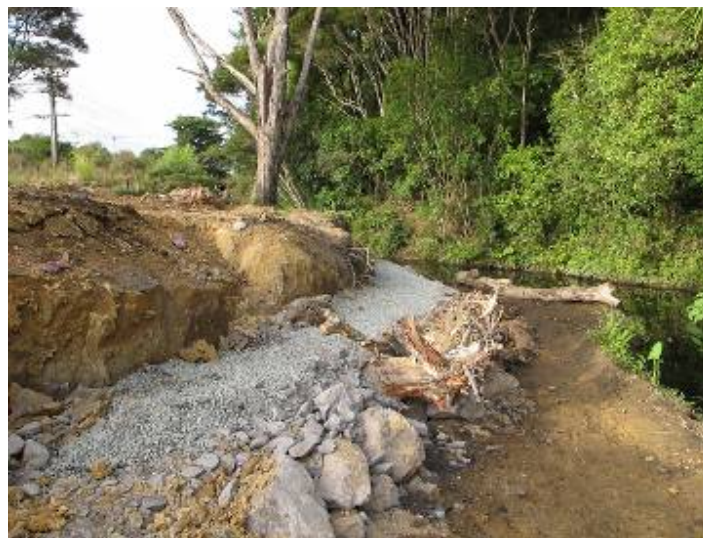
Figure 17: Rock toe with root wads

Figure 17 shows the same bend with rock toe and wood incorporated. From this secure base construction of a "living wall" built from compost berms and geo-grid for a reinforced soil wall.

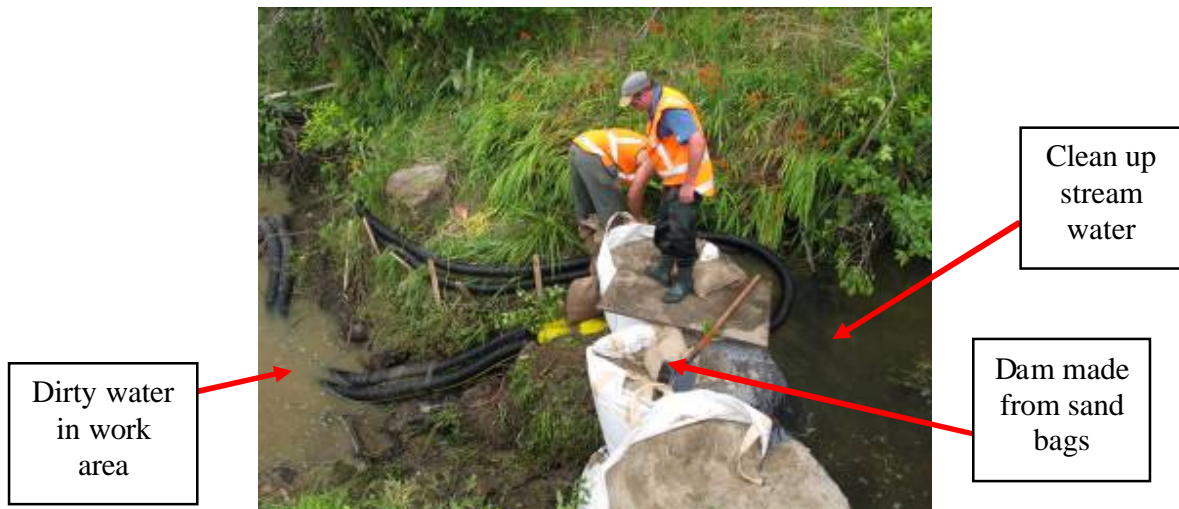
Figure 19: Damming and diverting

The traditional method of working in or around a water cause would be to temporarily dam the stream upstream and downstream of the work area and divert water around the work area. Any water between the two temporary dams would then be pumped out providing a relatively dry area in which to work. This would also require the trapping and translocation of eels, fish and other aquatic creatures. We initially tried this method on the first day of construction but found it to be unsatisfactory. (refer Figure 19). While it sounds reasonable, the overall effect was much more turbidity than wanted, for a longer period of time, and a badly degraded bottom (from walking on the soft clay substrate).

Also the dam leaked causing more turbidity. It took the contractors a day to seal the dam as best they could. Secondly, laying the diversion pipes in an "incised stream" was also turbidity producing. Thirdly, when you pump water around site it ended up causing erosion or extremely turbid water downstream - an option would be to require a huge sediment pond. Finally, walking thru the stream to rescue eels and fish causes

more damage to bottom and even more turbidity. On this occasion we removed 16 banded Kokopu, 55 kouri, 12 eels and 20 further unidentified identified fish from a single pool of 5m by 5m in area.

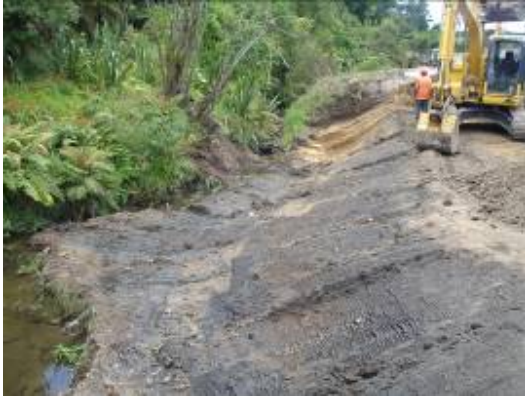
Figure 21: Berm removal

- The first step was to start excavating about a metre back from the bank so that a vegetated berm (called a bund) was left between the working area and the stream (refer Figure 20). This allowed the bulk of the earth works to be carried out without affecting the water course. Any runoff would be captured by this bund, preventing it from carrying sediment into the stream.
- The second step was to remove the bund. During this stage the digger operator carefully scrapped back the bund in stages, always creating a slope back away from the water so any clods or soil would fall away from the water. . Also note that the "back slope" of the bund is steep.
- Finally the banks were shaped right down to just above water level. Even at this stage we did not enter the water course as. (Figures 21 and 22).

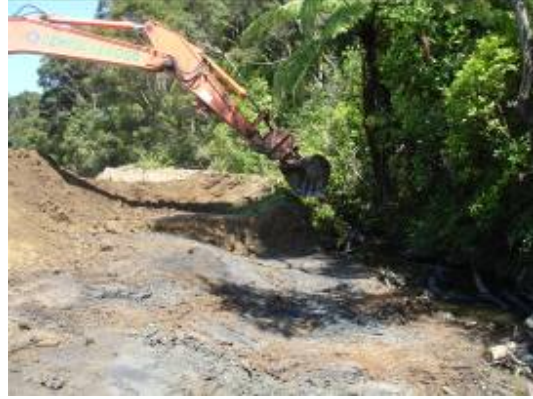
Figure 22: Working back from stream

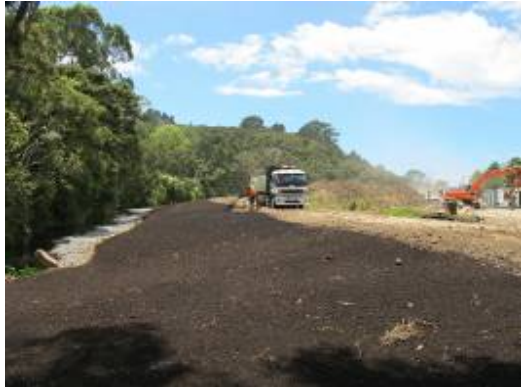
Figure 23: Compost blanket

Another approach was the use of a compost blanket to secure the earth-worked site until the site is fully vegetated. Figure 23 shows the use of a compost blanket instead of a silt fence to secure this worked area. Overseas research suggests compost blankets catch rocks and clods and certainly sediment from sheet flows. Grasses and vegetation will establish through the blanket. The other advantage is reduced disturbance after project has been stabilised and no silt fence going to landfill/dump. Properly aged compost doesn't discharge N to waterways and is reasonably resistant to floating or being washed away during small to moderate rainfall events. This approach is however quite costly and was only used on one section of the project due to costs.

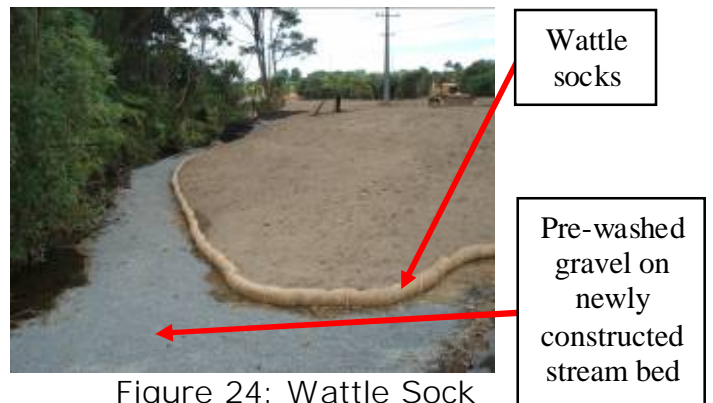
Figure 24: Wattle Sock

Wattle socks (Figure 24) were also used at the toe of the banks to capture any sediment from running into the stream. The bare soil was mulched with hay and hydro seeded to secure the banks until planting. The wattle socks were used where we would normally be required to install a silt fence. The advantage of the sock is that we can leave the socks in place and do not have to remove them as they will break down within a couple of years.

Another sediment control method used was the spreading of a layer of pre-washed gap 20 gravel on the newly constructed stream bed. Over time some of this gravel will get washed down stream. The use of prewashed gravel can clearly be seen in Figure 24.
