BAYSIDE – THE TRANSFORMATION OF A STORMWATER ASSET INTO A COMMUNITY ASSET

Carl Hewison, Chris Stumbles, Jo Campbell
North Shore City Council

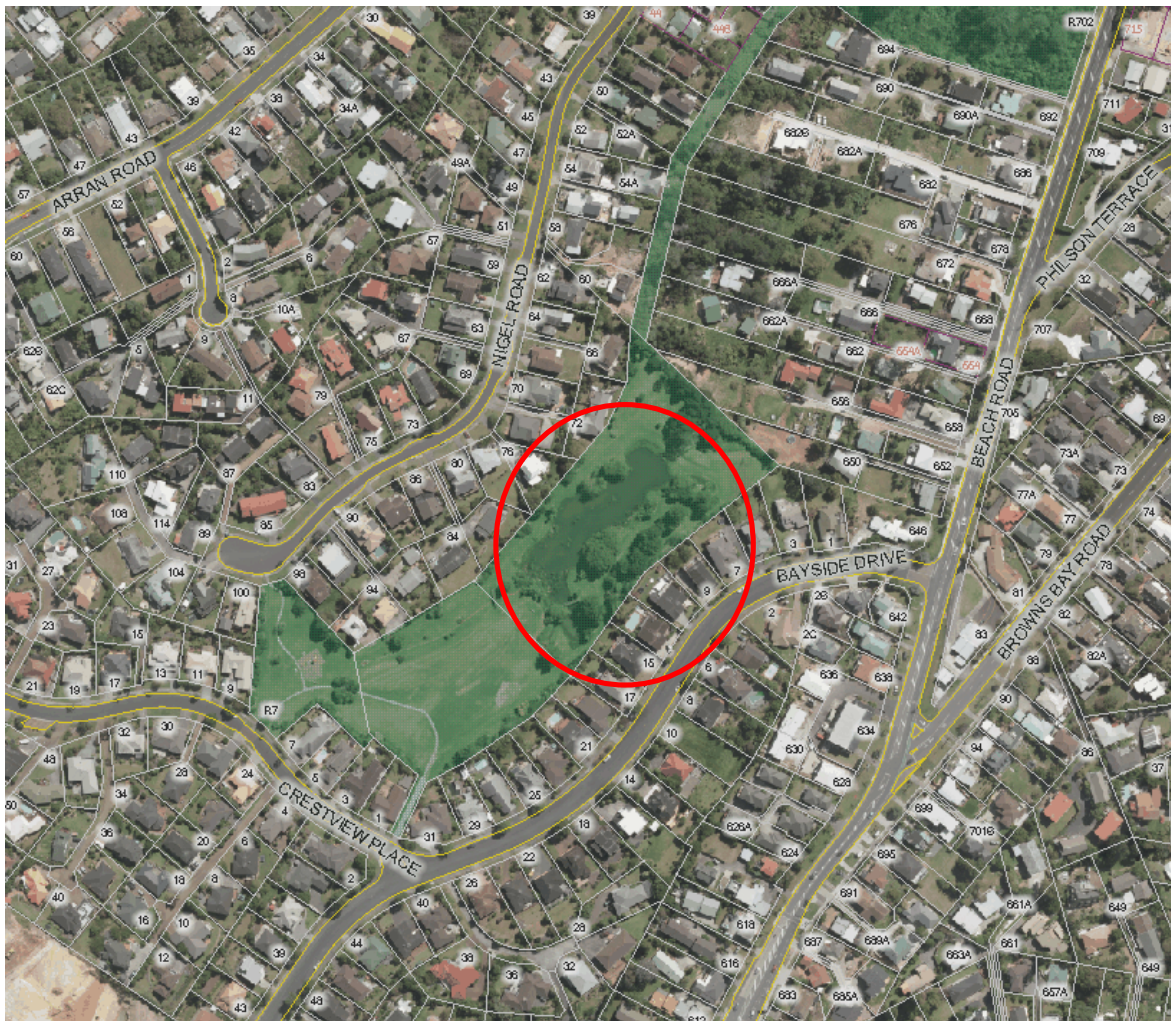
Figure 2 : Location of Bayside Stormwater Pond

The Bayside stormwater pond has two main stormwater inlets - the northern inlet discharges into the pond via an 85m concrete lined channel, and the southern inlet is piped to the pond.

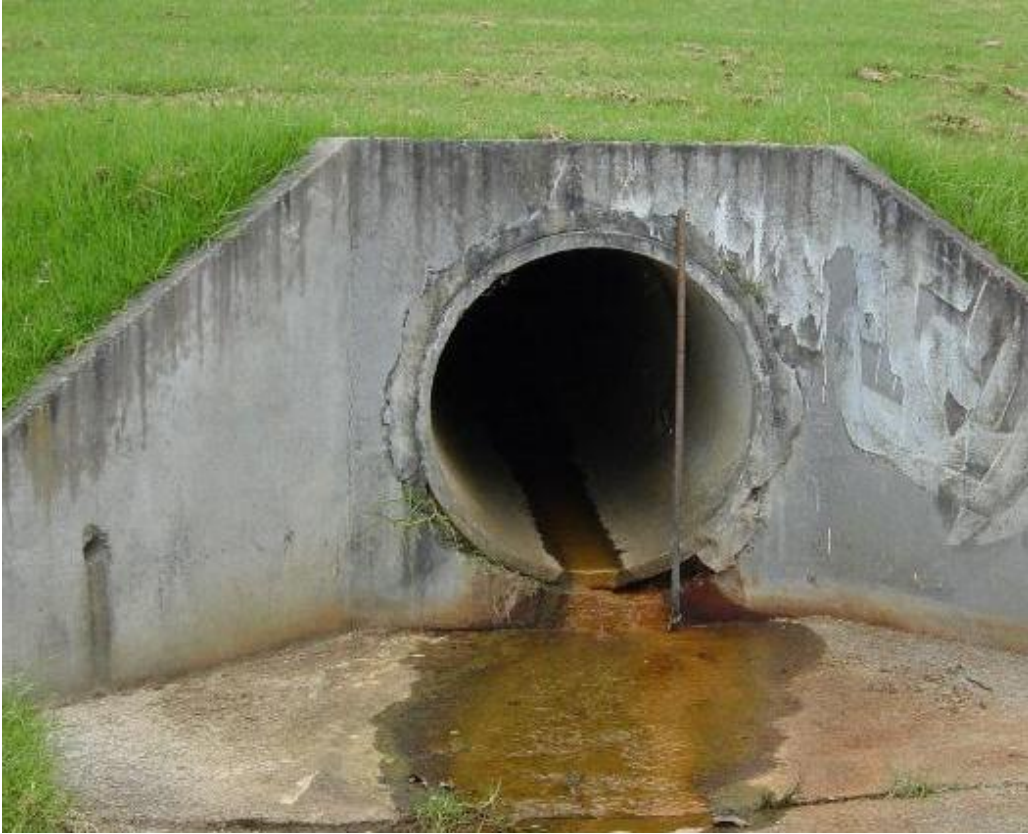
Figure 3: Northern inlet before restoration

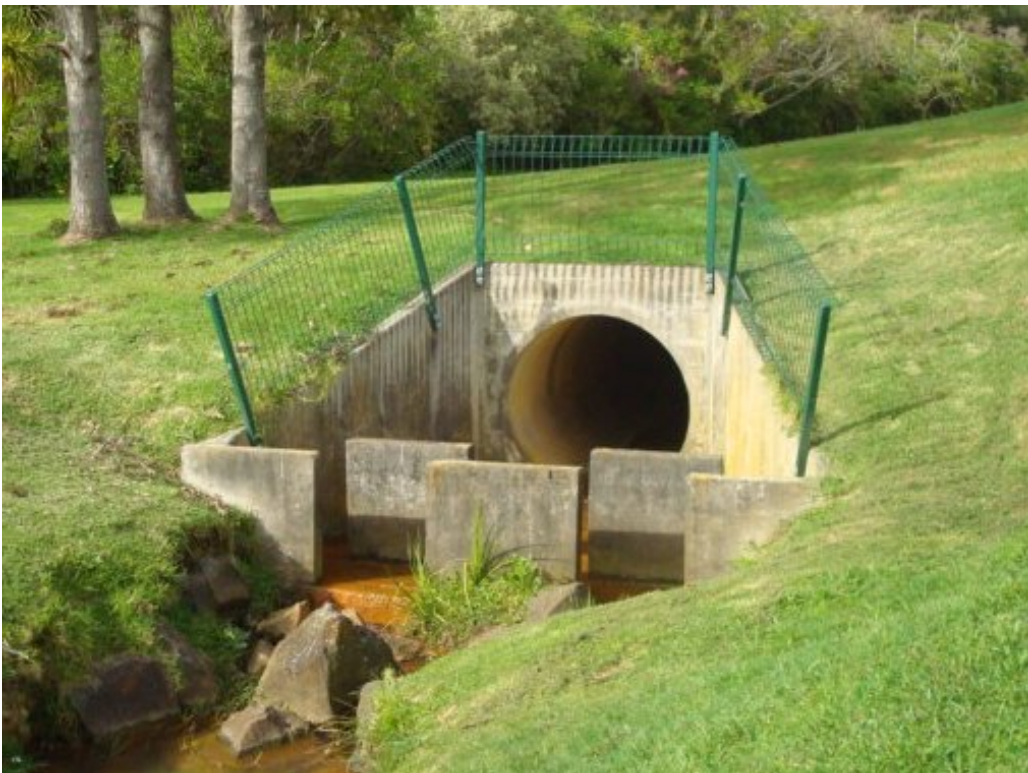
Figure 4: Southern inlet before restoration

Similar to the northern channel, the southern channel emerges from an outlet pipe, but travels only a short distance through an eroded and undercut channel to the southern forebay area. To achieve a functioning forebay, the southern channel was re-aligned to emerge in the centre of the forebay (to prevent short circuiting).

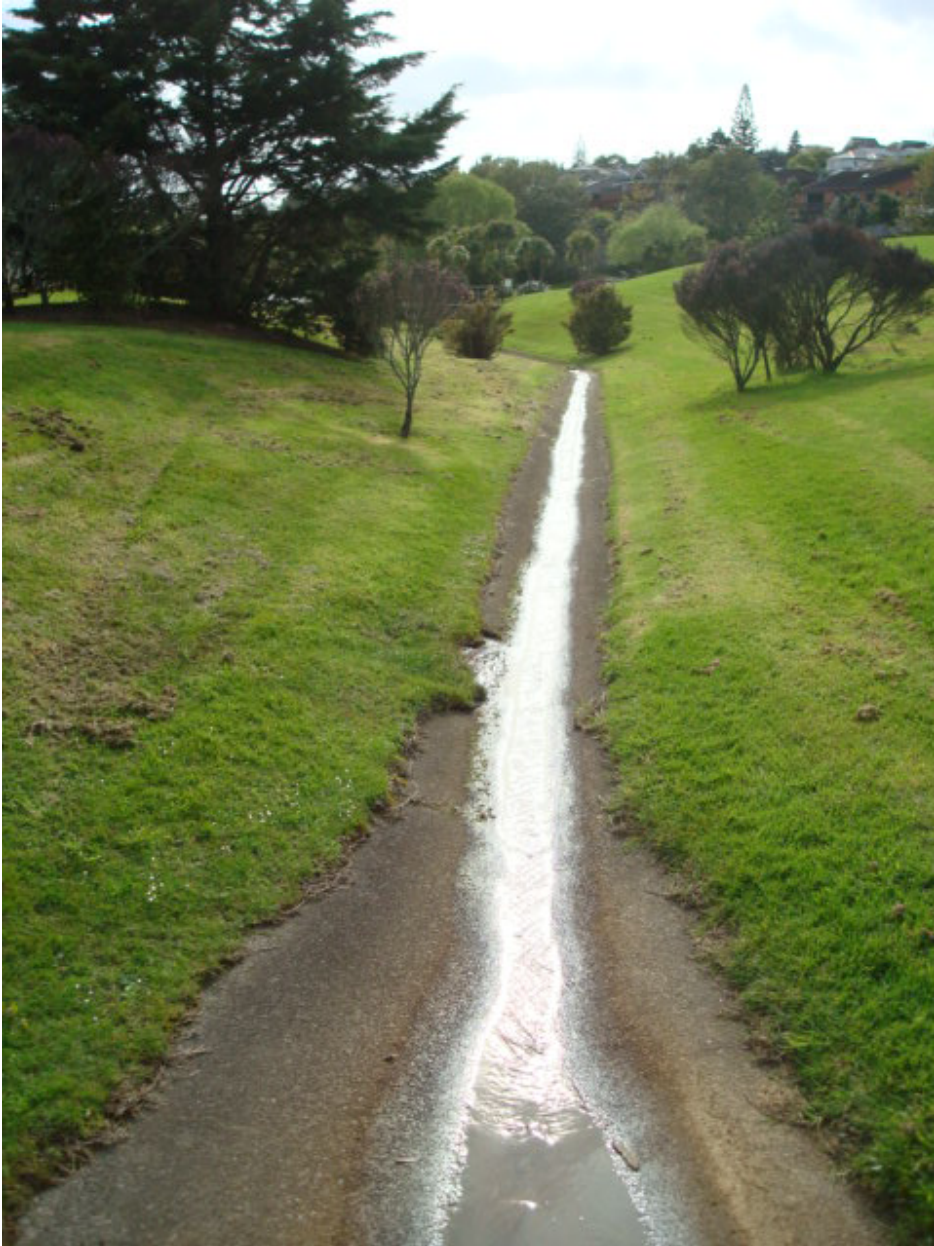
Figure 5: Northern concrete channel before restoration

An 85m concrete channel conveyed stormwater through the reserve and into the pond. This provided no habitat, increased water temperatures and provided no ecological value.

The northern stream is piped into the reserve and used to emerge from an outlet wing wall into a concrete channel approximately 85m long that then flowed into the pond.

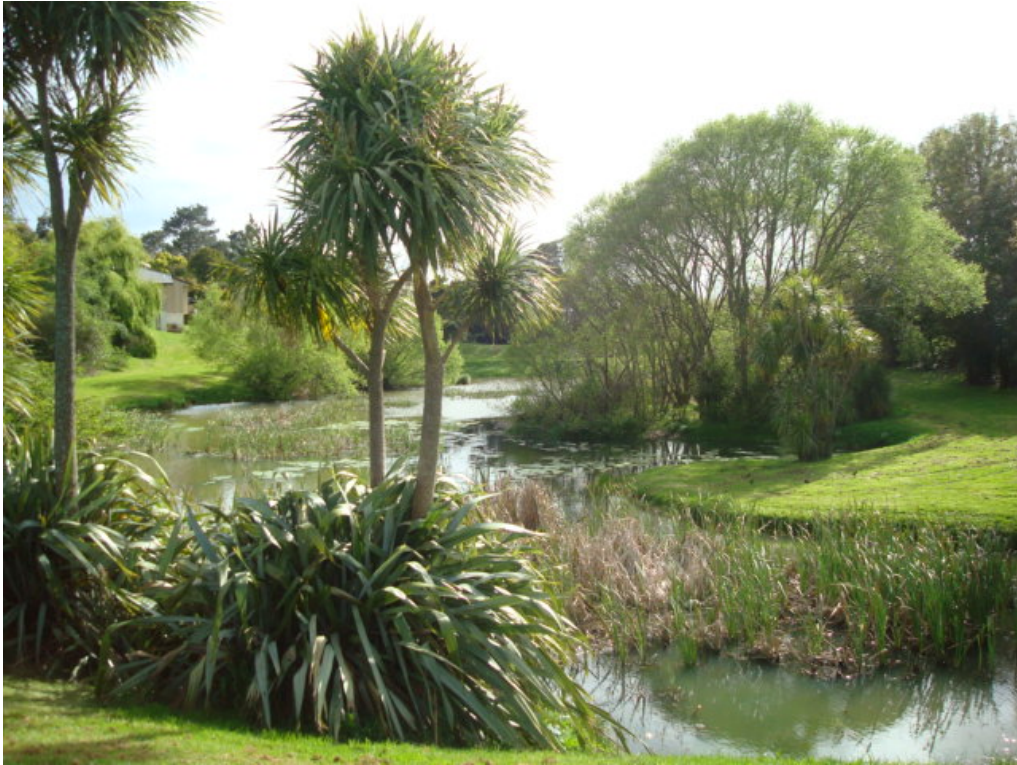
Figure 6: Bayside stormwater pond before restoration

The Bayside stormwater pond is an artificial pond which was constructed in 1986 as part of the local subdivision to capture sediment and attenuate flood flows. It was last maintained in early 2004 when it was drained to remove silt and aquatic weeds. Over the last five years there had been significant silt accumulation due to poor management of upstream development and it once again required maintenance.

The existing pond also had large volumes of sediments which led to Raupo establishing, which in turn increased localised sediment deposition.

The pond was overrun by aquatic plants requiring ongoing manual removal and a group of large crack willows had established along the banks of the pond.

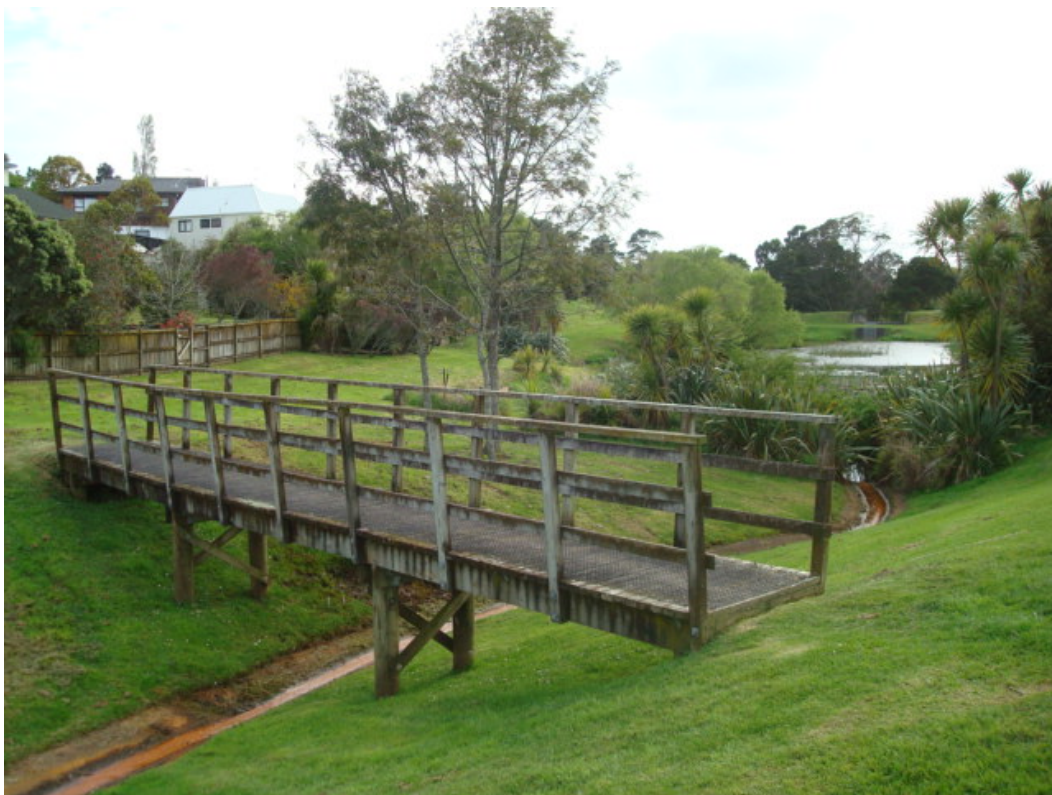
Figure 7: Existing bridge before restoration

There were two existing bridge structures on the site. One bridge crosses the open concrete-lined channel to the north and another crosses the southern forebay. These bridges were retained. There were no sealed pedestrian footpaths leading to or from these bridges and no formed pedestrian paths around the pond. The area around the pond can be very wet in winter months and this reduced the accessibility to the area by the public.

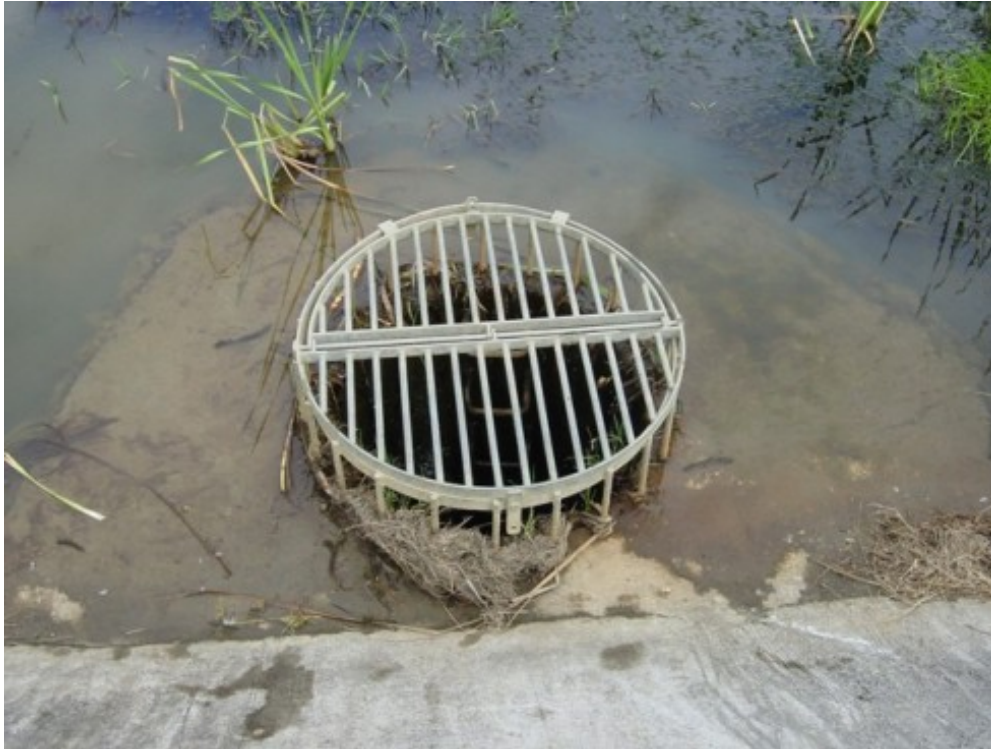
Figure 8: Outlet (debris screen) before restoration

The existing outlet structure created a barrier to fish passage between the pond and downstream watercourse. Existing fish species in the pond included introduced grass carp, eels, a few naturally occurring banded kokopu and introduced exotic fish. Improved fish passage would provide opportunities for increased ranges for inanga and common bully.

There are many ways artwork can increase the amenity of a surrounding area, greatly increasing both the look and feel of the area, while still providing a necessary function. The existing outlet / debris control device at Bayside pond was targeted for replacement. Due to the existing shape and height of the debris control device there was a high possibility of it becoming blocked by debris during a significant storm event. It was decided that it could be possible to replace the debris control device with a piece of functional artwork.

Fish passage was installed through the outlet structure (debris screen) using spat ropes.

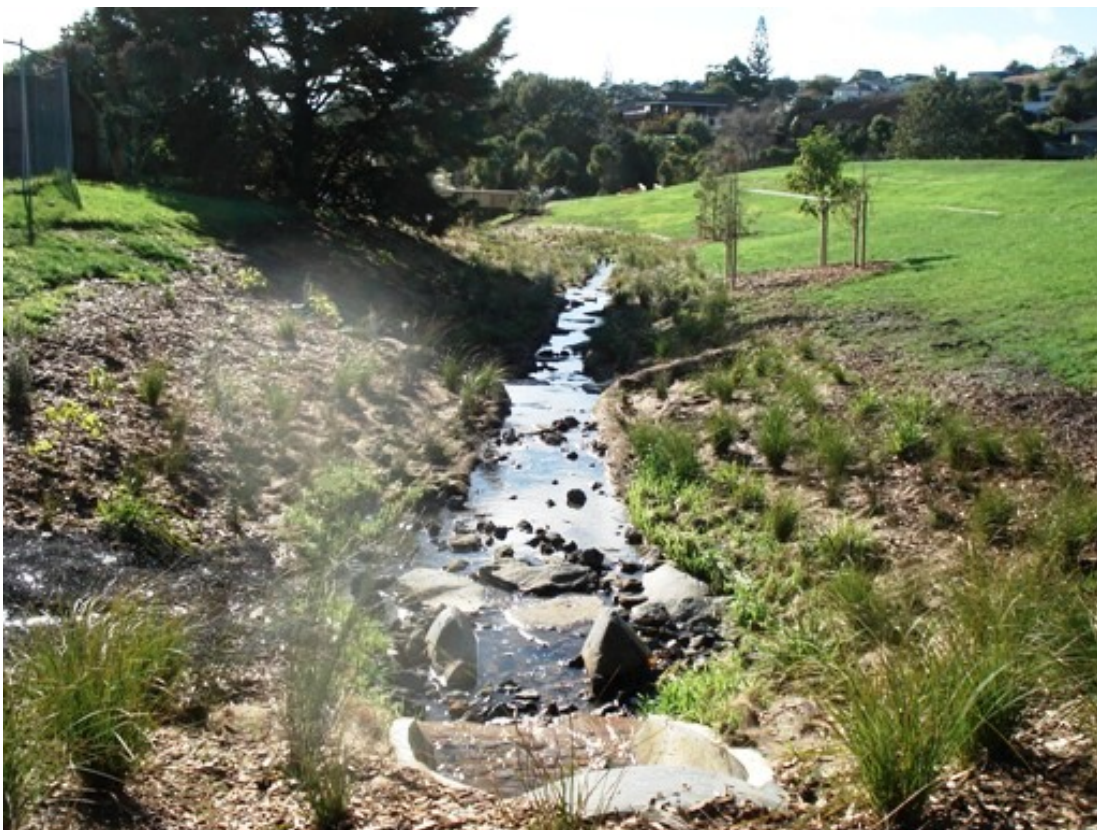
Figure 9: Northern Channel after restoration

The concrete forming the base of the northern channel was removed and the channel was realigned. This slightly increased the length of the channel, reduced the gradient, and 'naturalised' the appearance by use of meanders. The northern channel, which had an existing gradient of approximately 4%, was reduced to a gradient of 1% by using a series of cascading weir structures.

The final rehabilitated channel consisted of weir structures, boulders set into banks to dissipate flows, and riparian vegetative planting. The purpose of rehabilitating the channel was to provide a more effective means to treat stormwater quality while improving the aesthetics of the area improve habitat and increase aeration.

The project resulted in increased fish habitat in the rehabilitated northern channel. The proposed 1% gradient and addition of pools allows for increased depths for fish refugia. A dedicated fish passage was installed using spat ropes through the existing outlet structure to promote fish (climbing species) passage between the pond and the downstream environment.

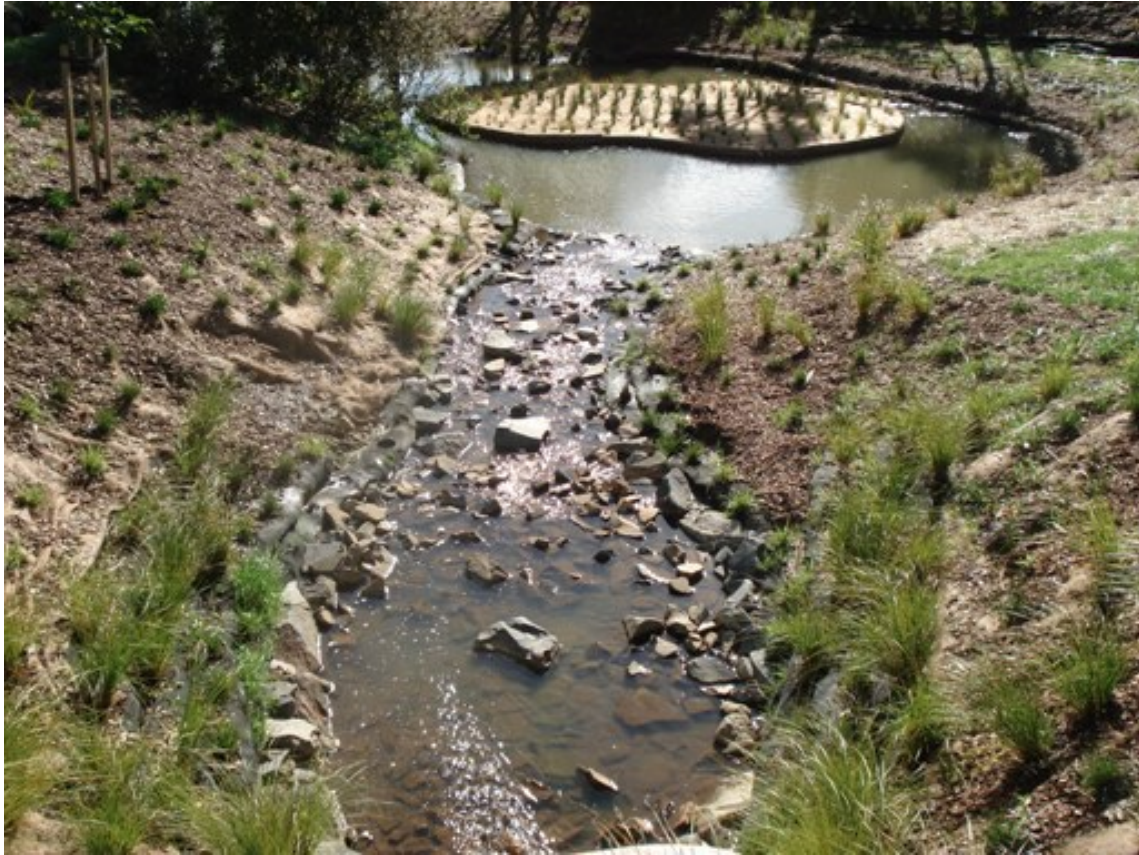
Figure 10: Southern Channel after restoration

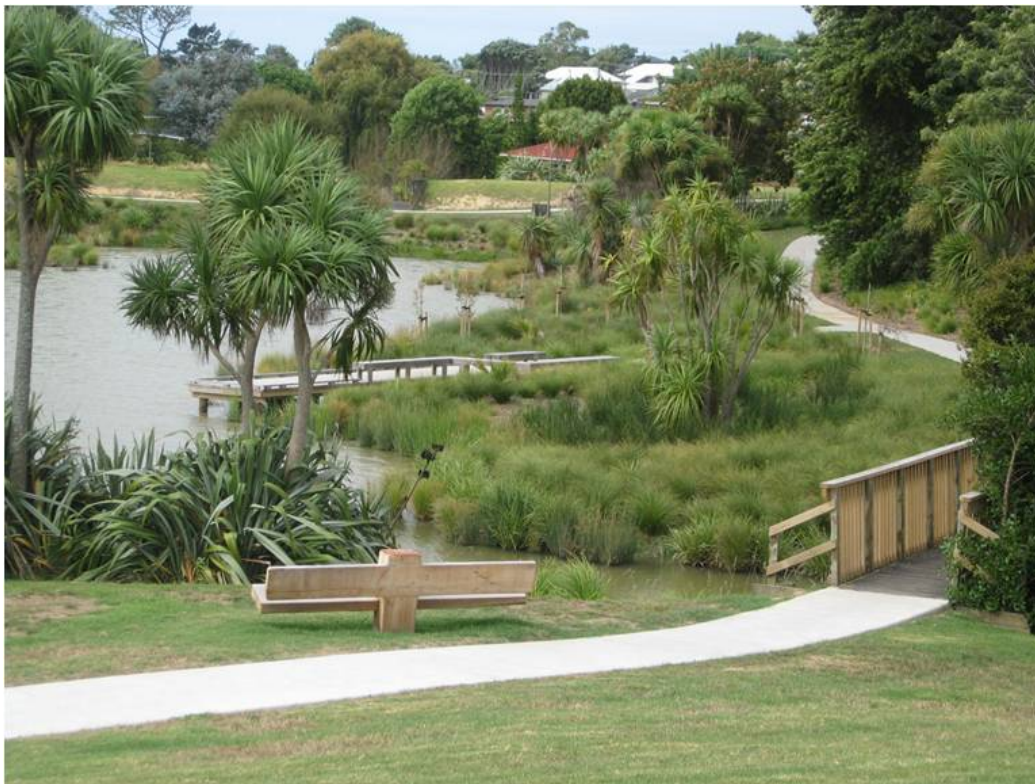
Figure 11: Planted Areas and New Footpath

A maintenance track and pedestrian footpath around the circumference of the pond was constructed. The maintenance track is to be utilised for general maintenance, to access the pond outlet structure, and to periodically maintain the forebays. The maintenance track consisted of permeable grass pavers (2m wide) with the concrete footpath (1.5m wide) adjacent to it forming a 3.5m wide access track. The placement of the forebay access track avoided steep areas and existing vegetation.

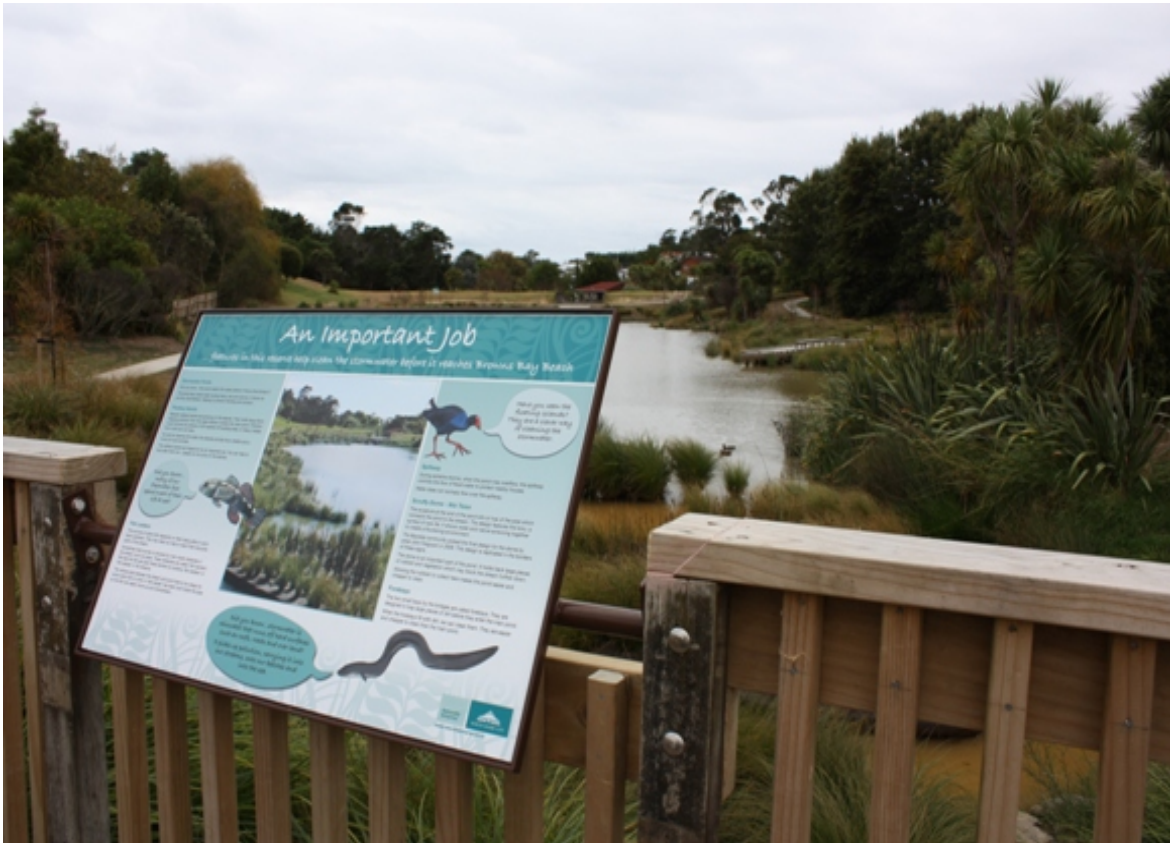
Figure 13: Interpretation panel

The community also expressed an interest in learning more about the different components of the stormwater pond and reserve, so four interpretation panels were installed to provide information on how the main components of the reserve treat stormwater, what plants and animals can be found in and around the stream and the history of the area.

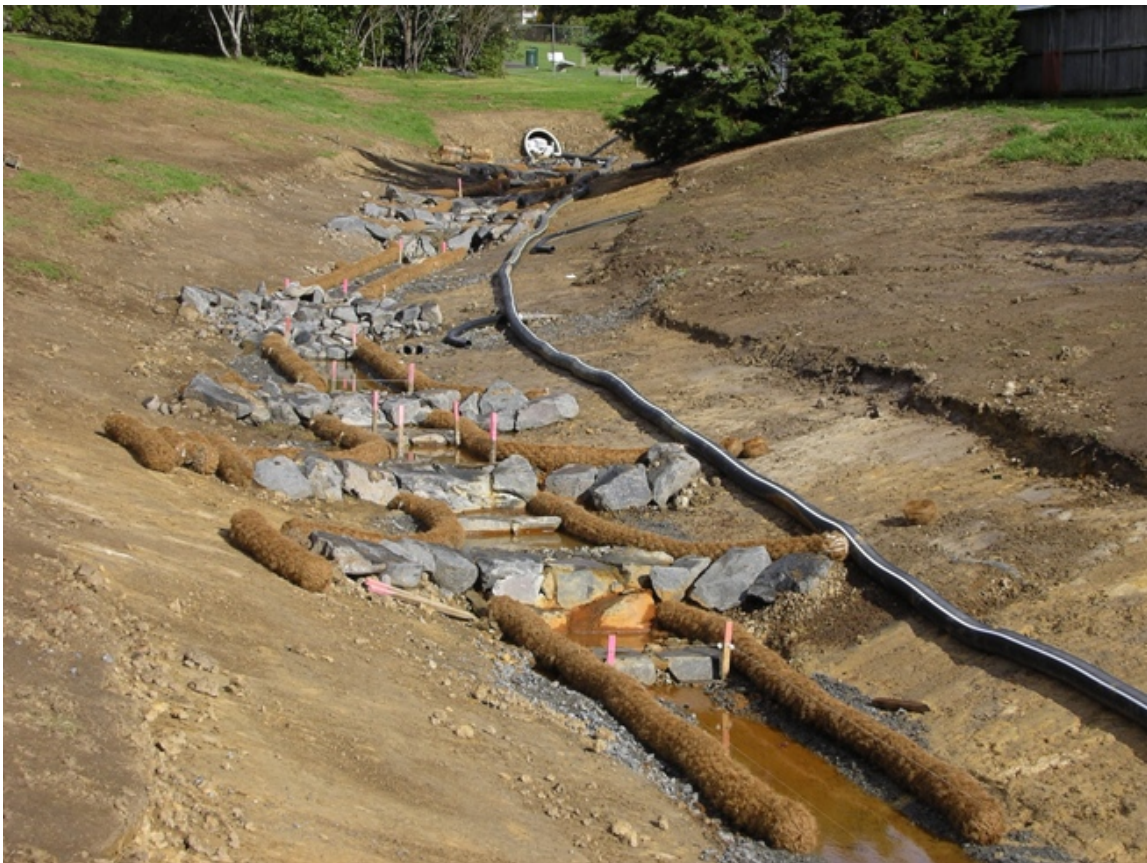
When transforming a concrete channel into a naturalised stream it is important to mimic nature as closely as possible. During the construction of the stream the coir fascines were set out with string lines, thus making the edge of the stream perfectly straight. This oversight was corrected and the stream edge curved slightly to more closely resemble a natural stream.

Figure 14: Stream constructed with string lines

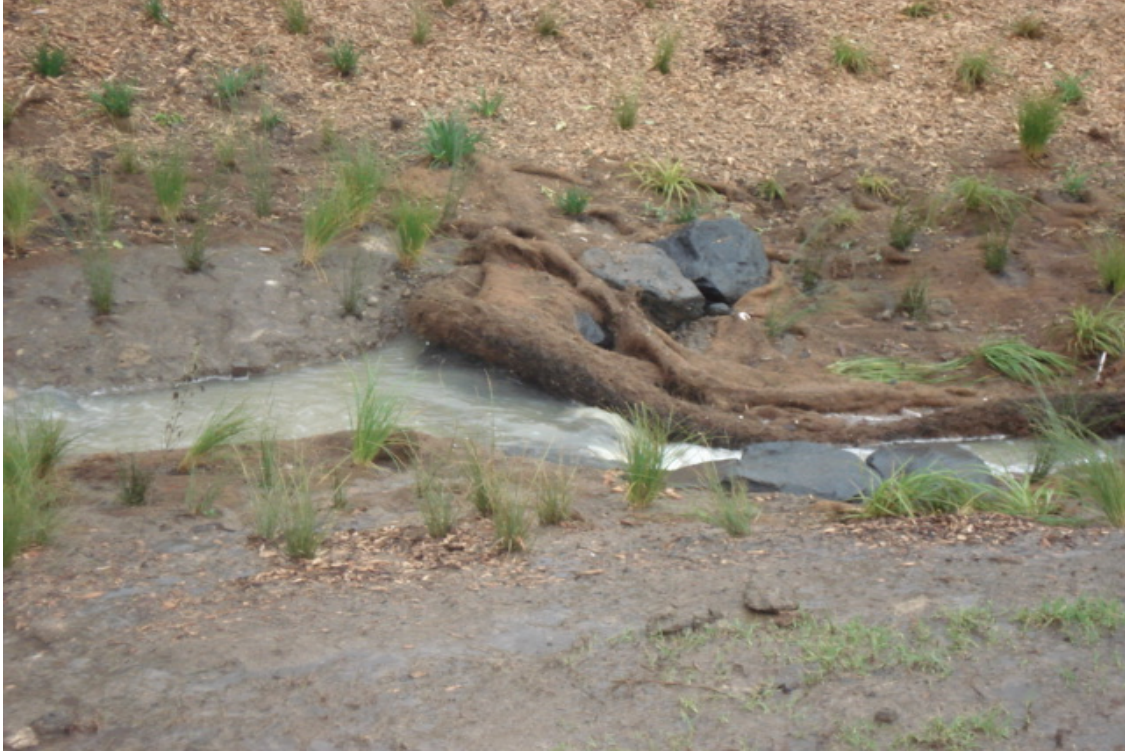
Weather also played havoc with the stream, with a heavy downpour lifting up some of the coir fascines and washing them downstream. This was corrected by staking the coir fascines down with “cross over” stakes and at more regular intervals.

Figure 15: Coir fascines washed away during heavy rainfall
