# EVALUATION OF RAIN GARDENS IN AUCKLAND REGION

**Rajika Jayaratne**, Auckland Regional Council; **Mike Martindale**, Auckland Regional Council; **Matthew D. Davis**, Auckland Regional Council; **Mike Timperley**, Timperley Consultants; **Judy Ann-Ansen**, Auckland Regional Council.

2010 NZWWA Stormwater Conference

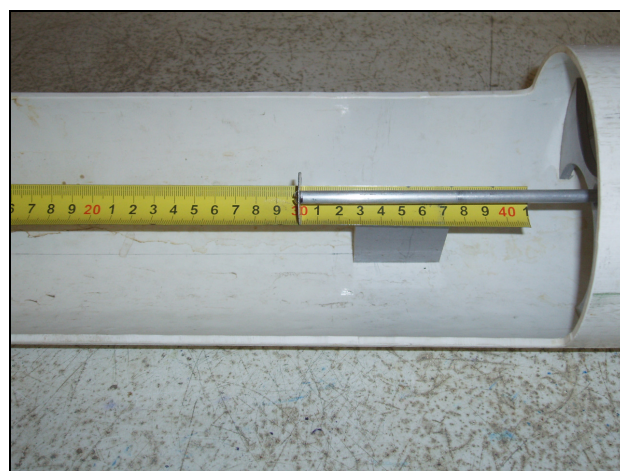
Percolation was measured using single ring Percometer (Figure 2 & 3) developed by the University Minnesota (<http://www.extension.umn.edu>). The Percometer comprises a 150 mm diameter plastic tube with a float and measuring assembly within the tube. The instrument is placed in a hole and filled with water. As the water elevation falls within the tube the drop in water is measured.

*Figure 3: Measuring system on Percometer*

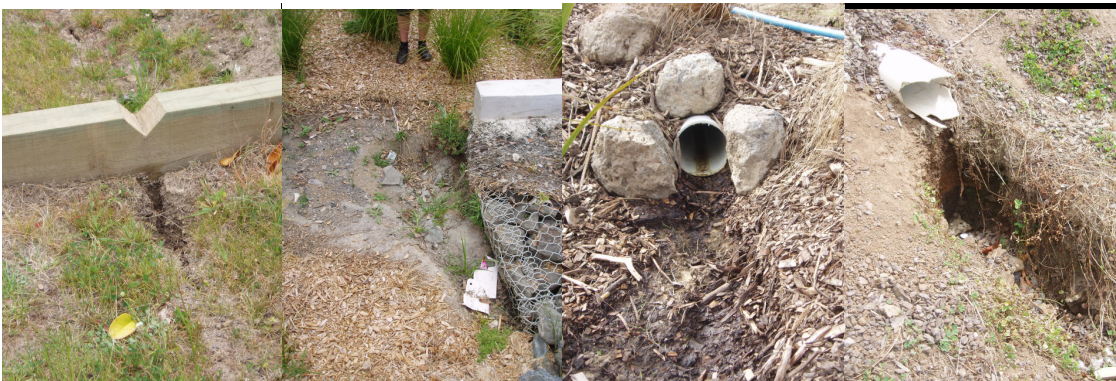
About 20% of the rain gardens evaluated showed evidence of erosion at the inlet (Figure 4). Typical causes of erosion were due to concentrated flow by piped inflow (Figure 4) and lack of erosion protection at curb cuts (Figure 6).

*Figure 4: Inlet erosion at St Lukes, Karaka Cove, Kia Ora and Oranga Community centre rain gardens*

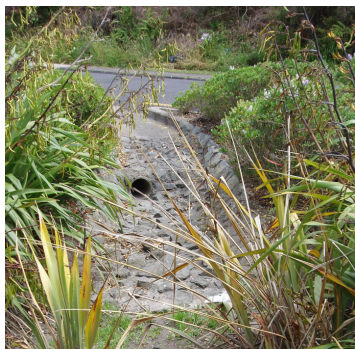
The type of inlet erosion protection structures observed in rain gardens ranged from level spreaders, Reno mattresses, and concrete with embedded riprap (Figure 5).

*Figure 5: Inlet channelization protection (Rangitoto College site, Northshore)*

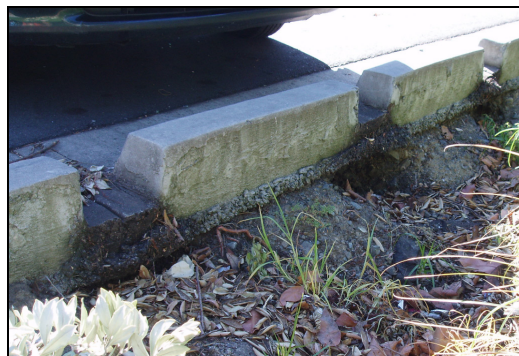
*Figure 6: Curb cuts and scouring (Wesley Community Centre, Mt Roskill)*

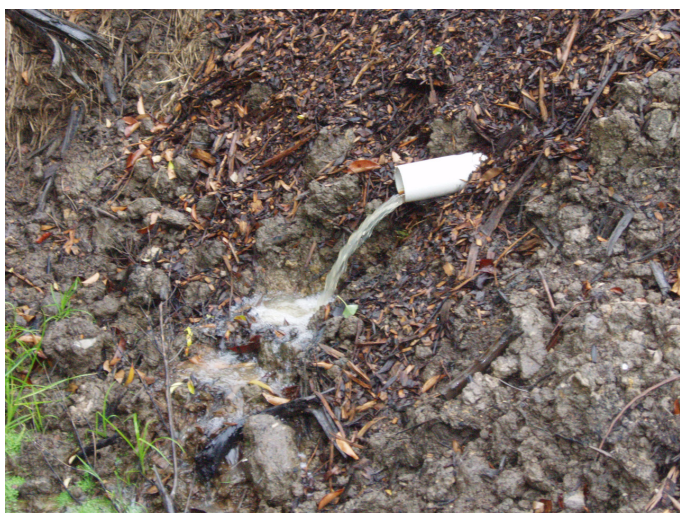
The rain gardens constructed on flat sites showed the least amount of erosion, as expected. These rain gardens provided diffuse overland flow into all areas of the rain garden. Most of the outlet structures observed consisted of standard catch pits with under-drains. These structures produced no obvious erosion. In some rain gardens erosion was observed at the outlet of under-drain pipes and banks due to over flow (Figure 7 & 8).

Figure 7: Outlet erosion at Kia Ora Road rain garden, Birkenhead

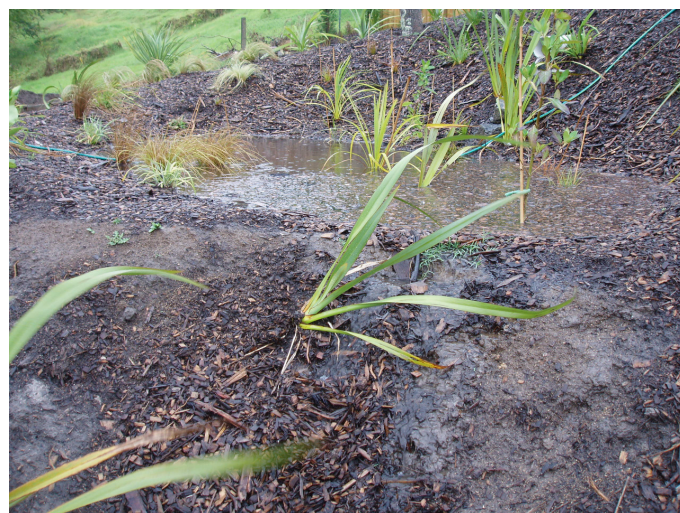
Figure 8: Overflow bank erosion at Kia Ora Road rain garden, Birkenhead

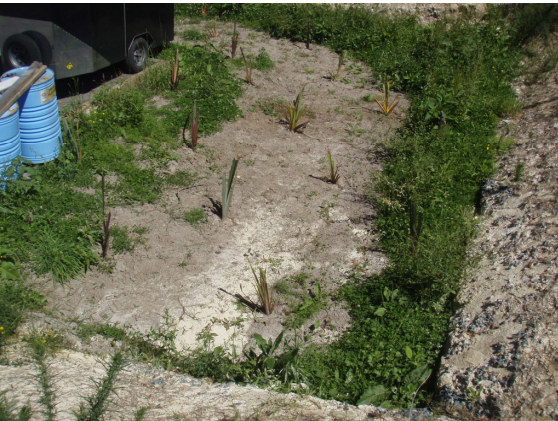
The depths of mulch varied from no mulch to 250mm in the rain gardens evaluated. About one third of the rain gardens had a mulch depth over 80 mm and one third had no mulch. The rain gardens with no or minimal coverage showed evidence of erosion of the substrate media, possibly resulting in increased media clogging as a result of accumulation of fine sediments (Figure 9).

*Figure 9: Good health Site*

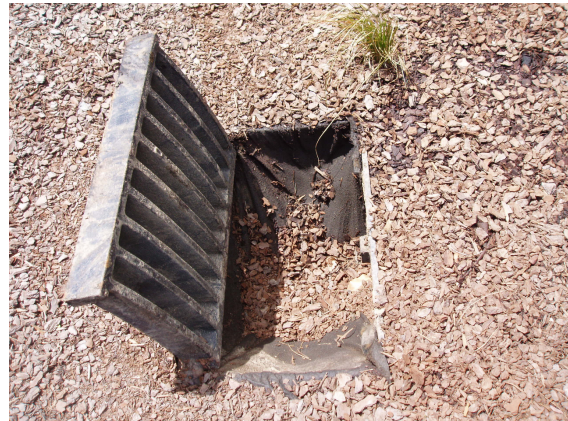
Rain gardens with mulch depths above 75 mm appeared to have an issue with the mulch floating away (Figure 10).

*Figure 10: Kirkbride Road Site*

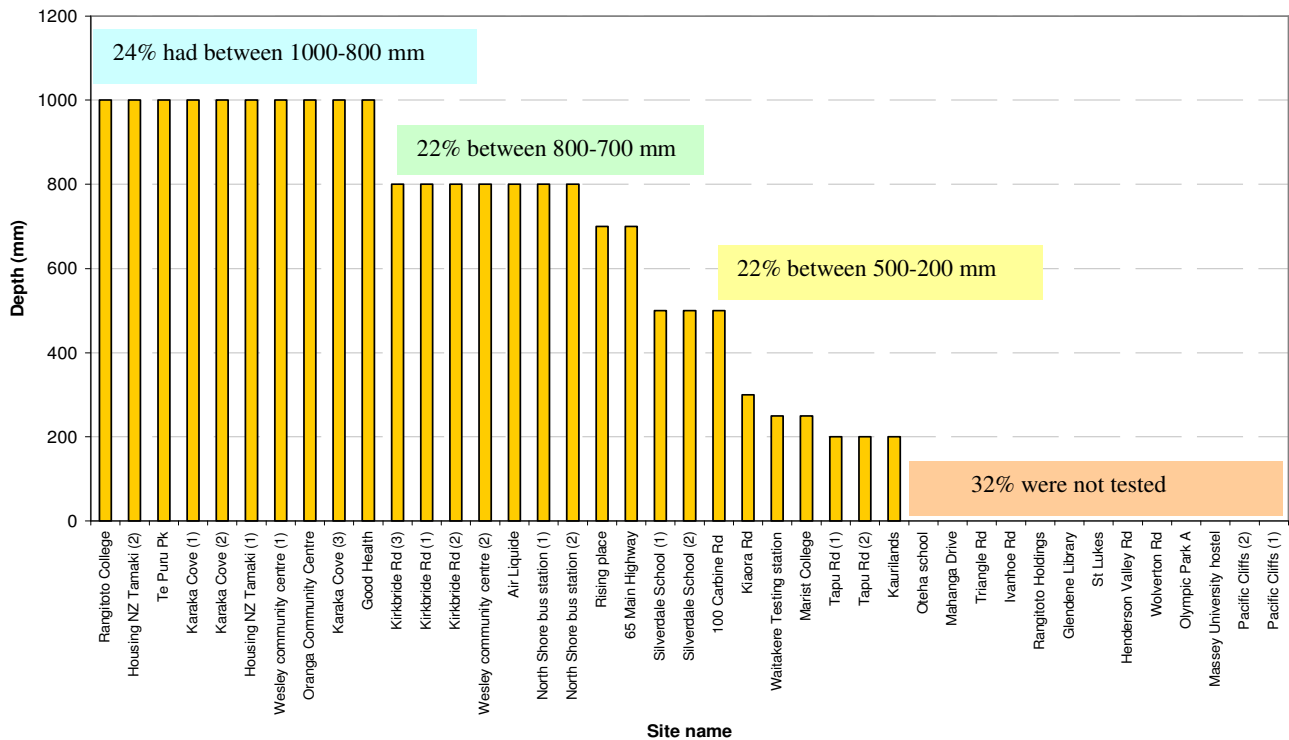
The media depth measured in the 41 rain gardens assessed was variable and is summarised in Figure 11. The depth of the media of about 32% of the rain gardens were not measured due to the presence of rocks (non-uniform stones sized 30-50 mm in diameter) in the media. Of the 41 rain gardens assessed, about 25% had the TP10 prescribed media depth.

Figure 11: Media depth variation for surveyed rain gardens

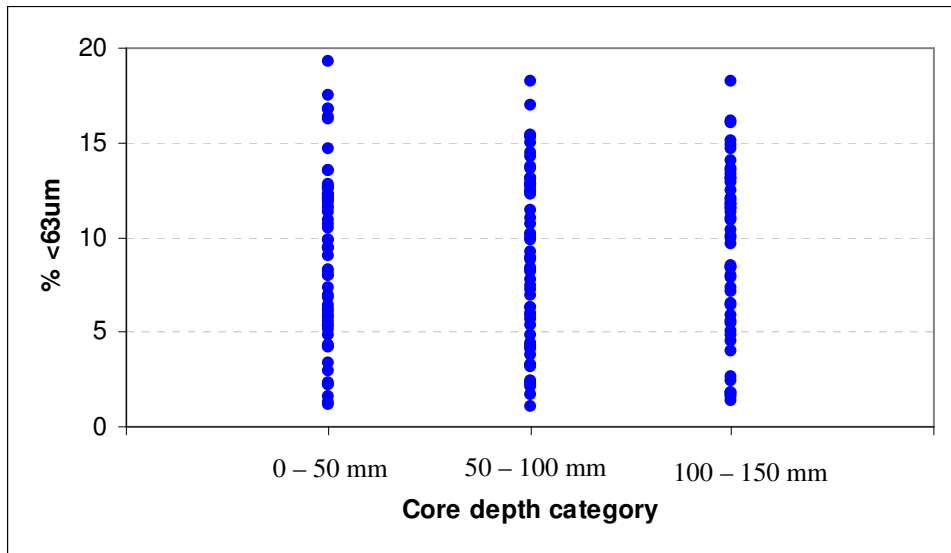
Core samples were obtained at three depths within the media profile to determine particle size. All media samples analysed had less than 25% of fines (particle size  $< 63 \mu\text{m}$ ), the sample median value was 10% of fines (particle size  $< 63 \mu\text{m}$ ) (Figure 14). Analysis results of the core samples indicates 62% of the rain gardens tested had well mixed media based on the distribution of particle size through the media profile.

Figure 14: Distribution of particles less than 63  $\mu\text{m}$  with different depth categories

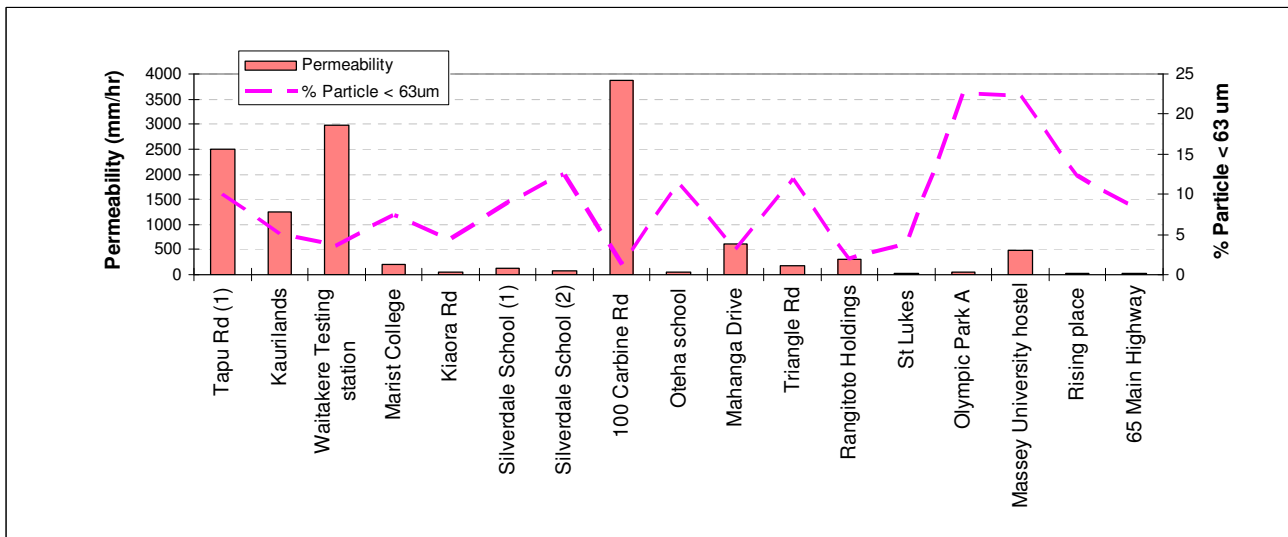
There was no relationship between fine particles ( $< 63 \mu\text{m}$ ) and the permeability (Figure 15). However, the highest permeability measured was associated with the percentage of coarser particles and some of the slower permeability rates were observed had media with more than 25% fines.

Figure 15: Distribution of permeability ( $\text{mm hr}^{-1}$ ) with % particles finer than 63  $\mu\text{m}$ .

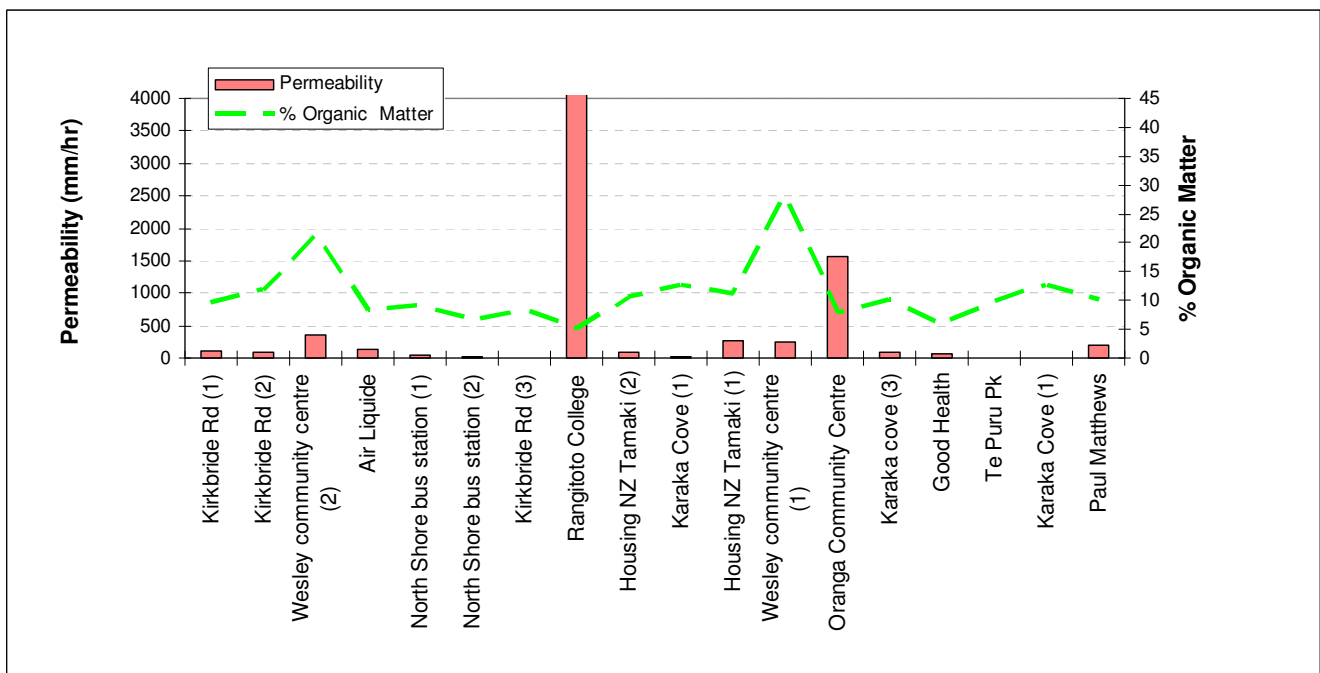
Organic matter content of the rain garden media ranged from 2% to 45% (Figure 16). There was no statistical relationship between organic matter and permeability.

Figure 16: Distribution of permeability (mm/hr) with % organic matter
