# EFFECTIVE OVERFLOW MANAGEMENT

*Phil Jaggard, Watercare Services Ltd  
Andy Gibson, MWH*

## ABSTRACT

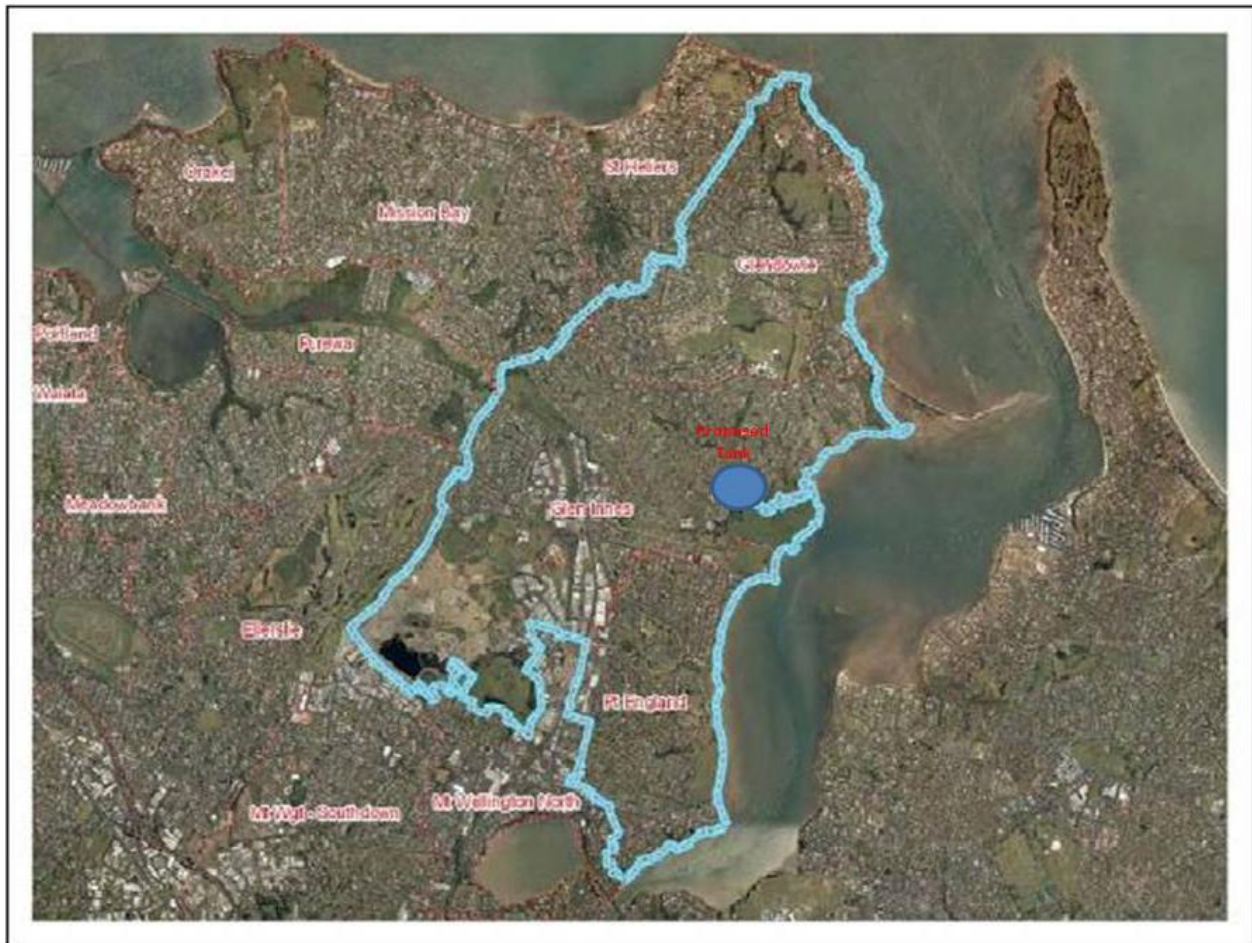
*Figure 1 – Wastewater Catchment*

Watercare (trunk wastewater network provider) recently completed a joint planning study with Metrowater (local wastewater network provider) into wastewater services for the Tamaki North wastewater catchment. The Tamaki North wastewater catchment has a total contributing area of 1,386 hectares, with 125km of wastewater reticulation, including 8 pump stations and 13 constructed overflows. The catchment is bounded by the Tamaki River in the East, the Waitemata Harbour to the North and Maskell St and St Heliers Bay Road define the western portion (Maunsell 2008).

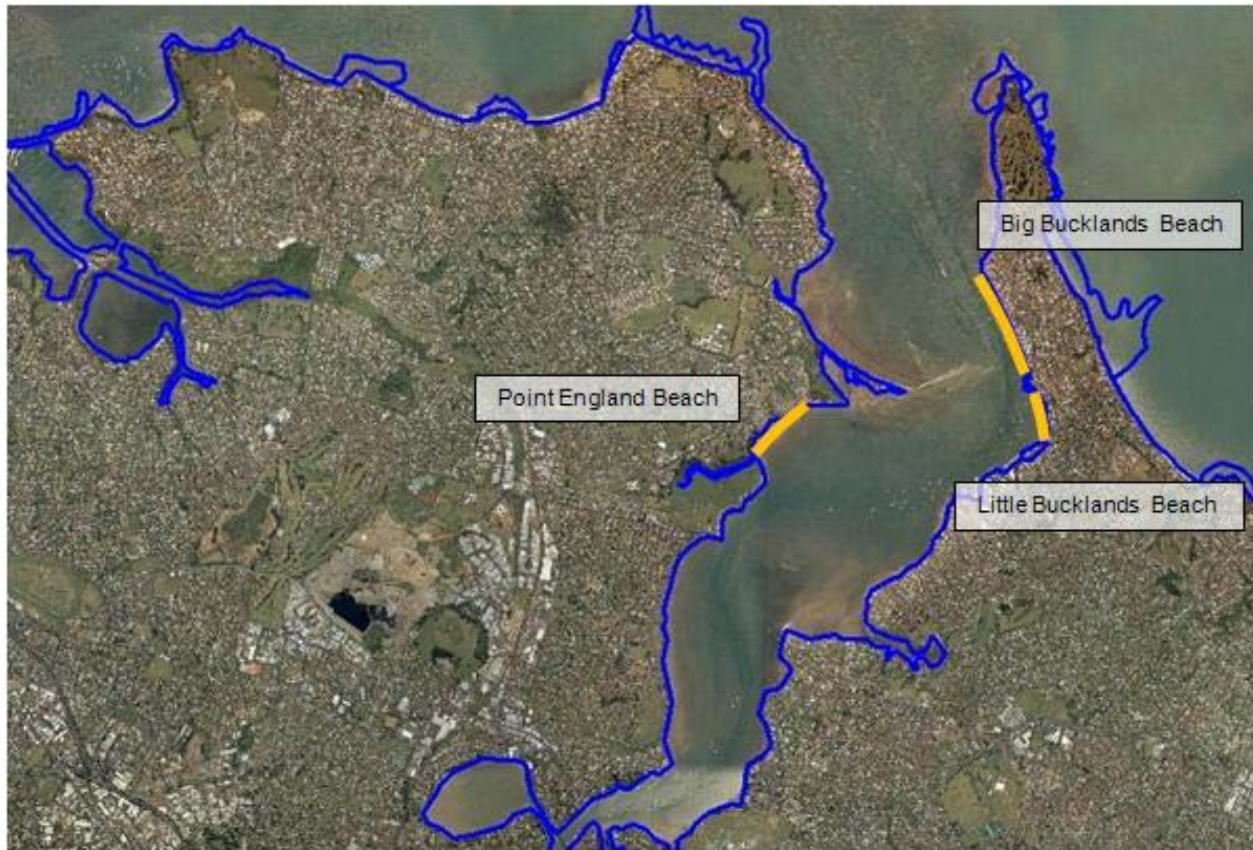
Figure 4 – Bathing Beaches

Within the Tamaki River catchment there are three designated bathing beaches; Point England Beach (within the Tamaki North Catchment), Little Bucklands Beach and Big Bucklands Beach (Manukau City Council area). These are shown below in Figure 4.
