# SOLVING OPERATIONAL PROBLEMS WITH INVERTED SIPHONS

*JR Miles, C Breen, B Coyle and K Morris*  
*North Shore City Council/SKM/Opus Project Team*

Inverted siphons on sewer networks typically suffer three main types of operational problems: siltation, air locking and odour. This paper describes the successful implementation of solutions for all 3 of these problems at inverted siphons on North Shore City Council's (NSCC) trunk sewer network.

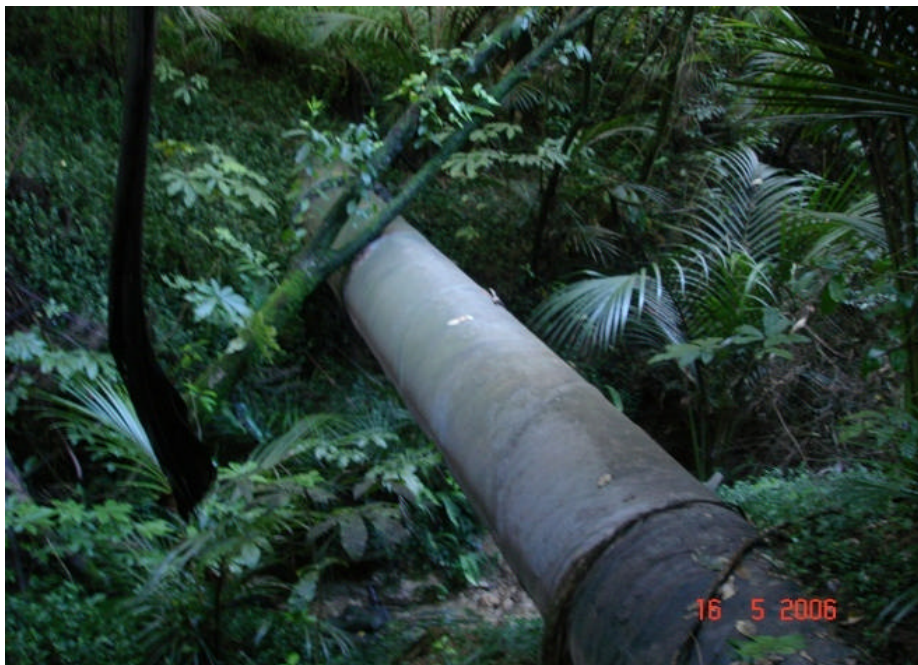
*Photograph 1: Typical Terrain around the Horizontal Sections of the Inverted Siphons*

While addition of access and drainage facilities appeared to be a straight-forward project, many issues needed to be addressed to ensure it was completed safely and with the minimum of environmental effects. Steep terrain, dense vegetation and slippery surfaces were some of the issues that had to be accommodated (see Photo 1). The first task was to create safe access to the horizontal sections, for installation of the drainage points and for future maintenance works. This was achieved by clearing vegetation and constructing paths, steps and working platforms.

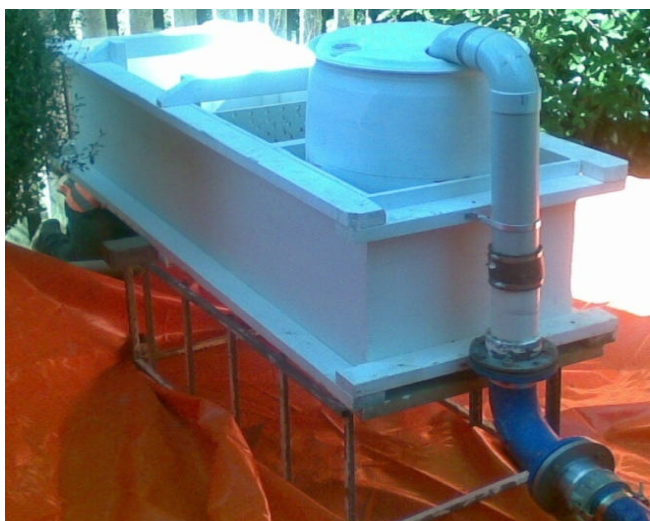
*Photograph 2: The weir box flow measurement device discharging to a local manhole*

One of the siphons could be drained to a local sewer which is at a lower elevation than the drainage point. However, to drain the others, flows had to be lifted 15 to 20 m, either to the downstream end of the siphon or to a more convenient location on the local network. Flow rates to local sewers also had to be controlled to prevent overflows occurring lower down the catchment. Due to the criticality of the drainage operation, a trial run of the draining equipment was undertaken at the contractor's yard prior to taking the equipment to site. A trial was then carried out on site. The drainage apparatus comprised a short length of flexible hose from the drainage valve to a light weight 0.4kW electric pump with a 100mm shut off valve, 100 m length of 100mm lay-flat hose laid out uphill to a weir box flow measurement device set up to drain into the local sewer manhole (see Photo 2 below).

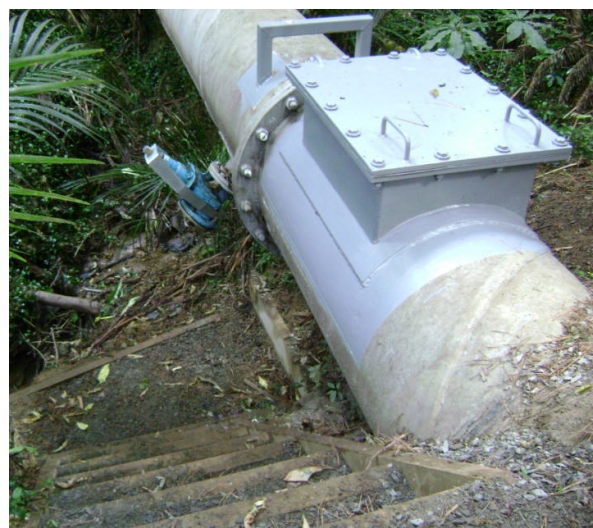
*Photograph 3: Completed installation*

Once emptied, the siphons were CCTV'd, jetted clean and CCTV'd again. 600 x 400mm holes were also cut in the pipe wall through the welded on hatch box assemblies. These openings allowed stones and other debris to be removed from the horizontal sections of the siphons using shovels and sewer spades. Photograph 3 shows an example of a completed installation.

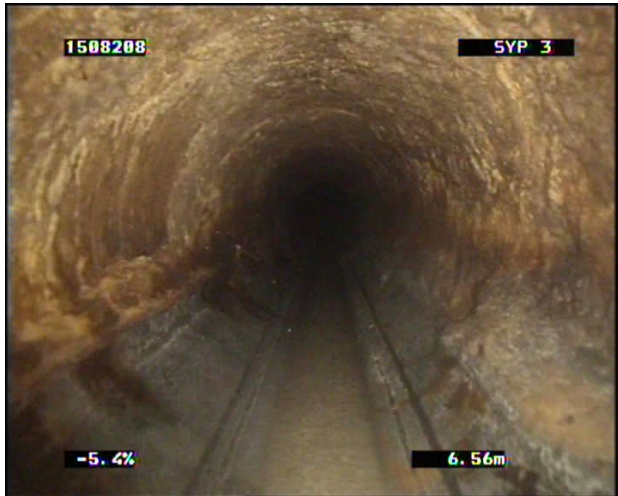
*Photograph 4: Corrosion on the descending leg of one of the siphons*

Below the normal water level the internal concrete lining was in a good condition, showing few signs of deterioration. However, above the normal water level there was evidence of acid corrosion, most significantly in the upstream sewers and where there is an initial shallow slope to the descending leg (see Photo 4).

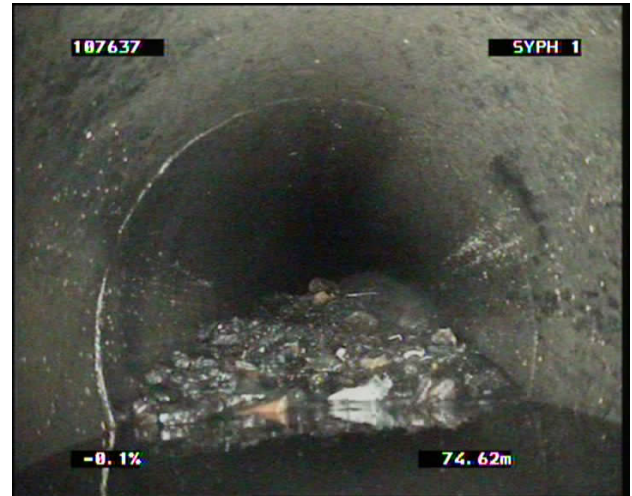
*Photograph 5: Silt build up at the transition from horizontal to ascending leg*

Stones and silt were present in the horizontal sections of all the siphons, and had tended to accumulate at the transition from horizontal to ascending leg, with depths up to 1/2 pipe diameter (see Photo 5). Silt had also collected along the invert of the shallower (7° and 12°) sloping sections of the ascending legs. But no material was observed in any steeply sloping (25° and 34°) ascending legs. Some larger objects were also found, such as a mallet and a barrow wheel.

It would have been best to locate the access hatches close to the transition from horizontal to ascending leg, as this is where most of the heavier sediment collects. These also happen to be the lowest points on the siphons, as the horizontal sections were constructed with a slight slope in the downstream direction. However, locating the drainage points where most of the silt collects would have led to blockages. In the end, feasible access routes, terrain, vegetation and consent issues determined where the hatch boxes and drainage valves could go.

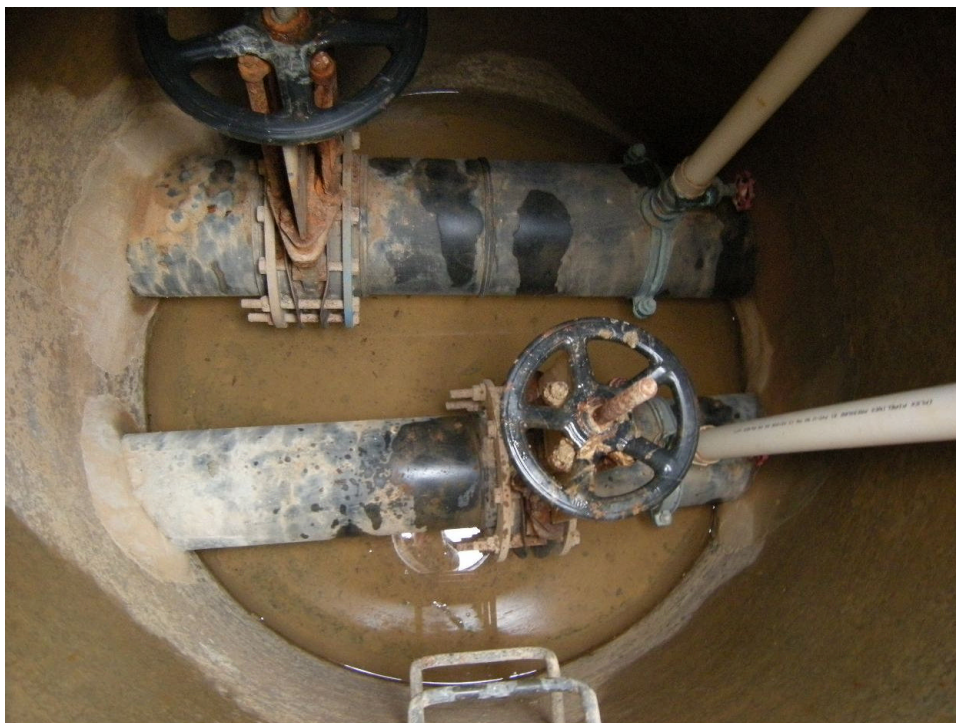
*Photograph 7: Air release vents*

A few metres after the inlet manhole the siphon barrels are fitted with isolation gate valves in a dry manhole chamber. This chamber therefore offered a convenient way to fit a pair of simple 50 mm diameter air release vents into the region where the air bubble was believed to be trapped. Photograph 7 shows the new vents. The vents exhaust back into the inlet manhole.

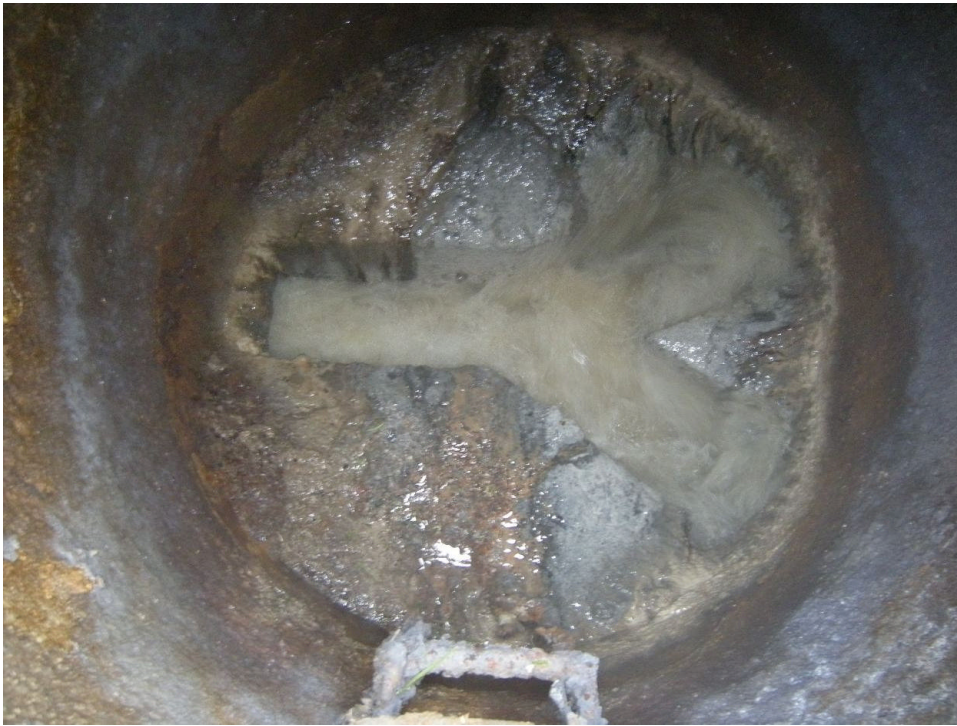
*Photograph 8: Behaviour at 70 l/s after installation of air release*

The change in siphon behaviour with the vents operational has been significant. Flows at 70 l/s remain within the benching of the inlet manhole and higher flows remain well within the manhole depth although some nominal surcharge is still observed. Photograph 8 shows the present behaviour at 70 l/s. Note that while flow remains within the benching channels, the flow pattern is still extremely turbulent reflecting the very poor layout of the inlets with the high velocity inflow jet directly striking a splitter structure.

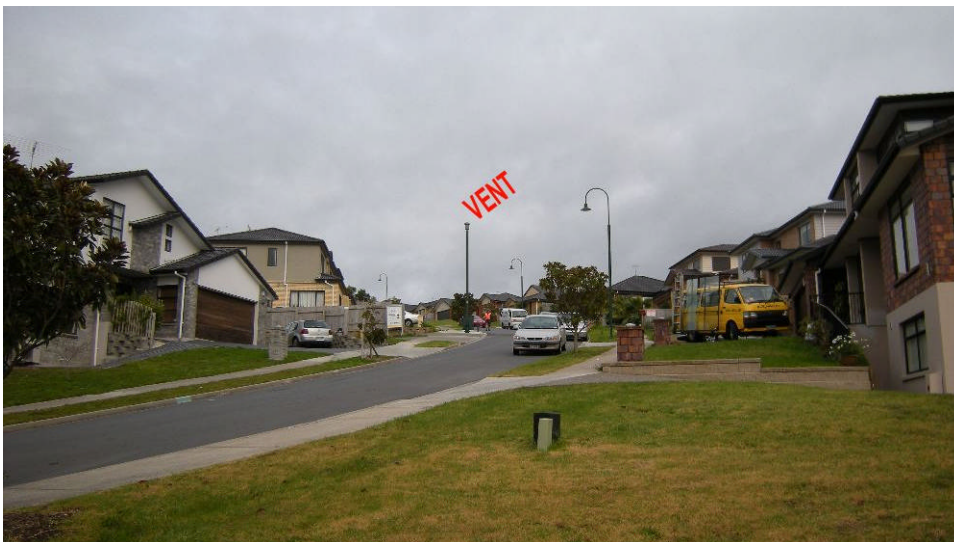
*Photograph 9: Proximity of houses to odour source*

The same siphon that suffered the air-locking problem discussed above (Spoonbill siphon), was also the council's worst odour "hot spot". Until recently the siphon inlet was in "green fields" and the odour issue was not recognised. However, when recent development surrounded the vent, odour complaints immediately arose. Photograph 9 shows the proximity of the neighbouring houses to the siphon inlet manhole vent stack.

At Spoonbill a small pine-bark biofilter of approximately 15 m<sup>2</sup> footprint and operational since April 2008 has proved extremely effective at reducing the odour nuisance. Occasional odour is still noticed, particularly during warm, still summer days, but monitoring of the air immediately above the odour bed has demonstrated better than 99% H<sub>2</sub>S removal and by inference, similar odour release reduction. Foul air is extracted at approximately 150 litres/second by fan from the siphon inlet chamber. The vent stack visible in Photograph 9 now operates as a supply of dilution fresh air, rather than a foul air exhaust.

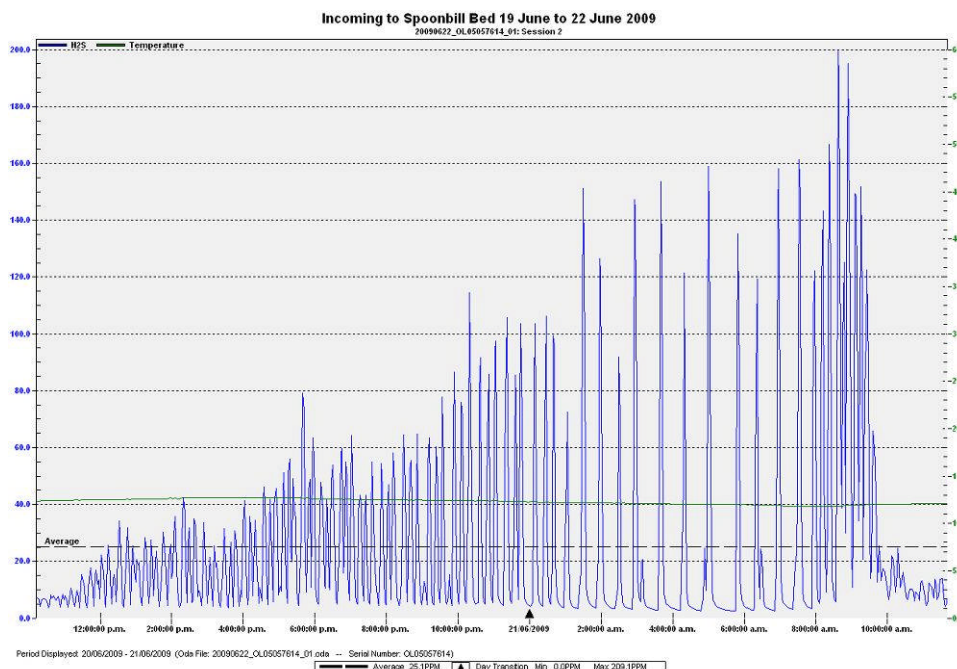
Figure 4: Observed Airborne H<sub>2</sub>S concentrations at Spoonbill Siphon

borne H<sub>2</sub>S within the siphon chamber regularly exceeded 200 parts per million and even now, with the measures described below, levels can still exceed 100 ppm. Unfortunately, at the time of writing, what concentration might represent “unacceptably odorous” remains to be determined. This will be determined as part of the Council’s Odour Management Strategy, but for the purposes of comparison levels elsewhere in the network are typically a few, to a few tens of parts per million. Figure 4 illustrates a typical diurnal H<sub>2</sub>S concentration pattern experienced at Spoonbill siphon. The plot extends over 13 hours from around 10 am to around noon the following day and shows steadily increasing H<sub>2</sub>S peaks through the night that coincide with each pump run from the contributing pump station. The highest levels (160 to 200 ppm) occur between 8 and 9:30 am, when the morning peak flushes the rising main to the siphon inlet.
