# THE EASTERN INTERCEPTOR PROJECT

*O. Smith, R. Rogers (BBR Contech Ltd), J. Graham (AECOM NZ Ltd), W. Brown (Watercare Services Ltd)*

## ABSTRACT

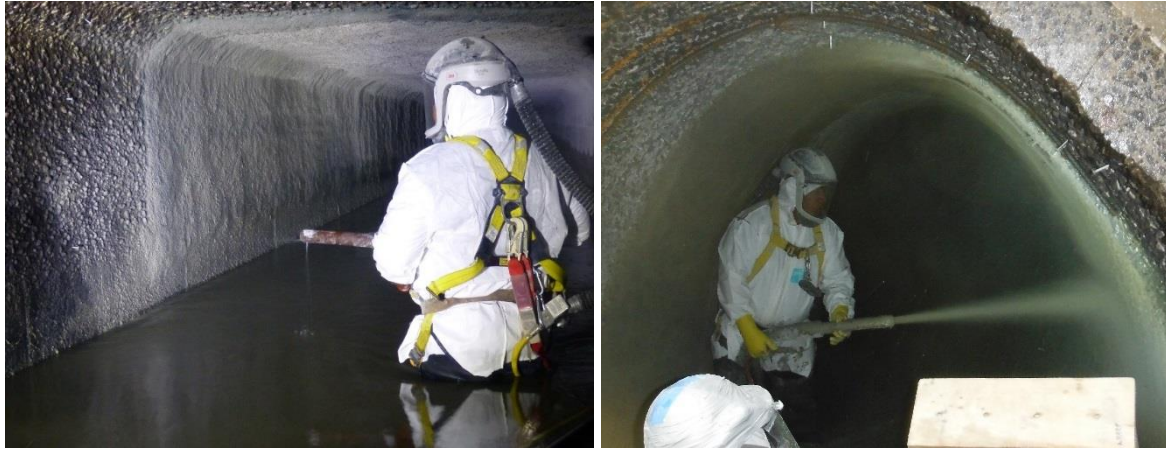
*Figure 2. Internal profiles of the Eastern Interceptor and typical equipment for gunite application in the Eastern Interceptor*

Ultra-high-pressure waterblasting (hydro-demolition) was used to remove the degraded concrete and contamination, and to prepare the surface. Supplementary reinforcing steel was tied in place where required before SewperCoat® was applied to the pipeline walls and invert using a dry spray gunite technique. Figure 2 shows the internal profiles of the Eastern Interceptor pipeline sections remediated during application of SewperCoat®.

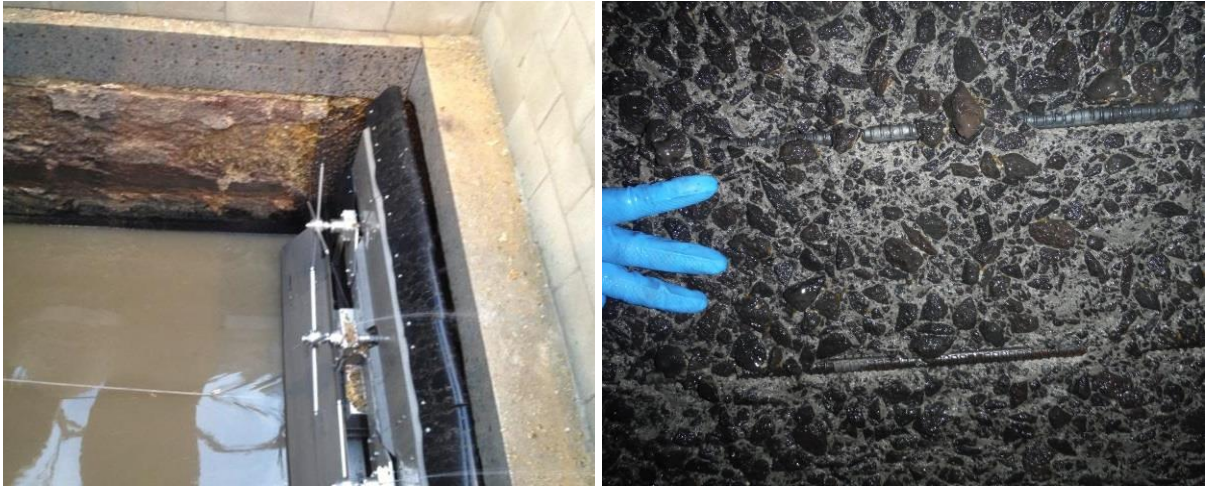
*Figure 4 Hydro-demolition cleaning trolley (left), and post substrate clean/preparation (right)*

Once all enabling works were completed and signed off, the ultra-high-pressure waterblasting commenced to remove all loose delaminated concrete and prepare the surface for SewperCoat® application. An innovative means of cleaning and surface preparation was implemented, employing the use of a remote cleaning machine shown in Figure 4 which was mounted on wheels and fitted with multiple high pressure nozzles. The remote cleaning unit was run continuously, winched backwards and forwards over a number of shifts until the required level of surface preparation was achieved. With the great majority of the ultra-high pressure water blasting preparation work being completed remotely, the project was able to significantly minimise and reduce the high

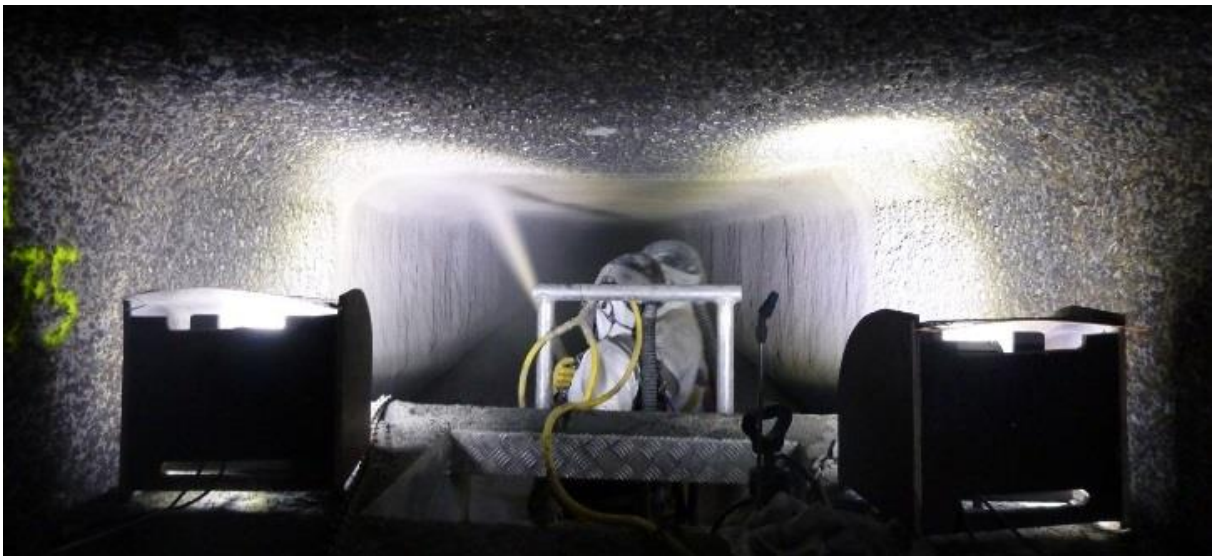
*Figure 5. Application of SewperCoat® at the WWTP (SP1)*

Following the completion of the surface preparation works, application of the SewperCoat® material commenced. A minimum of 25mm SewperCoat® depth was specified and regular depth gauges were installed to monitor the thickness of application. A custom made work barge to fit within the wastewater pipeline was fabricated for the dry spray gunite works, specifically designed to carry equipment and plant for the rehabilitation works. The barge and spraying operation is shown in Figure 5. The barge also served the critical function of providing a means to extract injured personnel should a serious incident have arisen. With working windows in the live sewer restricted to approximately 6 hours per shift, satisfactory completion of each shift's SewperCoat® application was emphasised to minimise rework.

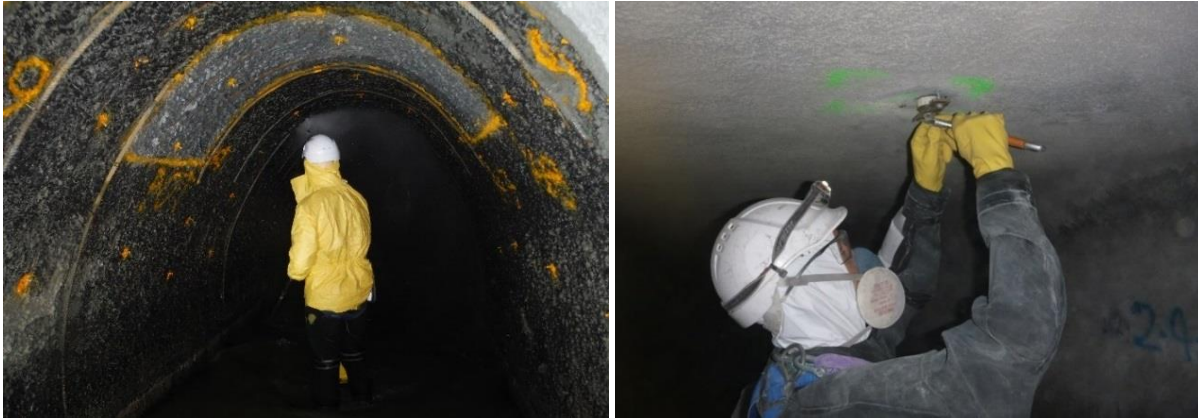
*Figure 6. Inspection following hydro-demolition and rebar installation in SP2 (left), and SewperCoat® adhesion testing (right)*

A joint inspection between the consultant and contractor served as a hold point for release of each section after the substrate cleaning and preparation works. As the sewer was always live and flows were increased following the completion of each shift, rigorous daily checks and photographic records were captured. At the commencement of each shift of SewperCoat® application, the section of pipeline identified for spraying was cleaned again by hand using a low pressure water-blaster in order to ensure that any sewerage waste and fat build up was removed. Regular QA testing was performed over the course of the project, including lab testing for compressive strength of the SewperCoat®, in-situ adhesion testing and daily thickness measurement checks to ensure the required thickness was installed (Figure 6).

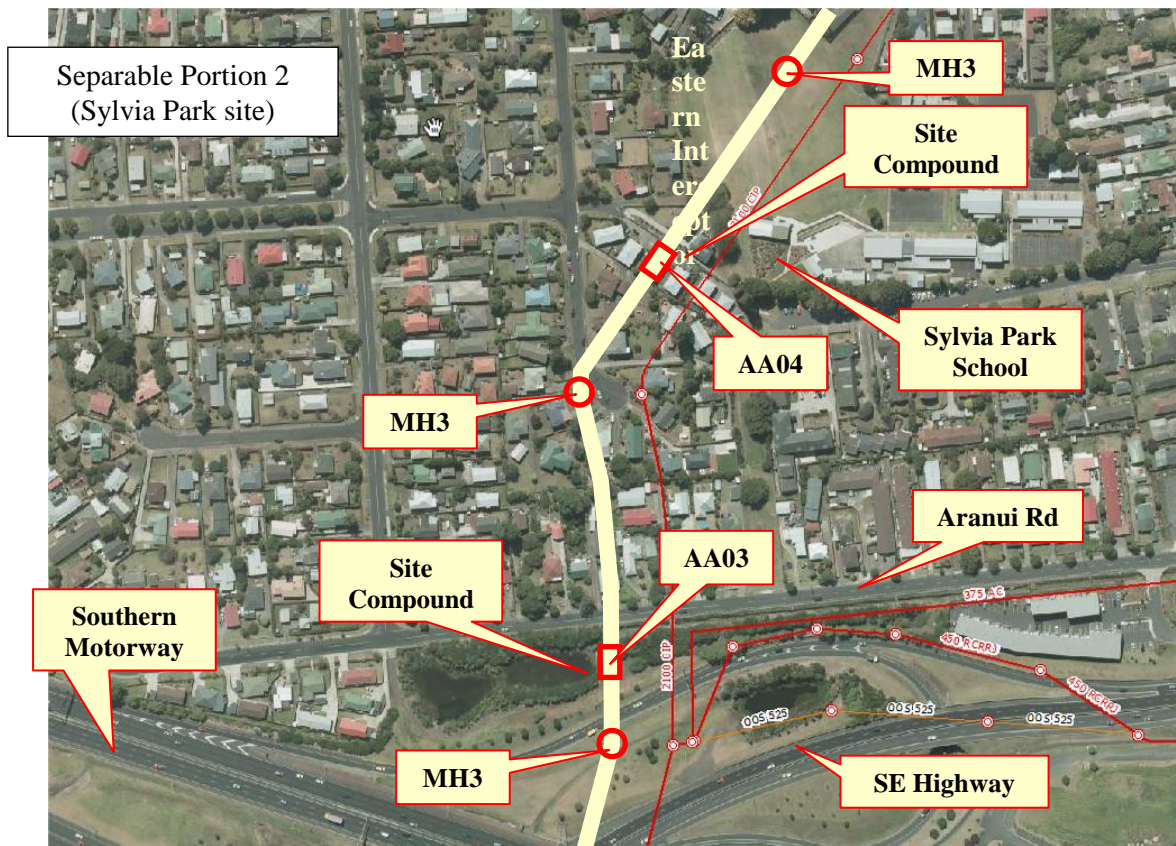
Figure 7. Site map of Seperable Portion 2 (Sylvia Park site)

SP2 consisted of a 450m section of the Easter Interceptor pipeline located between Manhole 33 and Manhole 35 (MH33 and MH35) in the Sylvia Park/Mt Wellington areas. A site plan for SP2 is shown in Figure 7. The upstream 130m section of pipeline to be remediated, and the main site compound and temporary sewer access aperture AA04 were situated within the Sylvia Park School grounds. The remaining 320m of sewer pipeline included in the SP2 scope was primarily located within the Sylvia Park residential area between Sylvia Park School and Aranui Road.

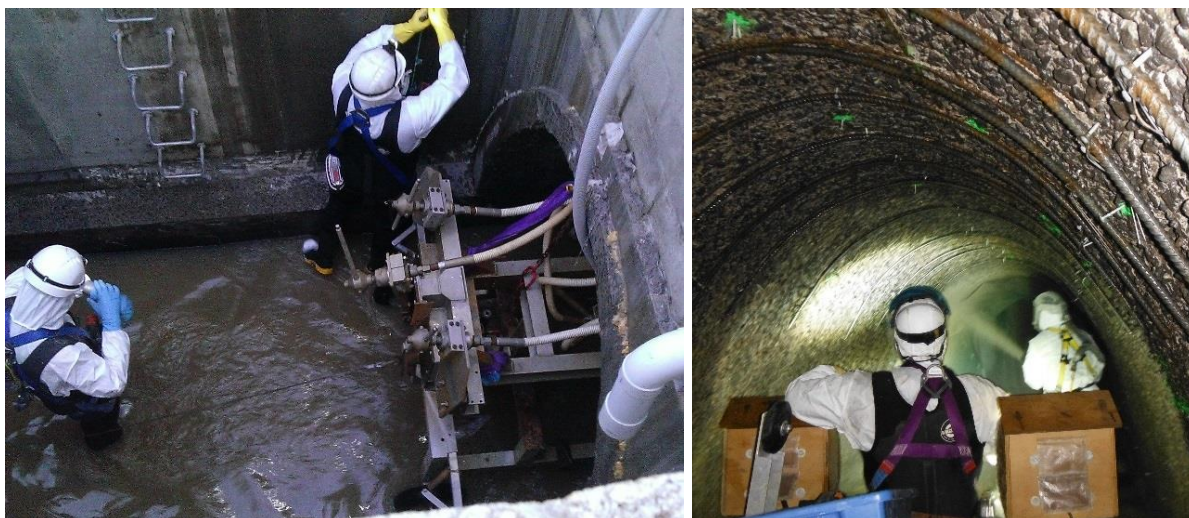
*Figure 8. Remote cleaning unit modified for the elliptical pipe section (left), and wheeled work trolley with SewperCoat® application in the Sylvia Park section (right)*

For the SewperCoat® application, a work trolley similar to the barge was designed and fabricated to run on wheels, taking into account the reduced flows encountered in the Sylvia Park pipeline sections (Figure 8).

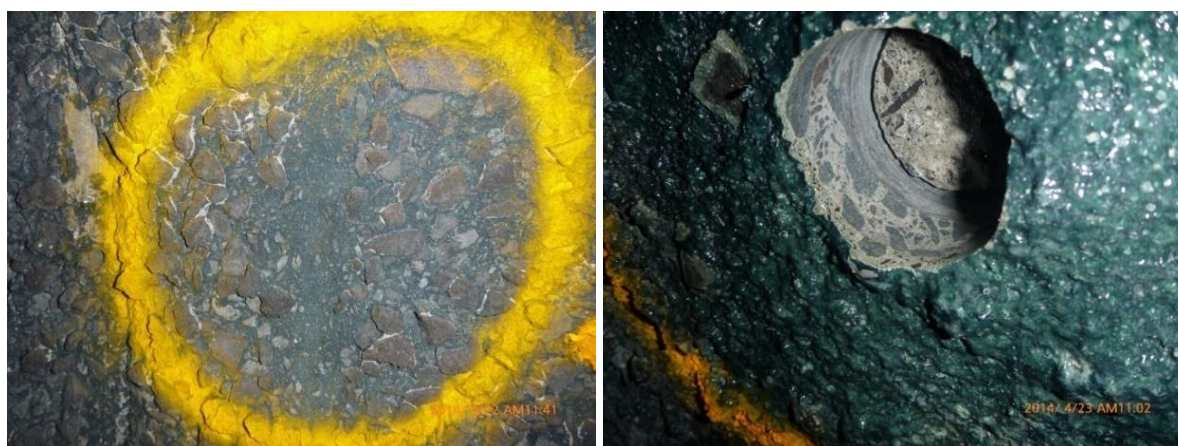
The management of technical issues that arose during the project was done by close consultation between the main project team members. An example was the discovery of an unexpected black colouring that formed on the freshly cleaned concrete substrate during the Sylvia Park phase of works (Figure 9). The black colouring became evident following the remote cleaning work. Due to the unknown properties of this condition, the decision was made to temporarily halt the application of the SewperCoat® until more was known about what was causing the black colouring effect. Samples from within the sewer were collected and dispatched to a laboratory for independent analysis immediately following extraction. The testing was unable to confirm the exact source and properties of the colouring although there was evidence to support the theory that it was some type of rapid bacterial/algal growth. The decision was made to remove the black colouring prior to the SewperCoat® application and further testing revealed the use of hydrogen peroxide to be effective in its removal.

*Figure 9. Black organic staining which appeared on alkaline surfaces of cleaned concrete and applied SewperCoat® in SP2*

The impacts associated with introducing the hydrogen peroxide application at the beginning of each shift of SewperCoat® application were worked through by the project team and the remaining wastewater pipeline rehabilitation at Sylvia Park was structured into smaller segments. This enabled a targeted approach to the black removal, increasing certainty of delivering completed rehabilitated sections of pipeline prior to incurring stand downs associated with the winter inclement weather periods.

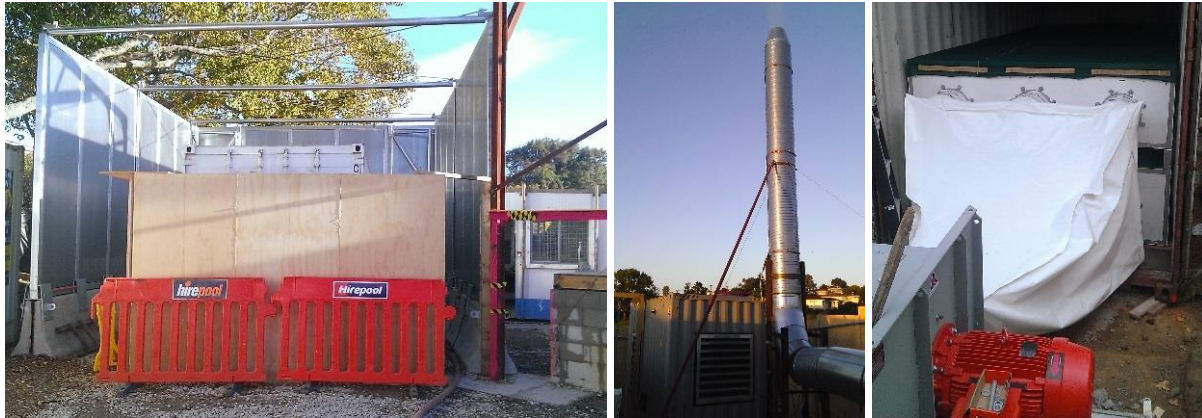
*Figure 10. Noise control enclosure in Sylvania Park School (left), ventilation chimney (centre) and activated carbon filter for odour control (right)*

Prior to the Sylvania Park phase of works commencing, likely noise impacts were assessed and noise management strategies developed. This included the implementation and development of a “U” shaped noise enclosure that was located within the main Sylvania Park School compound, shown in Figure 10. The noise enclosure was specifically designed to house the ultra-high pressure waterblasting cleaning unit followed by the Gunitite spray equipment once the preparation and cleaning works were completed. The fans used for the ventilation were also fitted with silencers in order to reduce the associated noise impacts. The success of the noise management strategies was critical in maximizing the available working windows in the sewer, particularly when taking into account the 5:30am sewer entries during the Sylvania Park Phase of works. This was verified by noise monitoring undertaken during the works.

An 8-metre-high chimney was initially established at the extraction ventilation point at MH35 with the aim of dispersing the extracted air in order to reduce the odour impact. When complaints were received regarding odour issues, the project team implemented the introduction of odour control fogging by placing the rings of nozzles around the chimney, injecting odour oxidizing agents into the air flow. When this was found to still not achieve the desired odour neutralisation, the works were temporarily halted in the Sylvania Park area and relocated to another section of the pipeline at the Wastewater Treatment Plant while the project implemented the design and construction and commissioning of a new activated carbon filter, housed in a 20-foot container, which proved successful in significantly reducing odour related complaints and associated stand-down delays for the remainder of the project (Figure 10). An odour curtain was also developed to restrict foul air flows into the pipeline works area, consisting of a series of heavy rubber mats hung from the sewer ceiling at a location above MH35. The odour curtain was attached to a pulley system so it could be raised above the sewer flow at the end of the day’s shift remotely from outside the wastewater pipeline. To manage the impact of SewperCoat® dust being extracted through the ventilation system during the rehabilitation works, temporary structures with filter cloth were erected at the ends of the extraction fans.

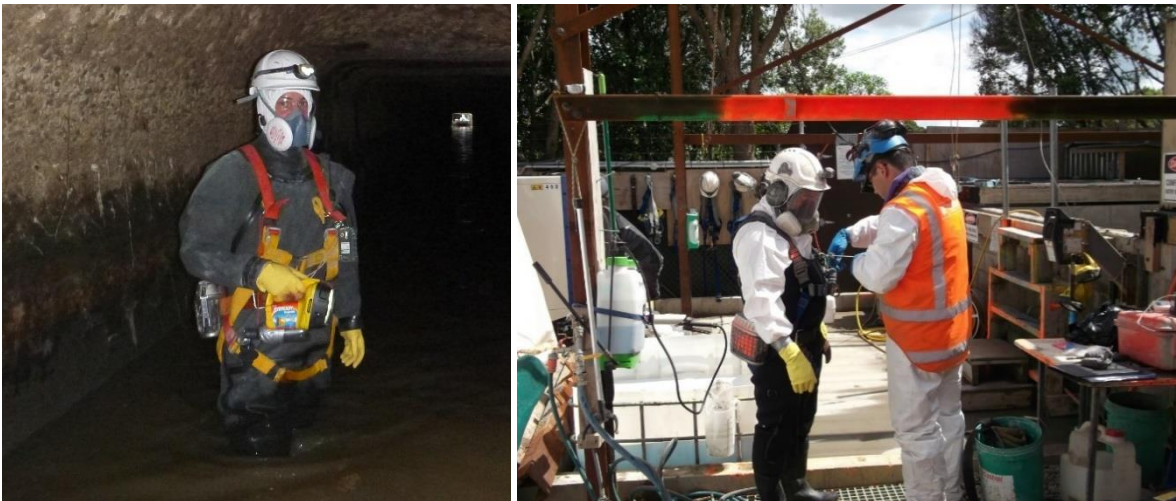
*Figure 11. Typical PPE for sewer entry (left) and PPE inspection prior to confined space entry (right)*

For works in the sewer pipeline involving spraying of SewperCoat® and areas where hand held ultra-high pressure water blasting was required, the operatives were equipped with a fixed air supply line feeding breathing helmets. The air supply was made available via an electric compressor fitted with air purifying filters.
