PRISONS, PLANTING AND FLOOD PROTECTION

David Hogg, MWH now part of Stantec
Caroline van Halderen, MWH now part of Stantec

ABSTRACT

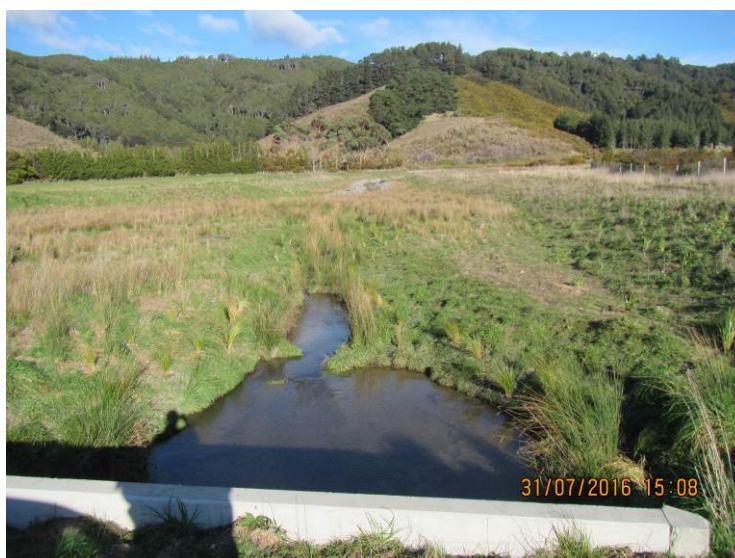
Photograph 3: Taken standing on the bund and box culvert looking upstream to the flood retention area

The purpose of the retention area was to mimic the performance of the previous system to satisfy UHCC's project driver of not greatly altering the catchment time of concentration. The volume of storage created on the new detention area matched the volume of water captured when the prison carpark previously flooded. A 1m x 4m box culvert was installed to allow up to a 2 year ARI to pass before flood detention occurs. The retention area is shown in Photograph 3.

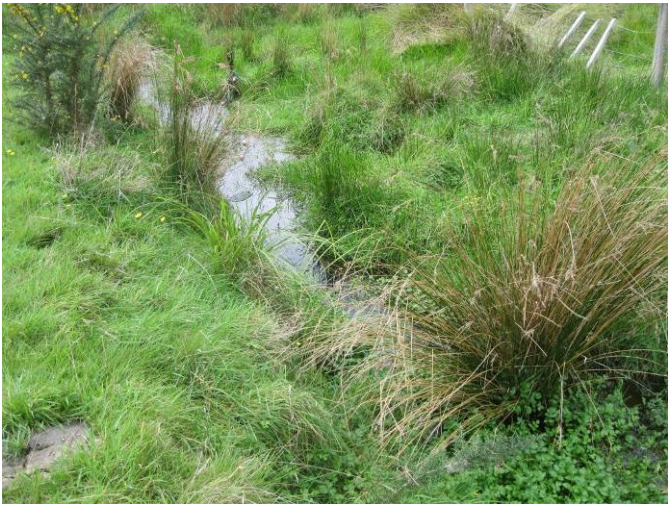
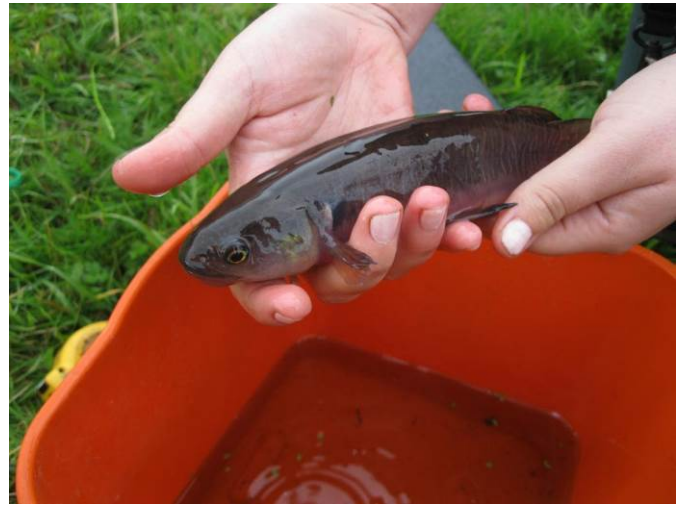
Photographs 4 and 5: Habitat where large banded kokopu (pictured) was caught and relocated upstream

One resource consent condition was to capture and relocate fish from waterways which were potentially affected by the earthworks. This work was undertaken in accordance with the approved fish relocation plan.

The total catch was four shortfin eels (*Anguilla australis*) from 350mm to 500mm in length, and three large banded kokopu (*Galaxias fasciatus*) from 200mm to 275mm in length. All fish were in good condition and were successfully relocated to suitable habitat in the upper stream, upstream of the boundary of the prison. All but one of these fish were caught in fyke nets in reaches two (Photograph 4). This area provided good quality habitat due to the presence of pools (0.4 to 0.6m deep), abundant riparian cover of grasses and

Juncus, and an associated small area of wetland. Fish records were uploaded to the NZ Freshwater Fish Database.

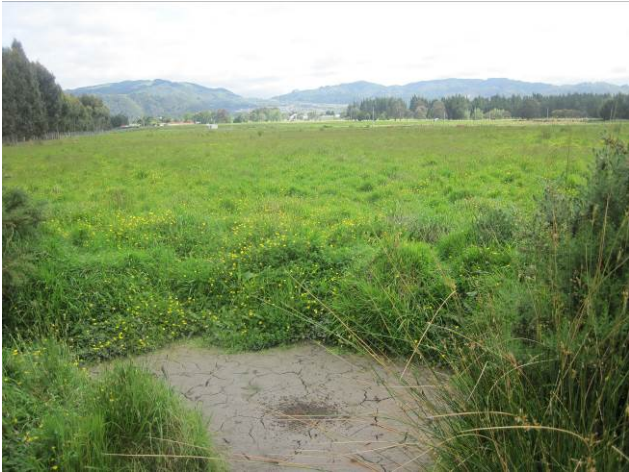
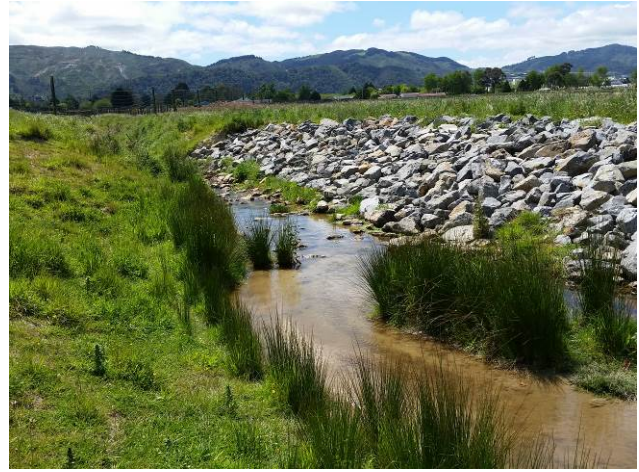
Photographs 7 and 8: Showing the NZDF land before and after channel construction and planting

Approaching two years after the first planting has been undertaken, the smaller grasses and wetland species have started to establish well.
