CRUMBLE MANHOLE PIE MEETS ITS MATCH

Kelvin Hill (Utilities Manager, Western Bay of Plenty District Council, Warwick Robbins (Senior Civil Engineer, Pattle Delamore Partners Ltd, NZ).

Western Bay of Plenty District Council and Pattle Delamore Partners Ltd have just completed a two year field trial of four alternative manhole restoration options. The trial aimed to identify the options with the best value for money and the best projected long-term performance in a highly corrosive environment (89 ppm H_2S). We discovered from the trial that retrofit manhole corrosion restorations require a careful design-install approach (compared to new installations).

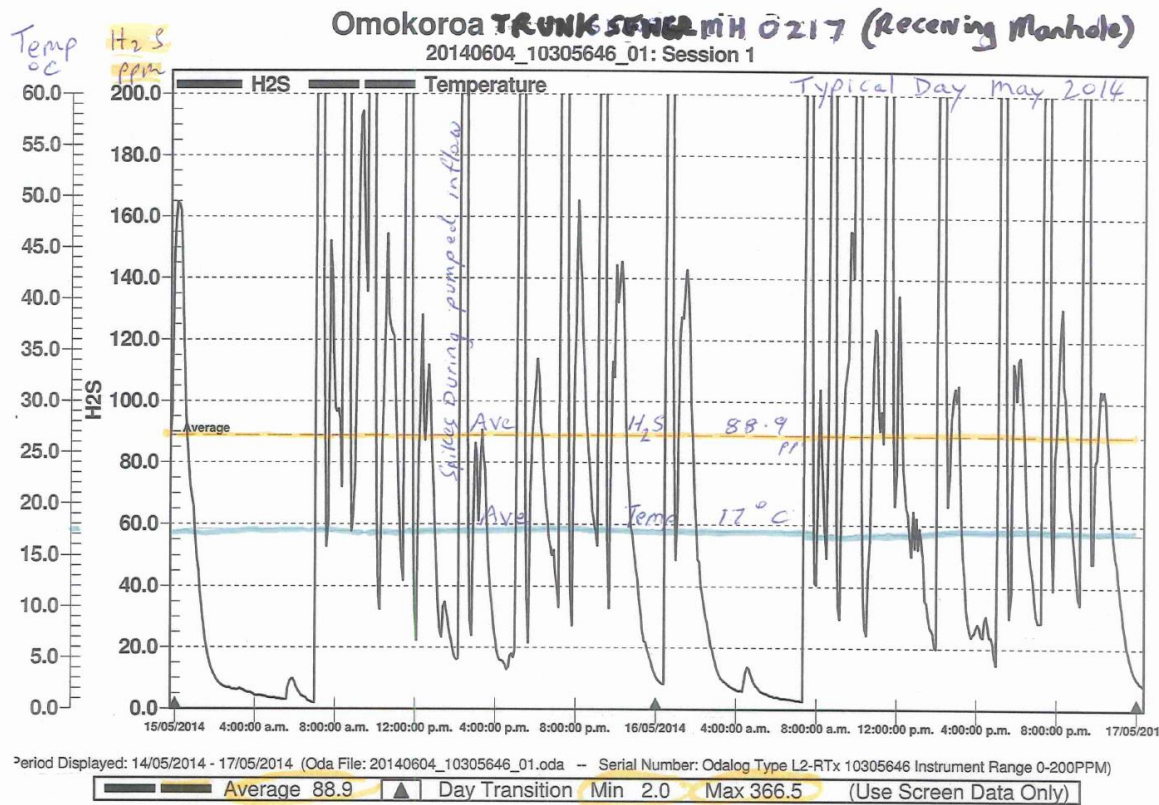
Figure 2: H₂S Levels Logged in Worst Receiving Manhole 0217.

Figure 2 shows daily H₂S gas variations in the worst affected receiving manhole SSMH 0217 during May 2014. The H₂S gas concentrations peaked at 366.5 ppm each time the incoming rising main discharged for 20 minutes or so. Taking into account the lower concentrations between incoming pumping, the average H₂S gas concentration in this manhole is 88.9 ppm. The incoming rising main operates on average 11 times per day and discharges 43 hour old septic sewage into the gravity trunk sewer.

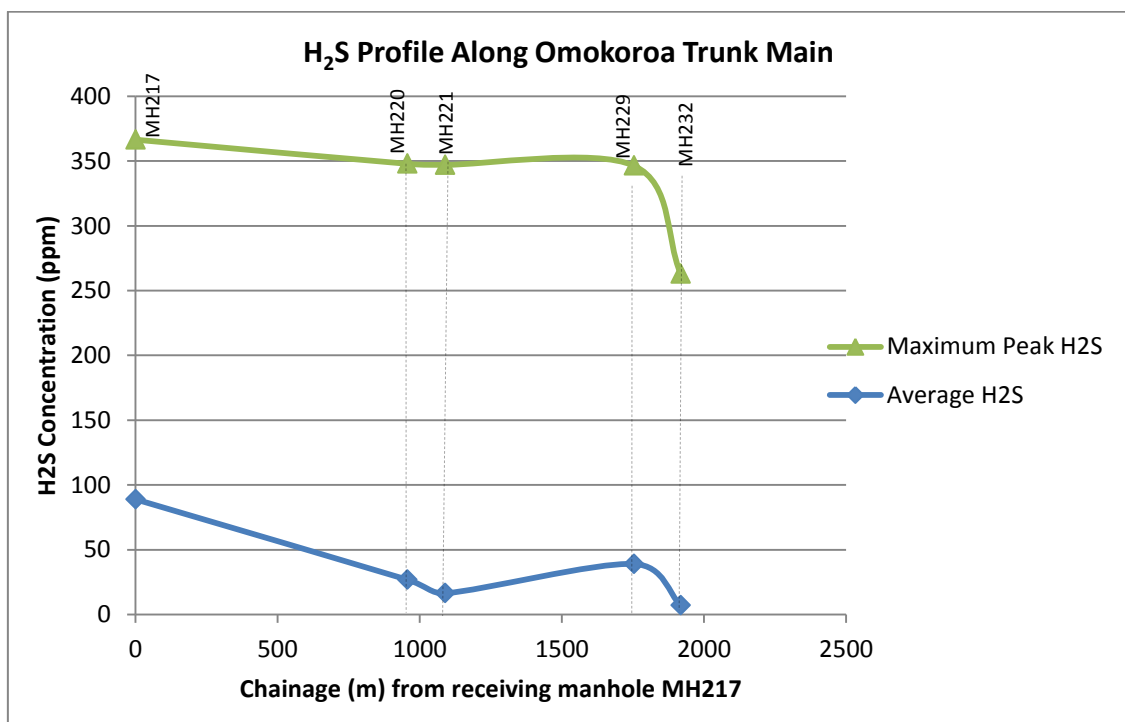
Figure 3: H₂S Profile Along the Trunk Main 2014 & 2015.

Figure 3 shows the average H₂S gas concentration profile along the 23 manholes, taking into account the lower concentrations between incoming pumping. These levels were logged continuously for a month at a time between 2014 and 2015 using two data loggers that were transferred between 5 of the 23 manholes. The upper line results show peak H₂S concentrations of 370 to 250ppm along the entire length of the trunk main as the incoming rising main discharges its 43 hour old sewage. The lower line shows the average H₂S concentrations drop to 89 ppm in the first few manholes and then go lower to approximately 25 ppm in the manholes further downstream.

These average H₂S gas concentrations are some 18 times higher in the first few manholes and 5 times higher in the remaining manholes than the 5ppm normally allowed in the standard epoxy protection for standard manholes.

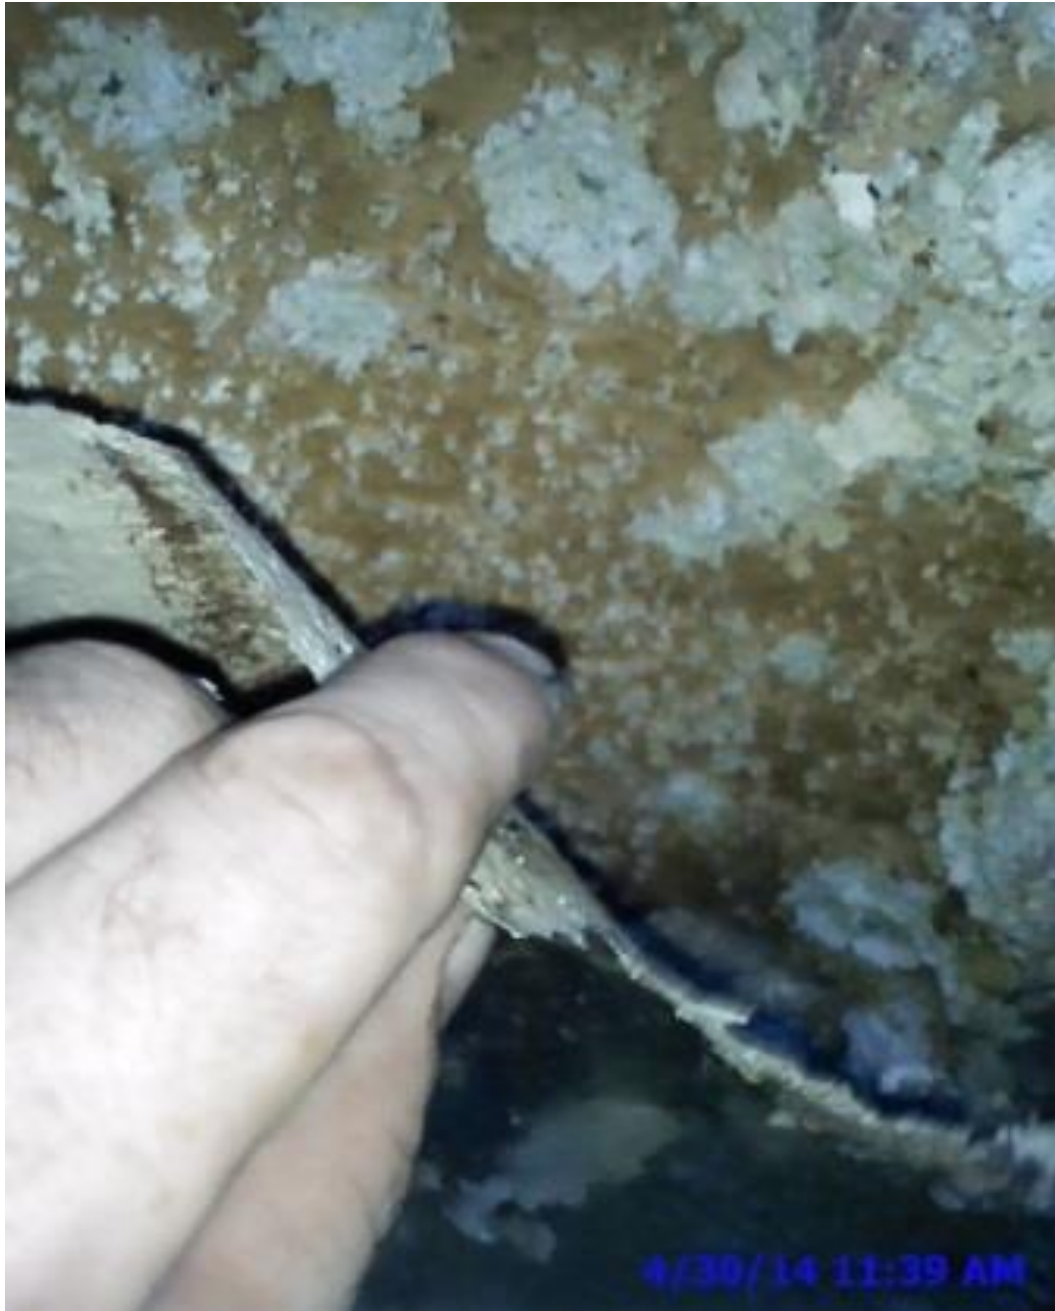
At the initial inspection of the trunk main manholes by PDP in 2014, the standard (painted on) epoxy liner on the worst affected manholes had lost its adhesion to the parent concrete and hung in sheets around the manhole walls. Corrosion then continued into the parent concrete to form a soft white concrete paste material. Cores drilled through the white paste and manhole walls showed a 33% loss of the original 65mm wall thickness over the 8 years since commissioning in 2007. This is equivalent to an annual wall thickness loss 2mm/year. The level of corrosion to the underside of the concrete manhole lids was relatively minor.

Photo 1 : Epoxy Coating (sheet) dislodged after 8 years at Manhole 0221

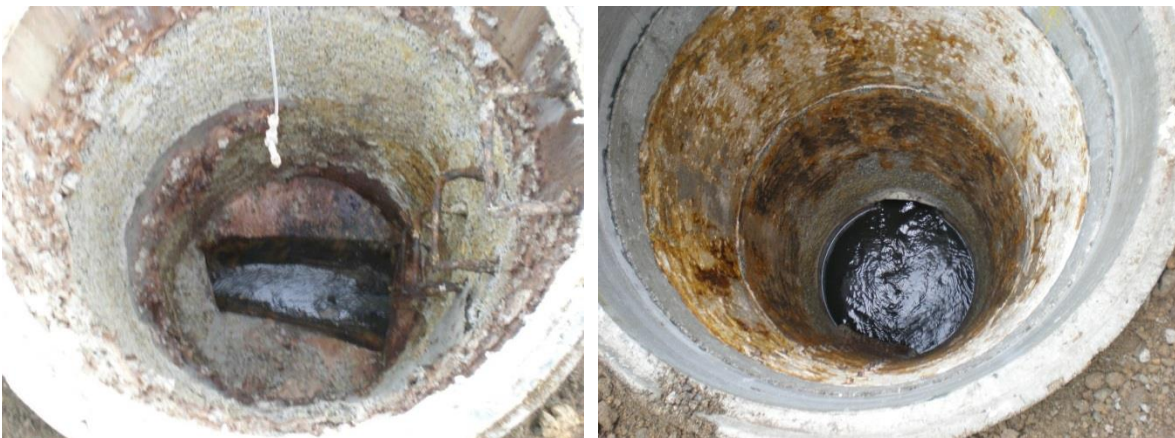
Photo 2: Continued Corrosion of Concrete & Steel Manhole 0226 & 0229.

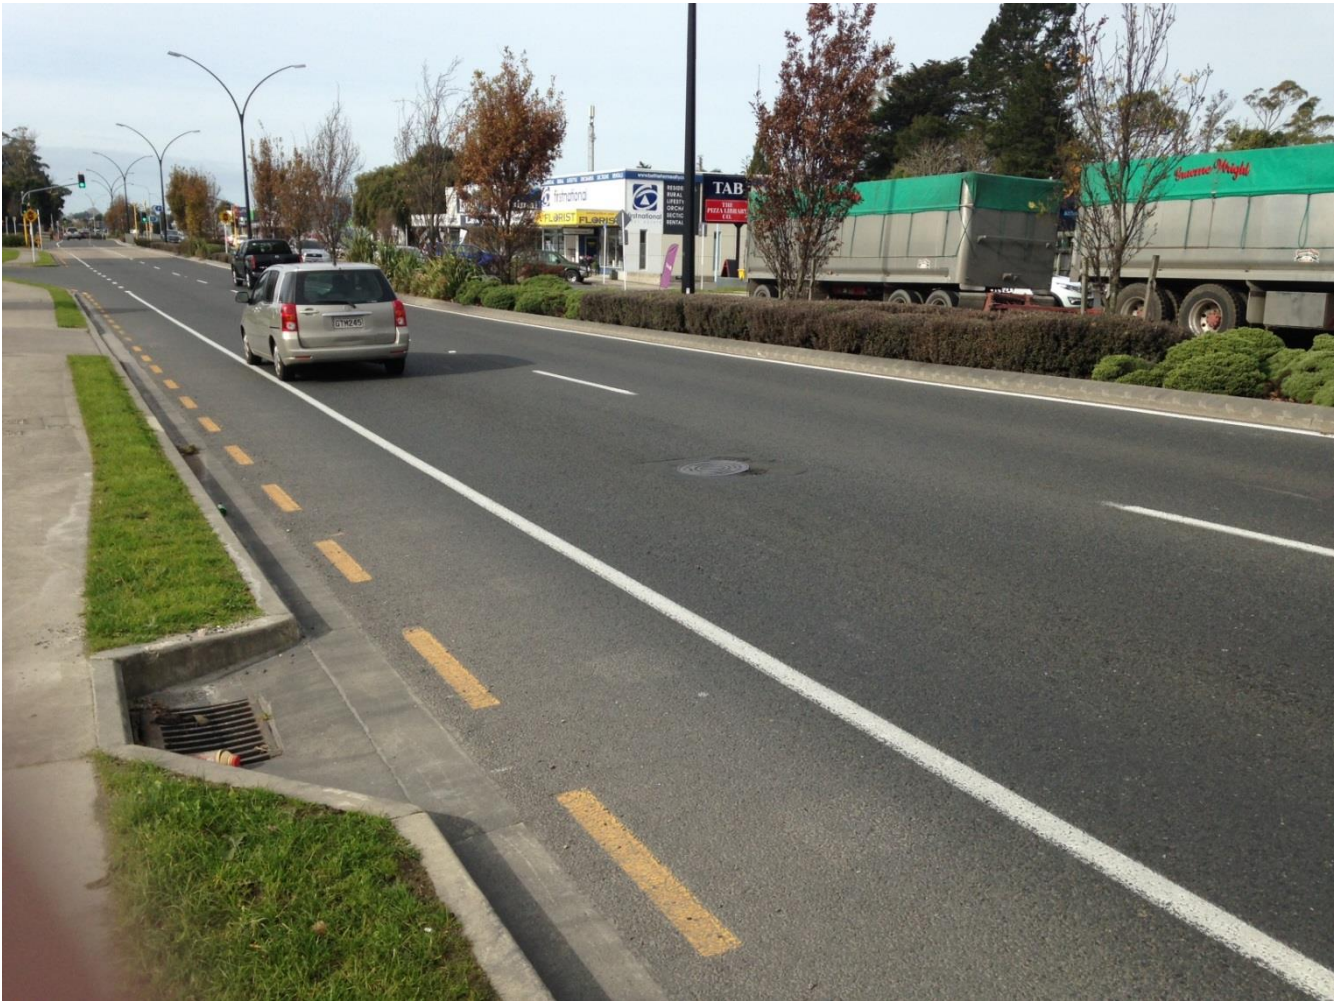
Photo 3: Difficult Access to Trunk Main Manholes in SH2 Bethlehem.

Five (5) manholes are positioned under the carriageway of SH2 in Tauranga, and the other 18 are under the edge of the carriageway. Structural failure of one of these manholes would result in a safety hazard to traffic, and/or a contaminated sewage discharge to the groundwater that flows to the grassed channels and into the wetlands around Tauranga Harbour.

SH2 carries busy regional traffic to and from the city of Tauranga. Therefore, any maintenance or restoration work on or under the highway should (wherever possible) be designed to minimise disruption to this traffic. For this reason, extensive excavation and re-compaction of earthworks is not a preferred option in the highways if there is an alternative.

Retrofit repairs to the manholes (without earthworks) are therefore the most practical (and cost effective) option in this situation.

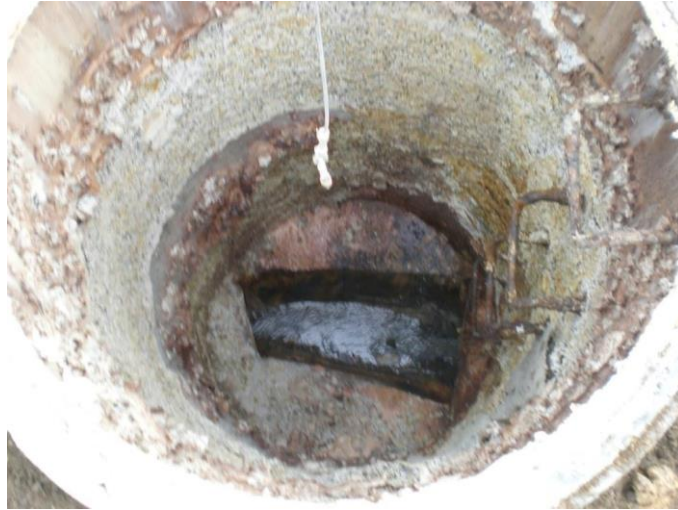
Photo 4: Every Manhole is Unique in its Surfaces, Depth and Shape.

Some manholes are deep with moist walls, others are shallow and somewhat drier, and every manhole has its unique crevices and construction flaws which must be recognised when choosing and fitting repair products. With this variability in mind, PDP and WBOPDC decided to trial four promising products to retrofit and repair the corroded manholes.

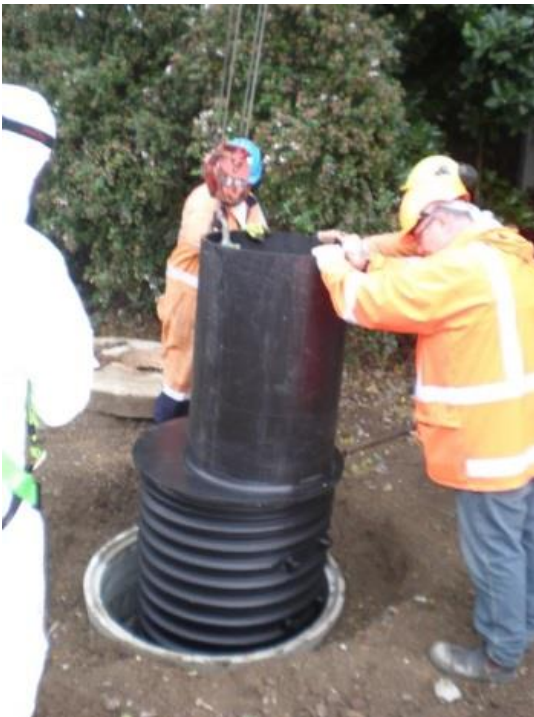
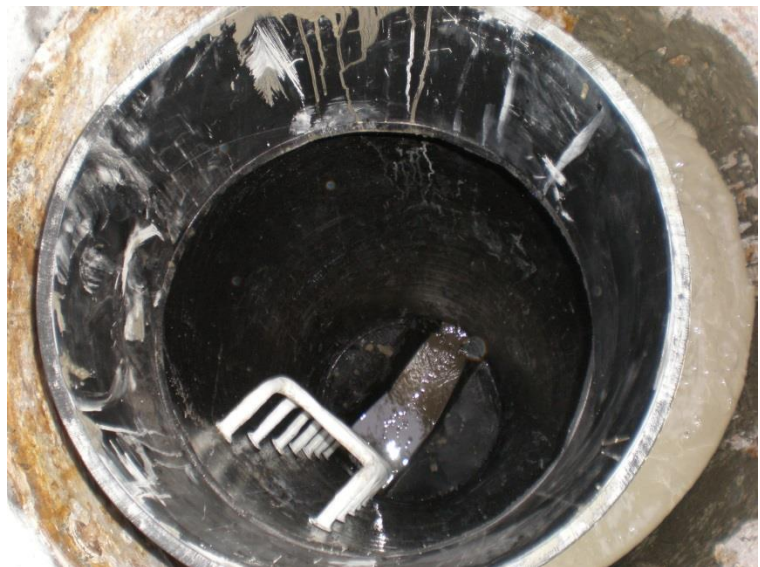
Photo 5: PE Plastic Manhole Inserted into the Existing Corroded Concrete Manhole.

The principle of this method is to replace the corroded concrete manhole with a smaller diameter PE plastic manhole that is inserted and grouted into the old manhole. This type of retrofit repair has been on the market for

The critical flaw of the PE manhole insert design is its floor. It incorporates a PE floor and channelling which requires the concrete benching and channelling to be removed from the parent manhole – the presumption being that the concrete channel and benching is corroded and easily removed. It took 4 hours to remove the concrete channelling in a confined space, and the concrete was in good condition anyway. We discovered that, although the manhole walls corrode, the channels and benching do not. The other flaw with having a PE channel and benching incorporated in the new manhole unit is the need to have it perfectly aligned in 3 dimensions with the incoming and outgoing sewer pipes. This trial has shown this to be very time consuming because onsite modifications to the manhole inverts are usually required. During the trial the manhole inverts were not accurately measured and a 2nd fabricated manhole insert was needed. This is an unacceptable cost and time constraint, and it introduces a risk of creating mismatched inverts that compromise the sewers hydraulics. Therefore, PDP and WBOPDC will (in future) reject PE manhole inserts that offer pre-fabricated PE channels and benching.

Performance checks (cores drilled through the walls) 9 months following installation showed that the PE plastic manholes were unaffected by the high concentrations of H₂S gas. The grout-backfill had successfully sealed and strengthened the old corroded concrete manhole walls.

However, there is a solution that avoids this extra work and risk. Pre-fabricated PE manhole inserts do not need channels and benching because corrosion does not appear in the channel/benching of manholes. If PE manhole inserts are fabricated with an open bottom which sits on the existing manhole concrete benching the corrosion on the manhole walls will be prevented, and the original channel and benching will not require any risky modifications.

1. Insert a new smaller diameter PE Plastic Manhole (note: do not replace the existing manhole benching and channel).
2. Apply a 15mm mortar coating to the manhole surfaces (*note: research the chosen mortar to validate that it does have a strong long term adhesion to all moist concrete*).

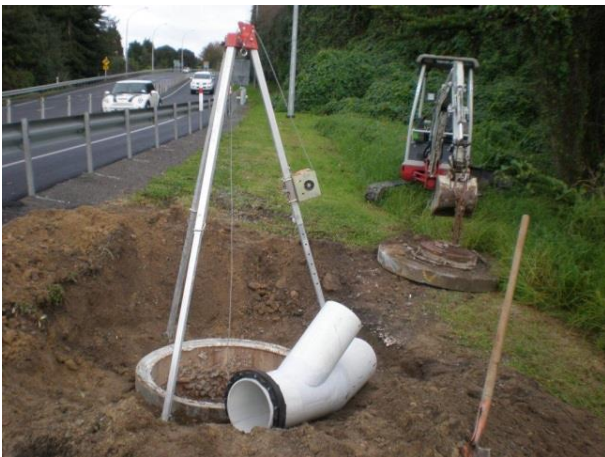
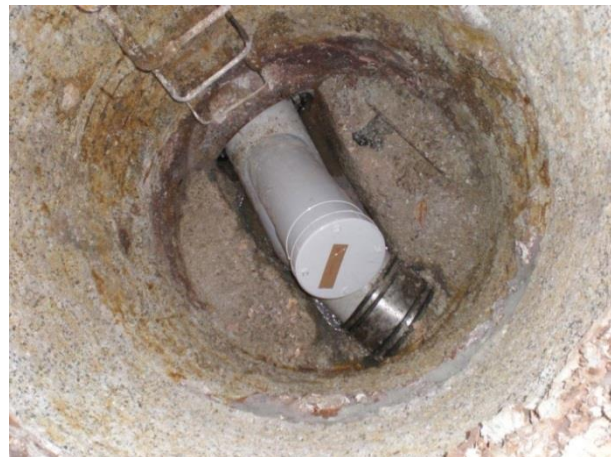
Photo 6: UPVC Plastic Pipe Insert across the Existing Concrete Manhole.

This method was developed by WBOPDC and PDP based upon its apparent simplicity and low cost. The principle of this method was to isolate the H₂S gas within the sewer and therefore stop corrosion of the manhole. Rodding access is maintained through the capped riser shown.

We expected this option to be simple and quick to install. However, as we discovered (as with Option 1) that the variations in the manhole floor and channel configurations present time consuming and expensive installation issues. Overall, it took some 7 hours to fit and seal the fitting into the barrel of the sewer. The corroded walls still need to be repaired if they are structurally compromised.

Performance checks over the months following the installation did, however, reveal that the seal was successful.

Notwithstanding the success of the rubber seals, PDP and WBOPDC will not consider this pipe insert any further because we realised it is susceptible to H₂S gas leakage as the rubber seals and metal brackets age – this can only be tested in the long term. We did realise at the end of the trial that this option could be modified to a much cheaper and longer-lasting solution by using a 600mm high x 800mm circular PE chamber (with a rodding access riser). This chamber could be placed on the manhole benching to allow the original manhole channel to continue under. The whole chamber (up to the rodding riser cap) could then be covered and sealed against H₂S gas leakage with grout backfill.

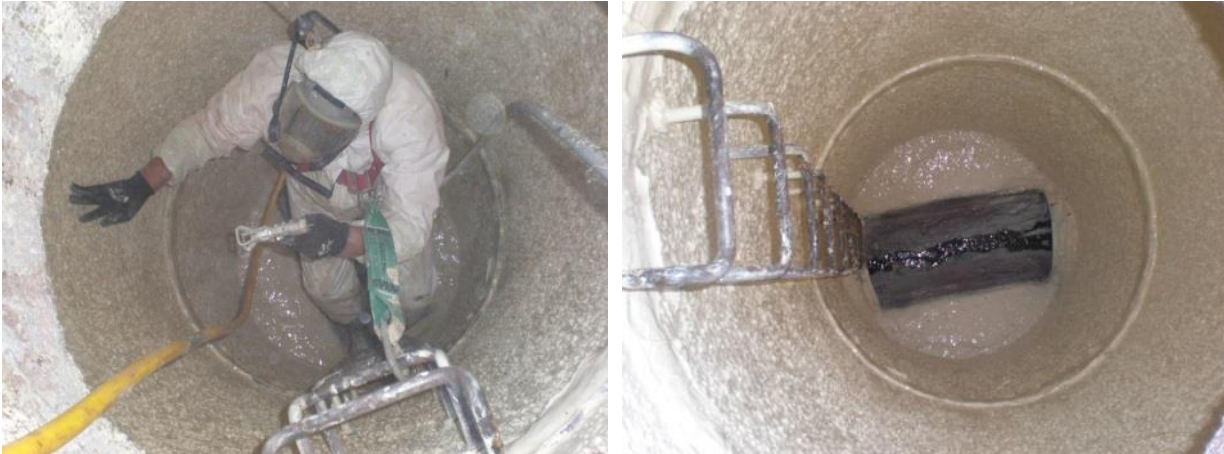
Photo 7: Apply a High Grade Epoxy Coating to the existing Concrete Manhole

The principle of this repair method is to seal off the corroded concrete surfaces with a 2 mm layer of the highest grade of epoxy (to resist H₂S gas concentrations of 90 ppm average).

The epoxy showed no signs of degradation after 9 months. The epoxy was well bonded to the parent concrete in one area. However, in the diagonally opposite area the epoxy easily sheared off the wall with the drilling. This demonstrates a variable adhesion of the epoxy around the corroded concrete surfaces. The entire epoxy coating principle relies upon consistent adhesion to the surface being protected.

Based upon this observation, epoxies should be subjected to quality control monitoring several years beyond application – particularly for retrofit applications such as corroded sewers which typically have humid conditions and difficult-to-clean cracks and crevices.

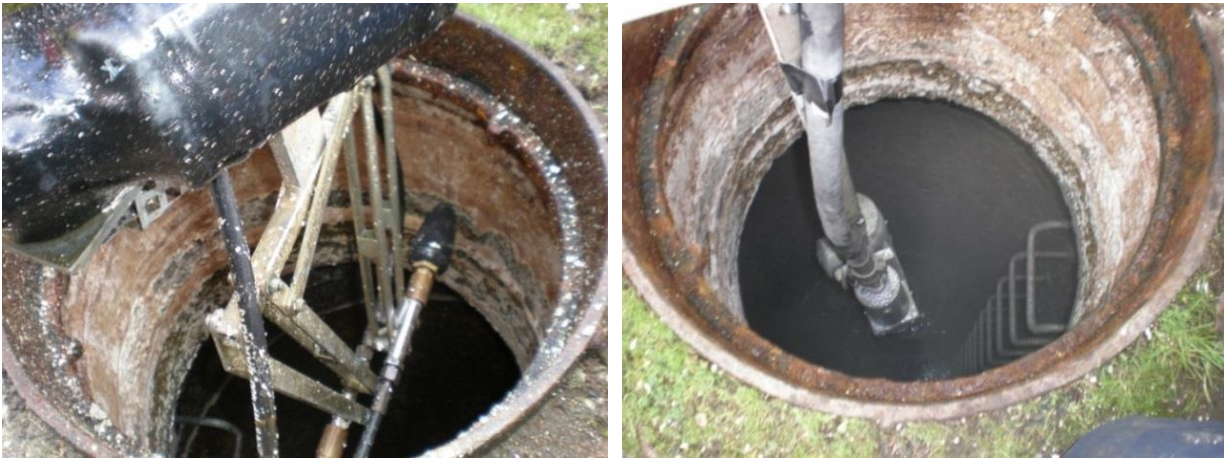
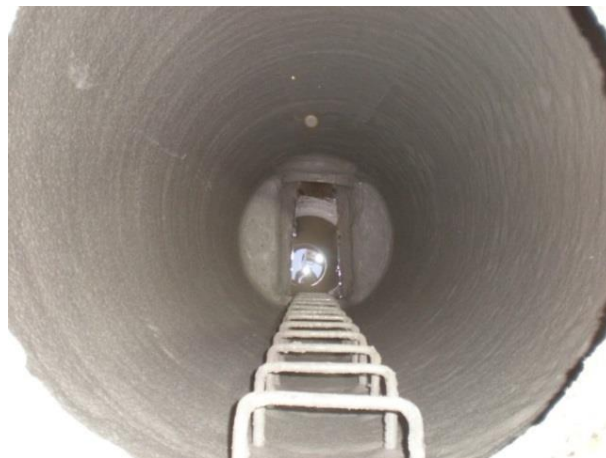
Photo 8: Apply a Mortar Type Coating to the Existing Concrete Manhole.

The principle behind this repair method is to seal off the corroded concrete wall and benching with a 15mm layer of mortar sprayed on in 1mm layers.

This method, although similar in principle to the epoxy coating, restores at least part of the wall thickness and strength of the manhole structure by having a 15mm coating thickness. Its automated rotary clean and spray operation controlled from above ground avoids extended periods of confined spaces entry for installation contractors. The manhole is firstly cleaned using a rotary cleaning spray (1st photo above), debris is trapped and removed from the manhole by hand, and the 15mm mortar coating is sprayed in 17 passes down and up the manhole (2nd photo above).

In terms of long term performance, several drilled cores taken through the mortar and manhole walls using the same method as used for the epoxy coating monitoring. The bond between the mortar and the corroded concrete was very strong in all cores both at application/curing and then 9 months later– the manufacturer of the mortar product attributes this bond to the water absorption qualities of the patented material.
