FLOATING WETLANDS – NATURE IMPROVED – AN END USER’S EXPERIENCE

F Pratt & A Twose Whangarei District Council

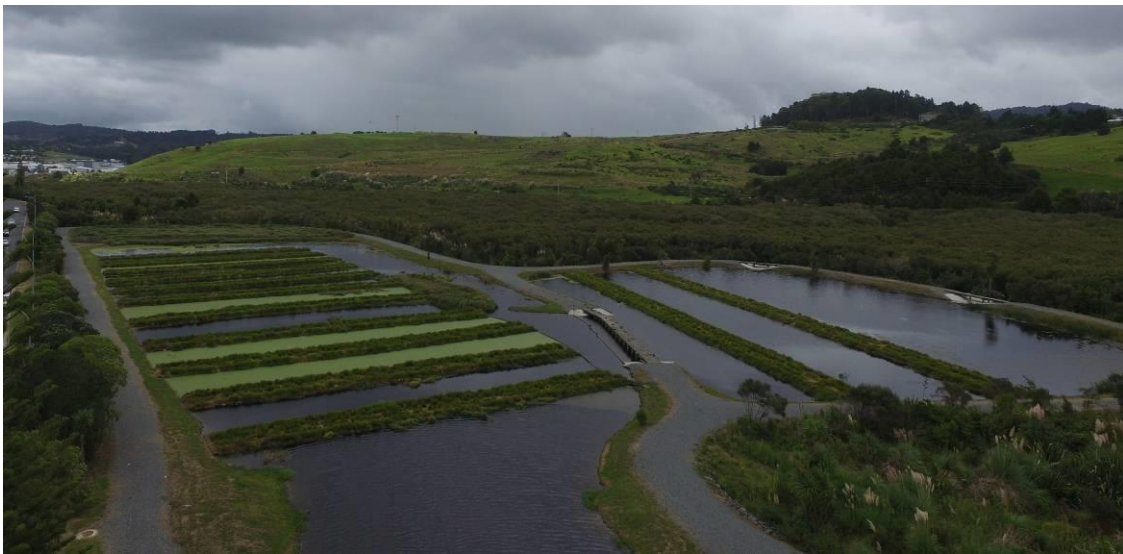
Photograph 1: Floating wetland systems installed at Kioreroa Road WWTP

Floating Wetlands utilise Floating Treatment Media (FTM) technology to offer an alternative to the constructed surface flow wetland systems currently employed in the Whangarei District. It is effectively wetland plants grown on a buoyant pod structure that sits in a pond 1.0 to 1.2m deep. The roots of the wetland plants dangle in the water, providing a contact zone for bacteria to grow and “consume” contaminants from the wastewater as it passes by. The pods are wired together and can be moved to allow de-sludging. The FTM installation at Kioreroa Road WWTP twelve months after completion is shown in Photograph 1.

Following the completion of the Kioreroa Rd WWTP FTM wetland it was observed that there was a difference in the distribution of duckweed (or lemnoideae) between the lines of the pods. This can clearly be seen in Photograph 1. Whilst the distribution of the duckweed itself is not believed to be detrimental to the performance of the wetland, it did raise the question of why. On investigation it was found that short-circuiting was occurring around an island that had been left during the construction. This channel was allowing the majority of the flow to by-pass eight lines of pods. This channel has only recently been filled in and the water quality sample results will continue to be monitored.

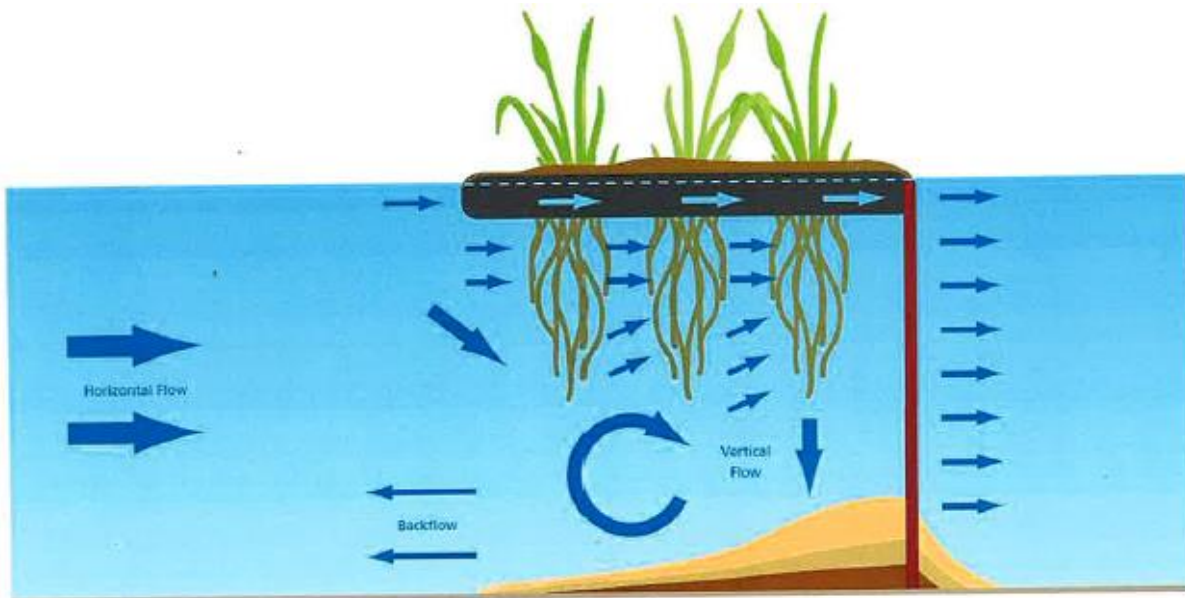
The FTM system also includes a baffle system on the downstream side of each pod that directs water up towards the roots structure. Figure 1, (provided by Waterclean, the supplier of the FTM), illustrates the flow paths created by the baffles. The FTM system is designed to remove a range of pollutants, the principals behind each pollutant removal process is detailed below;

Figure 1: The flow paths created by the baffle system on the FTM pods.

- Total Suspended Sediment (TSS) is removed through accumulation of the sediment onto the biomass on the wetland plant roots, pods & baffles, which is sloughed over time and settles below the pods in front of the baffles.
- Ammonia (and total nitrogen) is removed through nitrification (by nitrifying bacteria in the biomass on the roots, pods & baffles) to nitrites and nitrates before being taken up by de-nitrifying bacteria in the biomass or the plants and subsequently releases as nitrous oxide or nitrogen.
- Phosphorus is removed through uptake by the wetland plant roots into the plants and by the biomass on the plant roots, pods and baffles which is sloughed over time and settles below the pods in front of the baffles.

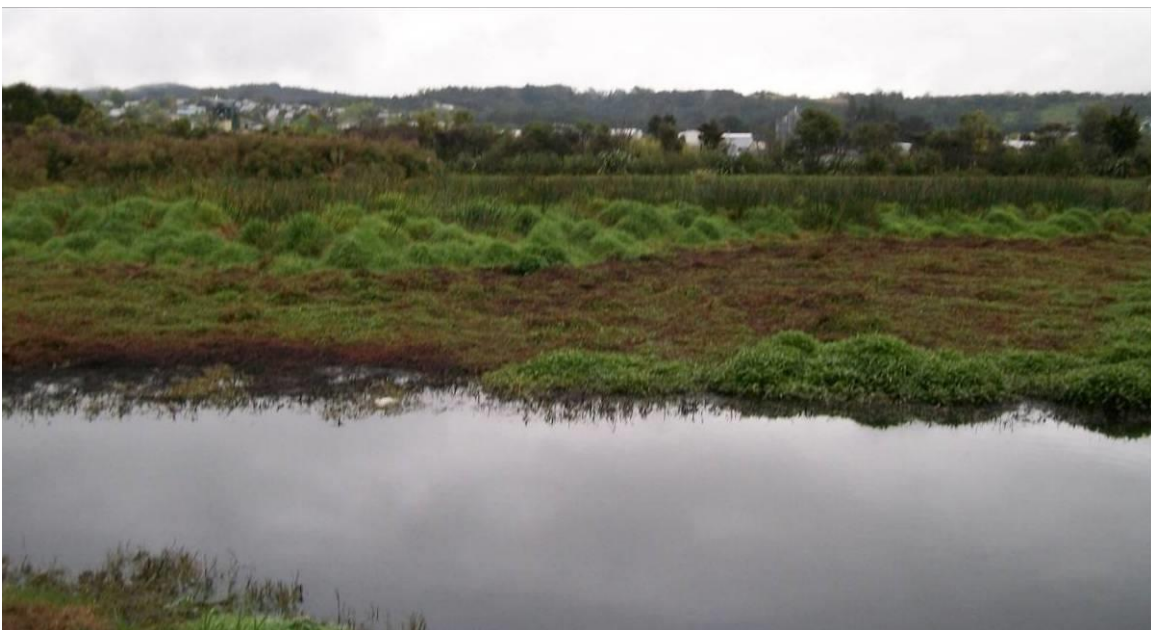
Photograph 2: Kioreroa Road WWTP Wetland Sept 2013 prior to de-sludge and FTM system installation

In 2013, all sludge and plant material was removed from wetland one, the depth was increased to 1.2m, overflow weirs were constructed at three of the discharge outlets to Limeburners Creek, and the FTM was installed.

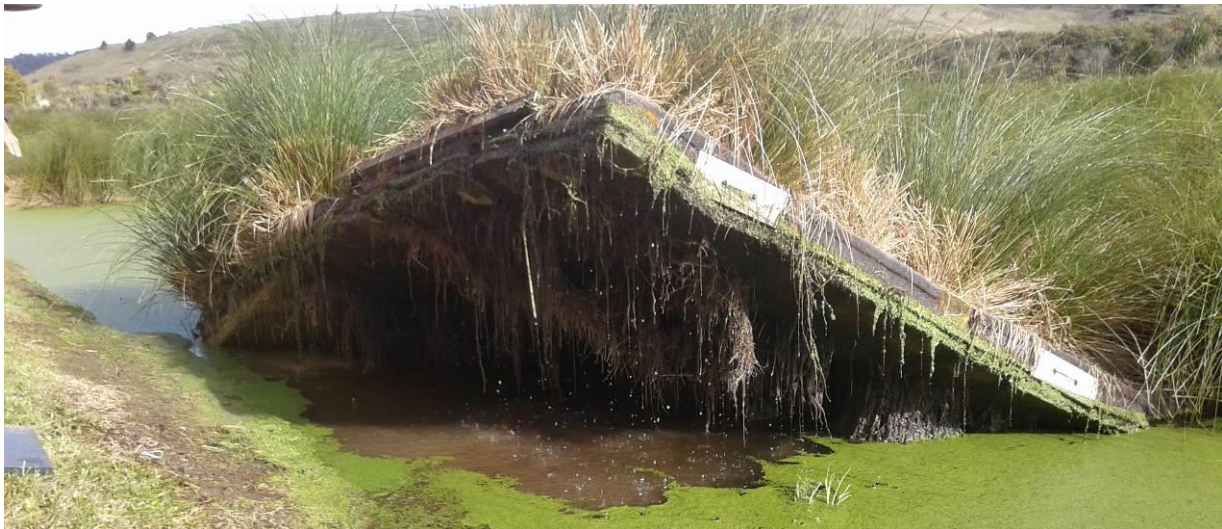
In August 2016, the floating pods on the FTM wetland were lifted by a crane truck to allow an inspection of the root system, (an invasive investigation undertaken whereby the plants were physically extracted from the floating pods proved inconclusive, with little root remaining on the plant once removed). Photograph 3 below shows the floating pods at the inlet end of the wetland. The figure clearly shows the well developed root structure, with the length of the roots being controlled by the depth of the water beneath the raft; short roots on the left where the water depth was minimal, much longer on the right where the water depth increases.

Photograph 3: *Lifting of one of the floating pods at the inlet end of the Kioreroa Rd wetland.*

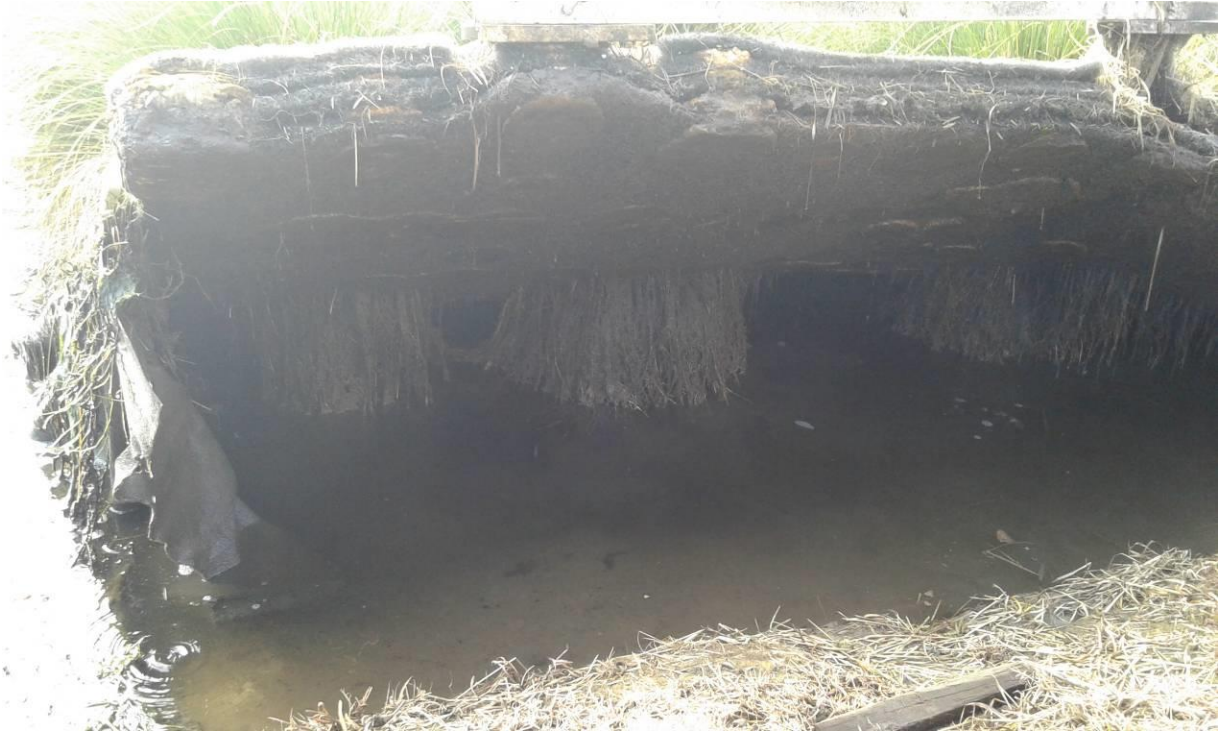
Photograph 4 shows the root structure below the floating pod located near the wetland outfall. At this location the underwater sides of the wetland dropped away much quicker, thereby not restricting the growth of the roots. The Photograph shows the roots, unrestricted by depth, as being uniformly well developed and extensive.

Photograph 4: Lifting of one of the floating pods close to the outlet of Kioreroa Rd WWTP wetland.

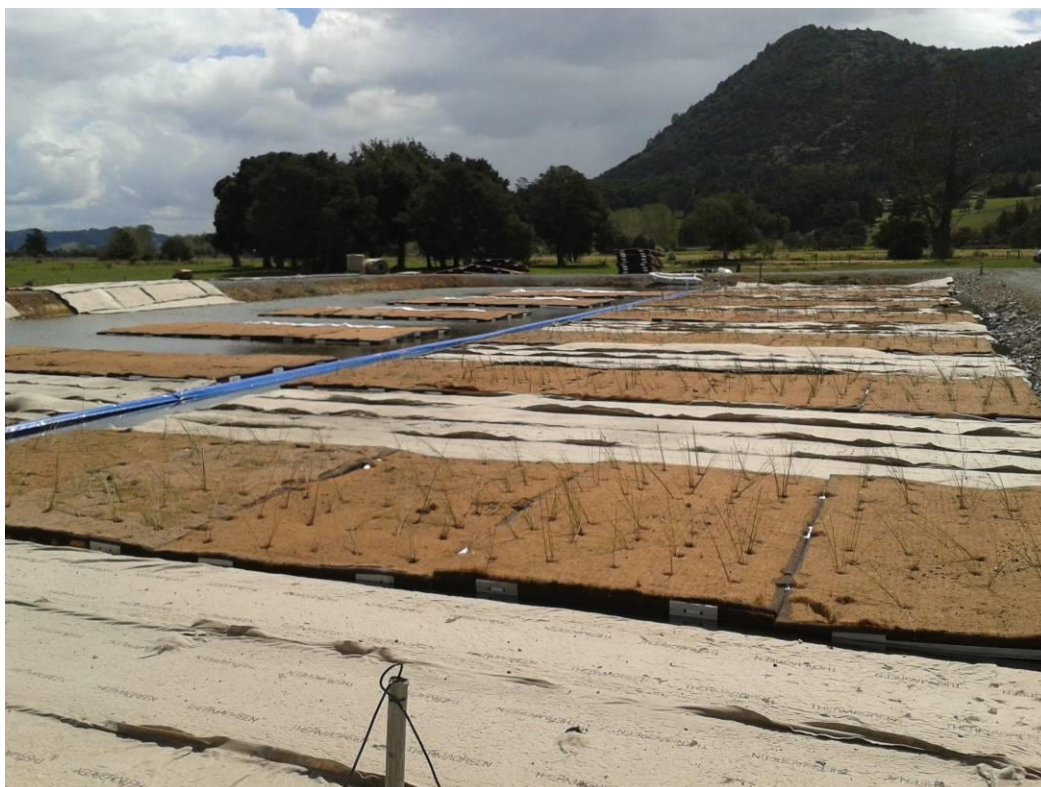
Photographs 5 & 6 below depict the size of the plants when they were first planted and again after two years once they had fully established.

Photograph 5: Photograph of the newly installed and planted FTM wetland at Hikurangi WWTP.

Photograph 5 shows the FTM being installed when the water level is at the correct height, with Photograph 6 illustrating what occurs when flows to the WWTP are high following wet weather, (due to inflow & infiltration on the reticulation). This issue of 'uncontrolled' flows into Hikurangi WWTP is proposed to be addressed in the 2016/17 & 2017/18 financial years through major upgrades to the reticulated network. Only once this work has been completed, with the flows and levels much more carefully managed, can the effect of the FTM and the SAM be considered to be effective. This will continue to be monitored through the water quality sampling.

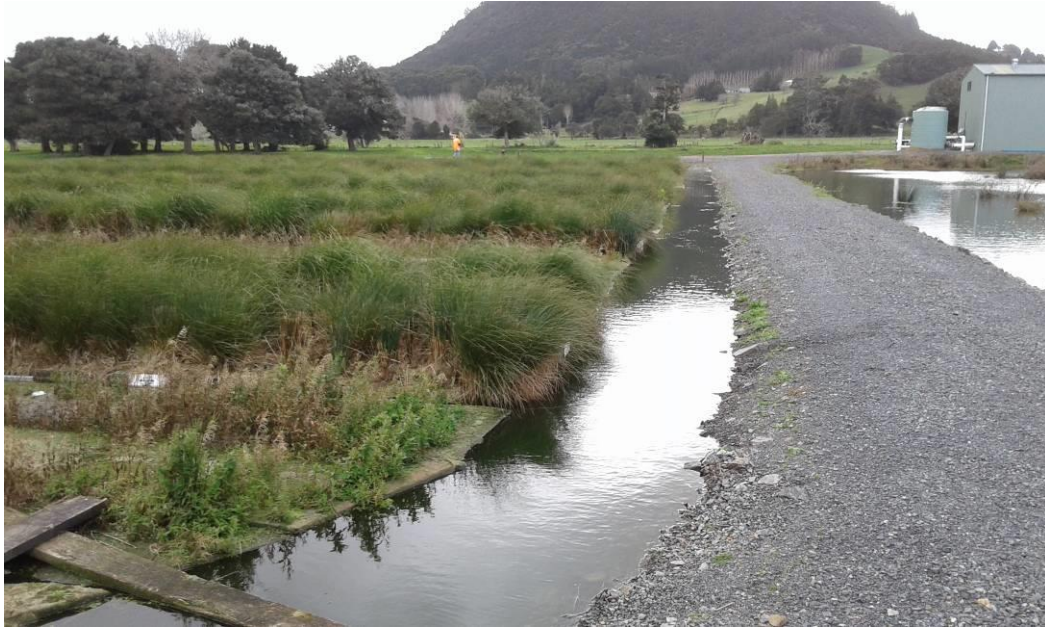
Photograph 6: Photograph of the established FTM wetland at Hikurangi WWTP.

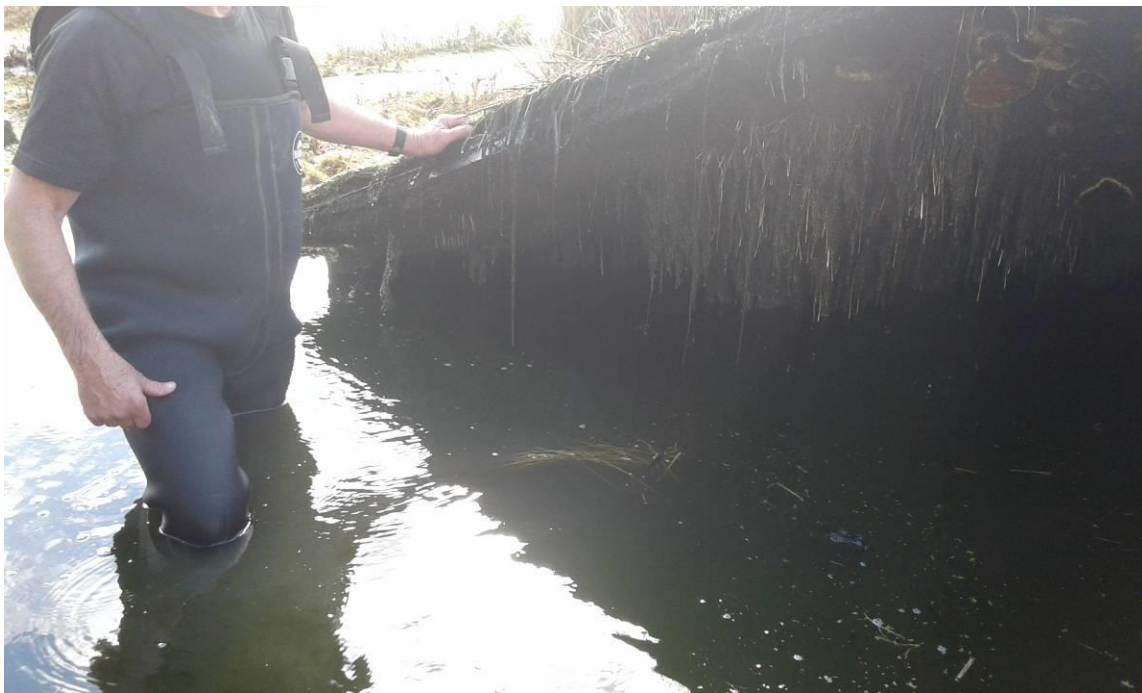
In August 2016, the floating pods were lifted by a crane truck to allow an inspection of the root system, (again an invasive investigation whereby the plants were physically extracted from the floating pods proved inconclusive with little root remaining on the plant once removed). Photograph 7 below shows the well established roots hanging down, as well as a number of unidentified fungus/mould growths as seen in the top left. There was no notable difference in root growth between pods at the inlet and the outlet of the wetland.

Photograph 7: Lifting of one of the floating pods on the Hikurangi WWTP wetland.

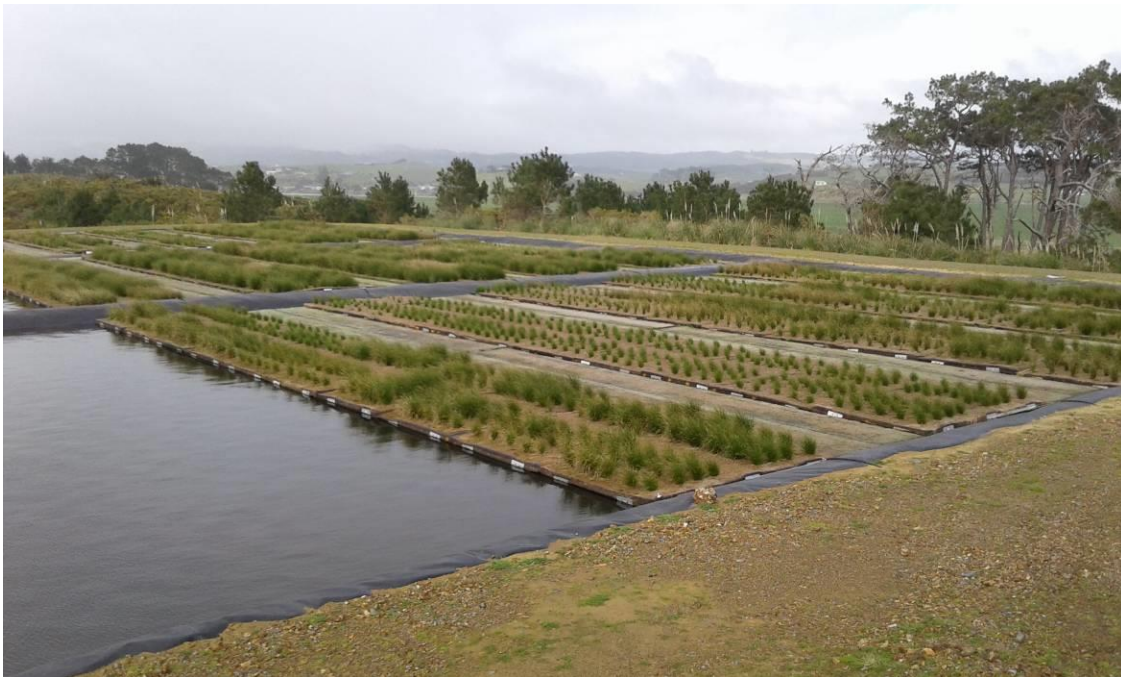
Photograph 8: Overview photograph of the floating wetlands at Waipu WWTP.

In August 2016, during an inspection it was evident that a variation in the growth of the plants between pods had developed. This variation is clearly illustrated in Photograph 8. This stunted plant development could not have been associated with depth (as noted in the root development at Kioreroa Road WWTP), as the depth was known to be constant beneath all the pods. The distribution of variations in healthy growing plants and those appearing to be displaying stunted growth and lost plants did not appear to be random, nor correlate with proximity to the inlet or outlet of the wetlands. What is evident is that there appears to be clear zones of healthy plant, zones of plants displaying stunted growth and areas of transition.

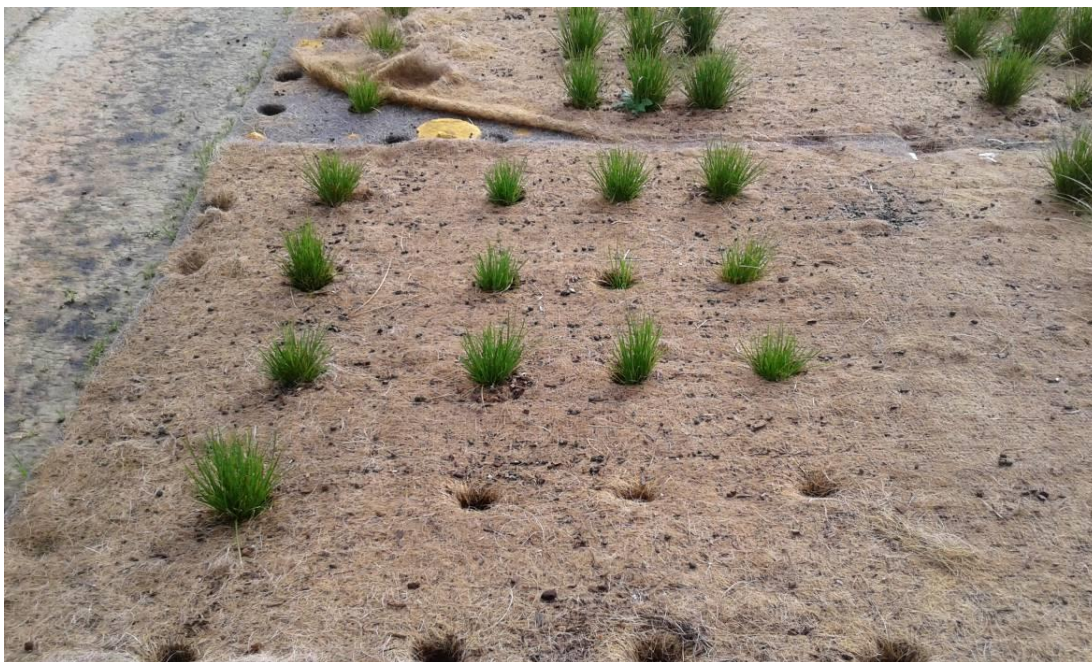
The results of a closer inspection are illustrated in Photographs 9 & 10. Whilst there has been no visual confirmation, a preliminary assessment of the extensive amount of feces indicates that the plants are being extensively grazed by Leporidae (the family of mammals that include rabbits and hares).

Photograph 9: Close-up photograph of the plants displaying stunted growth (including losses) on the FTM wetlands at Waipu WWTP.

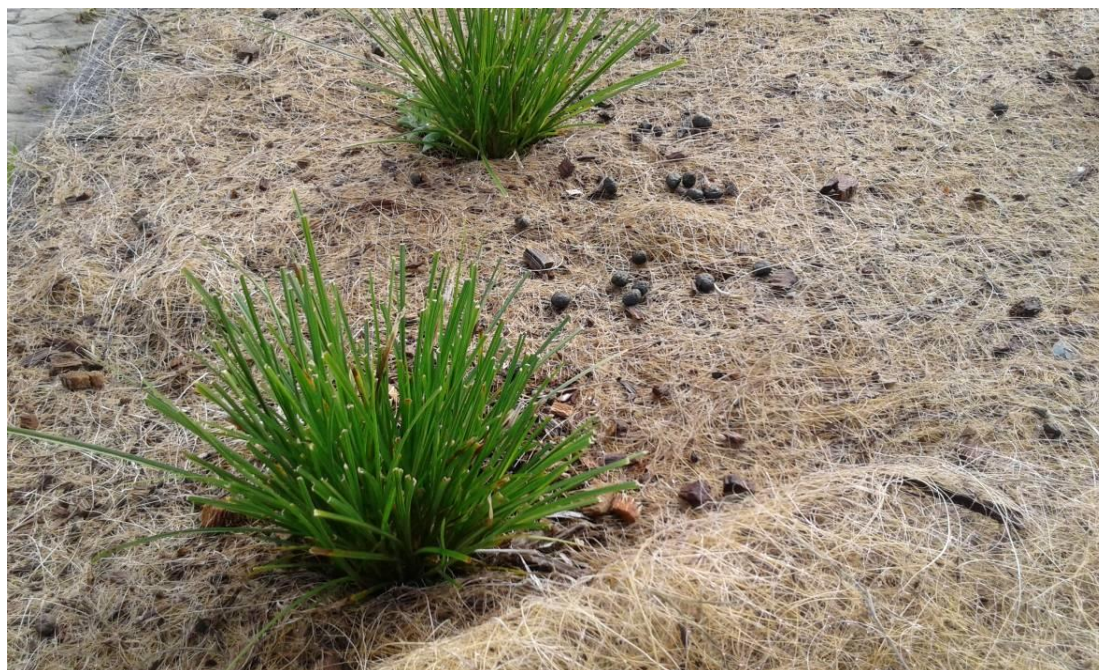
Photograph 10: Close-up photograph of the plants displaying stunted growth on the FTM wetlands at Waipu WWTP and the associated Leporidae droppings.
