## **A TALE OF TWO TOWNS: a Review of Two Taranaki Rain Events 2015**

**B. Manning and T. Mitchell (South Taranaki District Council)**

**Theme: Building Flood Resilient Communities: Flood Risk Assessment, Damage Cost Analysis and Management**

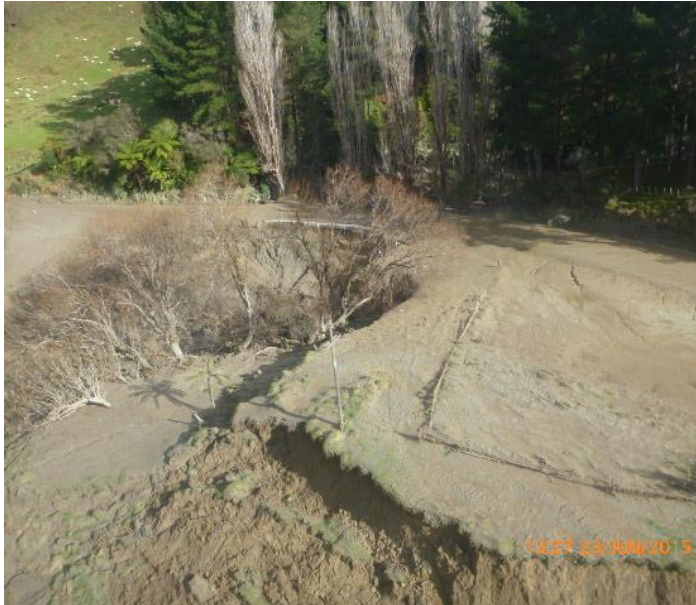
Figure 3 - Typical farm situation post flooding

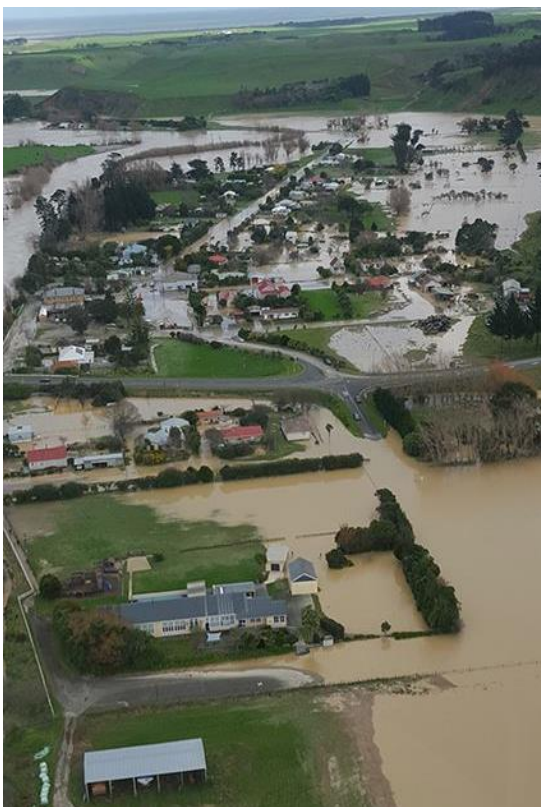
Figure 4 - Waitotara Village 21 June 2015

Significant damage was caused to infrastructure including bridges and under-slipping and over slips to roads, the flooding preventing road access, and power disruptions. Massive slips and landslides, as well as surface flooding, blocked local roads and the State Highway 3 bridge at Waitotara was closed to all traffic. A state of emergency was declared on 20 June and the Waitotara Township was evacuated prior to the flood peak at the township late on Saturday evening.

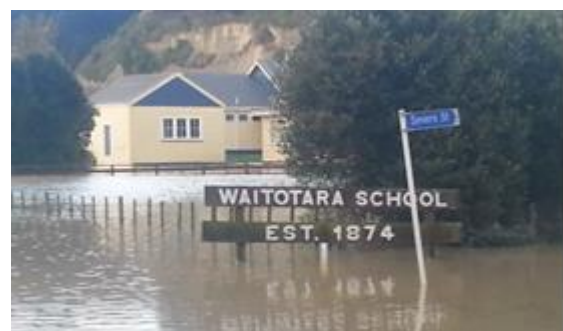
Figure 5 - Waitotara School

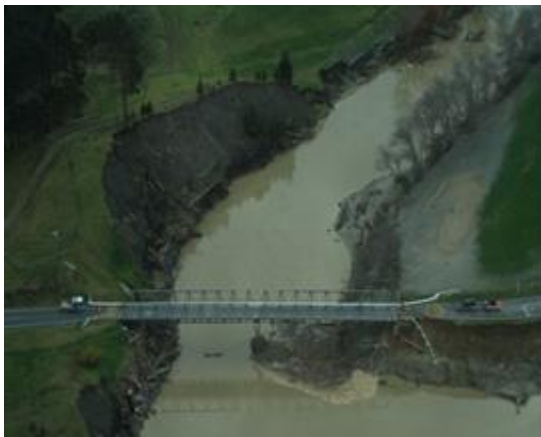
Figure 6 - Limeworks Bridge Waiinui Beach Road

The other residential area of Waitotara affected by the flood is the coastal settlement of Wai-inu Beach; although not flooded or impacted by the storm, apart from a brief power outage, the only road into this village had become inaccessible. Wai-inu Beach Road leaves State Highway 3 and passes through the Waitotara Village; there is a two-span bridge (known as the “Limeworks Bridge”) that crosses the Waitotara river, this was severely damaged during the flood with the abutment undermined and the bridge deck became unsafe (see Figures 6 and 7). The only access was overland through a farmer’s track for four wheel drive vehicles for approximately three weeks after the event.

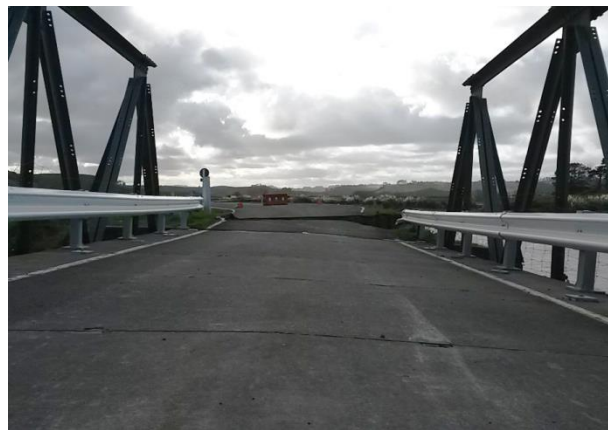
Figure 7 - Damage to Limeworks Bridge

As well as Waiinui Beach settlement, also cut off so was the local meat works plant; once the flood waters receded (days later), the long term viability of ensuring the meat works could operate became important as its closure would mean a loss of many jobs in the District. This was not the first time the Limeworks bridge had been damaged in a large storm event; wholesale replacement would still leave this area vulnerable in another flood, so a decision was made to repair the bridge and keep in its current position as a medium term measure, this has since been completed. A project has been initiated to construct a new road to Wai-inui Beach and the meat works that access the State Highway south of the Waitotara River; this will provide a resilient long term solution. The farmer most affected by the temporary diversion of traffic across his land offered the land for the new road (6.5 km).

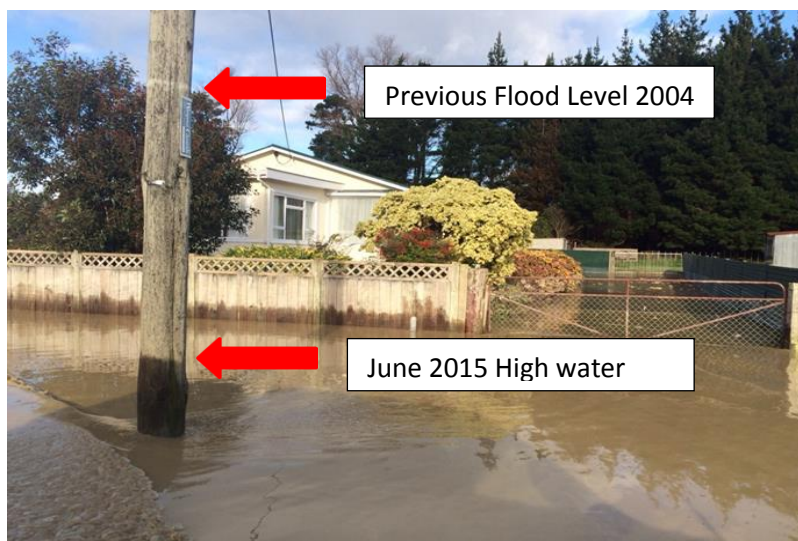
Figure 9 - Comparison of flood levels

Although the flood peak flows were the highest recently recorded for the Waitotara River (at Riminui, TRC gauging station) the flood peak in the township of Waitotara was at least 1.5 metres below that of 2004 (see photo), the 2004 peak marked by a white painted line on the power poles.

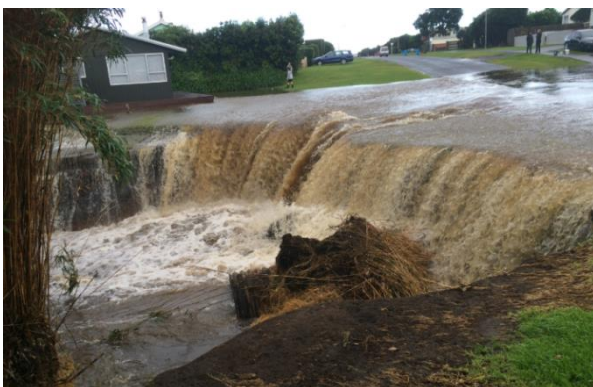
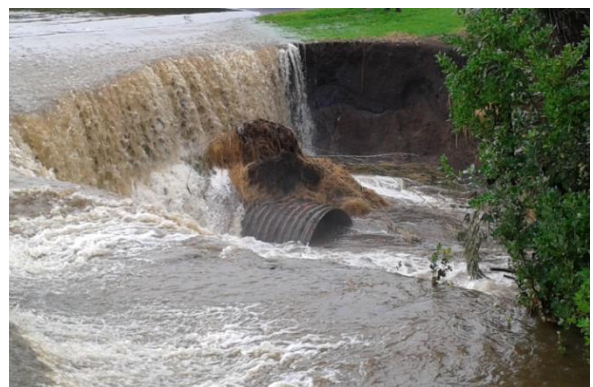
In August South Taranaki District again experienced a significant rainfall event; this time over the Opunake Township on the coastal ring plain; however this event was quite different in nature and duration to the Waitotara flood in June. The storm occurred overnight; with the main intensity over two hours in the early hours of the morning; highly localised and resulting in significant runoff through previously poorly defined channels and secondary flow paths within the township of Opunake, population 1,335. Eighteen houses were inundated with a further 71 having sheds and outbuildings and surrounds flooded. A road and water main were undermined too as an urban culvert overtopped spectacularly at Dieffenbach Street (see Figures 9 & 10)

Figures 10 and 11 - Dieffenbach Culvert Failure

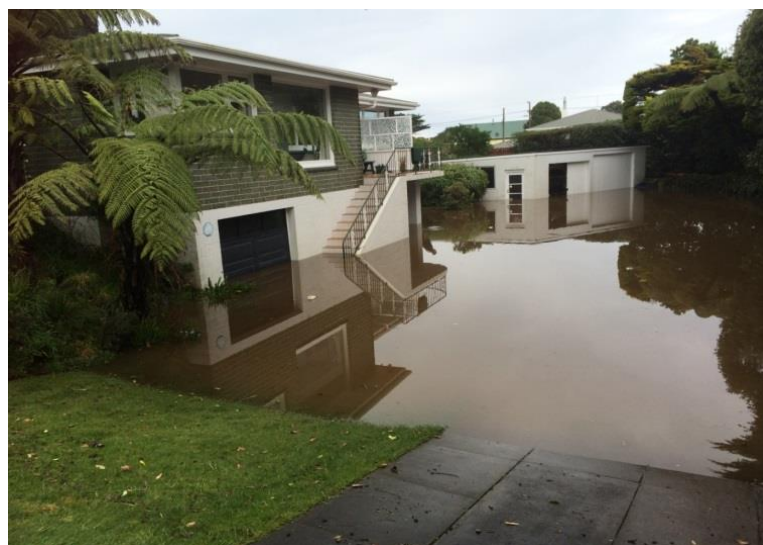
Figure 12 - Flooded property Opunake

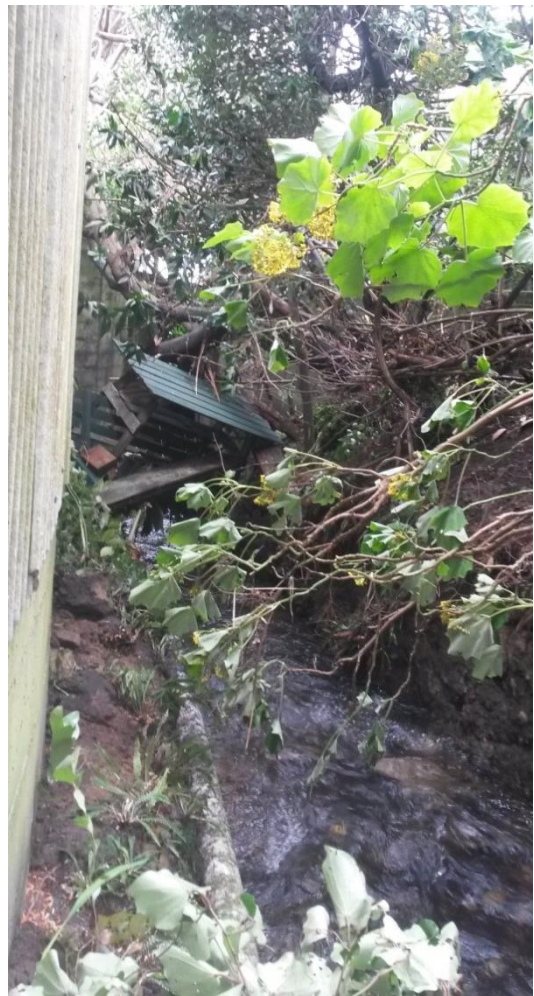
What we have found in our investigations since this event is that the insufficient capacity occurred mainly in the streams that run through private property, with debris and overgrown stream banks impeding the flow. Council's approach up until this point was to leave the maintenance of these streams to the individual landowners; in some cases this worked well and the streams remained clear, in many places the stream areas were used as dumping areas and poorly maintained. In some cases residents took great pride in their backyards and built structures or channelled the stream through a smaller area; this had the same affect, restricting flow and adding debris to the streams.

Importantly Opunake is on the edge of the Mount Taranaki volcanic ring-plain bordered to the north east and up-gradient by intensively farmed dairy pastureland and farms. Significantly two small creeks which carry run-off from those farms bisect the town forming the back boundary to many residences within the town. In some cases residential properties have been modified to include the open waterway as a landscaped feature, and in others the watercourse has been piped or bridged, or realigned by the respective landowners.

Figure 13 - Debris blocking open drains in private property

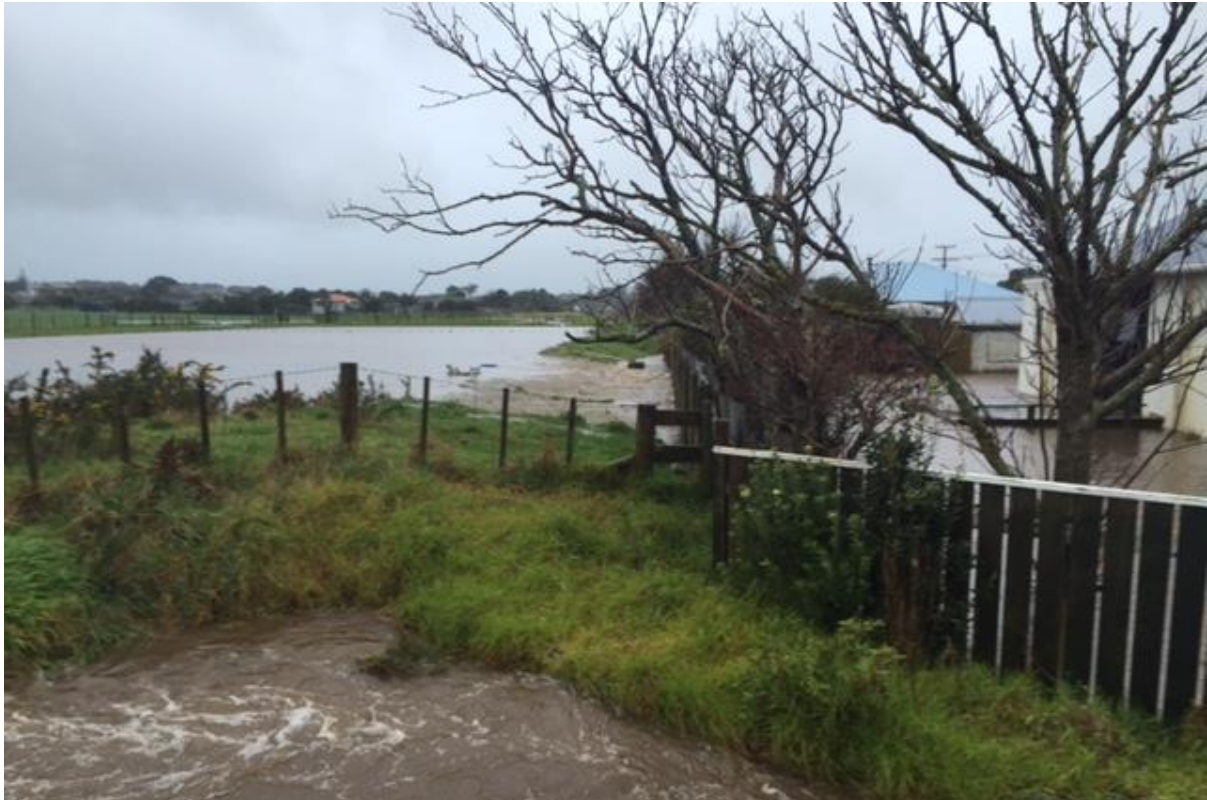
A compounding effect on 6 August 2015 was the failure of a modest detention pond, built within the township by the Council in 2011, primarily to provide attenuation of storm flows and protect downstream properties. In the event the inflows exceeded the capacity and hydraulic detention time offered by the structure, and the earthen side bunds were over-topped, flooding through the back of three adjoining residential properties. Subsequent investigation has shown that the secondary flow path does not spill as intended by the design.

Figure 14 – Stormwater Detention Area

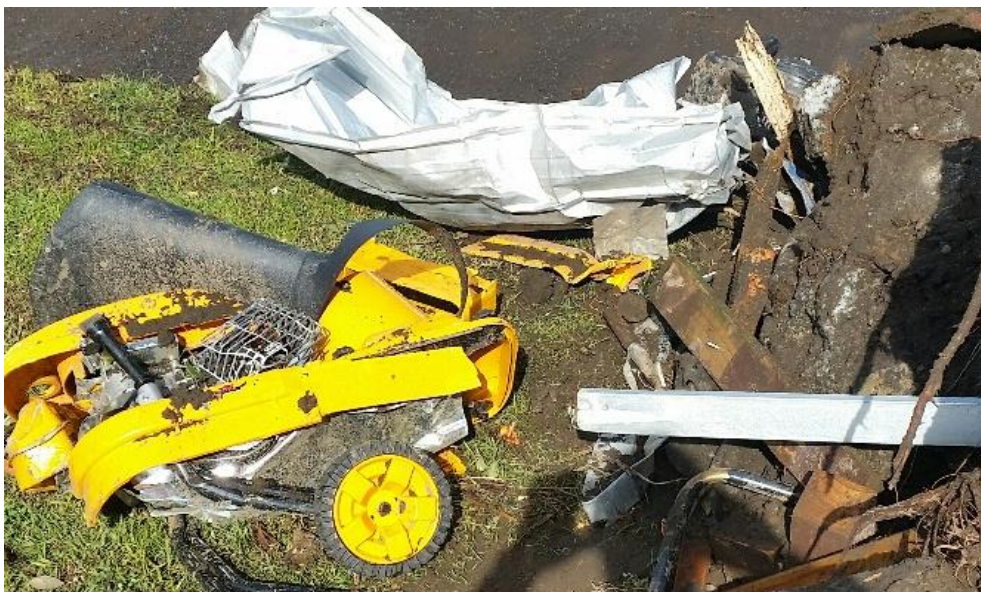
The lack of maintenance on some properties has meant that rubbish and garden waste was dumped along the stream banks causing problems for other residents and blockages in the culverts. No spraying or tree trimming of low hanging trees took place either. More vocal residents have expressed frustration with what they saw as Council not taking responsibility and Council saw as beyond their level of service.

Figure 15 - Debris pulled from Diffenbach Culvert

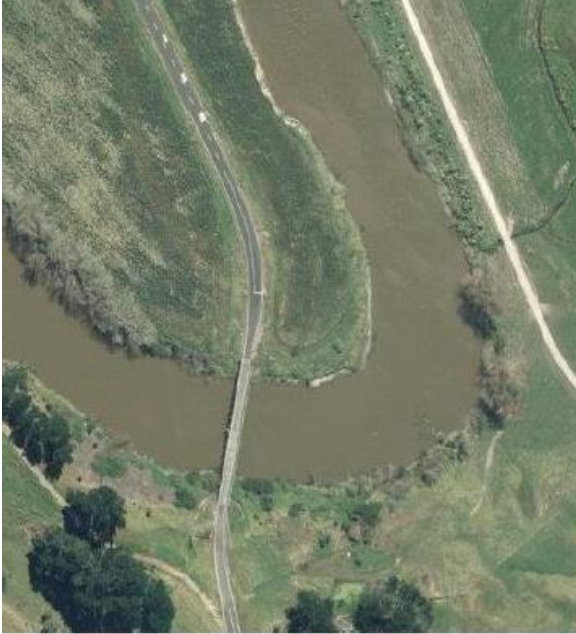
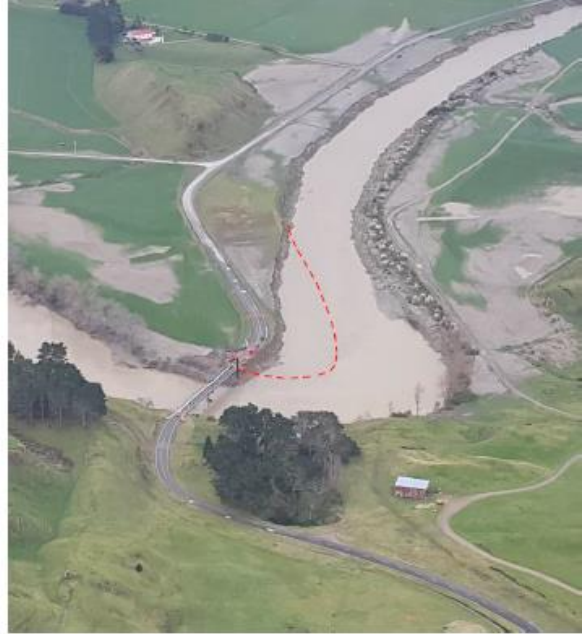
Appendix C – Limeworks Bridge Area before and after June 2015 Flood
