SAWMILL STORMWATER MANAGEMENT

Mark Groves, Ben Melvin, Reagan Knapp, Opus International Consultants Ltd.

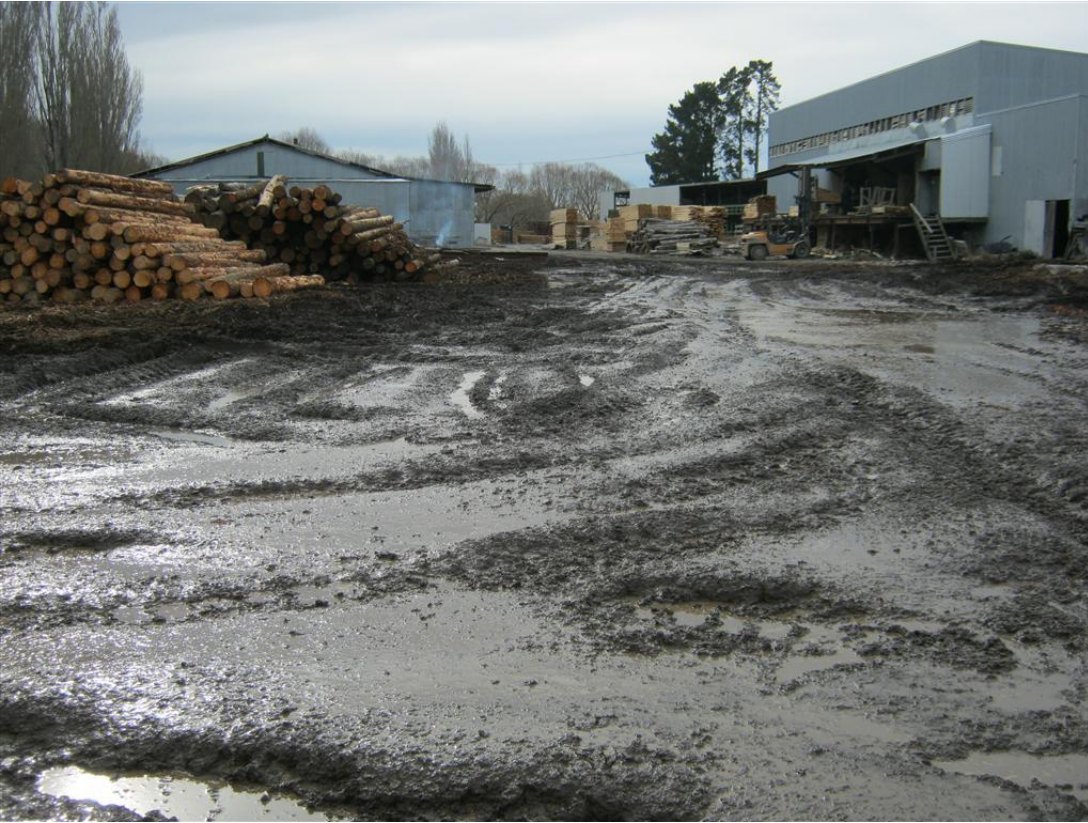
Figure 1 – Example of the organic sludge that used to cover areas of the site

The sawmill site as it stood had poor drainage. It sits within the former floodplain of a major river and is still prone to backwater flooding from that same river. The site soils are deep silts which are poorly drained and depth to groundwater is shallow, with springs at one portion of the site and ponding water within its perimeter drain. The site drainage was informal with no roof drainage and only limited pavement drainage, whilst the perimeter drain was blocked with stockpiled material in several places. Areas of the site were covered in large puddles and organic sludge through accumulated organic fines that severely limited drainage.

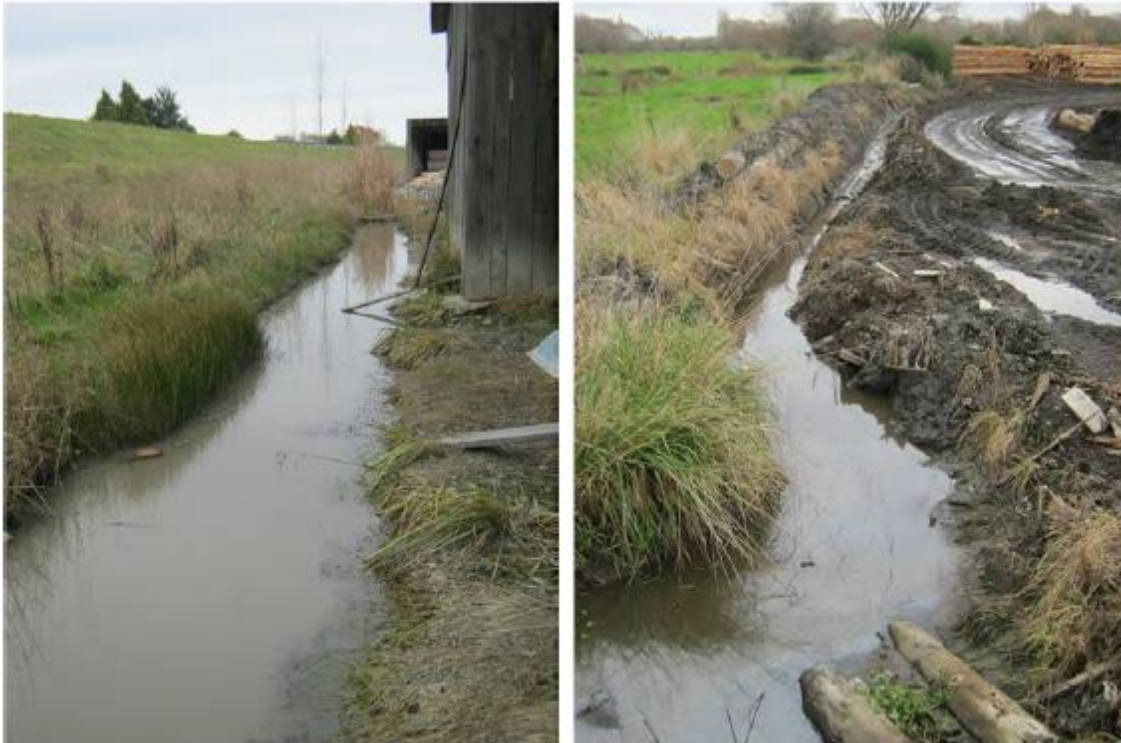
Figure 2 – Ponding water in the perimeter drain prior to the re-development

Site investigations revealed high levels of heavy metals associated with timber treatment in areas of the site, including Arsenic, Copper and Boron. It was also evident that these metals were present in high concentrations along the perimeter drain, though the concentrations reduced with distance downstream. Despite the high levels of contaminants observed in the perimeter drain, on-site soils and groundwater, at the point of mixing with a small adjacent drain all but one contaminant was within Australian and New Zealand Guidelines for Fresh and Marine Water Quality (ANZECC) 95% protection thresholds. By the time the flow from site met the main river, the water quality was excellent. This is due to the high level of dilution with clean and rapid moving water that was occurring. However, stormwater treatment was still required by the regional council despite a lack of evidence of any downstream environmental effect from the existing sites historic operation.

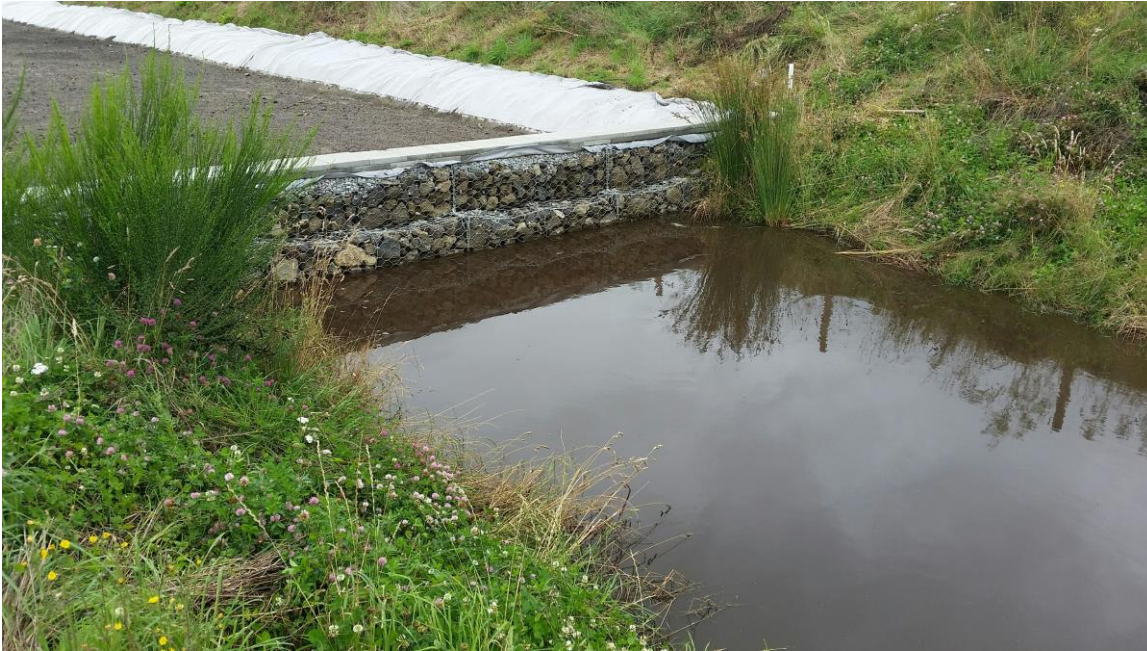
Figure 3 – Sand filter (lined with a sand compost mix), gabion weir wall and wetland forebay pool (post its first rainfall event)

The sand filter has been designed to capture and hold all run-off from a 25mm depth rainfall event over any rainfall duration with no allowance for infiltration losses. The 25mm capture relates to approximately 97% of annual rainfall events for the area and was adopted due to the high risk nature of the site. This results in a conservative size, but also reduces maintenance frequency; as long as the water can drain half-way within 24 hours it is considered to be performing. This means the system will still operate with an infiltration rate of 5mm/hour, or even slightly lower. This also allows for the limited head available for drainage.

The sand filter layer (a mixture of sand and compost specified by the regional council) is 200mm thick and sits just above groundwater. Flow through the sand filter displaces the water stored in a porous aggregate below which flows laterally to a central perforated collector pipe which discharges to the downstream wetland.

By not allowing for any infiltration losses in the sizing, sufficient storage is provided in the sand filter to indefinitely hold the entire event such that no by-passing will occur if the permeability is low due to blinding or the wetland level is elevated. This mitigates the low head available, as the water volume can be held back until such a time that there is head available. The sides of the sand filter were lined with filter cloth over free draining rock material to provide additional infiltration once it starts to fill above the sand layer. This acts as a back-up filter if the sand is clogged and not performing.

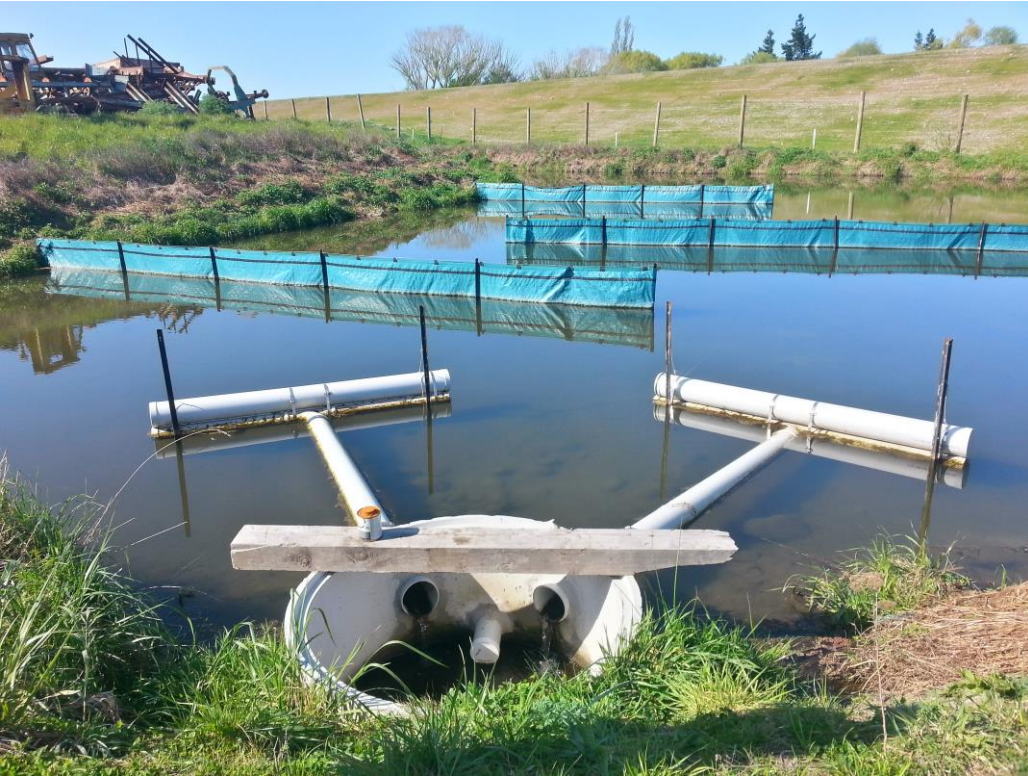
Figure 4 – The wetland in its temporary construction form with decanting outlet (this was the sampling point)

Monitoring of the wetland to date has been undertaken during its temporary construction form. During this period the wetland was not lined with the gravel layer (increasing dead storage). There was also no sand filter upstream; instead this area acted as a sediment forebay with a gabion filter wall. The temporary outlet consisted of a decanting outlet. Together they formed a large temporary treatment pond.

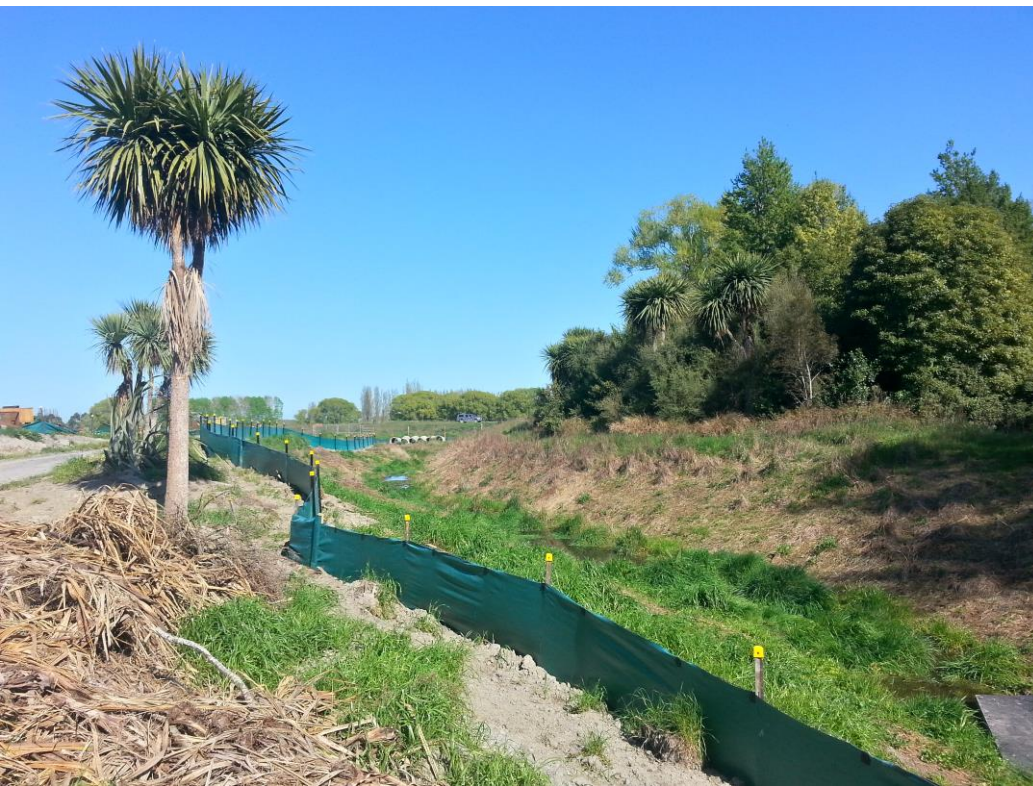
Figure 5 – The new outlet channel constructed to separate the discharge from the existing drain

- Separation of the stormwater discharge from the adjacent drain via a new outlet channel to the nearby river.
- Provision of sub-surface drainage to control groundwater levels and to direct the flows to the stormwater system

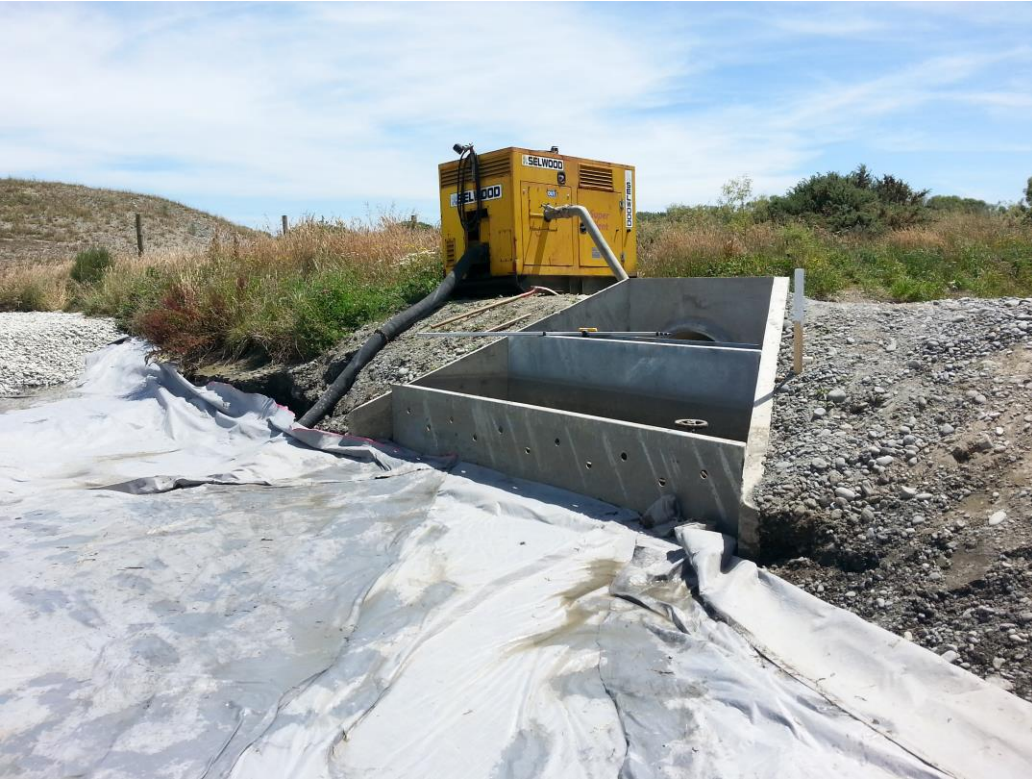
Figure 6 – Outlet headwall with baffle plate, screen and V-notch weir (obscured) under construction

Further to this, when displaced flow leaves the wetland it is attenuated to increase residence time and also to limit the rate of discharge. This increases the level of dilution downstream (there are no quantity controls for the nearby river as it does not flood and sits within the functional and undeveloped flood plain of a major river). The sub-surface storage consists of a 500mm deep layer of gravel, which provides a large contact area to improve removal of dissolved metals.

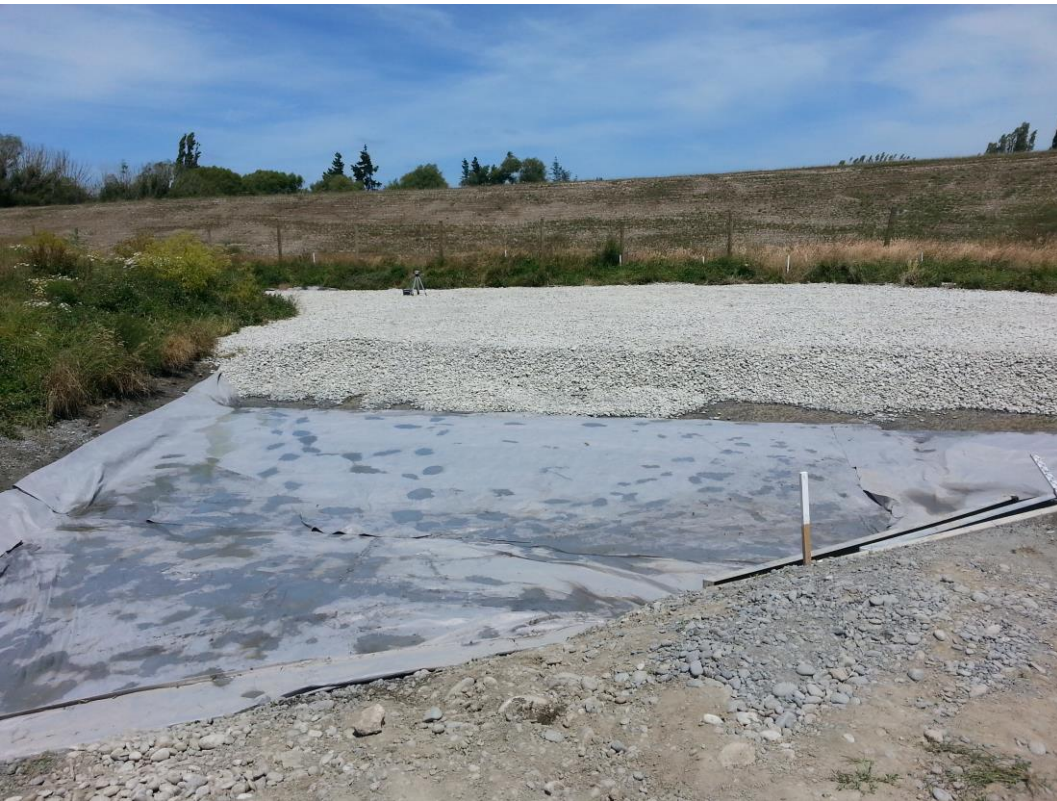
Figure 7 – Placement of the 500mm deep gravel lining underway
