# PROTECTING BRISBANE CENTRAL DISTRICT– CASE STUDY IN FUTURE FLOOD READINESS

*K Olsson, J Logan, B Andrews*

## ABSTRACT

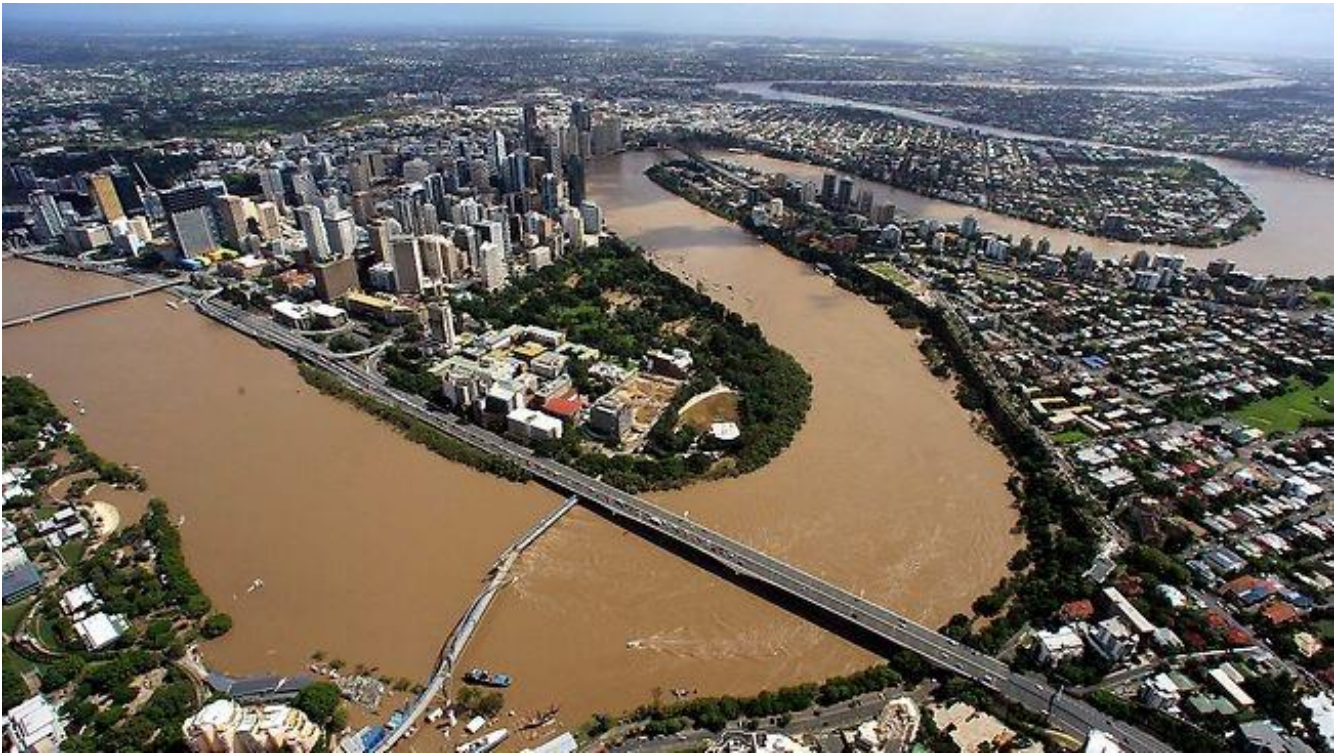
Brisbane R at City Gauge \*  
Highest Annual Flood Peaks

Seven major flood peaks have been recorded at the Brisbane gauge since records began in 1841. A major flood peak of 4.46 metres (6th highest) was recorded at 3:00am on Thursday the 13th of January 2011. This is the largest flood peak recorded since the January 1974 flood when the Brisbane River reached 5.45 metres. Higher levels are possible in Brisbane with two floods (8.35 metres and 8.09 metres) being recorded two weeks apart in February 1893 and higher still in the record flood of January 1841 at 8.43 metres.

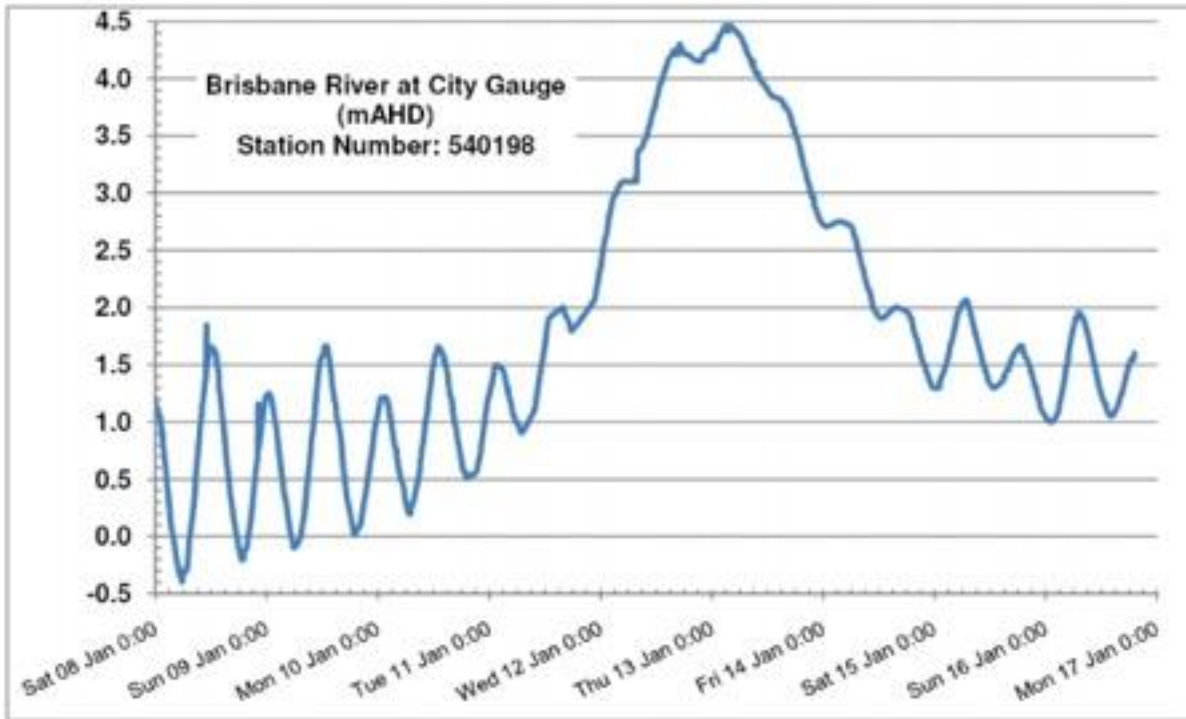
Evident in Figure 1 above are two peaks—a minor peak at 5:00 pm on Wednesday 12th January (4.30 m) and then later at 3:00 am on Thursday 13th January, when the river reached 4.46 m. Given a "major flood" at the Brisbane City gauge is defined as a gauge height of 3.50 m or greater, Brisbane City experienced a major flood from 10:00 am on Wednesday 12th January until 6:00 pm on Thursday 13th January, a period of 32 hours. This 32-hour period at the City gauge spanned three high tides:

The major peak of 4.46 mAHD at the City gauge corresponded almost exactly with the high tide at 2:34 am on 13th January. The minor peak of 4.30 mAHD at 17:03 Wednesday 12th January (Figure 1) probably represents the highest river flows. Brisbane felt the full force of these.

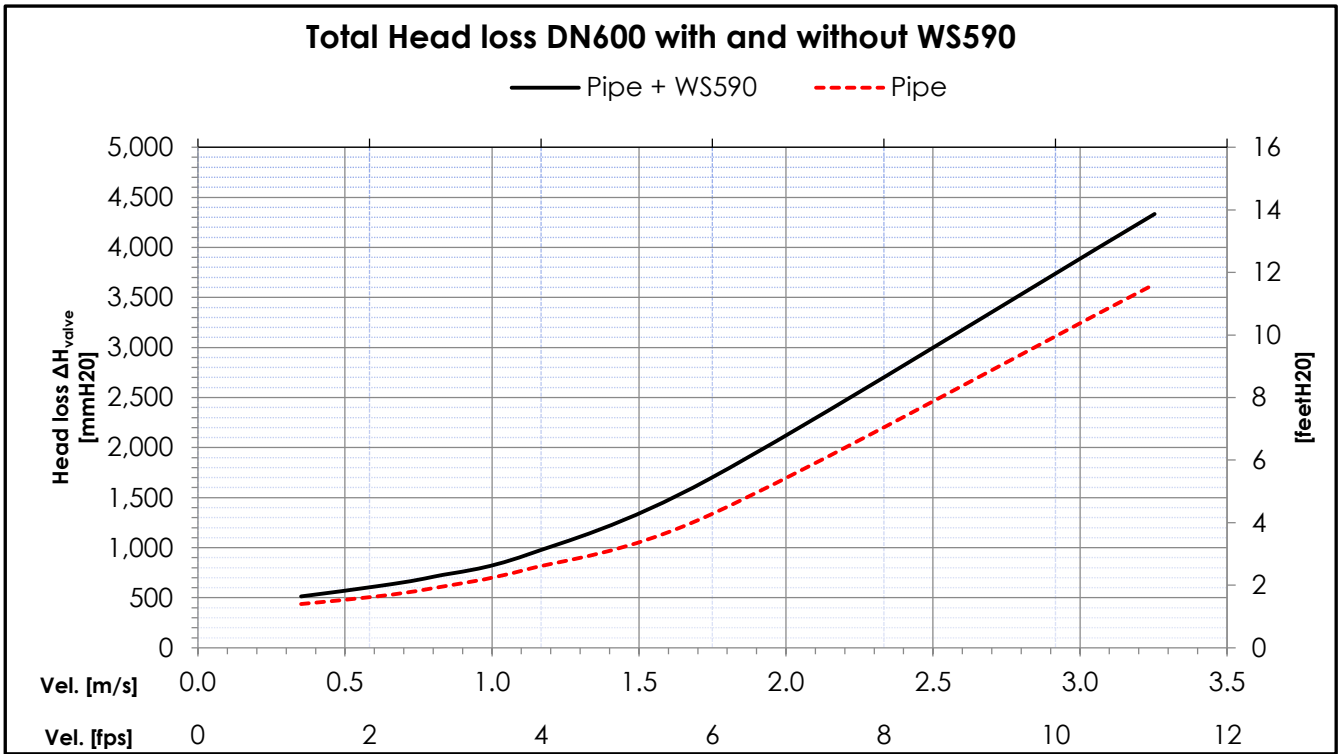
Here is an example of a head loss curve for the WaStop Valve compared to the head loss in the pipe system.

#### ASSUMPTIONS:

Pipe roughness  $k = 2$  ( $\epsilon = \frac{2}{600}$ ), pipe diameter 600mm (24")

Discharge submerged, all the velocity potential is lost;  $K_L = 1$  (without a Wastop)

Inlet to the piping system  $K_L = 0.5$

$K_L$  values for the given flow rates for the outlet with a WaStop from a test done at the Utah State University Water Researched Laboratory.

Incline 4 ‰ (=0.4%)

WaStop has the lowest head loss on the market for gravity check valves. Testing conducted at Utah State University confirmed this and showed that the head loss with the valve was only slightly higher than the normal head loss of the system.

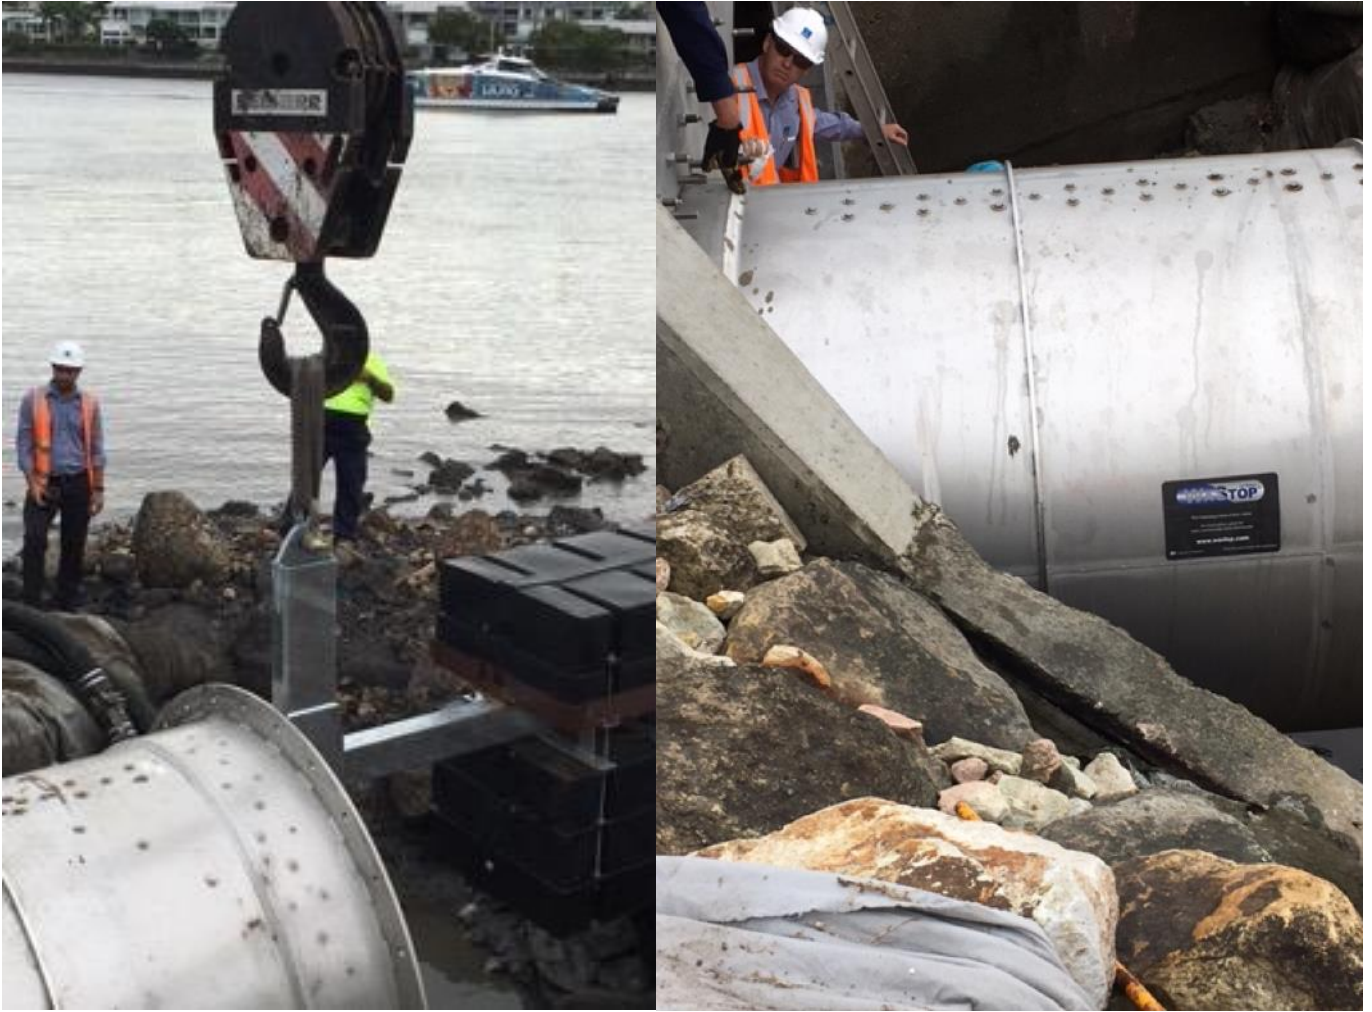
Installation of WaStop is simple and effective. Simply sliding the valve into the pipe and bolting it into the headwall is all that is required. The valve is then operational.

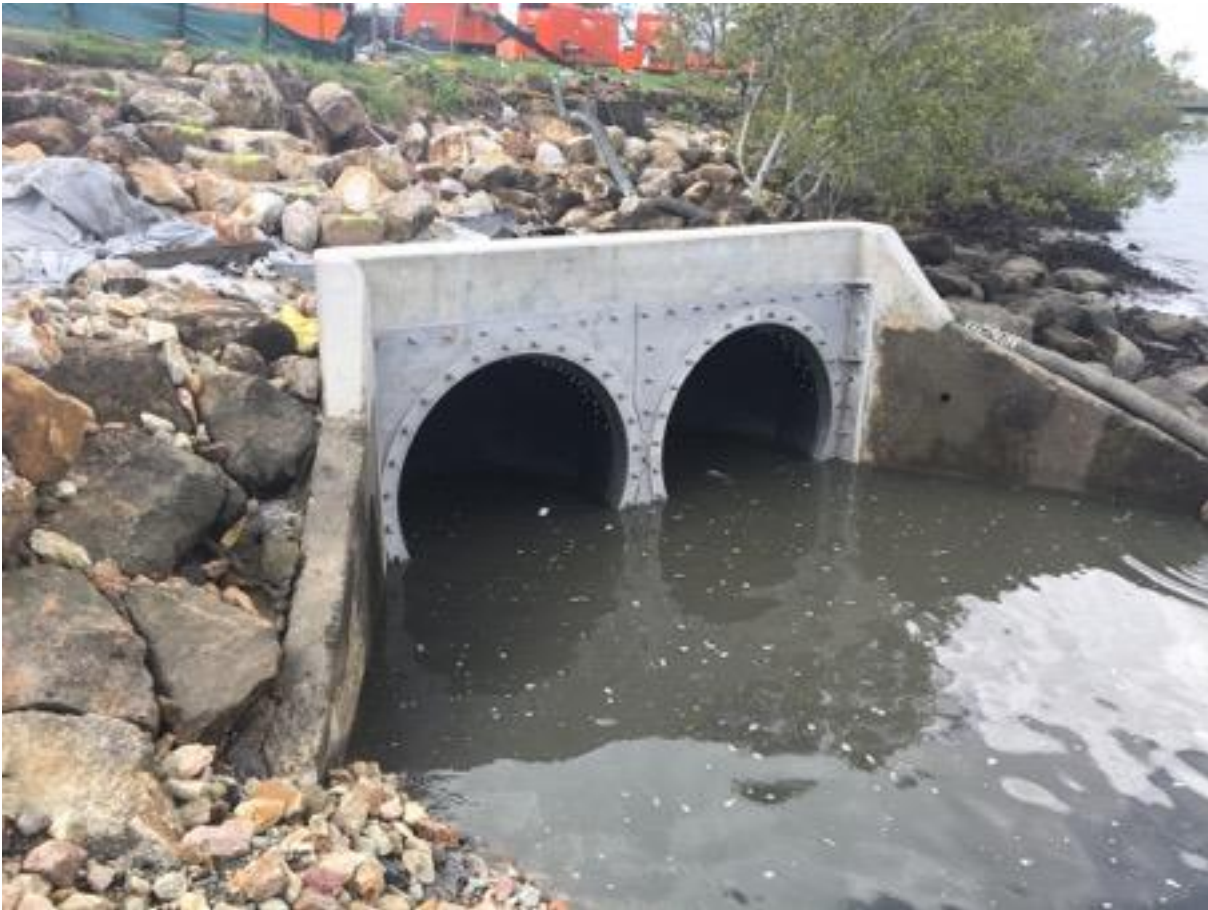
Given that the valve sits inside the existing pipe the device is protected from lateral pressure and tidal debris

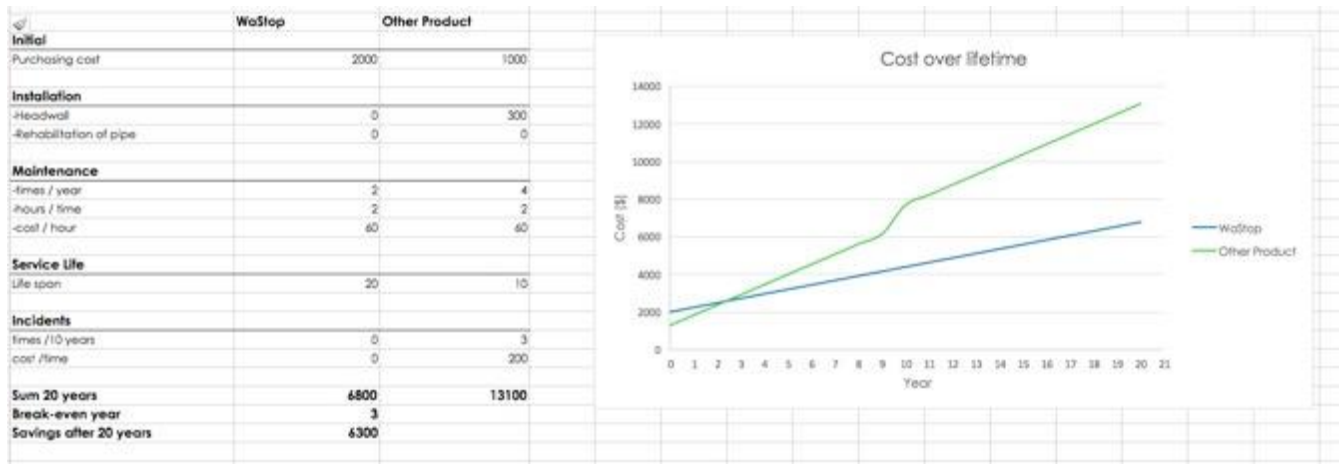
A quick calculation allows municipalities to estimate the life-cycle cost of different device options based on earlier collected data. With reduced maintenance budgets it is important to ensure that the ongoing maintenance is reduced as much as possible.
