# MINIMISING THE ENVIRONMENTAL EFFECTS OF DREDGING – WHAREMAUKU STREAM

*Kyle Christensen – Christensen Consulting Limited*  
*Disna Pathirage – Kapiti Coast District Council*  
*Paul Halliday – Kapiti Coast District Council*  
*Rita O'Brien – Kapiti Coast District Council*  
*Guy Forrest – Goodman Contracting Limited*

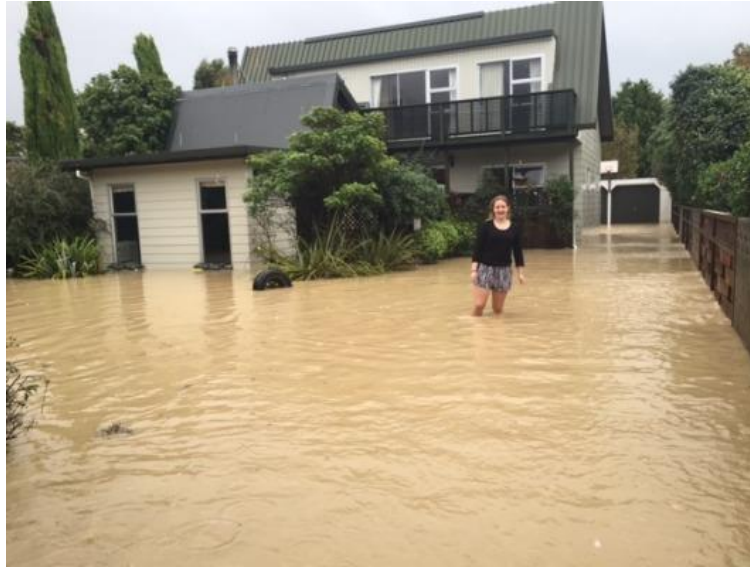
*Figure 2: Residential Flooding Lower Wharemauku (Photo source – [www.stuff.co.nz](http://www.stuff.co.nz))*

This May 2015 event caused widespread flooding across the Kapiti Coast including within the Wharemauku Catchment (See Figure 2.) which triggered a review of proposed stormwater capital works and further investigations into stormwater and open channel capital works across the entire district. During this period of further investigations there has been a number of smaller flood events (See Figure 3. which have caused notable damage and disruption with a total of 833 flood related complaints received by the Kapiti Coast District Council between June 2015 and December 2016.

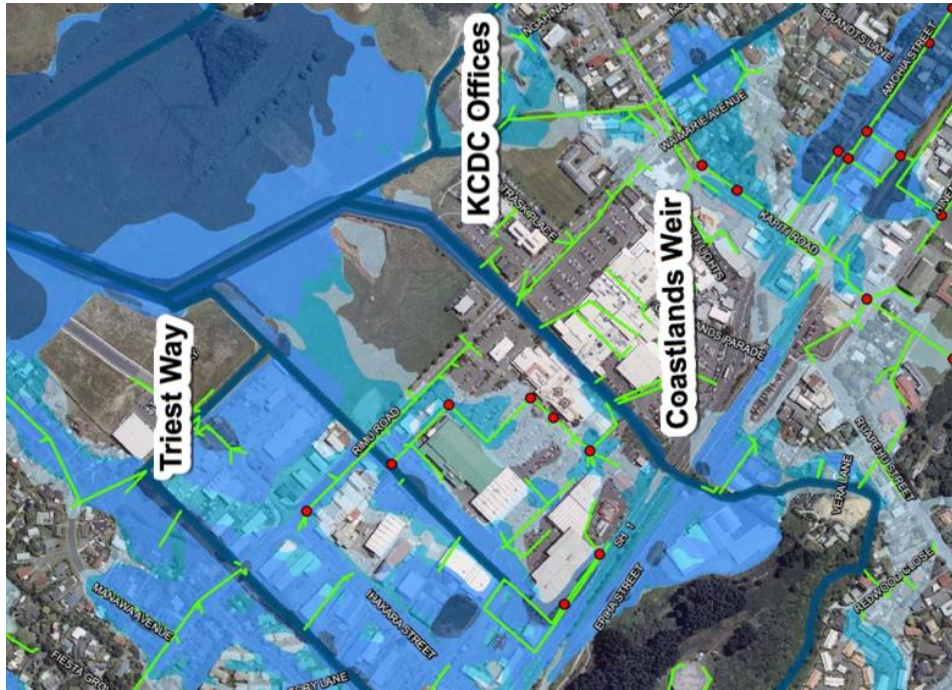
Figure 4: Upper Reach of Wharemauku Stream (Source SKM, 2006)

A number of key parameters need to be considered to develop a successful dredging programme. This section describes each of the parameters considered for the Wharemauku Stream dredging programme. Figures 4 and 5 show the extent of the stream channel and key reference points referred to in more detail.

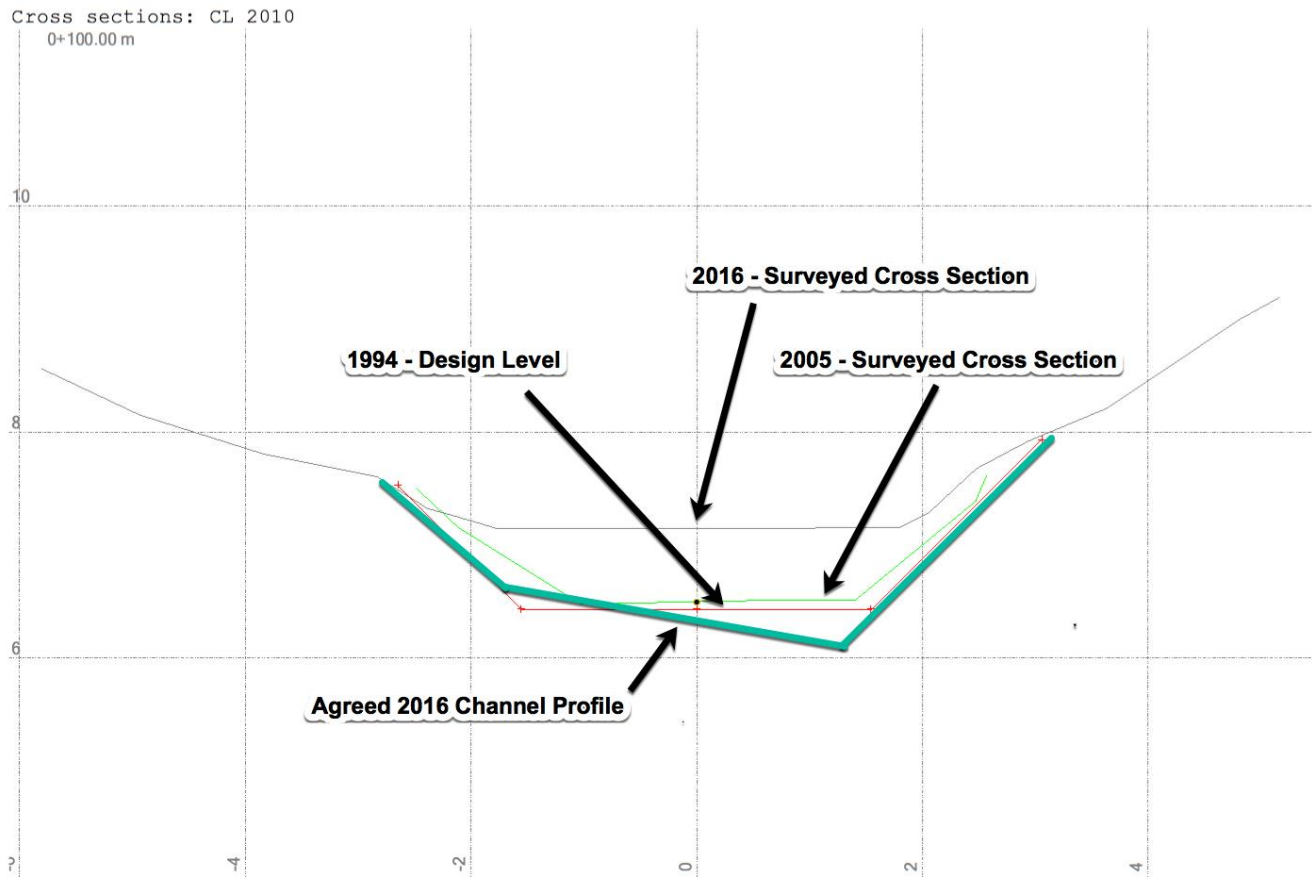
Figure 7: Wharemauku Design Cross Section (Chainage 100 m)

With the depth and extent of dredging determined the proposed cross section now how to be determined. The original 1994 design level provided for a uniform flat based channel (See Figure 7.). The project team, including Greater Wellington Regional Council decided that this lacked habitat diversity and that a profiled channel with a deeper side that alternated from the left bank to the right bank would provide a better solution. In addition to this, pool-riffle-run sequences were incorporated into the long section profile to mimic the existing habitat.

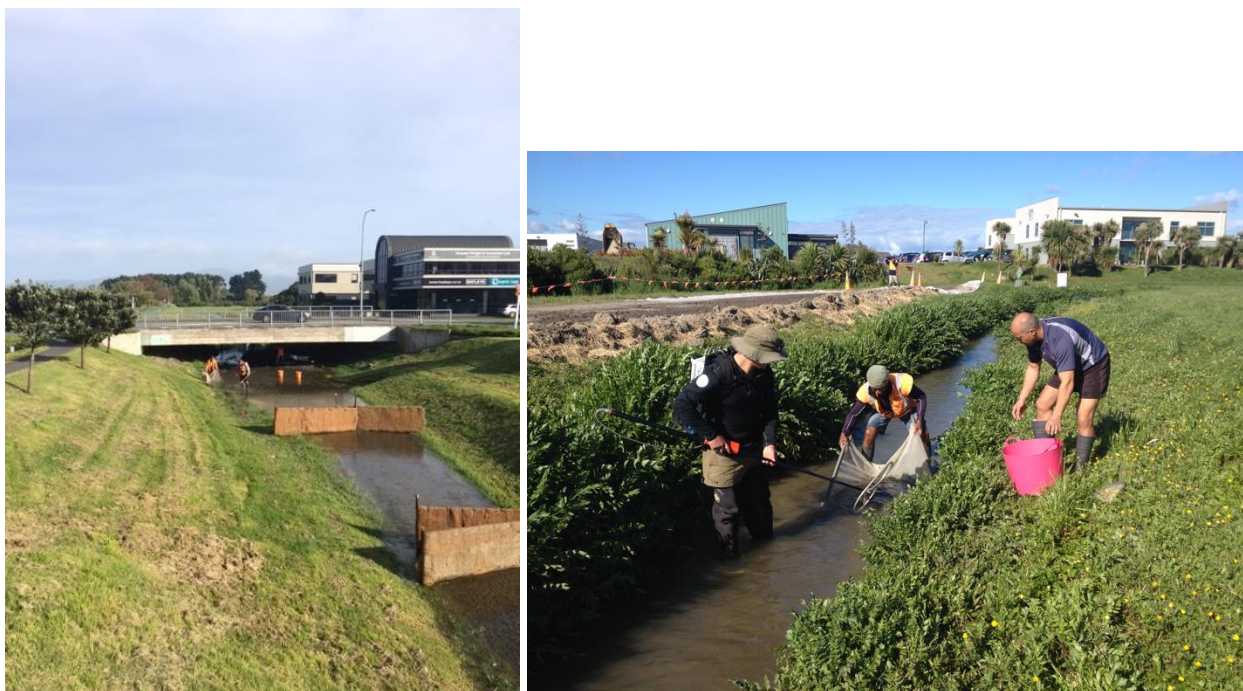
*Figure 8: Erosion and sediment control and fish relocation*

The physical works commenced mid-October with the reach isolation and electric fishing being undertaken to then allow the dredging to commence. The isolation and sediment control nets along with the electric fishing team are shown in Figure 8.

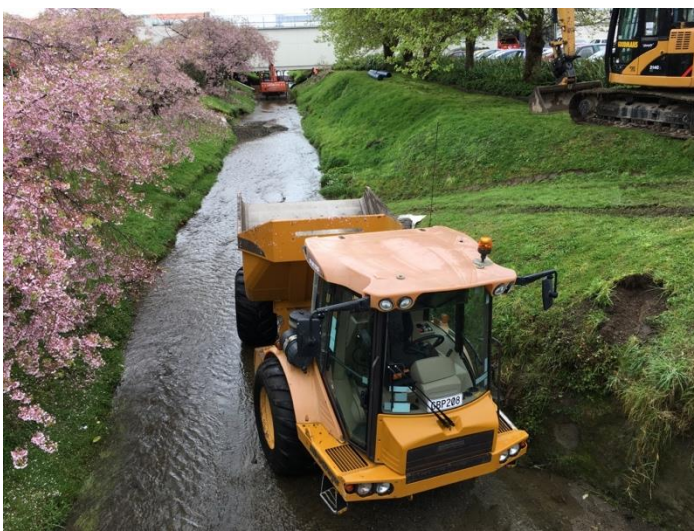
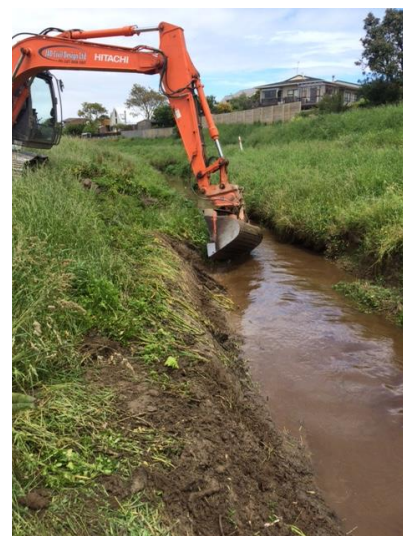
*Figure 10: Working in the stream through confined Coastlands Section (left) and from bank edge further downstream (right)*

Once the isolated reaches had been fished the main earthmoving equipment moved in to excavate the channel down to the required depth and width as well as construct the erosion protection works. Where possible work was undertaken from the bank edge, but in the confined section, where the Coastlands building is over the top of the stream, machinery had to be in the stream (See Figure 10.). The excavators were equipped with on-board GPS tracking so were able to accurately cut down to the required design profile.

In some reaches material was stockpiled next to the channel before being removed off site but in other areas this was not possible so it was loaded directly into trucks and carted away. A total of close to 3000 m<sup>3</sup> of material (solid measure) was removed by the dredging operation.

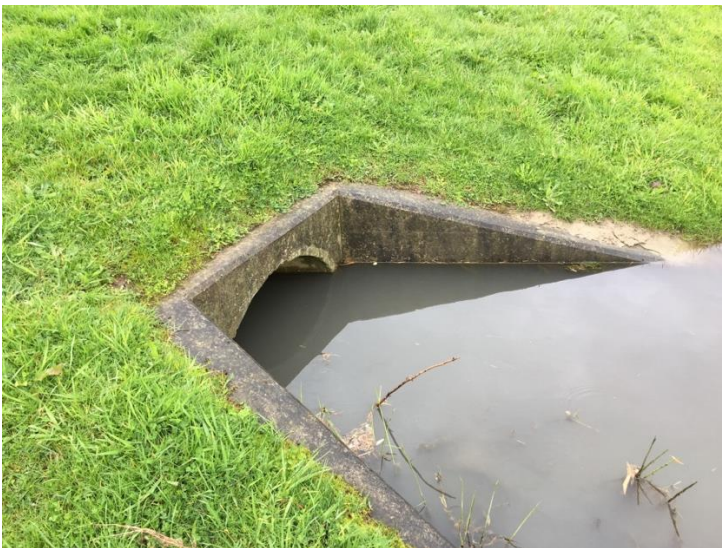
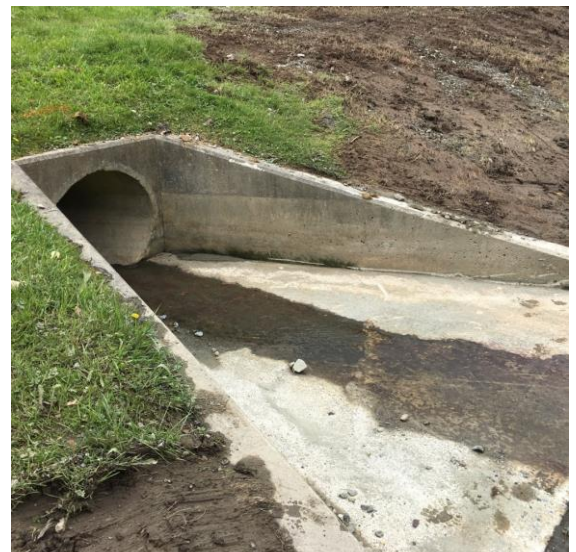
*Figure 11: Before & after at main (625 mm diameter) stormwater outfall*

The effects of the dredging are most dramatically shown at the main stormwater outlet from the Coastlands Shopping Mall (Figure 11). Prior to dredging, during normal flows this outlet was completely drowned. Following dredging the water level dropped by approximately 700 mm and the water stored in the stormwater network drained away over a period of several hours. It is noted that during periods of high flows in the main Wharemauku Stream that this outlet will be drowned but the timing of the peaks from the large rural catchment affecting the main channel and the commercial area will be sufficiently different that water will much more effectively be able to drain away from this area. Through anecdotal observations, the November 2016 flood event caused much less inundation of roads and properties in this area compared to a smaller event that occurred in June 2016 prior to the dredging being undertaken.

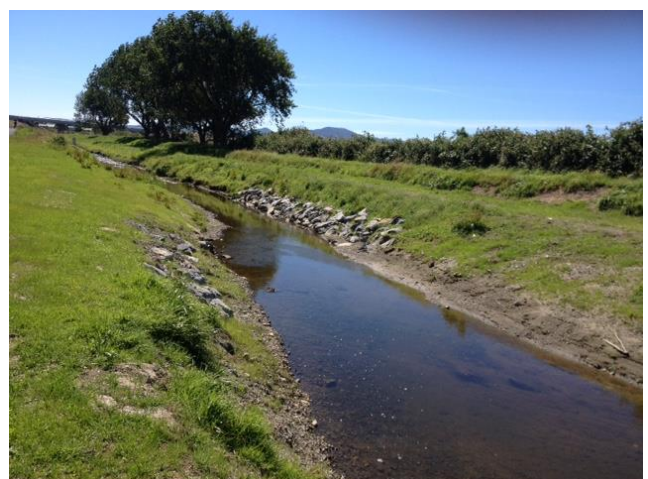
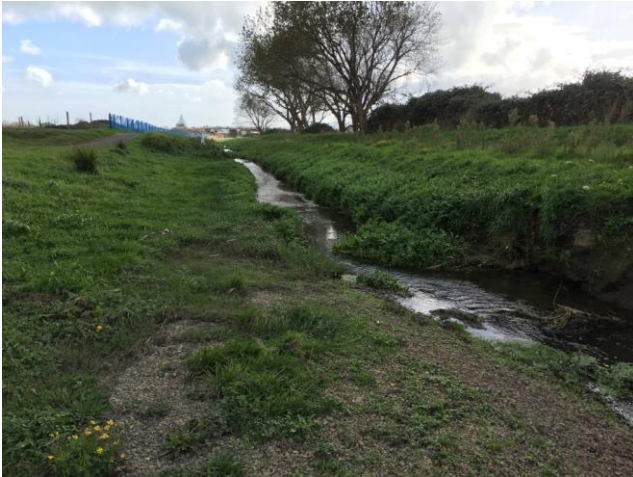
Figure 12: Before (left) & after (right) at Triest Way

Further downstream the effects on the open channel are clearly evident with a much increased width and capacity as well as erosion protection works completed and in-channel riffle-pool-run sequences as shown in Figure 12.
