Havelock North Water Supply *Campylobacter* Outbreak – source and ingress investigations

Tony Cussins, Discipline Manager - Hydrogeology, Tonkin + Taylor Group

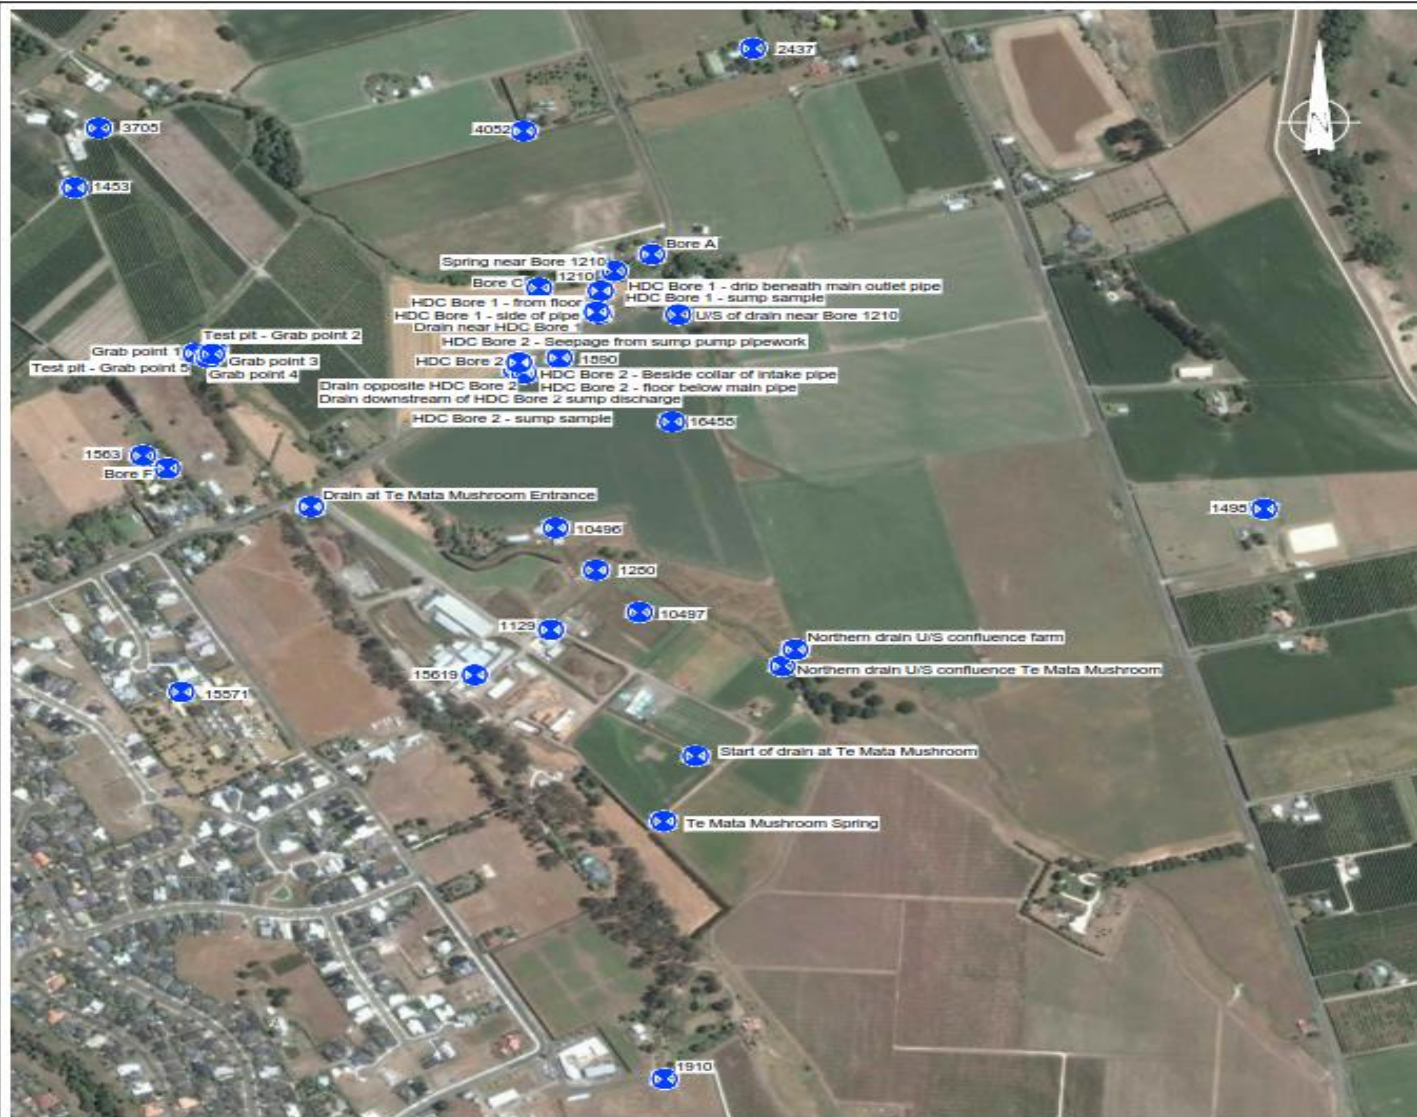
FIG. No. Figure 6
REV. 0

HASTINGS DISTRICT COUNCIL
BACTERIOLOGICAL CONTAMINATION INVESTIGATION
BROOKVALE ROAD WATER SUPPLY BORES
HBRC Sampling Locations

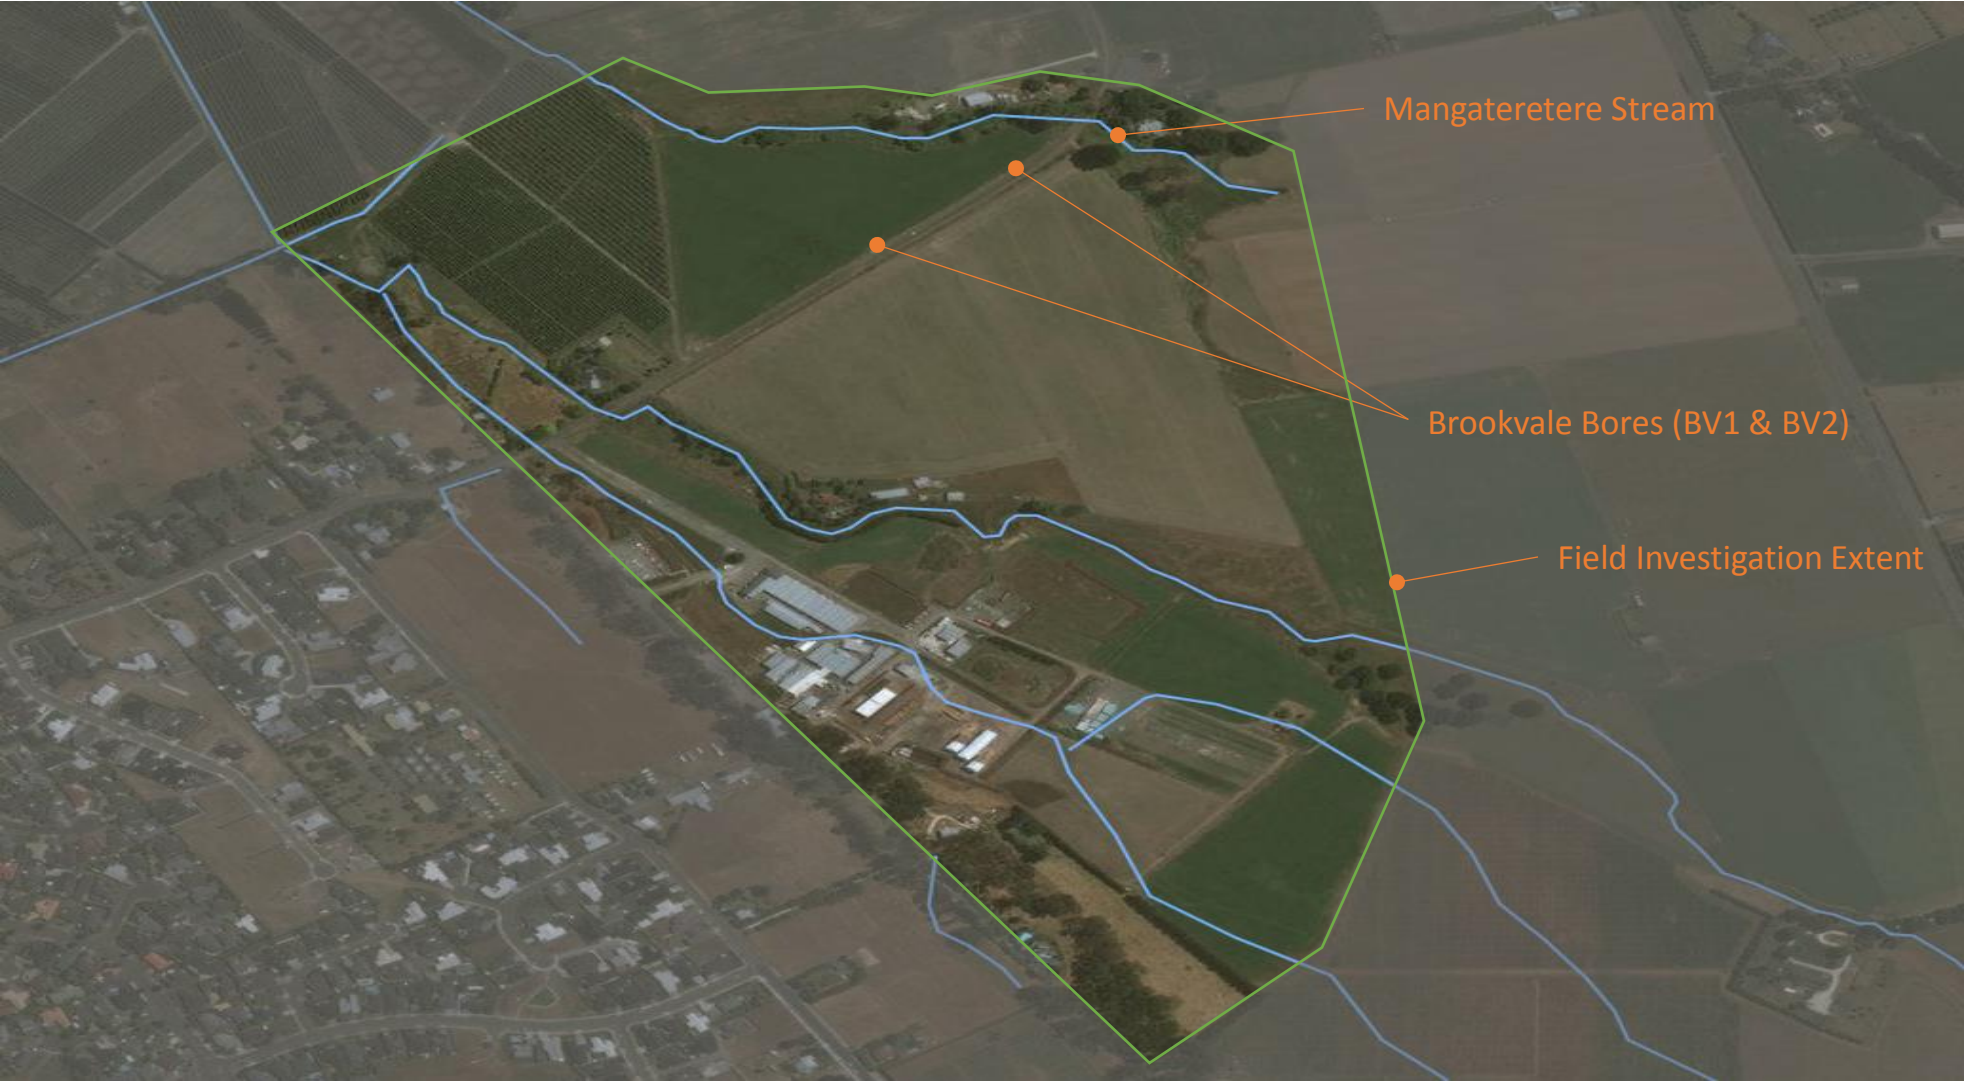
Conceptual hydrogeological model

- Relatively thin confining layer overlying Te Mata Aquifer
- Upper screen in Bore 1: 11.4 – 17.4m bgl
- Hydraulic connection - pond/groundwater
- Very high transmissivity in the area – >30,000 m²/day
- Preferential flow pathways through paleo-channels
- Water level in ponded area observed to be immediately drawn down when Bore 1 turned on (had not been observed before)
- Kh / Kv relationship poorly understood

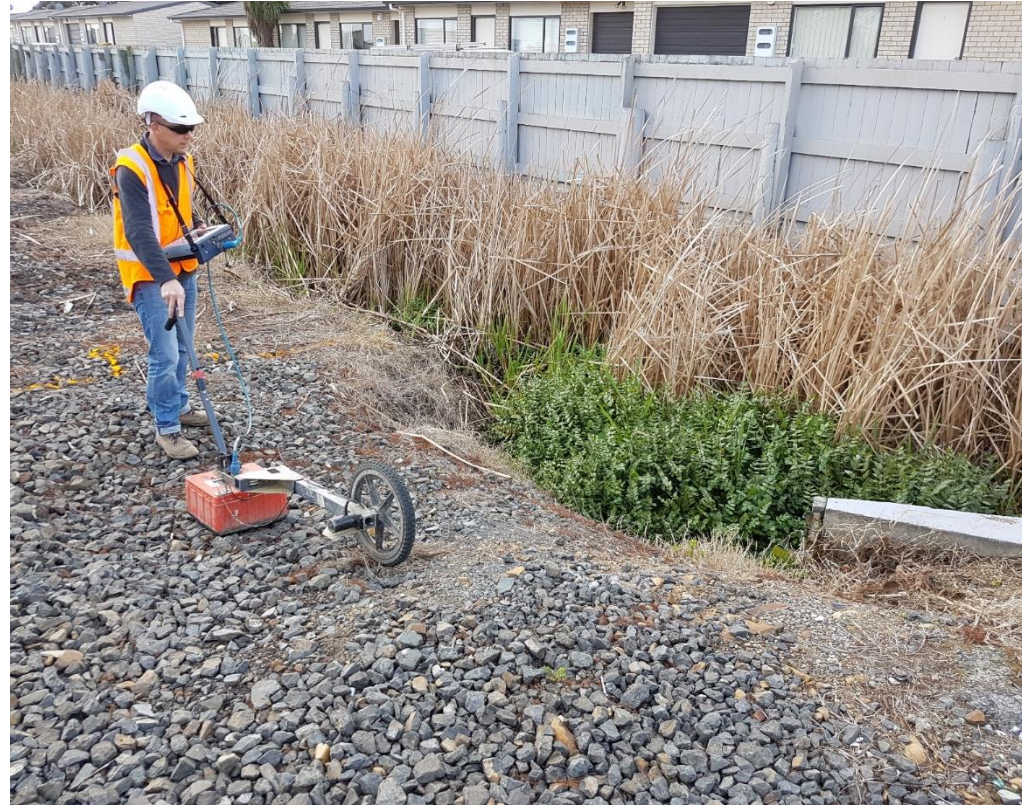
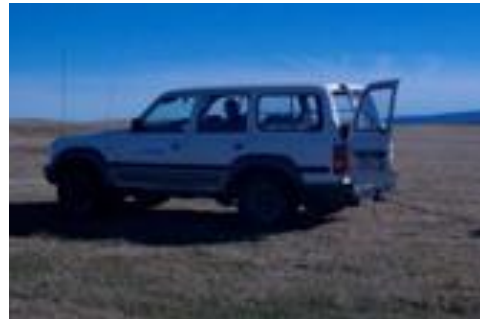
Geophysical survey

ScanTec – specialised geophysical equipment / techniques:

- Ground Penetrating Radar (GPR)
- Electromagnetic Induction (EM-34)
- Electrical Resistivity Imaging (ERI)

- Characterise the near surface geology within the area of interest (15m depth), including the upper Te Mata Aquifer
- Increase knowledge about the confining layer (or aquitard) in the vicinity of the Brookvale Rd borefield
- Total area of approx. 140 ha
- Included land disturbance or fill

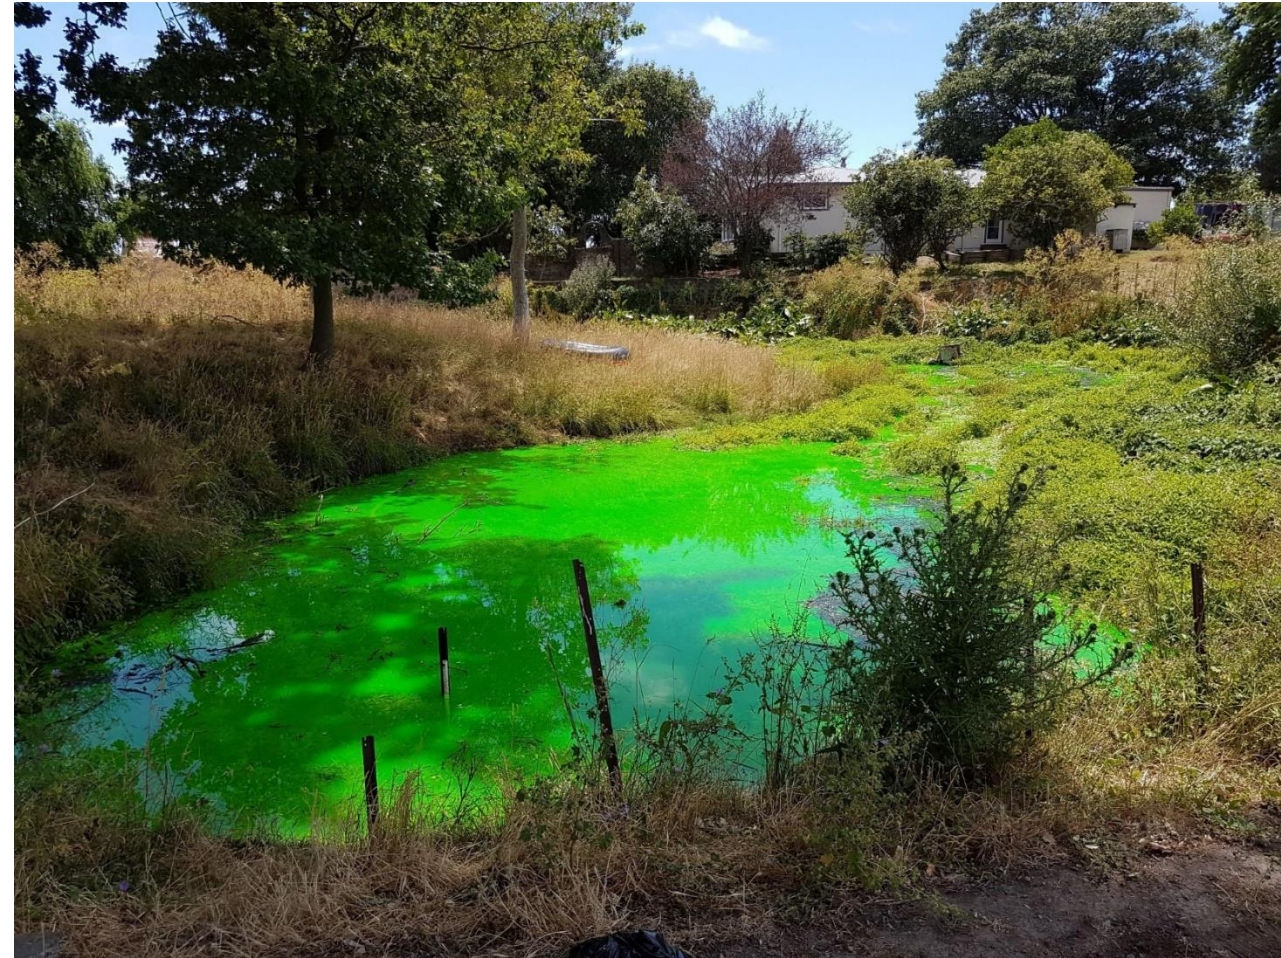
- Second dye tracer test undertaken to correct deficiencies in 1st test
- Undertaken in January 2017, with the following refinements:
 - Water levels in pond raised to approximately 18.08mRL - replicate outbreak conditions in August 2016
 - Greater mass of fluorescein dye (8kg) was used
 - Pumping regimes (BV1 and BV2) synchronised to commence 5-6 August 2016 rainfall through to outbreak
 - Testing of a range of parameters including *E. coli*, *Campylobacter*, total coliforms

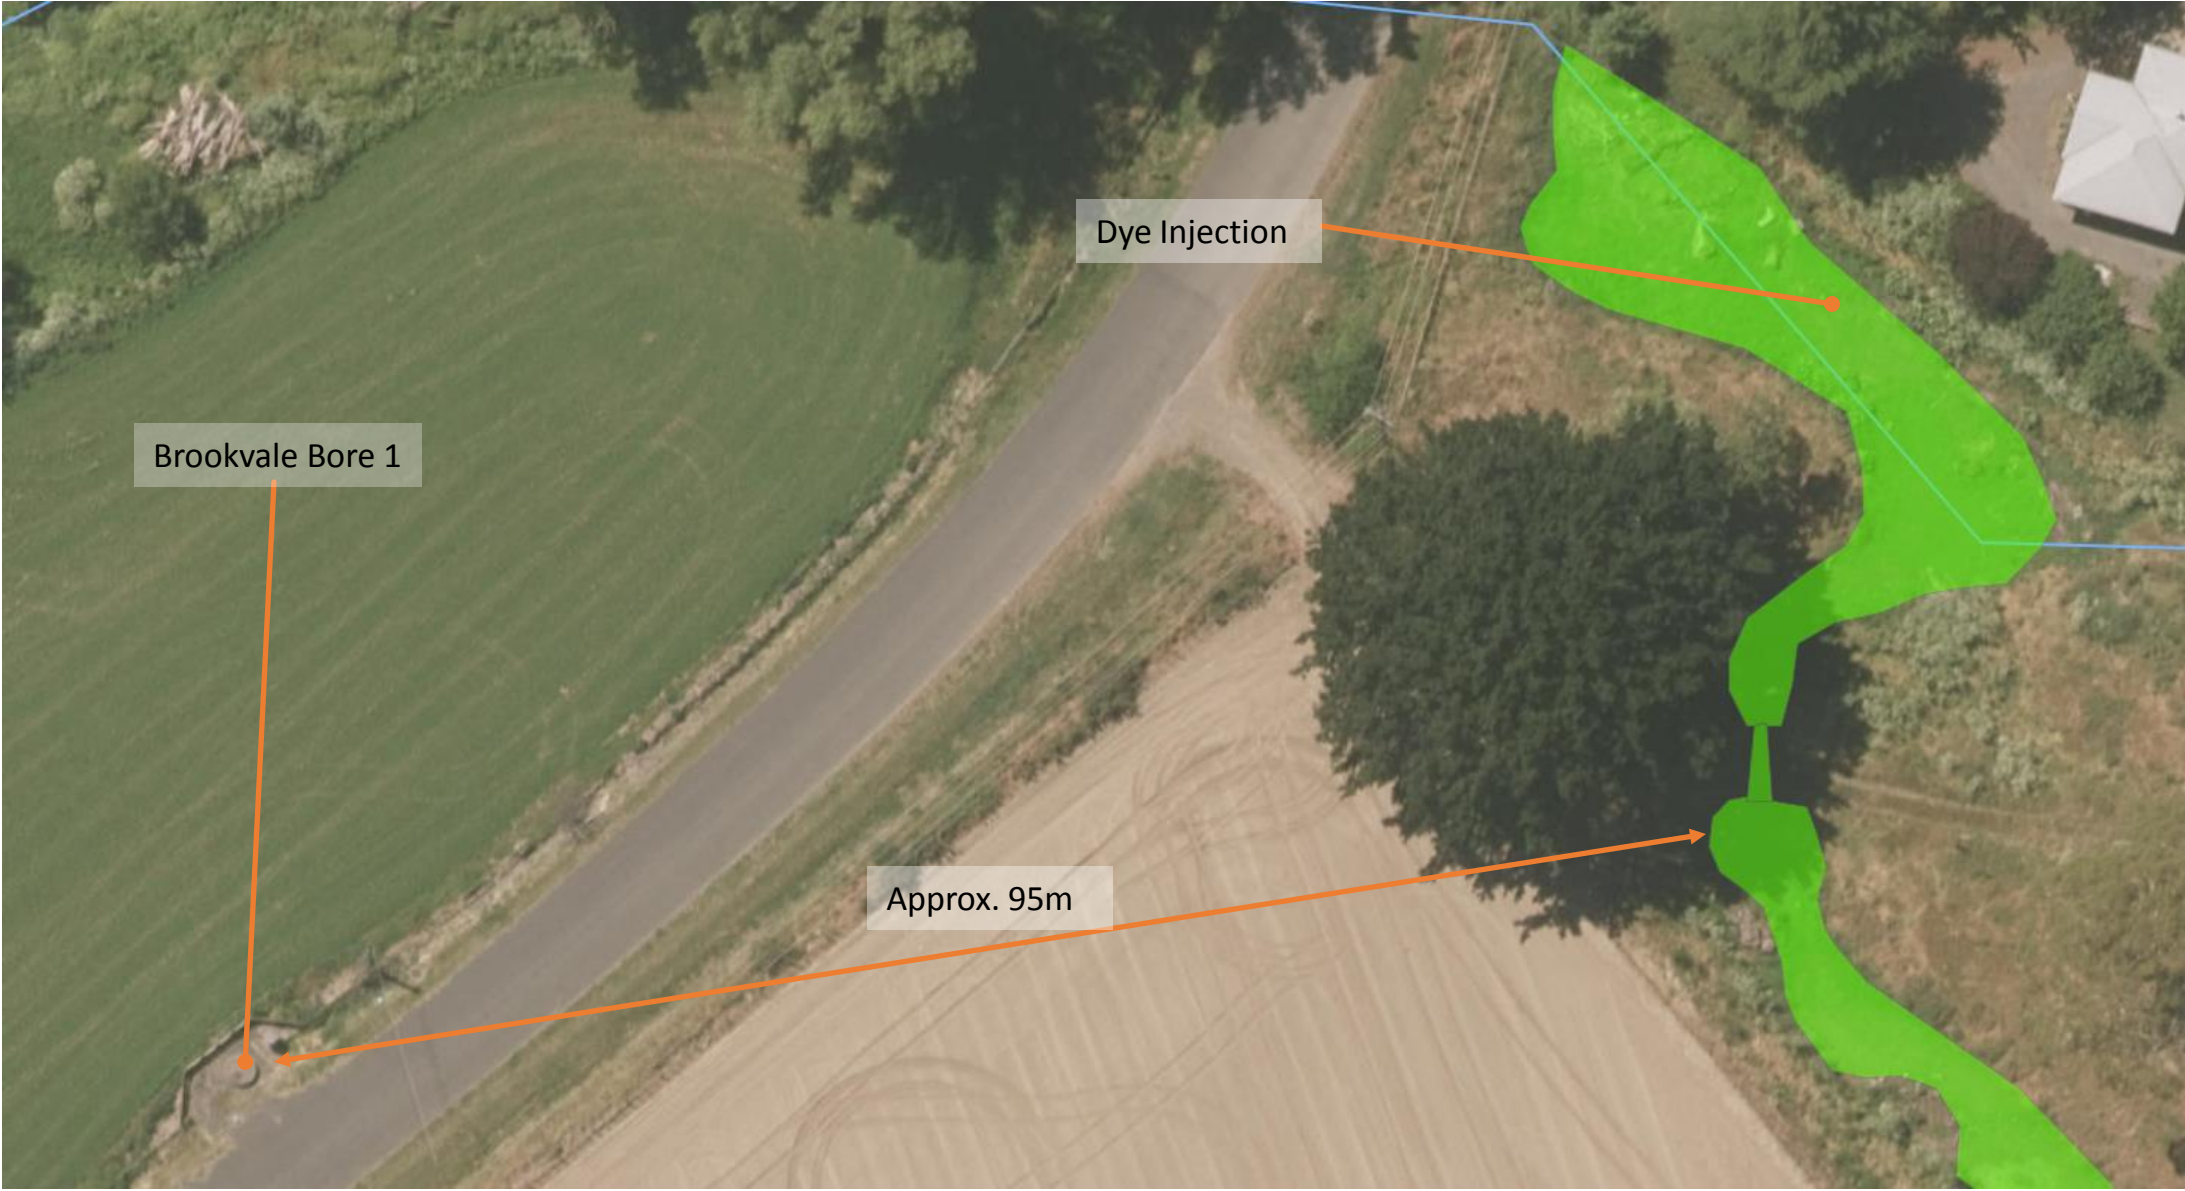
Brookvale Bore 1

Dye Injection

Approx. 95m

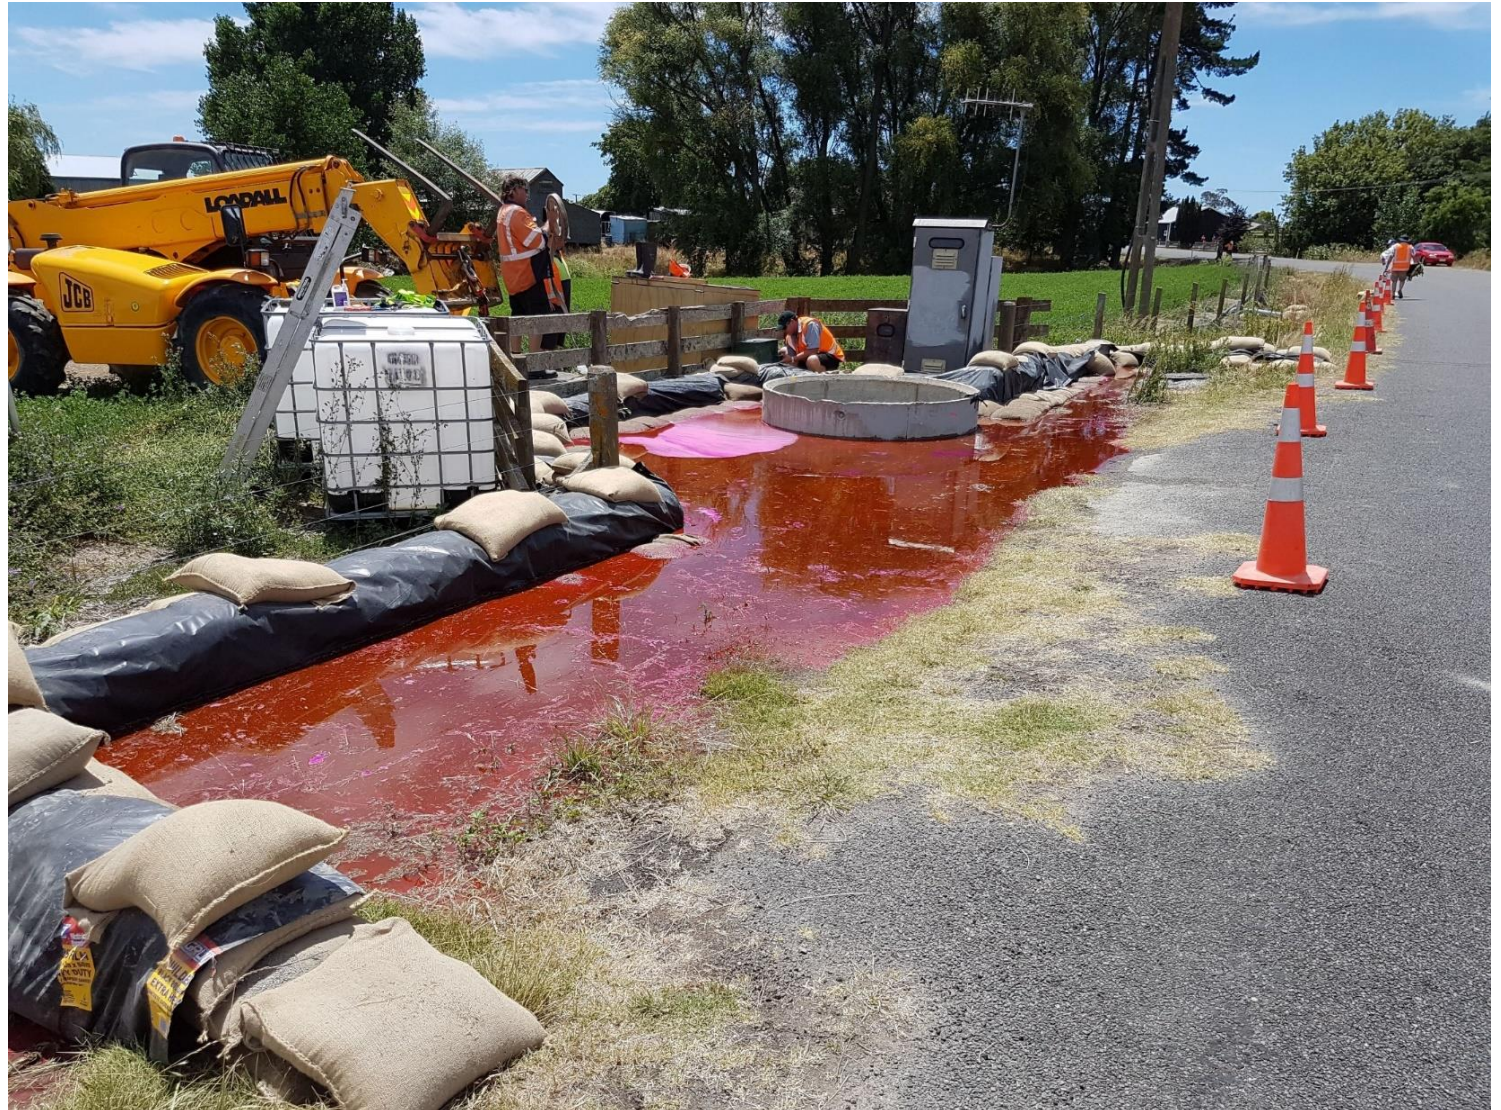
Rhodamine tracer

- Rhodamine WT dye was used to assess a potential contaminant migration pathway adjacent the BV1 bore head
- Concurrent with the fluorescein dye tracer test in the Mangateretere pond.
- No clear evidence of pathway from the surface to the bore screen

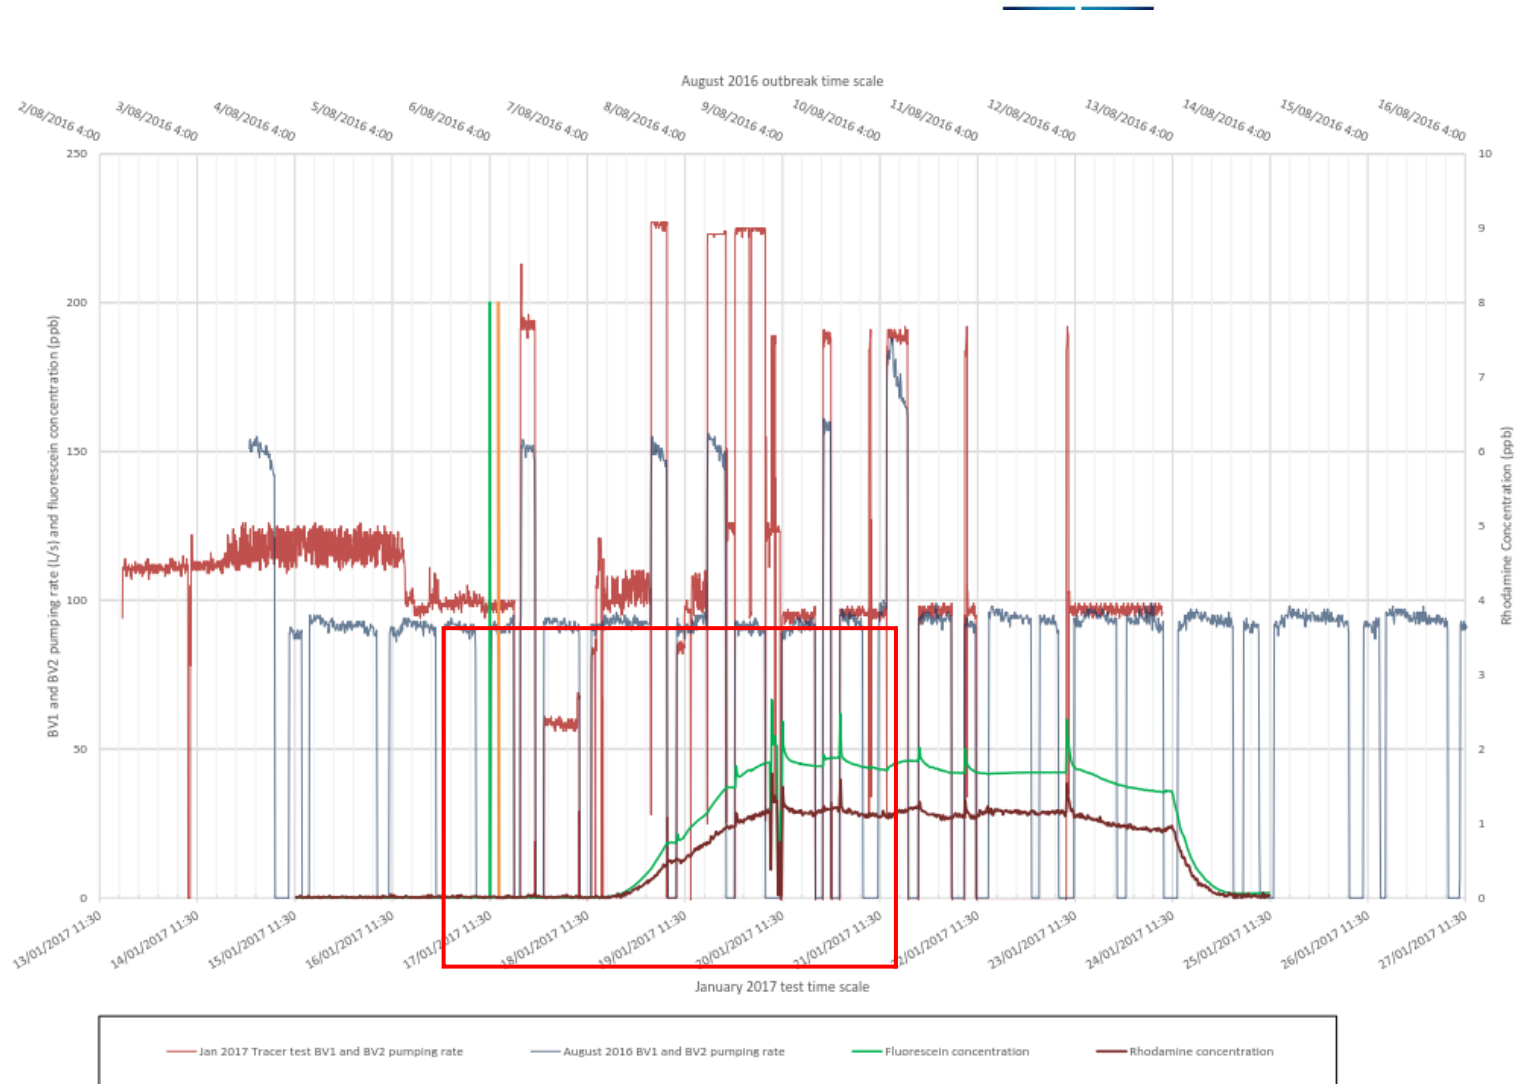
Results of tracer test

Fluorescein dye first appeared in Bore 1 approximately 29 hours after injection into the Mangateretere pond.

Strongly supported by contaminant data, including:

- *E.coli*
- *Campylobacter*
- *Total coliforms*
- O157:H7 pathogenic *E.coli* strain

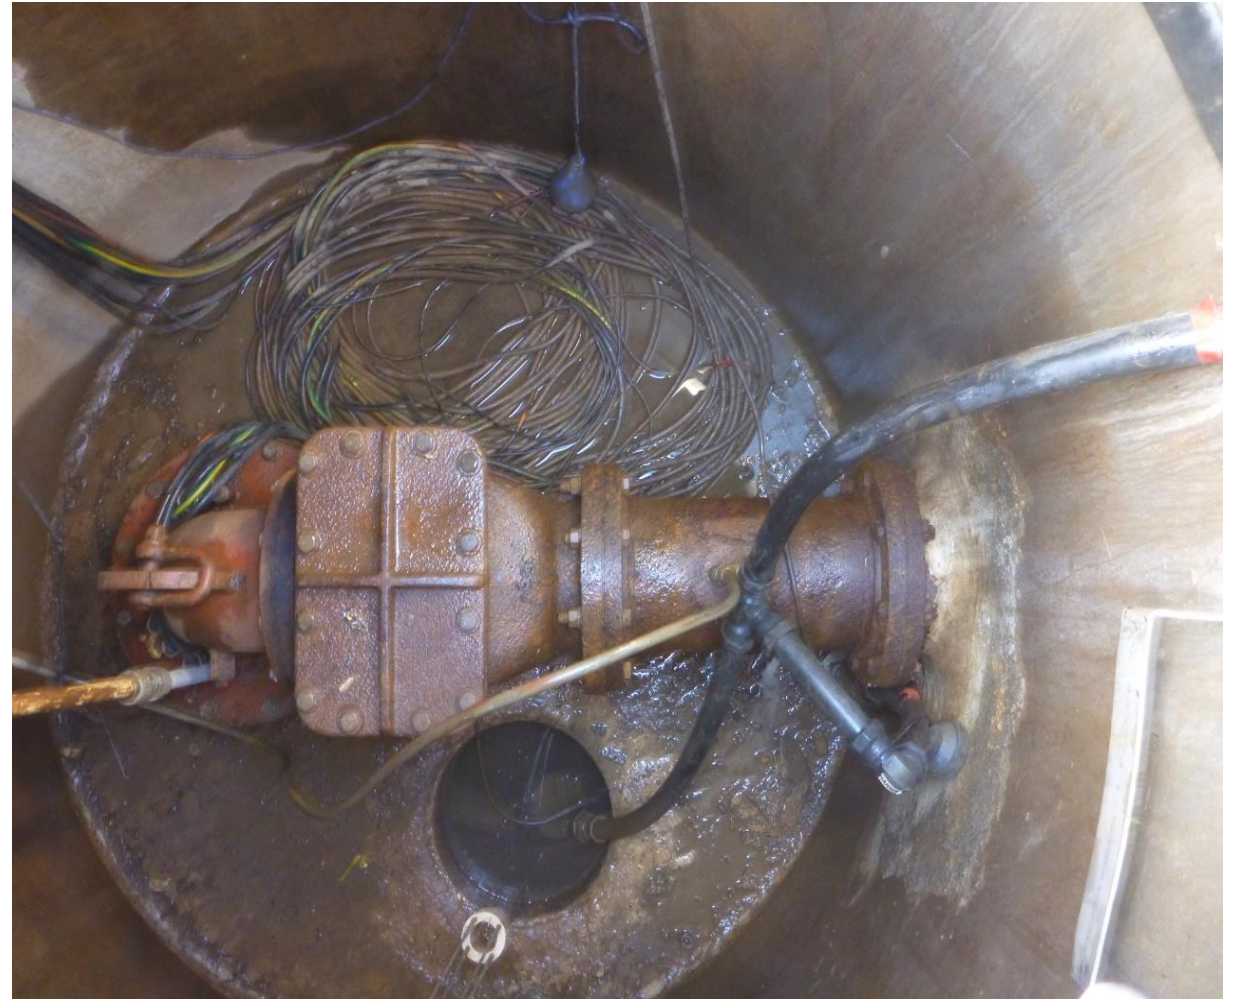
High level float switch operation

- Focus on float switch cable attachment - critical
- MWH Bore Head Security Report (2014) - float in exactly the same position as 2016
- No interference with the float cable between 2014 and 6 September 2016
- Inquiry accepted that high level float switch had likely operated as required

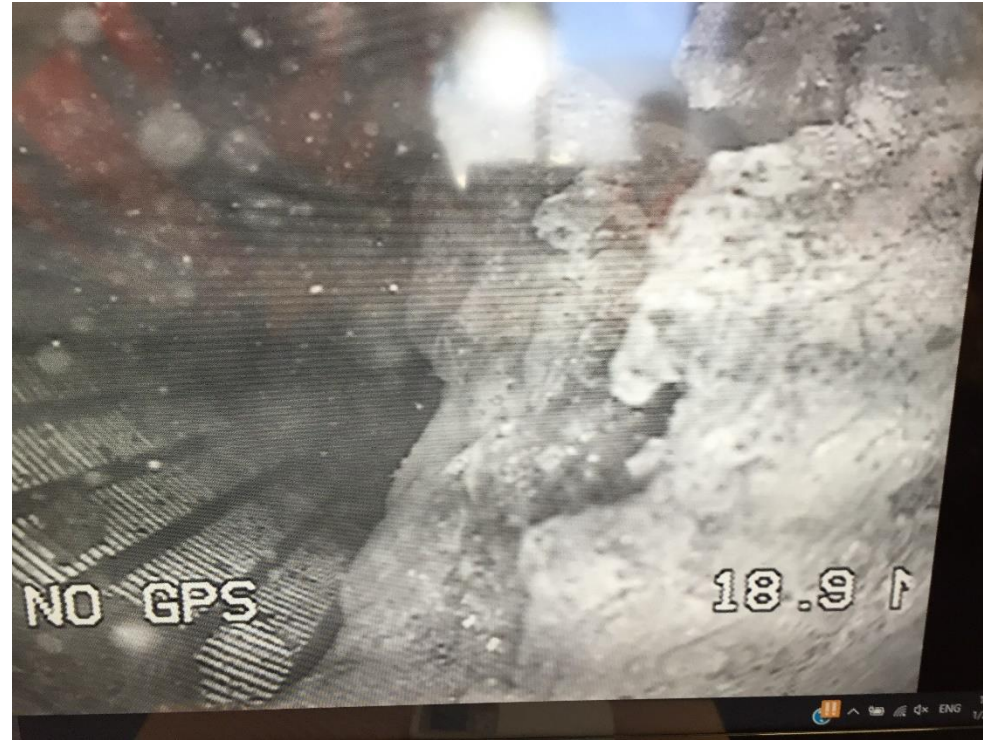
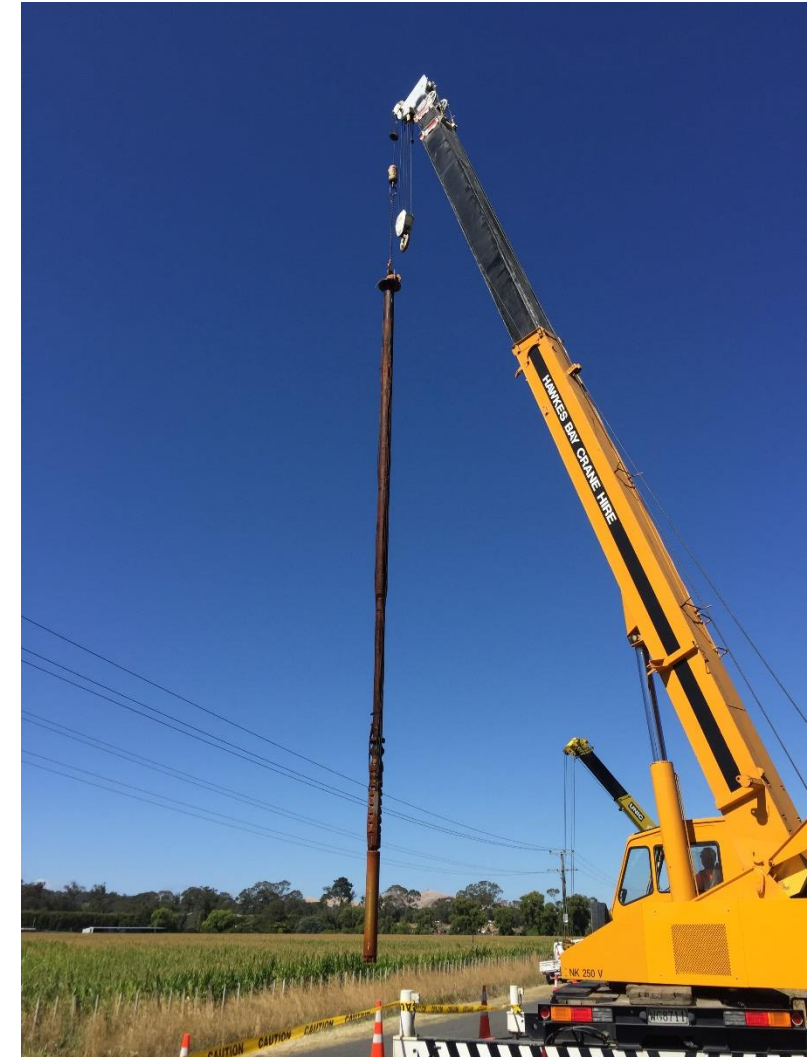
Bore / casing assessments

- Bore 1: 1982 – 2017 (35 years)
- Electrolysis nodulation – top of lower screen (nearby transformer)
- Condition of pump string and pump – reflective of 10 years (replacement).
