WHY REPLACE EXISTING PIPELINES WHEN THEY CAN BE REHABILITATED USING POLYETHYLENE PIPES AND FITTINGS

*Andrew Wedgner, Borouge Pte Abu Dhabi
Alan Shore, Borouge NZ Ltd, Auckland*

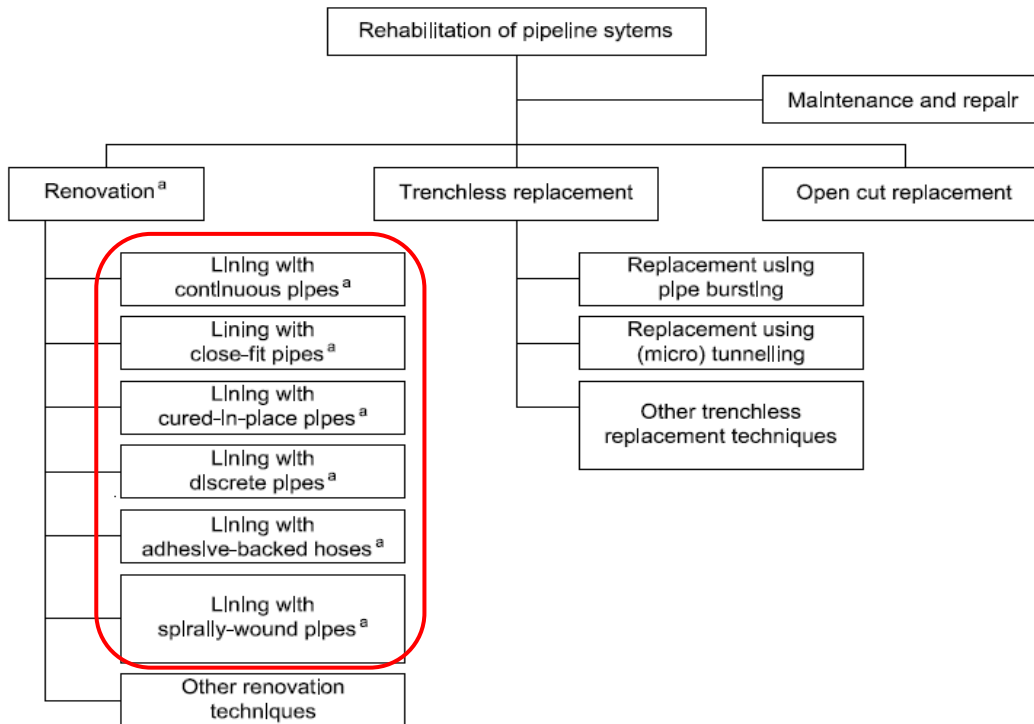
Figure 1. The highlighted box identifies the trenchless techniques that are covered in ISO 11295.

The different techniques are classified in families as shown in figure 1. The family is a group of renovation techniques that are considered to have common characteristics for standardisation purposes. For example, lining with close fit pipes includes pipes that are reduced in diameter by passing them through a die or rollers prior to insertion and pipes that are formed into a U or C shape.

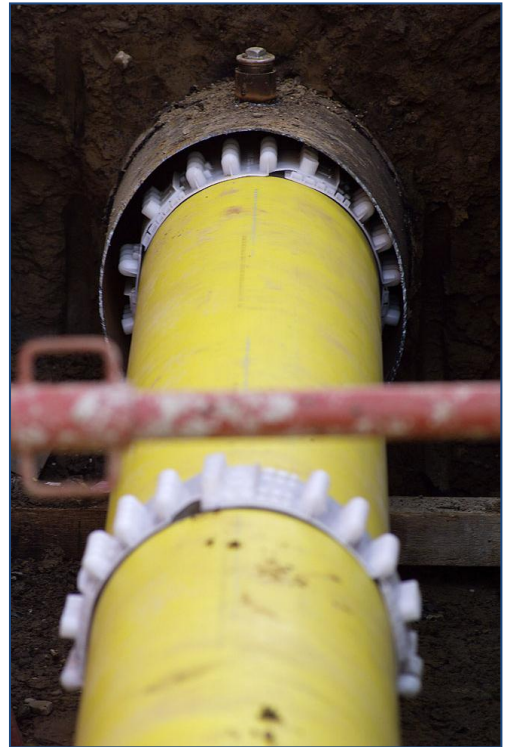
Figure 5. Plastic spacers centralise the PE80 liner in the gas main.

The 400mm SDR11 was produced in 6m lengths by Idrotherm 2000 s.r.l. On site the pipe lengths were butt welded and attached to a pulling head to enable them to be drawn through the 160m of steel main. Plastic spacers were used to centralize the PE pipe in the host main. The lining pipe was introduced through a 12m long launching pit but due to the flexibility of the MDPE pipe only two small, 4m long, receiving pits were required thereby reducing the disruption to a minimum. The project was completed in just four days convincing AEM that they indeed had a solution to their medium pressure mains renovation programme.

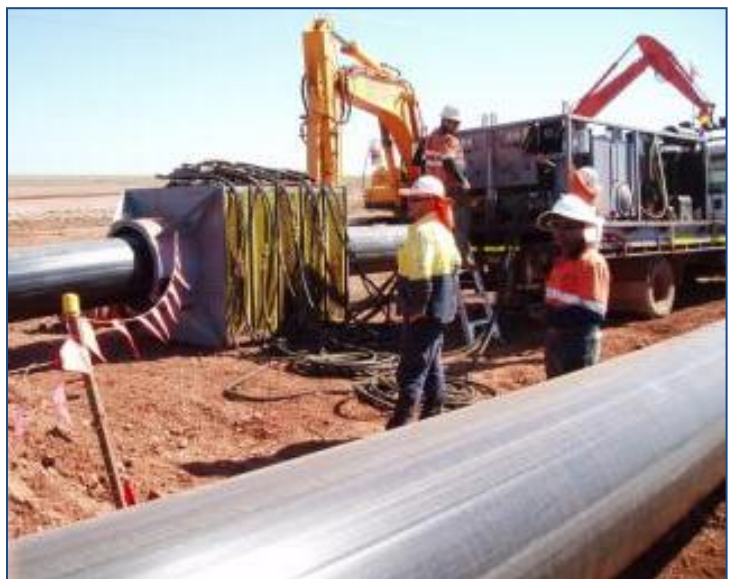
Figure 6. Reducing the diameter of the HSCR PE100 liner pipe prior to insertion.

The pipes were extruded by Kingston Bridge and delivered to site where they were butt welded together and then inserted into the steel pipes by United Pipelines of the USA using their “Tite Liner” technology. Before insertion the PE pipes are drawn through a hydraulically powered roller reduction box which reduces the outside diameter of the pipe as shown in figure 6. This smaller diameter PE pipe can then be easily pulled through the steel pipe and once in position the load is released so the pipe can recover and form a tight compression fit with the bore of the host pipe where it will protect this pipe from abrasion and corrosion.

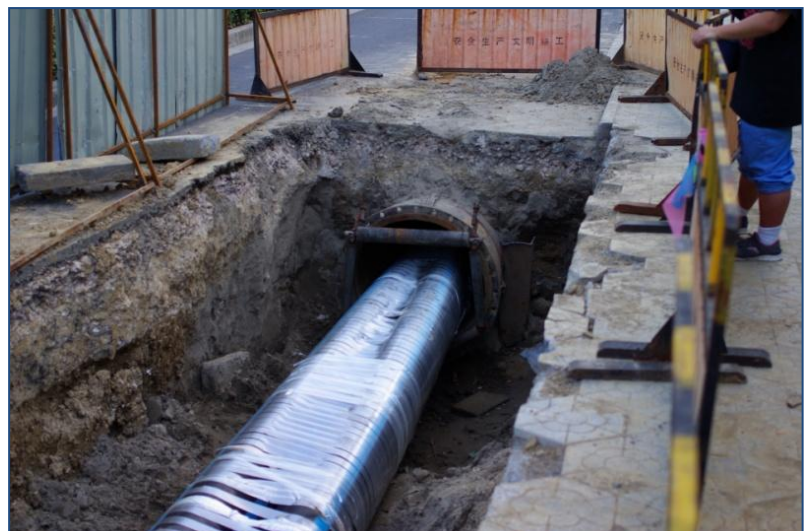
Figure 7. The pipe folded and strapped being inserted into the old leaking water main

For the project a non standard 983mm diameter pipe with a 15mm wall thickness was manufactured by Shanghai Chinaust using BorSafe HE3490-LS-H HSCR PE100 material from Borouge. On site the team from the Shanghai Water Special Engineering Co. butt welded the pipe sticks together and removed the external bead prior to passing the pipe through a folding machine that formed it into a “U” shaped section. Strapped in this form the effective diameter of the liner pipe is greatly reduced and it could be easily inserted into the bore of the old pipe. Once in position the PE100 pipe was pressurised to break the strapping and to form a close fit liner, which will eliminate leakage and prevent further contamination of the drinking water, thereby providing the water company with a very cost effective solution to their problem.

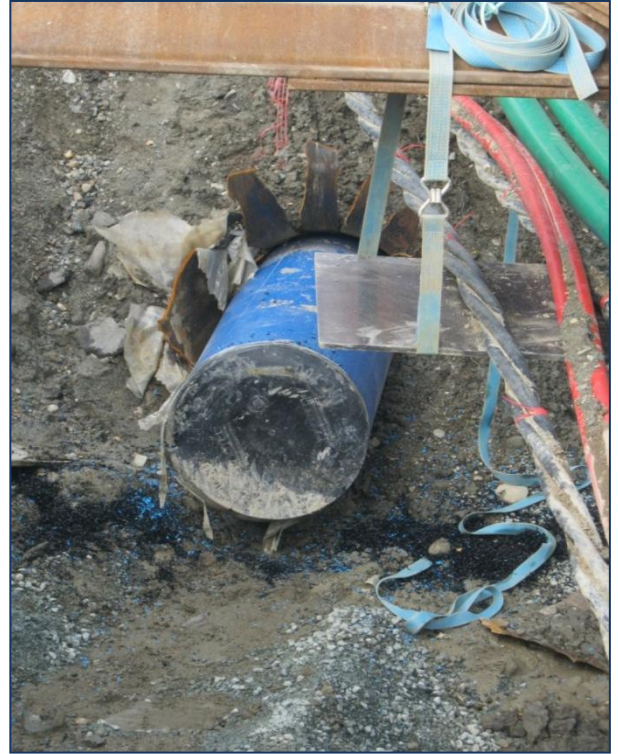
Figure 8. The new main installed after the pulling head had been removed.

Local specialist contractor Sandum carried out the installation. The 18m pipe lengths from the factory were butt welded into 150m pipe strings, which were coupled to the pulling head behind the hydraulic bursting head. The bursting head was pulled through the old main at around 50cm/min, which meant each 150m pipe string was installed in around 3 hours. Once in place the pulling head could be cut off and the end of the pipe cleaned up and joined to the adjacent section using electrofusion couplers.
