DESIGN FOR EARTHQUAKE INDUCED MOVEMENT ON LIFELINES – THE FERRYMEAD BRIDGE EXPERIENCE

John Black, Technical Principal – Pipeline Materials, Opus international Consultants Ltd, Christchurch, NZ

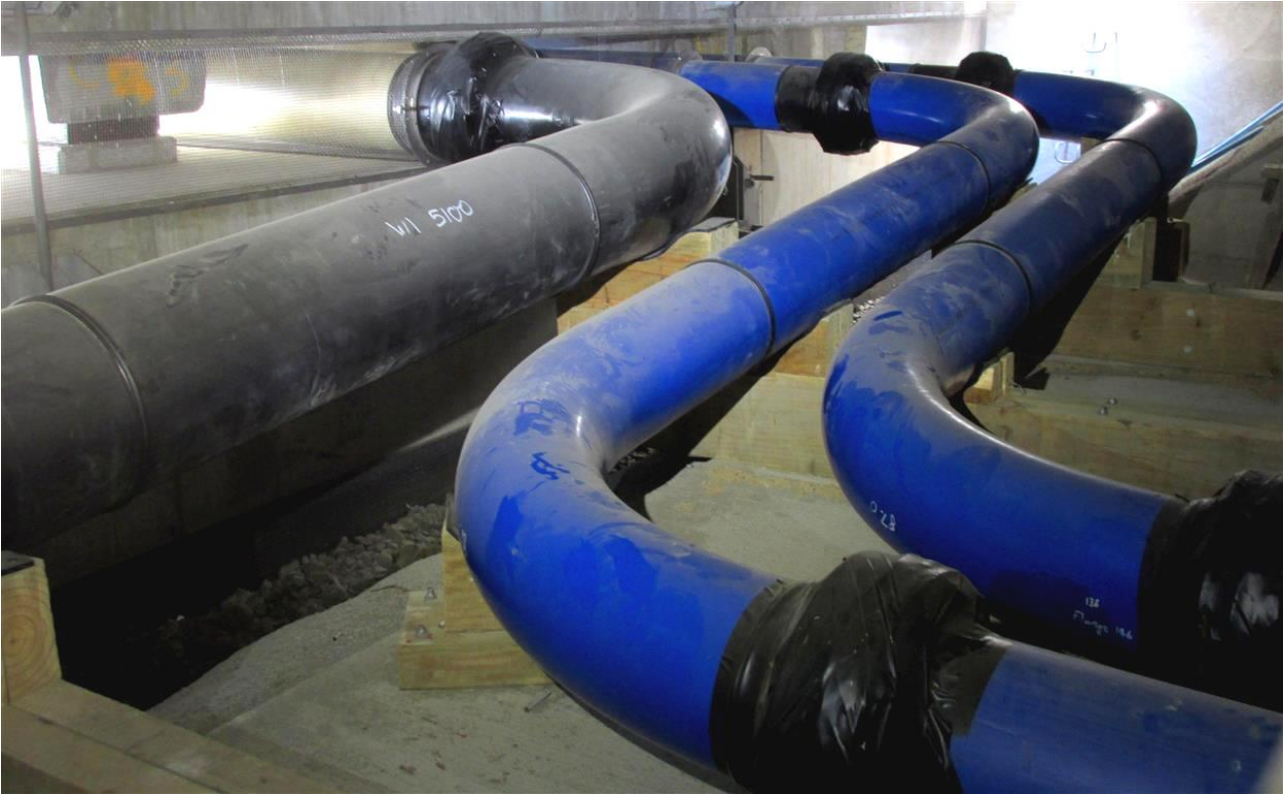
Photograph 1 shows the “cranks” as installed in the cavity beneath the land-span on the City side of the bridge. The crank cavity was made bird-proof by using stainless steel mesh between the pipe cap and the bridge deck (see Photograph 2) which also made it difficult for vandals or homeless people to frequent the area and potentially cause damage to the PE pipes or air valves. The only access to the two cavities is through a cast iron manhole cover, one on each side of the bridge. Entry into these cavities requires a manhole lifter and a ladder.

Photograph 1: View of the installed "cranked" specials on the City side of the river. The DN 450 sewage pressure main crank has been extruded from black PN 16 PE 100 resin.

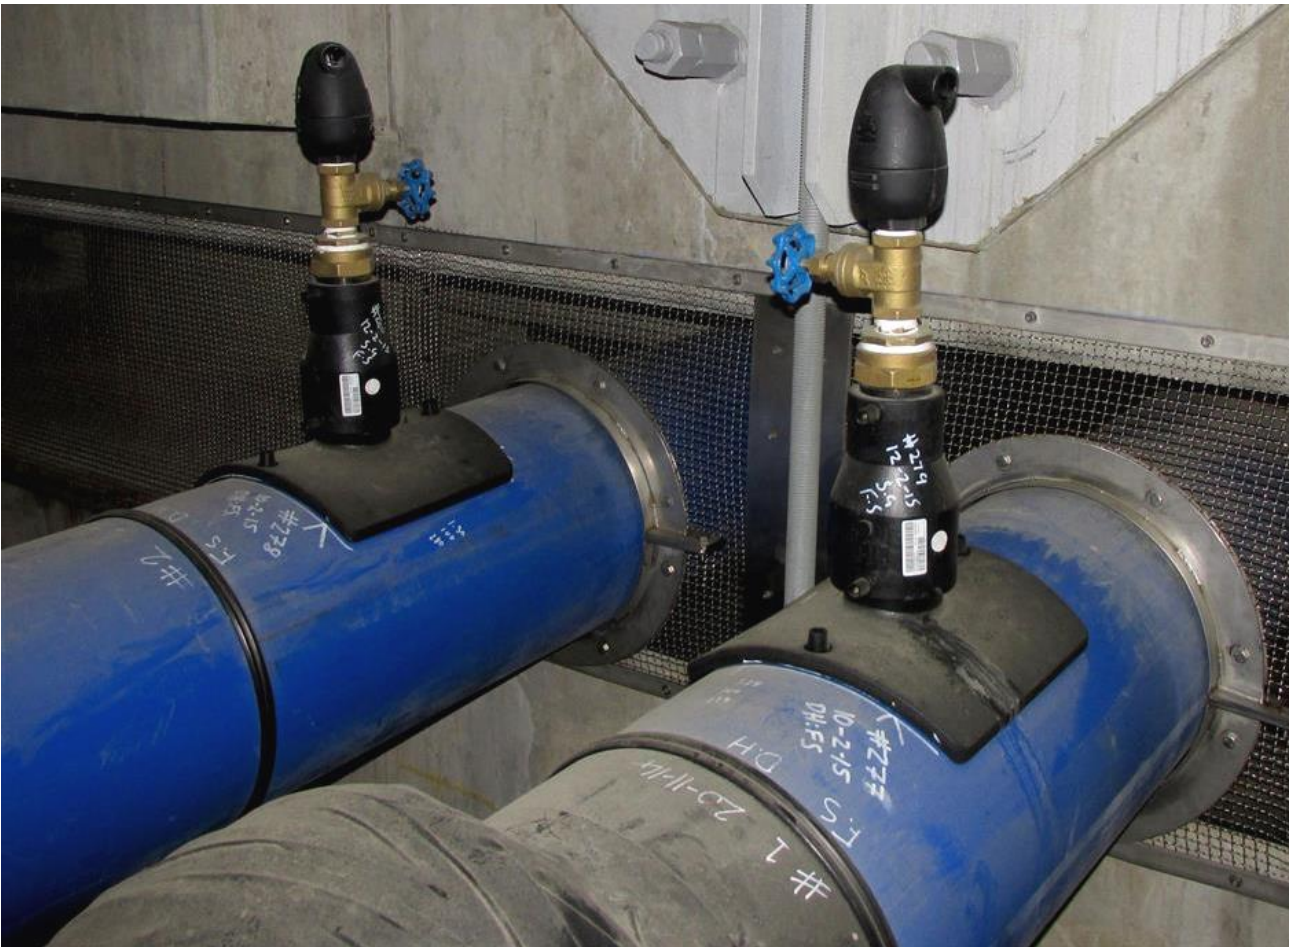
Photograph 2 shows part of the two DN 355 water main cranks, the air valves and the stainless steel mesh (bird and vandal proofing) on the Sumner (eastern) side of the bridge.

Photograph 2: View of the air valves on the DN 355 water mains on the Sumner side of the river. The stainless steel mesh prevents unauthorized access to the cavity area.

Two EF saddle fittings were needed for the air valves on the water mains, see Photograph 2. While these types of fittings also present a significant risk of failure, it was decided that provided a test saddle weld showed acceptable ductility and the welding procedure for the two saddles in Photograph 2 was observed to verify the preparation work (the effectiveness and depth of scraping to remove the oxidized layer) and the fusion process, any risk of failure would be low and would be acceptable. Also, there was assess for repairs and the second water main provided an alternative supply.
