ALTERNATIVE APPROACHES TO ASSESSING ASBESTOS CEMENT PIPE & CRITICAL ASSETS INSITU

ABSTRACT

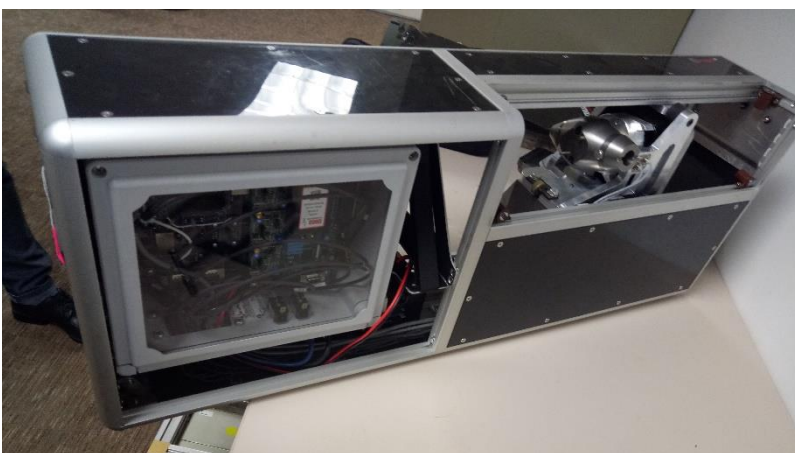
Figure 1, The back scatter CT scanner developed by Inversa, Canada.

The samples were stored in thick plastic asbestos safety bags that ensured the samples were safe to handle. All samples were stored in additional rigid plastic sample containers to prevent any objects penetrating the bag during transportation. The samples were then placed into a medical CT scanner and scanned at a resolution of 200 microns. In comparison, a back scatter CT scanner developed by Inversa, Canada, was used to analyse the same asbestos cement sample. The sample was shipped to the Inversa trial facility and scanned within their laboratory using their back scatter CT scanner. As seen by comparing Figure 1 and Figure 2 the size of the back scatter CT scanner is significantly smaller than the medical CT scanner, this provides it the ability to be used within the field.

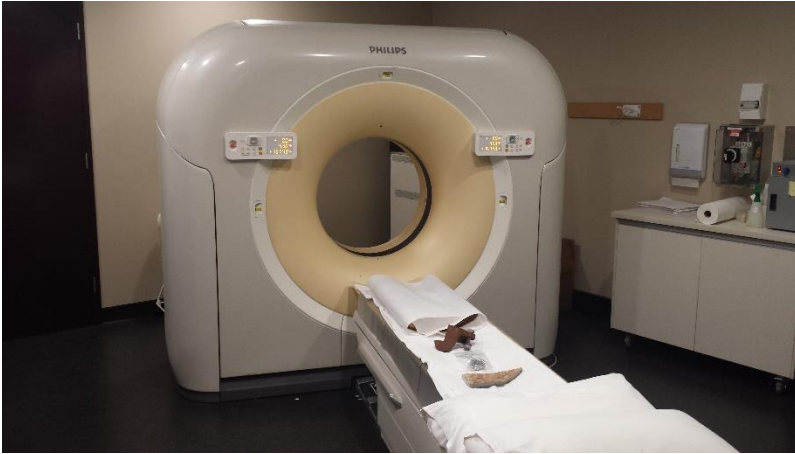
Figure 2. The CT scanner used to analyse the asbestos cement pipeline.

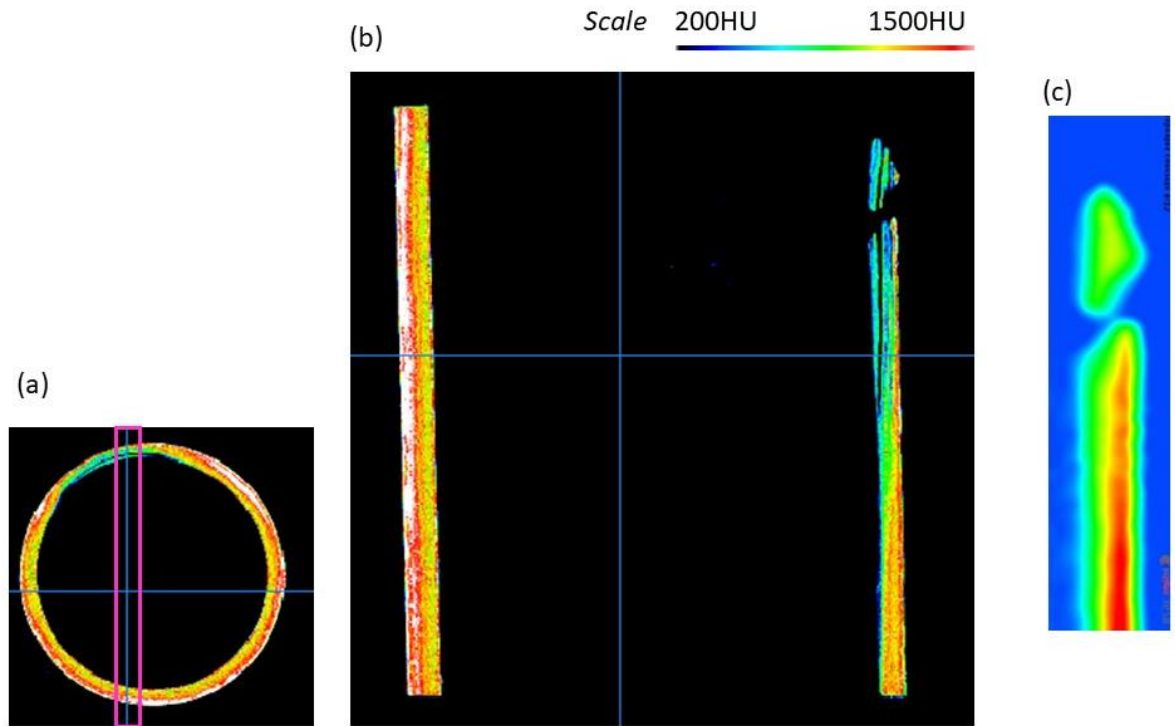
Figure 3, (a) represents the slice from where a comparison between a medical CT scanner and the back scatter CT scanner will be compared. (b) the medical CT scanners image of the AC pipe. (c) the back scatter CT scanners image of the left side of the pipe.

The objective of this investigation was to observe how effective the use of innovative technologies such as back scatter CT scanning can be to assess AC pipeline within the field. The variation in the density observed in Figure 3 is due to the presence of sulphur within the sewer pipe that has caused the AC pipe to leech calcium out of the cement matrix (Matti and Al-Adeeb, 1985). Once the calcium leaches out it only leave the cement matrix behind, therefore the density of the material is reduced and in turn the strength is reduced (Matti and Al-Adeeb, 1985, Wang et al., 2011a, Wang et al., 2011b). A distribution of the density is shown in figure 5, 1500HU represent pipe that has undergone little to no degradation and still has a high amount of calcium present in the cement matrix, while a majority of the pipe is found to be ~1000HU which has leached calcium and reduced in density, this indicates that a majority of the pipeline has leached the calcium from the cement matrix. Therefore, the pipeline was highly susceptible to a burst which could have been caused by a number of factors.

It was observed that the back scatter CT scanner is an effective tool for assessing AC pipeline. Figure 3 displays a comparison between the two technologies (medical CT scanner and back scatter CT) on the same AC pipeline. The degradation of the AC pipe is similar in each image indicating that the back scatter CT scanner can produce the same results obtained from a medical CT scanner. The crown of the pipe suffered from sulphur attack, as well the bottom of the pipeline appeared to have a much lower density due to potential loss of calcium, this is commonly observed in other sewer pipelines where acidic sediment is found (Wang et al., 2011a, Hu and Hubble, 2007, Matti and Al-Adeeb, 1985). The wall thickness was originally 16mm though in the burst location it is completely gone, other areas on the crown where it is still intact clearly show a low density (~1000HU) due to high degradation.

The medical CT scanner was observed to have a higher resolution and more detailed result when compared to the back scatter CT scanner, the resolution achieved by the medical CT scanner was 200 microns. The resolution of the back scatter CT scanner was lower in comparison to the medical CT scanner, though it clearly showed the remaining effective wall thickness of the AC pipeline. Therefore we can suggest that the resolution of a back scatter CT scanner is sufficient to determine the remaining wall of an AC pipeline.

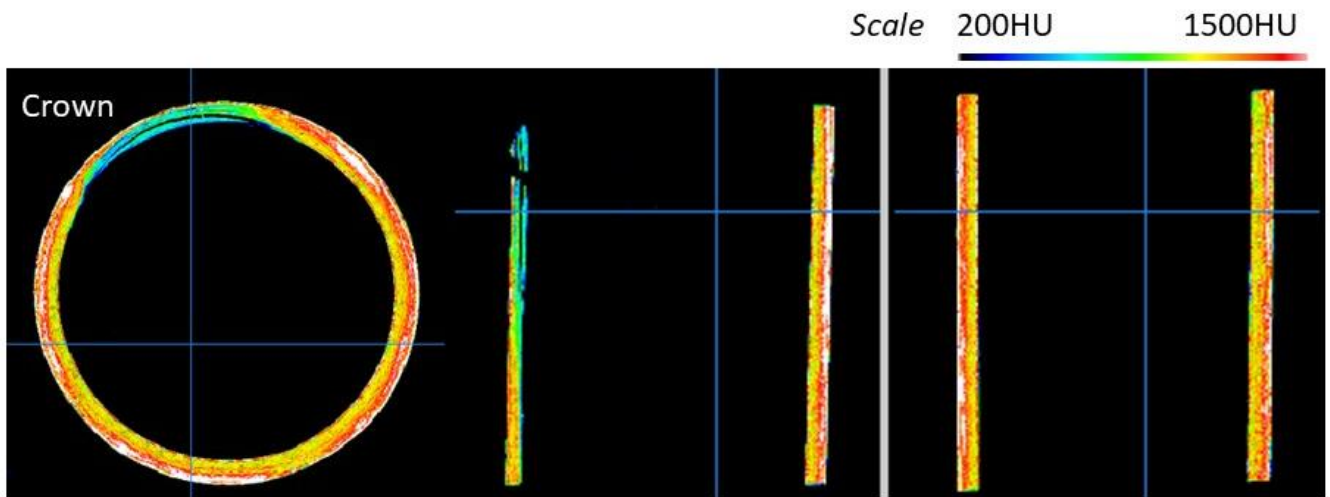
Figure 4, CT data the AC 200mm sewer pipe.
