STREET-SCALE BIORETENTION – PRACTICAL LESSONS LEARNT FROM APPLICATIONS IN CHRISTCHURCH

P. Christensen (CTN Consulting Ltd), Christchurch, New Zealand

M. Stone (Aurecon NZ Ltd), Christchurch, New Zealand

P. Wehrmann (Christchurch City Council), Christchurch, New Zealand

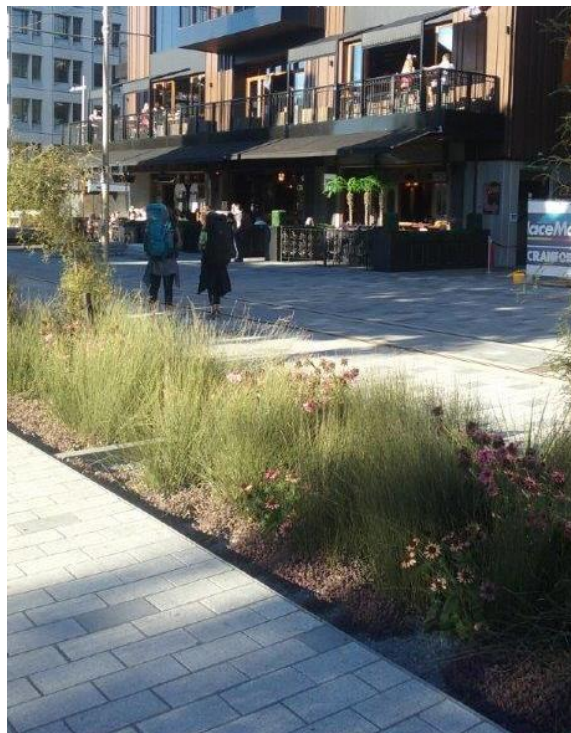
Figure 1: Avon River Precinct (Oxford Terrace, Christchurch)

The Avon River Precinct (Figure 1) was one of the first projects to be completed with bioretention devices included. Located in a high traffic pedestrian mall environment, they were found to be less expensive than the surrounding pavement. They provide a linear strip of greenery while also providing treatment to the surrounding hardstand.

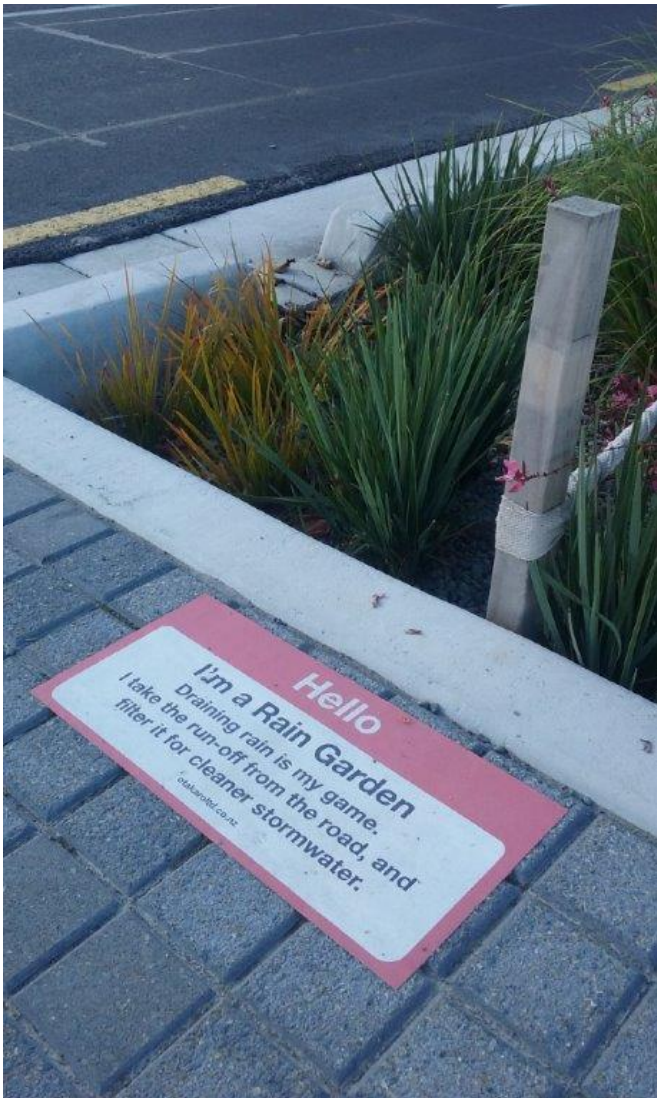
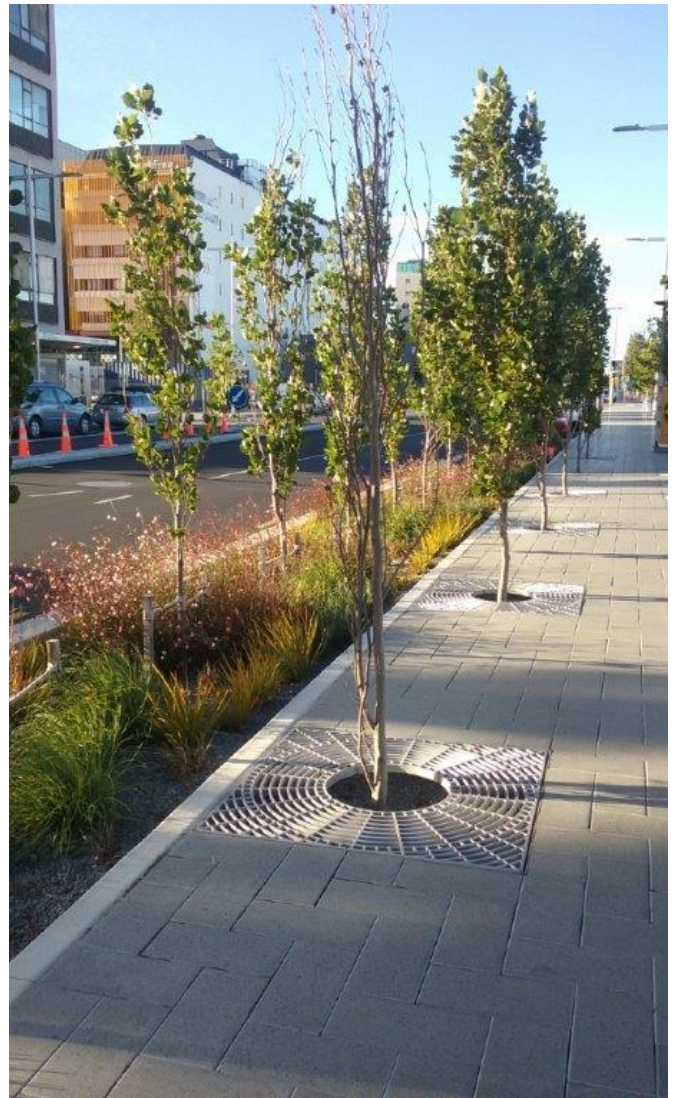
Figure 5: Rain garden installed as part of cycle route development, Christchurch

The CCC Major Cycle Routes (MCR) programme will construct thirteen new cycleways in Christchurch to offer safe and direct routes around the city. A number of these projects will comprise new street-scale bioretention devices (Figure 5) to treat stormwater runoff.

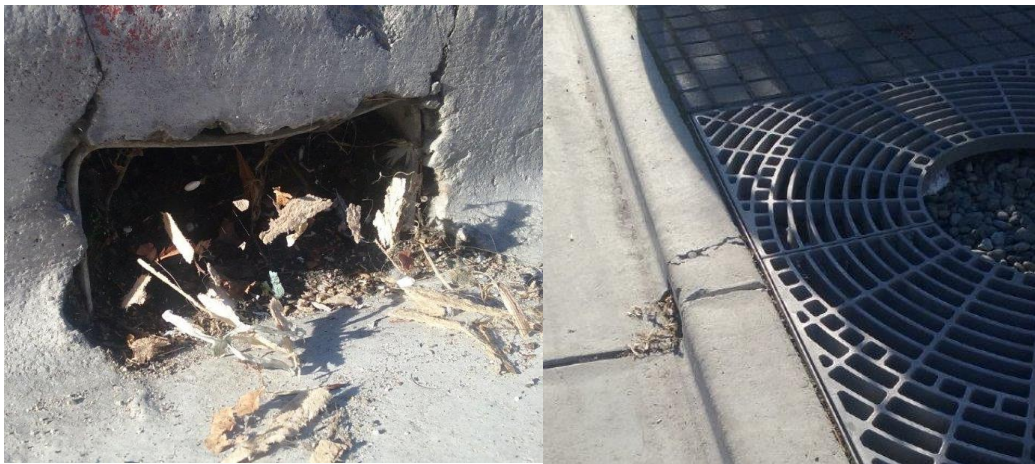
Figure 6: Kerb inlets - blocked (left) and cracked (right)

In some instances, rather than cutting down the kerb locally, small openings were installed into the kerb. These have been noticed to be performing poorly and are mostly blocked after street sweeping (Figure 6, left). These inlet types are also sometimes constructed above the kerb invert level which results in low-flows bypassing the device. The thin section of concrete above these kerb inlets is typically cracked (Figure 4, right) and will require more frequent repair than a kerb opening. It is considered that wherever possible this type of inlet should be avoided. An alternative to this arrangement would be a combined tree grate and wide kerb inlet, although this is more costly and requires buy in from landscape designers.

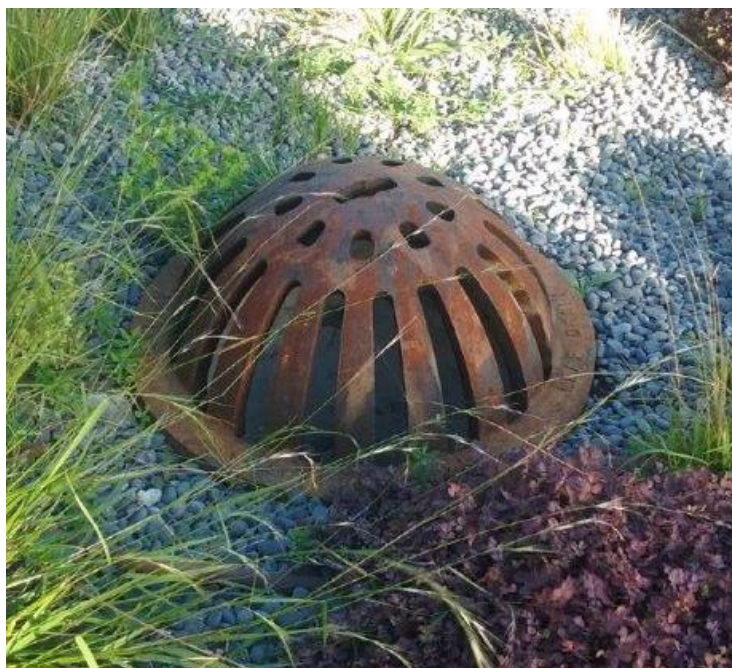
Figure 7: Dome sump inlet

Cast iron dome sump inlets and outlets have been incorporated in to a number of devices, particularly where the flows bubble up into the device. These have been found to be less prone to blockage than a standard flat sump inlet or a 'scruffy' dome, while also blending in to the planting more easily (Figure 7). 'Scruffy' domes also tend to let more litter pass through the system, and as most are galvanised also introduce additional zinc into the system. It is considered that this type of sump should be used for inlets and outlets to bioretention devices in the city, although appropriate locking mechanisms still need to be refined.

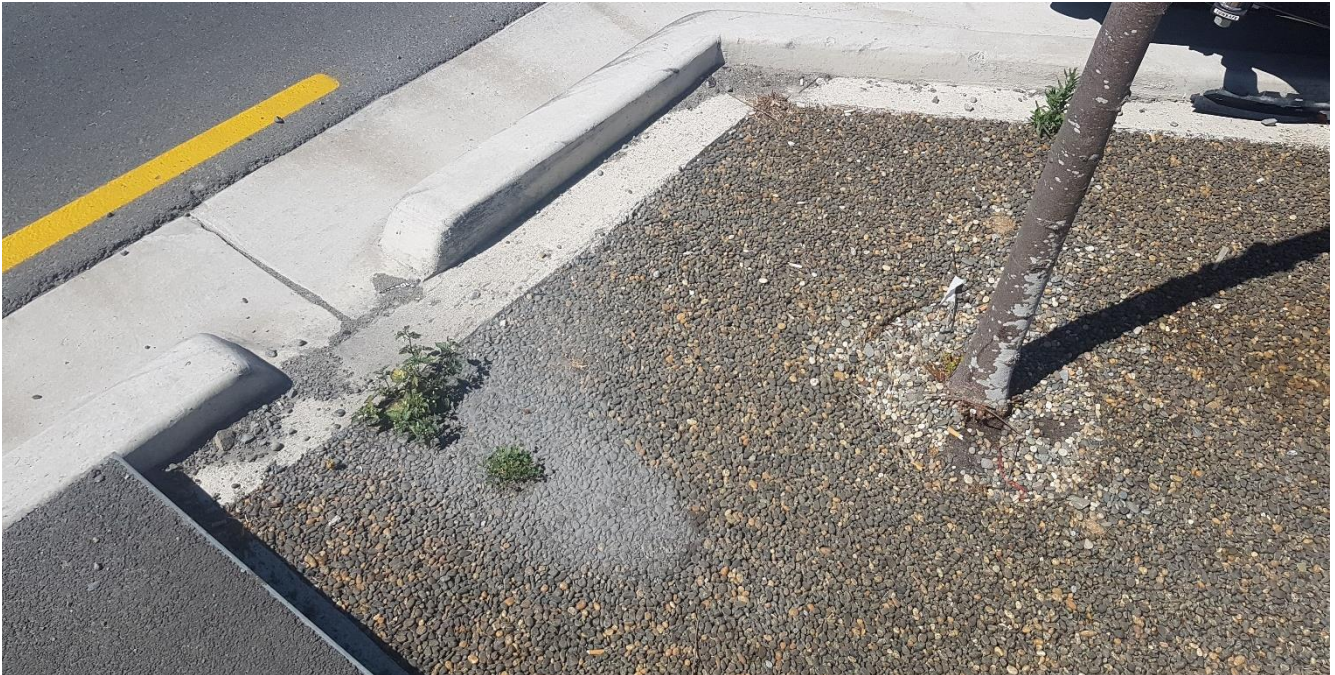
Figure 8: Clogged resin bound aggregate

Resin bound aggregates were specified in some tree pits in reaction to maintenance concerns regarding ongoing weeding of planted areas. Resin bound aggregate was considered to provide a solution to this, although it was not favoured by the design engineers due to concerns over clogging. These concerns have been proved valid, with early clogging of the aggregated seen (Figure 8). It is considered that a mulch with planting will offer better long-term performance at a lower installation cost, and remove the need for specialised equipment to clean these areas.

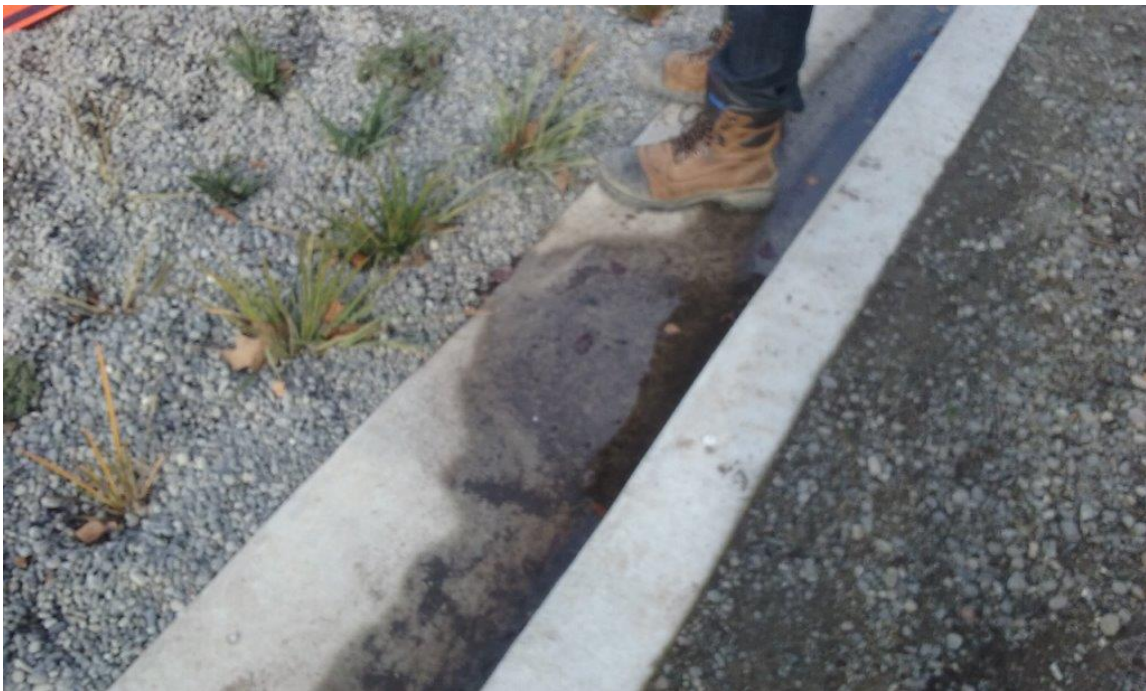
Figure 9: Poorly performing kerb inlet with noticeable ponding

Kerb openings are typically performing well. However, sometimes the cross fall of these are being constructed a bit flat, resulting in some sedimentation. Crossfalls should be greater than typical fender crossfall, but this requires close supervision during construction as it is not a familiar detail to construct. In Figure 9 it can be seen that when inlets in kerb fenders are not constructed to the required crossfall this can result in water not being able to easily enter the device.

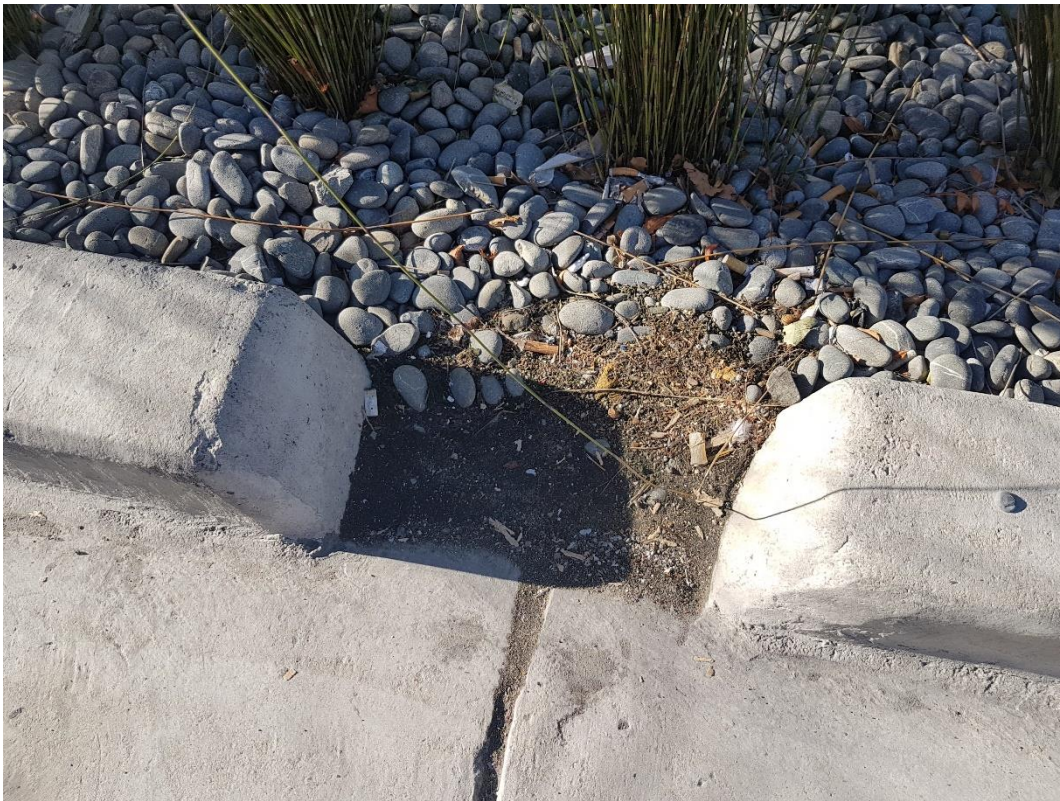
Figure 10: Mulch placed at or above the inlet level

Firstly, mulch has been observed being placed at or above the inlet level (Figure 10). This prevents water entering the devices, reduces the volume treated and traps sediment at the inlet causing water to bypass more frequently. This can be easily avoided through close supervision during construction. Ideally prior to mulch placement the height of the media will be checked to ensure there is sufficient depth allowed for the mulch.

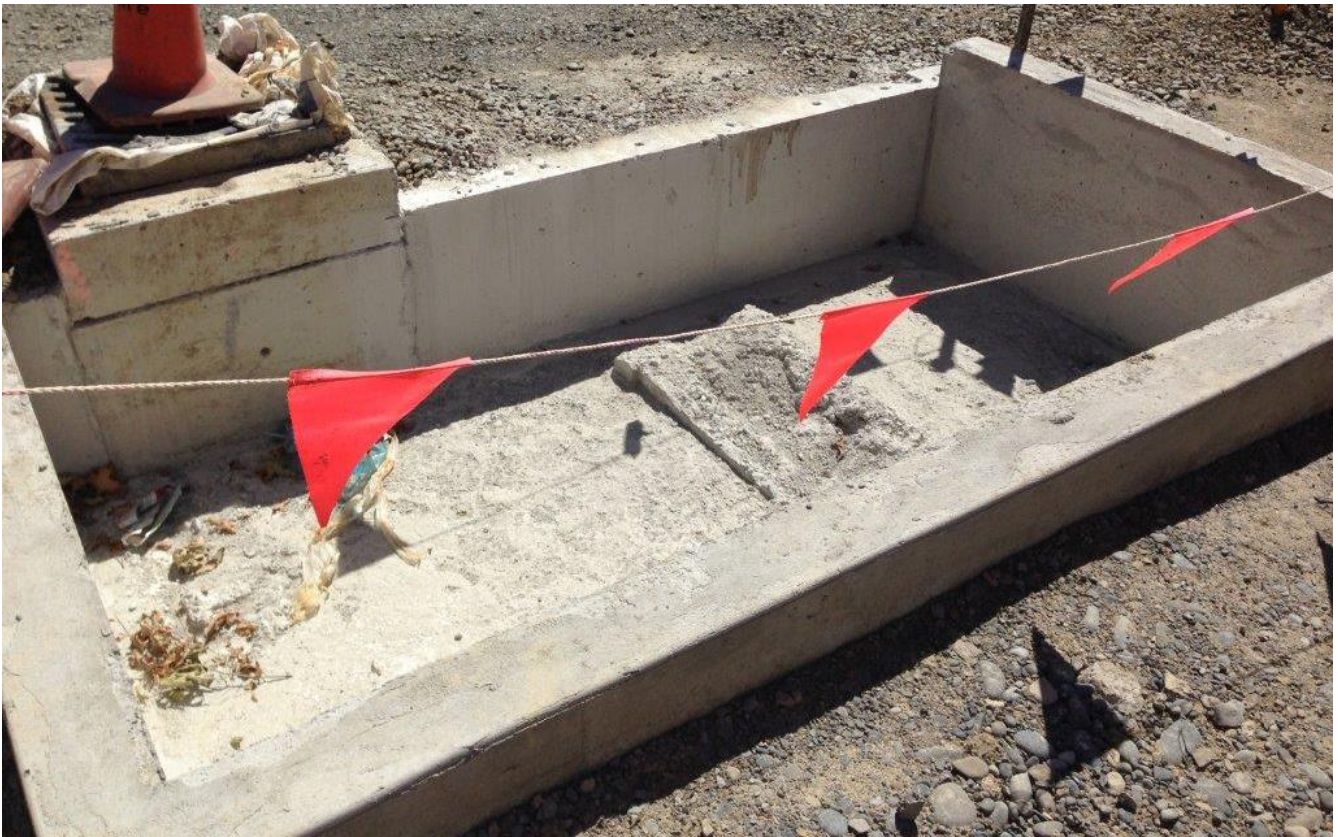
Figure 11: Concrete disposed of in base of rain garden

Where this is not conveyed this can lead to issues. An example of this is where the contractor did not understand that the device being constructed needed to infiltrate to ground. The contractor used it for a location to dispose of excess concrete (Figure 11) and this had to be removed. Issues like this require close supervision during construction to avoid, and an understanding by all parties of the intended function of the device.

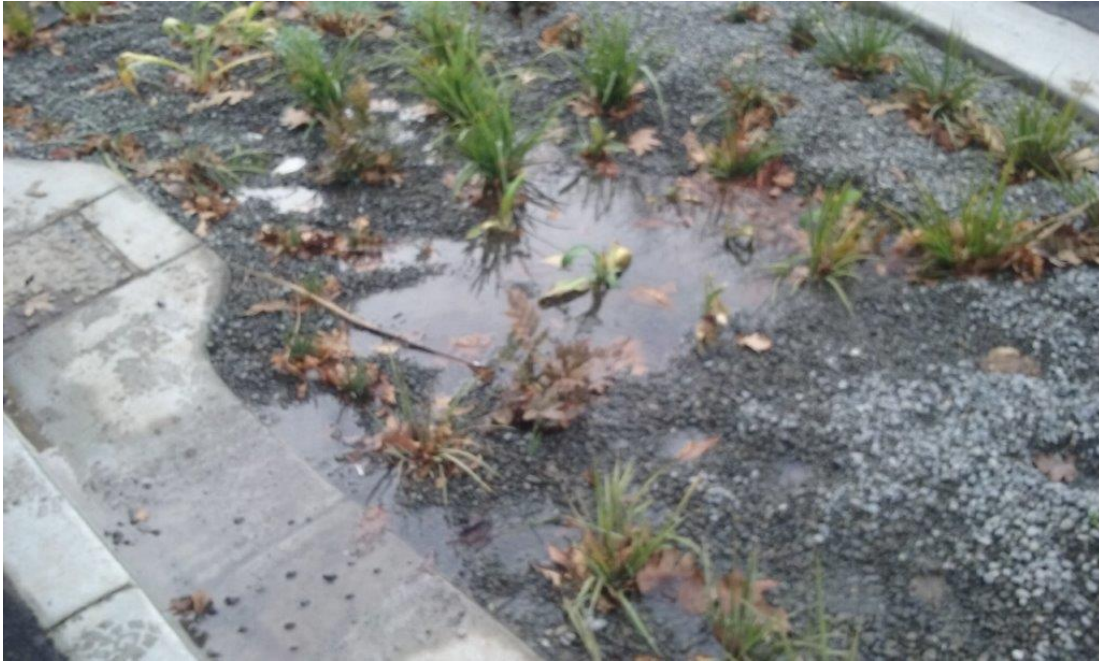
Figure 12: Depressions within a rain garden surface

The surface of bioretention devices are required to have a flat (zero) grade to ensure that all areas are inundated by stormwater runoff. However, many instances have been observed where this is not occurring. An example of this is shown in Figure 12, although this was able to be rectified during construction.

Even compaction over the entire device is an important way of avoiding this, as is letting the media to settle for a while. An infiltration test provides an opportunity to wet the media and allow it to settle. The media can then be topped up and levelled prior to planting and adding the mulch. This avoids costly remediation once plants are established and mulch applied.

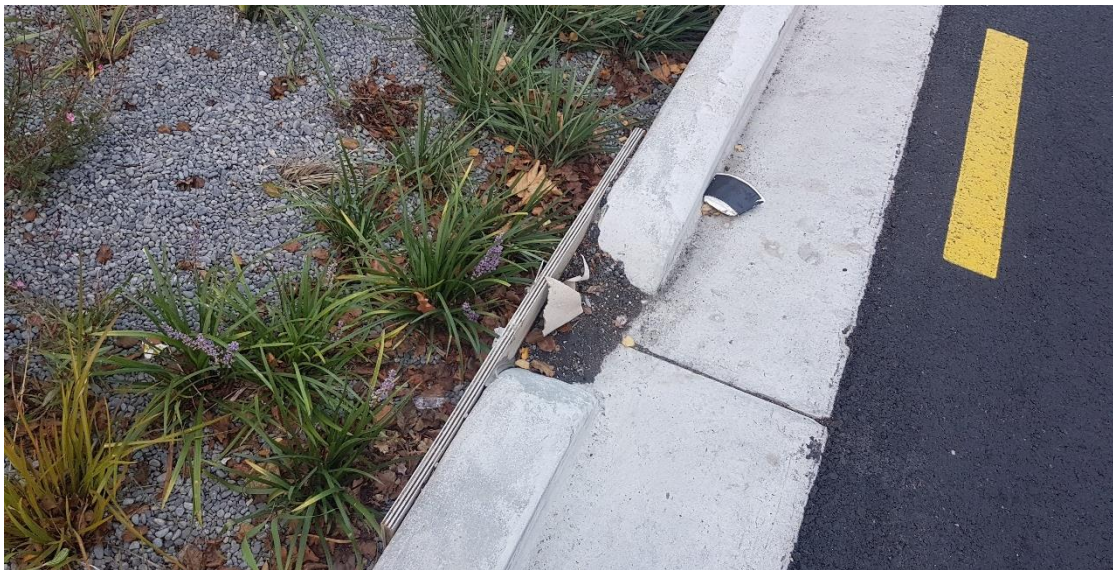
Figure 14: Temporary barrier to prevent construction sediment entering new rain garden

Sediment laden stormwater runoff must be prevented from entering bioretention devices during construction until surrounding surfaces have been fully stabilised. There have been some devices clog up with sediment during construction when proper erosion and sediment control requirements were not followed. Bioretention devices are typically constructed and sometimes have media installed prior to stabilising the adjacent carriageway and footpath surfaces. This requires inlets to the devices to be blocked during the construction phase (Figure 14), and a procedure in place to remove these when contributing surfaces are stabilised. This needs to be covered in project specifications and closely managed during construction.

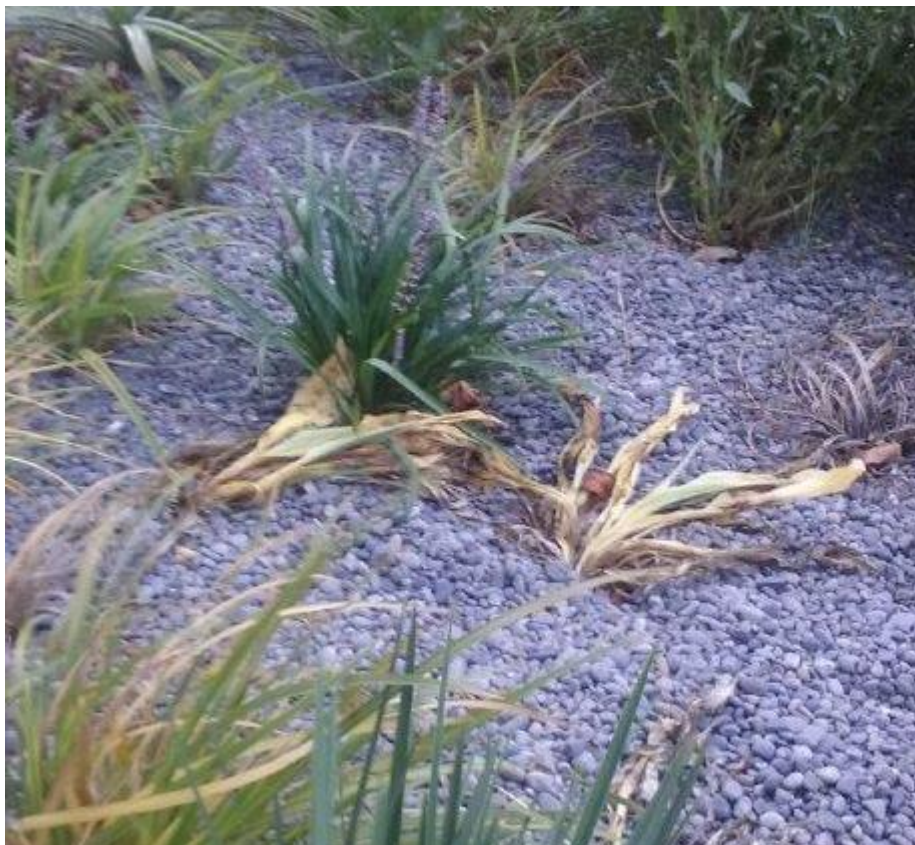
Figure 15: Plant stress observed in an area with thick mulch

The depth of mulch has an influence on weed growth and plant growth. It has been observed in Christchurch that devices with approximately 50 mm thick mulch typically have less weeds and less stressed plants. A shallower mulch thickness than this increases weed issues. Thick mulch is also believed to be a contributor to stressed plants (Figure 15).

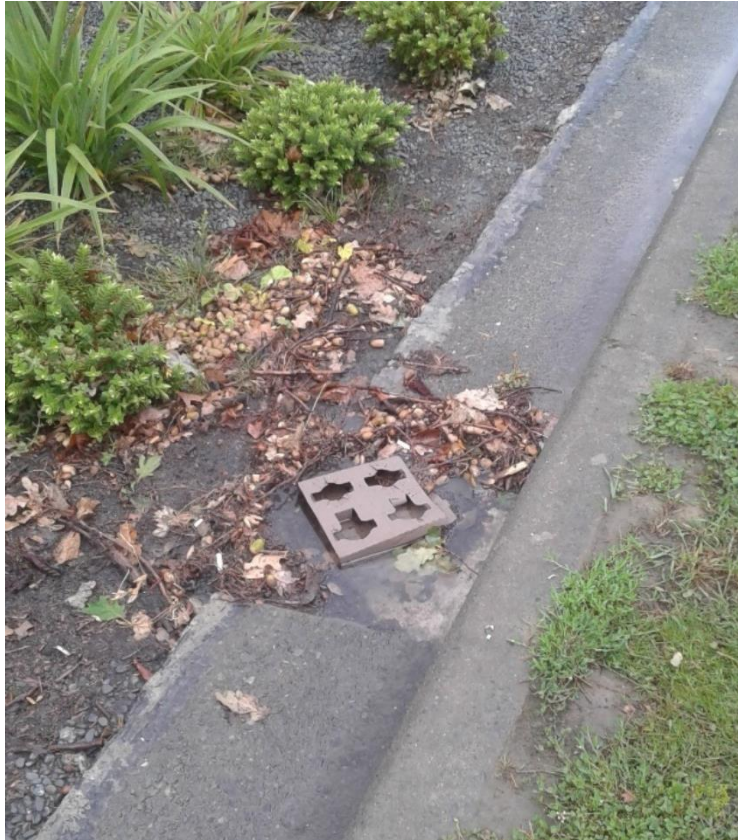
Figure 16: Litter partially blocking an inlet

Any stormwater treatment device will trap litter. In a bioretention device, as the inlets are often relatively small, when litter is trapped then it can block the inlet (Figure 16). This can be prevented by ensuring the inlet area is lower than the surrounding device surface, increasing the number of inlets, and removing litter frequently. If litter is left to accumulate too much then there is the potential for bioretention devices to look like large ashtrays with the associated negative perception and likely lower uptake of these devices. Therefore it is important that appropriate maintenance allowance is made when proposing to install bioretention devices.

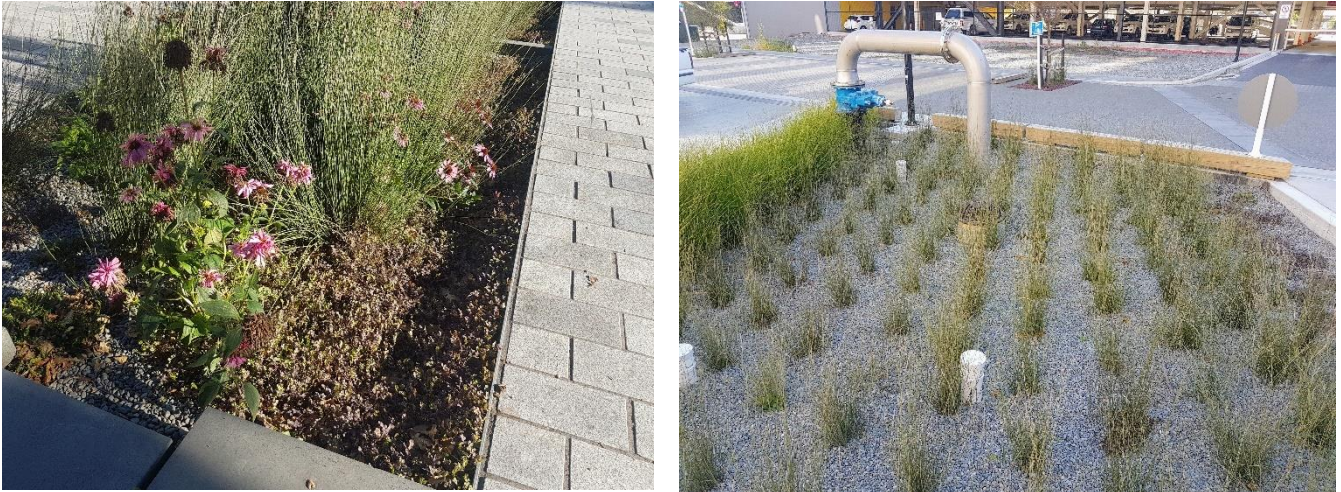
Figure 17: Biodiverse rain garden (left) compared to a monoculture rain garden (right)

It is also noted that many devices are also being planted with a single species, *Oi Oi*, as this plant is well suited to rain gardens (Figure 17, right). However, this species takes some time to thicken up and spread throughout the device. During this time the device may be more susceptible to weed growth and litter is more visible requiring more frequent maintenance. Where rain gardens are planted with a variety of species (Figure 17, left), these may result in quicker coverage and helps to ensure that if one species fails then another species more suited to the conditions may grow instead.
