PERFORMANCE OF NEW STORMWATER SYSTEM AT FONTERRA TIRAU

*M. Peacey, J. Barlow (Fonterra)
C. Moore (Beca)*

2018 Stormwater Conference

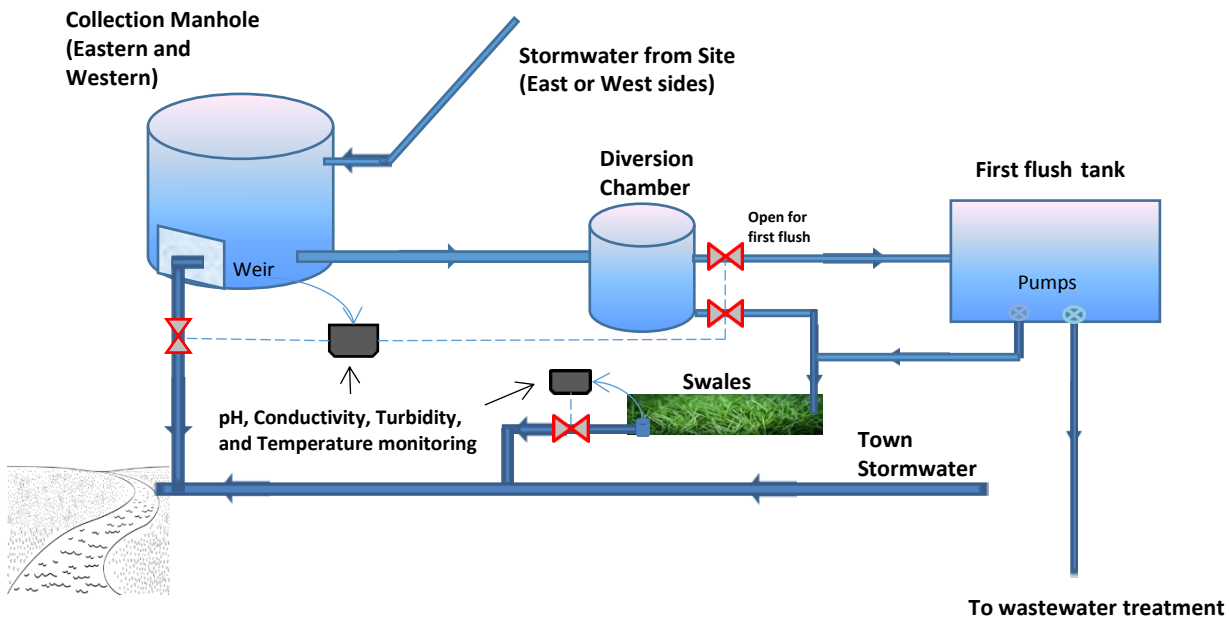
Figure 1: Overview of stormwater treatment system at Fonterra Tirau

As shown in figure 1, the new system collects stormwater from the eastern and western catchments with a combined area of 4.3 ha. Manholes at the collection point for each catchment are fitted with weirs, isolation valves, and quality monitoring, and have overflow paths directly to the stream discharge for high intensity rainfall

From the manholes both catchments flow to a diversion chamber. The first-flush volume (first 10mm of rainfall) is automatically drained to a 350 m³ first-flush tank, as well as any non-compliant flows including contaminated cooling water detected at other times.

Water from the diversion chamber below the divert limits is directed to two 65m long swales planted with *Apodasmia similis* (oioi), with the treated water at the end of the swale discharging to the Oraka stream. A monitoring station with an isolation valve at the swale outlet can be used to prevent any contaminated water exiting the swale or for containment of large spills.

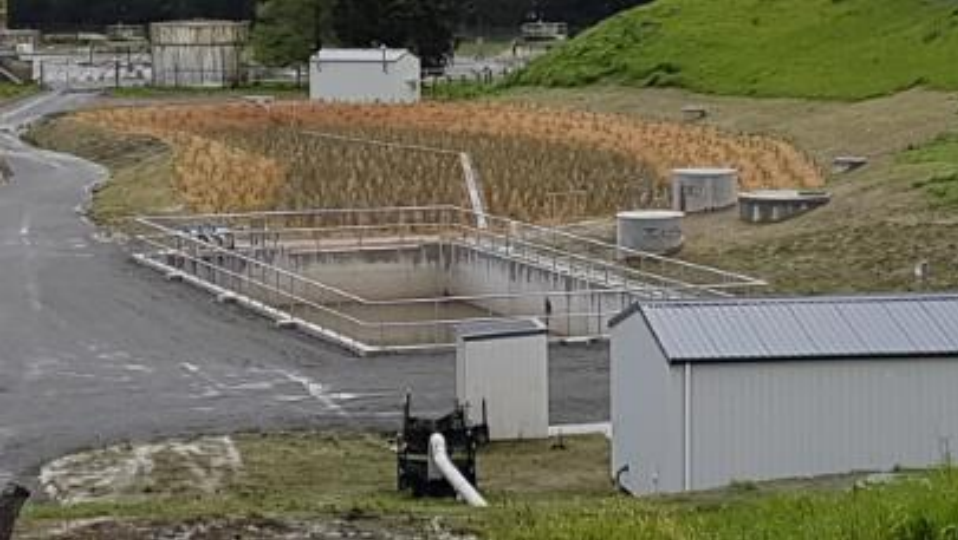
Figure 2: Overall view of first flush tank (centre) with swales (top) and monitoring sheds (bottom right, and top).

The first flush tank is of concrete construction set below the ground surface as shown in figure 2. The overall capacity is 350 m³ with 45 m³ of dead storage to avoid resuspension of sediments. The 10 mm first flush volume of 266 m³ (corresponding to 80% level in the tank, with 300 mm freeboard) is automatically sent to the first flush tank from the diversion chamber, and further water bypasses the first flush tank directly to the swale.

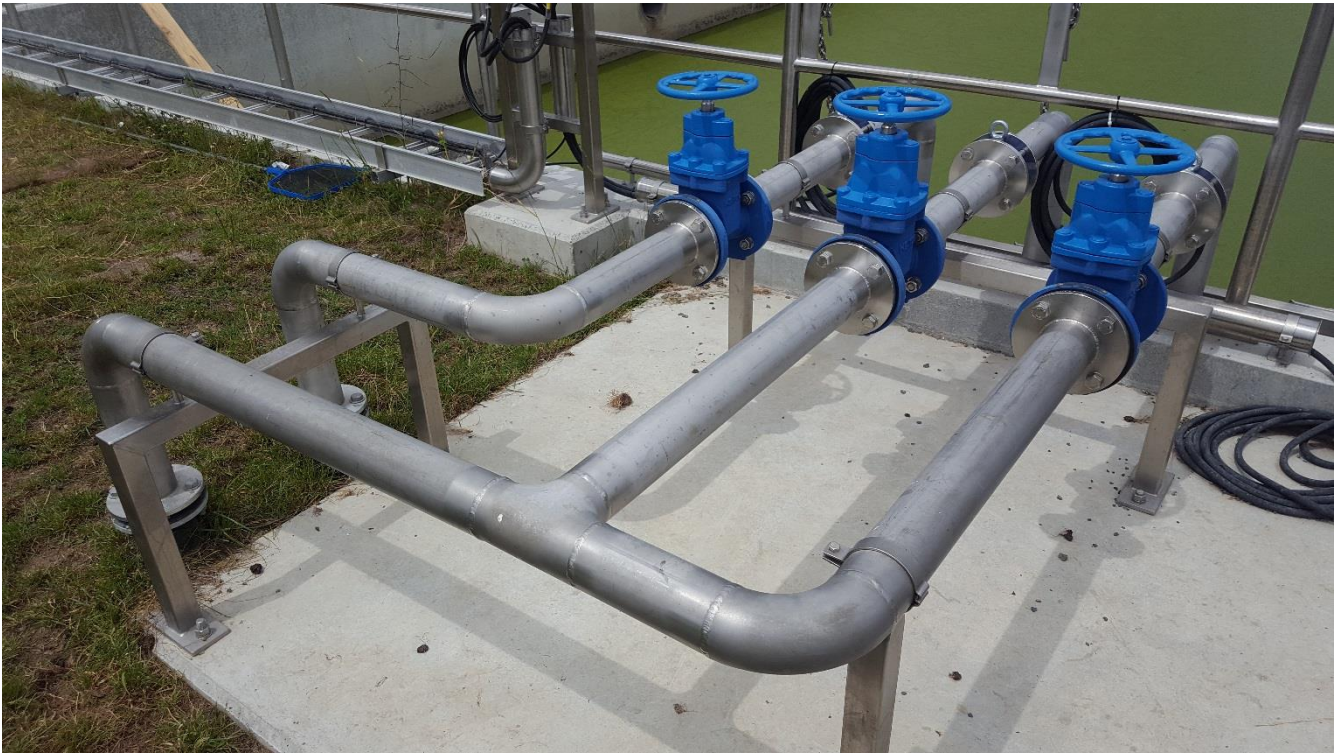
Figure 3: Pump station from first flush tank for transfer to wastewater or swales.

A pump station at the northern end of the tank (figure 3) automatically transfers water via two pumps at 2 - 4 ls⁻¹ to the WWTP, which if the first flush tank is full, takes 21 - 42 hours to empty. The low flow rate is designed to minimise hydraulic loading to the WWTP during wet weather, especially during production when volumes are high.

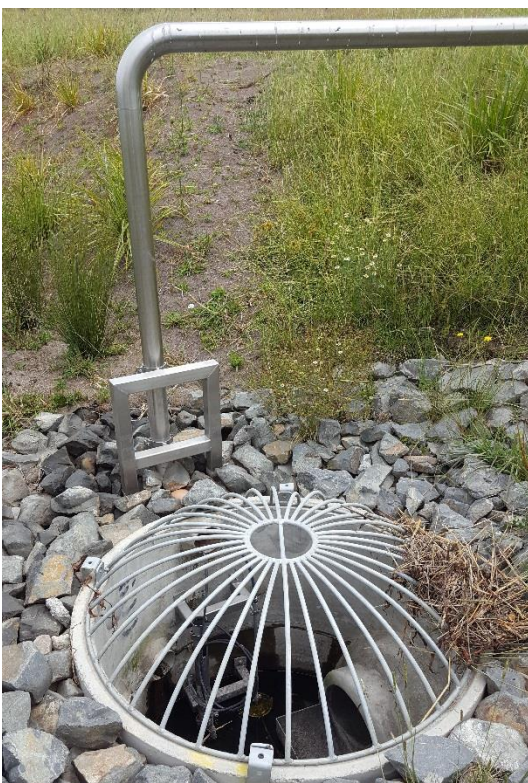
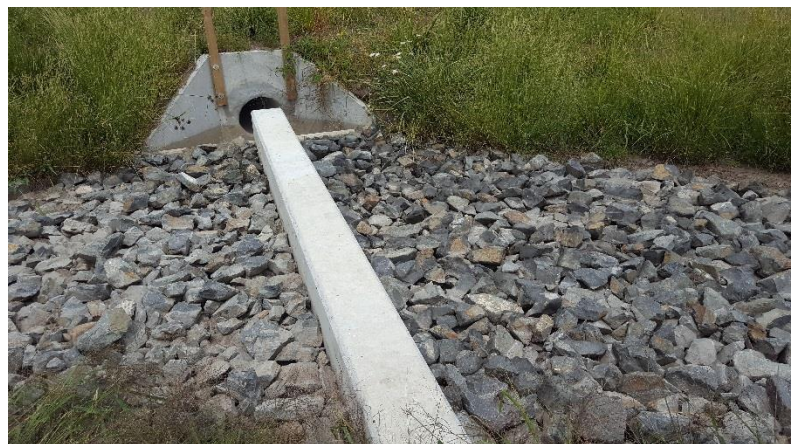
Figure 4: Photos of the stormwater treatment swales showing (a) inlet structure with riprap and centre wall, (b) outlet structure with sampling line, (c) detail of riprap and textile cloth with oioi planting near the outlet structure.

The wetland swales are twin 65 m long, 7 m wide channels separated by a 100 mm high concrete nib wall running down the centre (figure 4a). Influent enters via the concrete culvert and header box shown in figure 4a, is spread across the full width using a perpendicular concrete bar, and exits via a scruffy dome with sample pump and monitoring as shown in figure 4b.

The bed of the swales comprises sand and topsoil covered with textile cloth (figure 4c). Below the sand and soil is a drainage network with HPDE liner underneath. The entry and exit to the swale are filled with riprap as shown in figure 4.

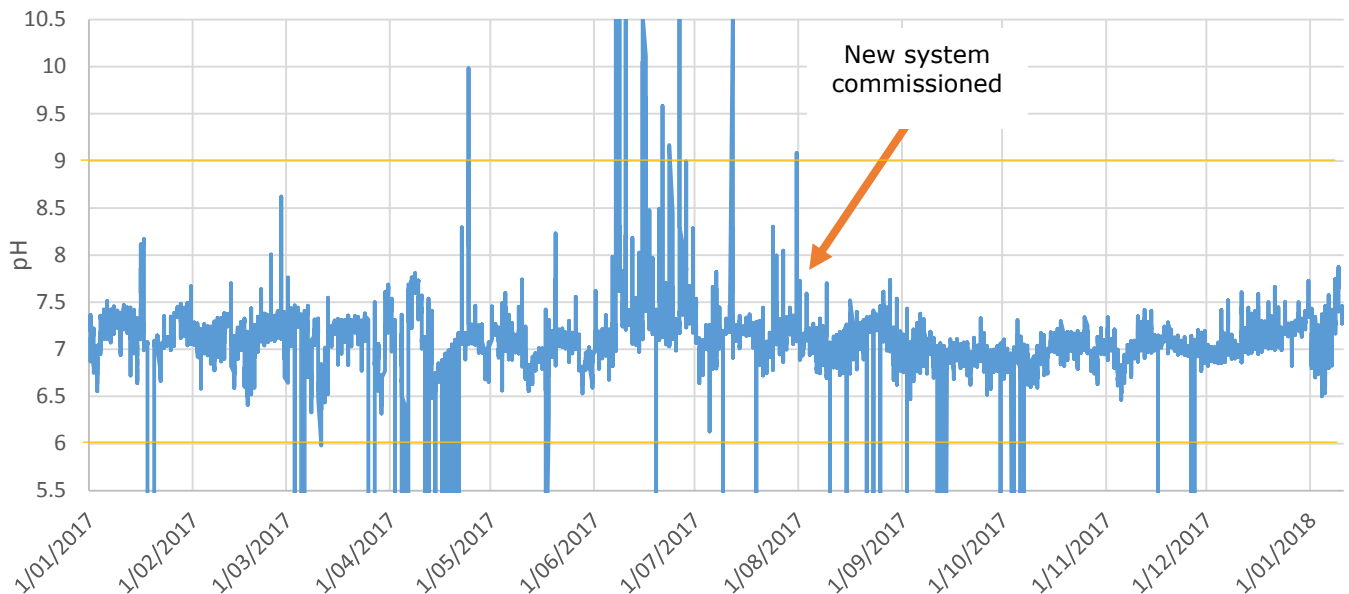
Stormwater Final Discharge pH

Figure 5: Online pH monitoring of final stormwater discharge to the Oraka stream for full 2017 year. Readings of zero are due to loss of instrument signal. Consented pH range is shown by the yellow lines.

Figure 5 shows that between January and June, pH commonly varied by around 0.5 units above and below neutral with few excursions beyond the 6 – 8 range (very low readings are due to loss of instrumentation signal). July and August saw a number of high pH events due to containment failures during construction events, soil erosion, and contamination from cross connections, as described in the non-compliance reports in section 3.

After the new system was commissioned in August, the pH trend shows smaller variations than the first part of the year, of around 0.25 units either side of neutral, except for the period at the end of the year. There are also no discharges of stormwater outside of the 6 – 8 range. This demonstrates that the first flush tank and swale provide improved buffering and attenuation of high and low pH events.

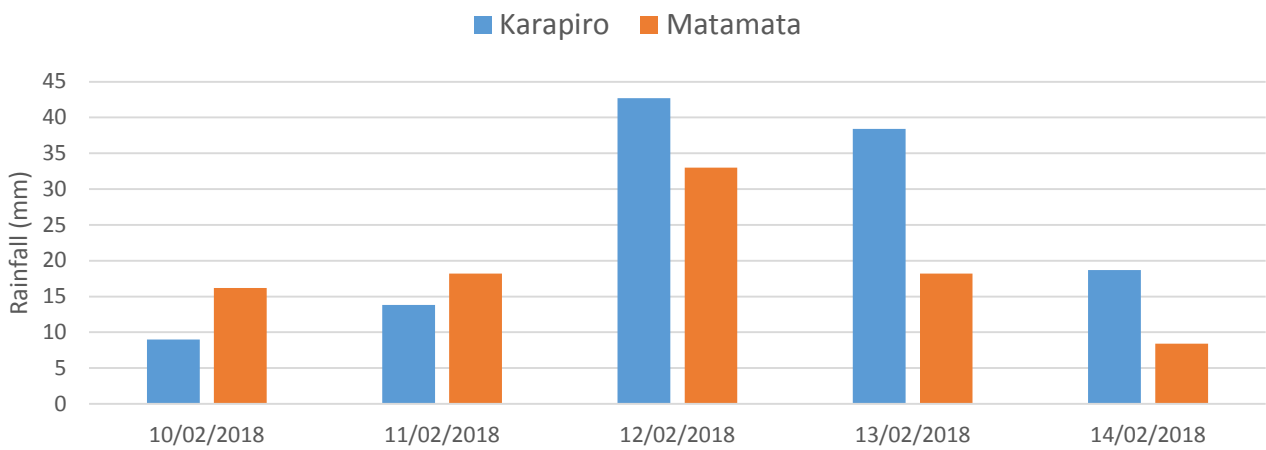
Figure 6: Rainfall totals at two sites near Tirau during 10 – 12 February rain event.

To demonstrate the performance of the system during a rain event, the period from 10 – 14 February 2018 is studied. There is no NIWA rainfall monitoring in Tirau, so rainfall data for the nearest two stations at Karapiro and Matamata for the period were retrieved from NIWA's CliFlo database and are given in figure 6. Total accumulations for the period were 122.6 mm at Karapiro and 94.0 mm at Matamata.

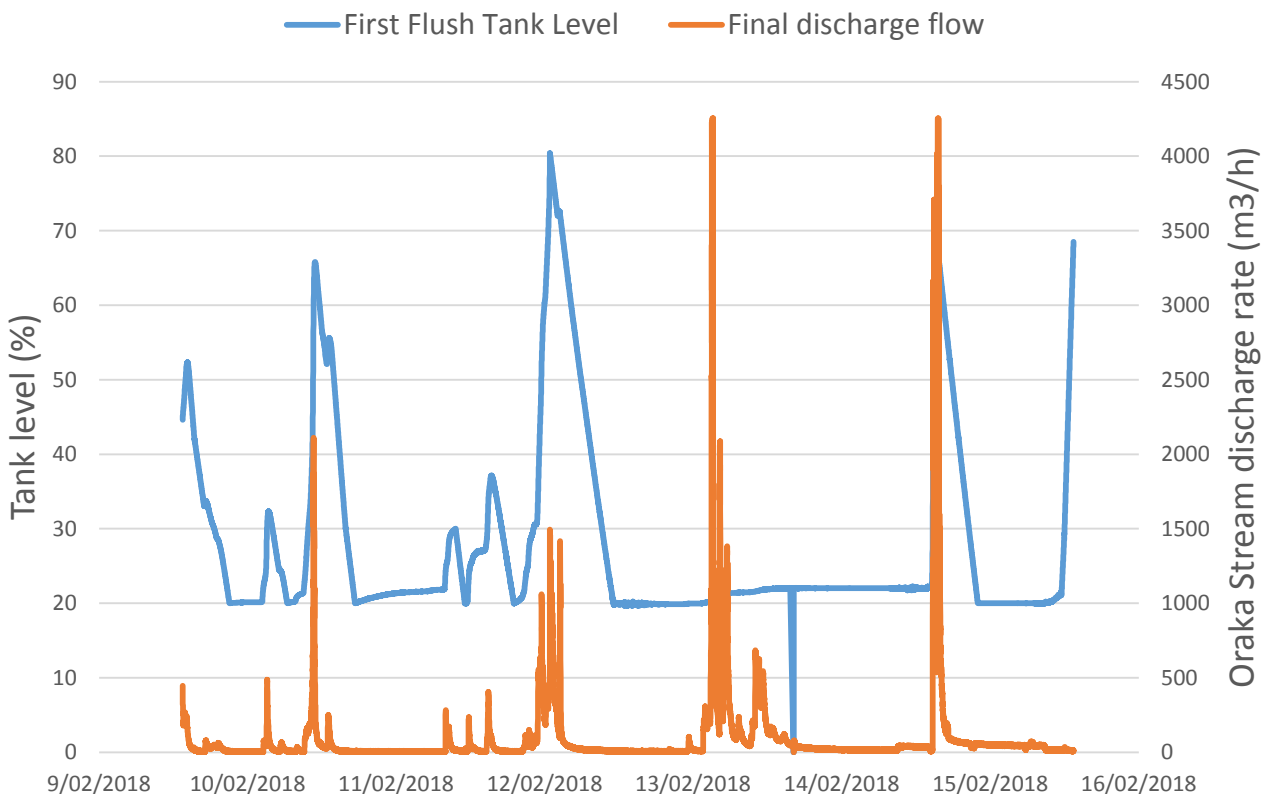
Figure 7: First flush tank level and stormwater final discharge flow rate (including town stormwater) over the rainfall event. See text for explanation.

The level in the first flush tank and the stormwater flow rate is shown in figure 7. In the 5 days preceding the event the rainfall totaled less than 10 mm and the first flush volume was not reached. It can be seen that the rainfall on the 10th and 11th begin to fill the first flush tank, but the 10 mm flush volume is not reached (80% level). In each case the tank is pumped out to the WWTP and the first flush volume is reset.

The higher rainfall on the 12th filled the first flush level requirement, and the diversion chamber began sending water to the swale directly while the first flush tank was pumped out again. The level in the first flush tank reduced to the dead volume and saw a small increase due to direct rainfall into the tank on the 13th.

The rainfall late on the 14th began diverting to the first flush tank again, because there was a pH probe fault which gave a reading outside of the discharge criteria. The three day first flush wait period (period in between first flush events where contaminant levels from runoff are expected to be low) had not passed yet so the flow would have discharged to the swale if the pH was within the limits.

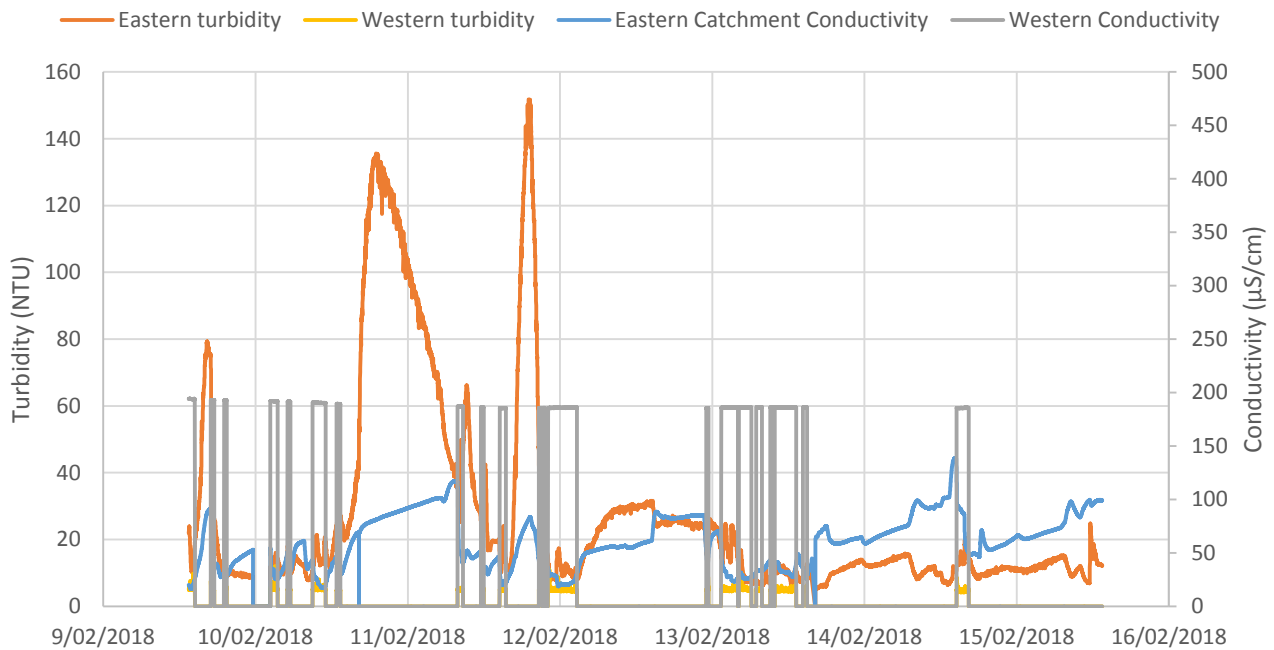
Figure 8: Conductivity and turbidity monitoring at the eastern and western catchment monitoring stations.

Figure 8 shows the conductivity and turbidity of the stormwater influent during the event from the two eastern and western monitoring stations.

1. The western catchment does not have any flow when it is not raining. This suggests there are no sources of water into the system apart from stormwater.
2. The western catchment has lower turbidity than the eastern catchment, although during rainfall they are similar. The conductivity probe for the western catchment appears to have faulted, with the same reading whenever flow is present.
3. The eastern system appears to have a base level flow with turbidity up to 150 NTU, as seen by the spikes during the dry periods on the 10th and 11th. These are diluted during rainfall events to give much lower measurements and do not reappear on or after the 12th, suggesting that the source of the flow had stopped at this point.

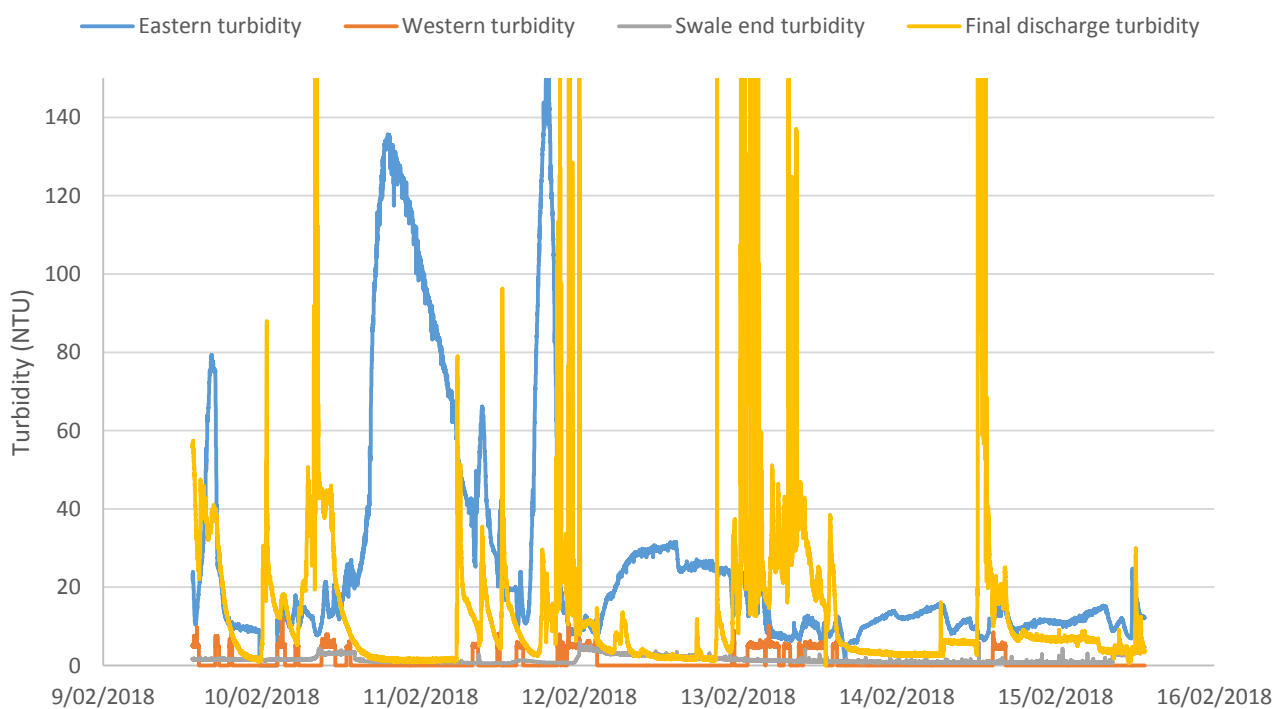
Figure 9: Turbidity over the rainfall event measured at the two upstream catchments, at the swale end, and at the final discharge after combining with town stormwater.

Figure 9 shows the change in turbidity between the two catchment monitoring stations, the end of the swale, and the final discharge point. The high turbidity in the eastern catchment is captured effectively by the swale, with a maximum of 6 NTU at the swale end across the period.

The final discharge point is much higher in turbidity than any of the catchments or the swale, suggesting there is a large sediment load coming from the township which is measured along with the site stormwater.

The suspended solids concentration reduced at least fourfold, which is consistent with the turbidity results in figure 9. The swale system is designed primarily to reduce suspended solids, which is demonstrated here. It is encouraging that even during heavy rain the reduction is significant, since during lower flows one would expect slower infiltration and less turbulent flow leading to greater reduction.

The combined final discharge includes stormwater from the township and site cooling water which was not separated as part of this project. As demonstrated in figure 9, the town storm water can contribute very high suspended solids during rainfall.

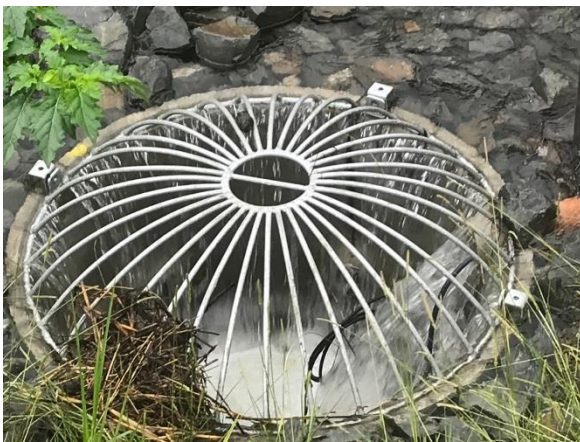
Figure 10: Swale discharge during heavy rain event.

Samples were also collected at 11am on 13/02/18, during heavy rain, from the inlet and outlet of the swales. One sample of each was submitted to Hill Laboratories for analysis, the results of which are shown in table 3. It should be noted that the flow through the swales was high, and overland flow was occurring as well as infiltration through the bedding and subsurface drainage (see figure 10).

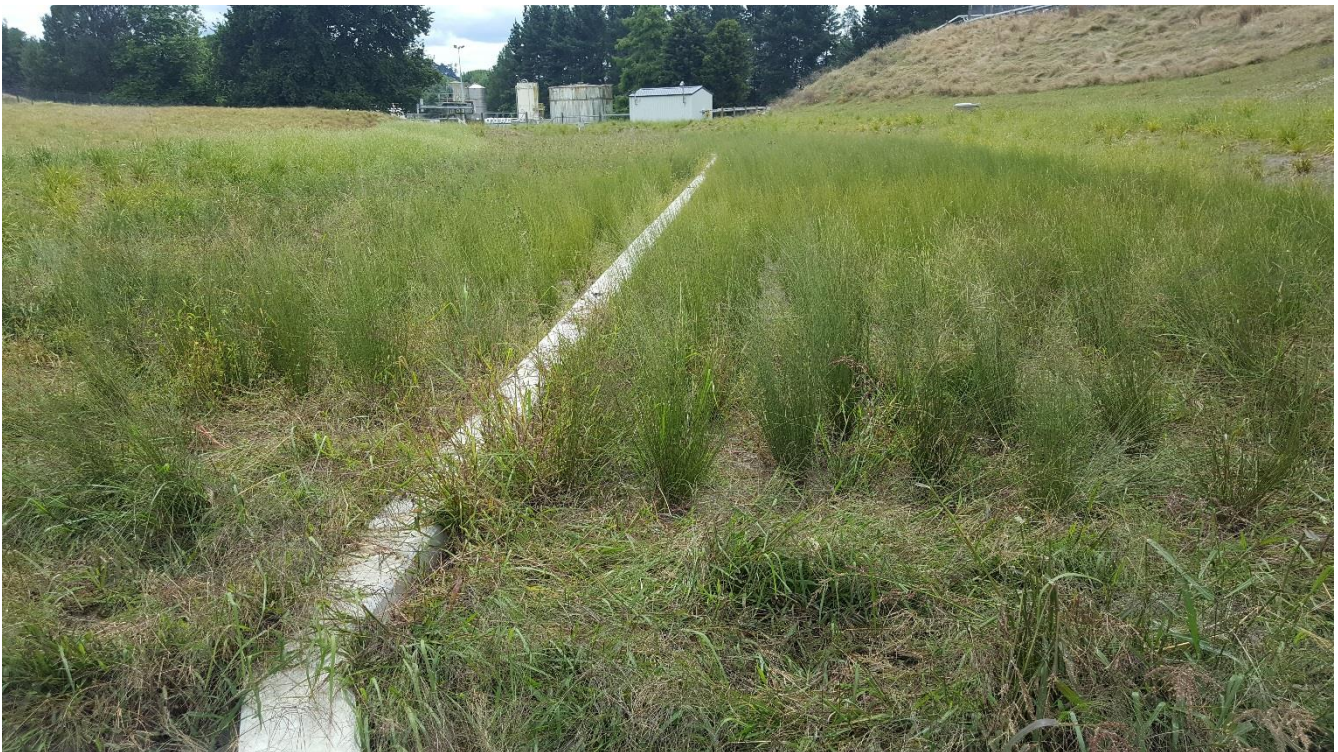
Figure 11: Oioi planting in the swales after weeds had been trampled (photo date 8/2/18).

Advice was sought from Waikato Regional Council, who suggested trampling the weeds down to allow the oioi to grow higher and slow down weed growth. So far this has proved effective as can be seen in figure 11.
