SOFT SOLUTIONS FOR HARD ENGINEERING PROBLEMS

L. Norman (ACH Consulting Ltd.)

ABSTRACT

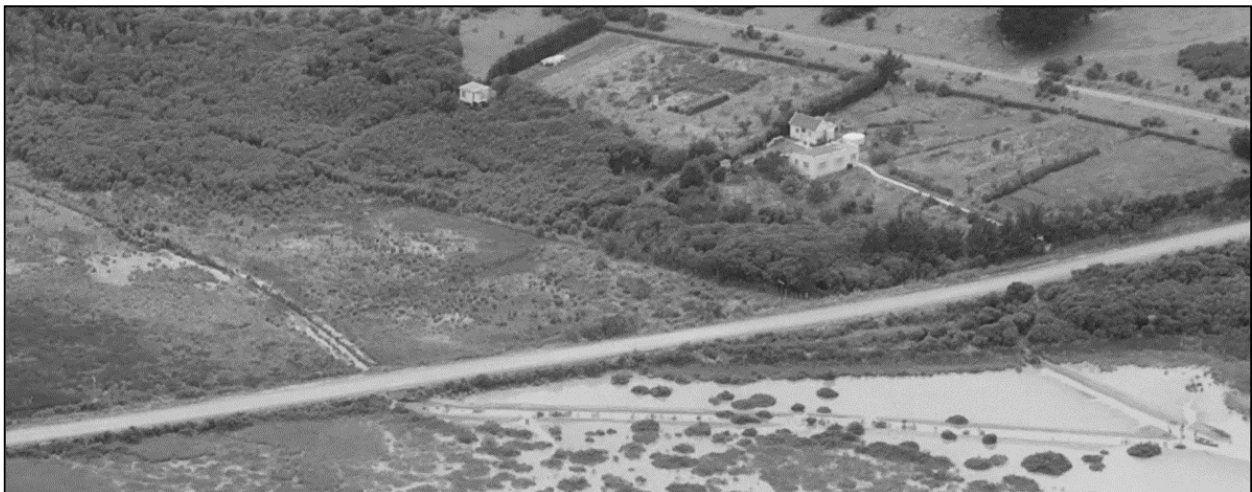
The estuarine wetland plays a significant role in flood storage, wave buffering and ecology. New Zealand's threated fish species rely on them for migration as most of our native species are anadromous or catadromous, spending at least some of their life cycle at sea. Most estuarine wetland systems have been cut off from the sea by dikes formed during road building.

Photograph 1: 1954 Photo of Tawaipareire Creek Estuary.

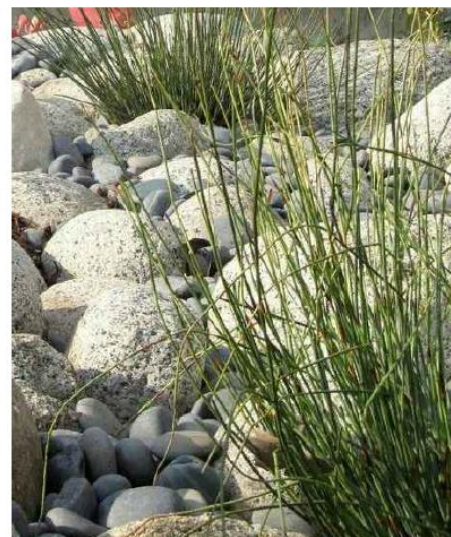
PROPOSED RETAINING WALL DESIGN
SCALE: NTS

Wetland restoration requires both soft and hard engineering solutions in an urban environment. Road bridges and culverts need to include mechanisms for fish passage. Where the outlet of the estuary is confined by urban development the formation of a channel or fish road to restore connectivity is essential. Large spalls or boulders placed in the bottom of the channel planted with appropriate salt tolerant species allows for the connectivity to occur.

DRAINAGE CHANNEL BASE

Figure 6: Hard and soft engineering solutions for wetland restoration.

A retaining wall has been proposed along the shared boundaries of the commercial properties. Together with gabion baskets or gross pollutant traps the retaining wall would exclude sediment from the wetland and open channel site decreasing unwanted sediment input. This would also delineate the boundary between the wetland and the commercial properties which can be seen creeping into the wetland over time.

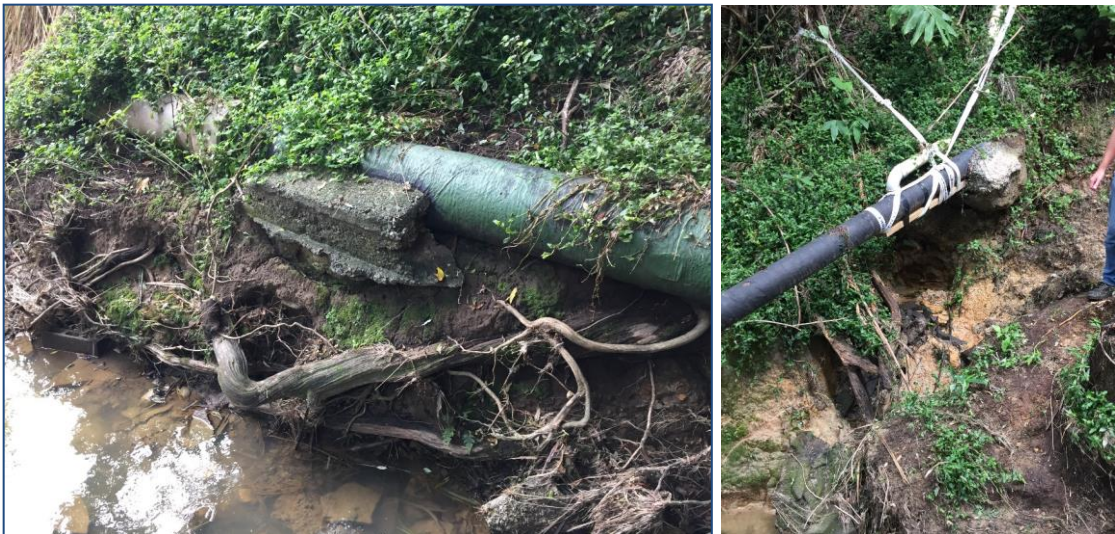
The wastewater asset is adjacent to the natural stream which flows out to sea. The stream erosion within the reach is causing areas of the slopes on either side of the stream to become unstable. There is a large slip at 17 & 19 Liston Crescent which occurred on 3rd March, 2017 resulting in the failure of a wastewater pipe (Barnes, 2017). Other pipes within the reach are similarly at risk and as such stabilisation of the stream banks was required.

Photograph 2 & 3: Abutment being undermined. Undermined abutment with temporary support (Barnes, 2017)

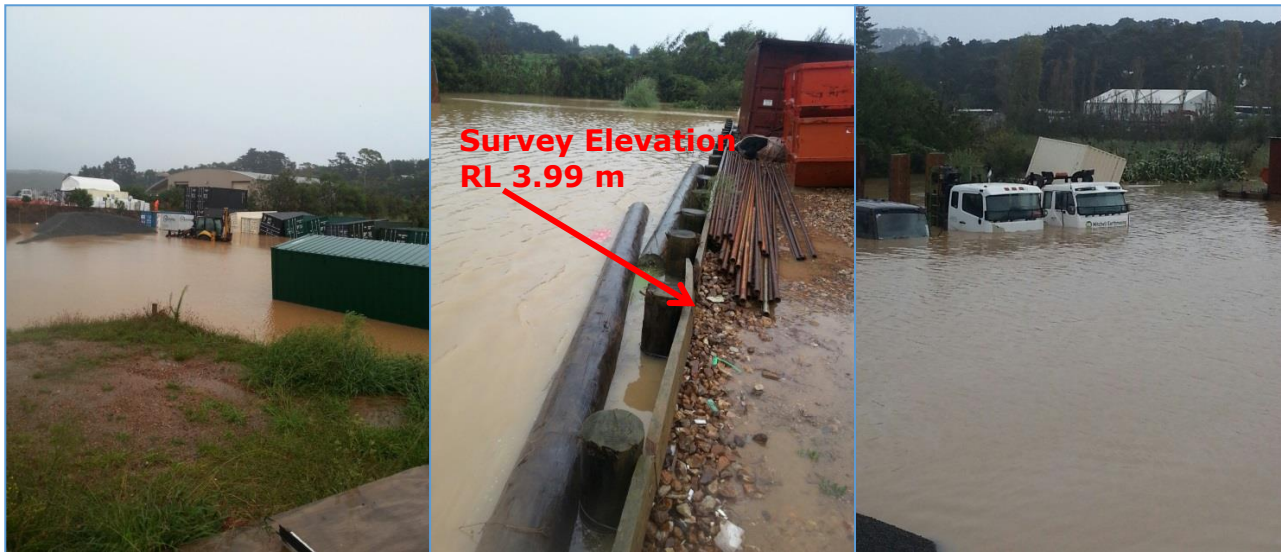
Currently the 108 ha catchment is drained by a 160 m long, 825 mm diameter concrete pipe with no overland flow path available to drain flood water until it overtops the dam. The culvert which runs from a small wetland within the Tawaipareire Reserve to the mangrove area located south of Ostend Road has a maximum flow capacity of approximately 1.3 m³/sec. The stormwater discharge into the reserve during the 10% AEP (1 in 10 year) rainfall event is 15 m³/sec. As a direct result of the catchment modifications the properties along Tahi Road flood regularly.

Photographs 3, 4 & 5: Flooding during March 2017 (Courtesy of Ron Stevenson).
