Copper and Zinc concentrations from an Artificial Turf Field

Ed Clayton – Pattle Delamore Partners

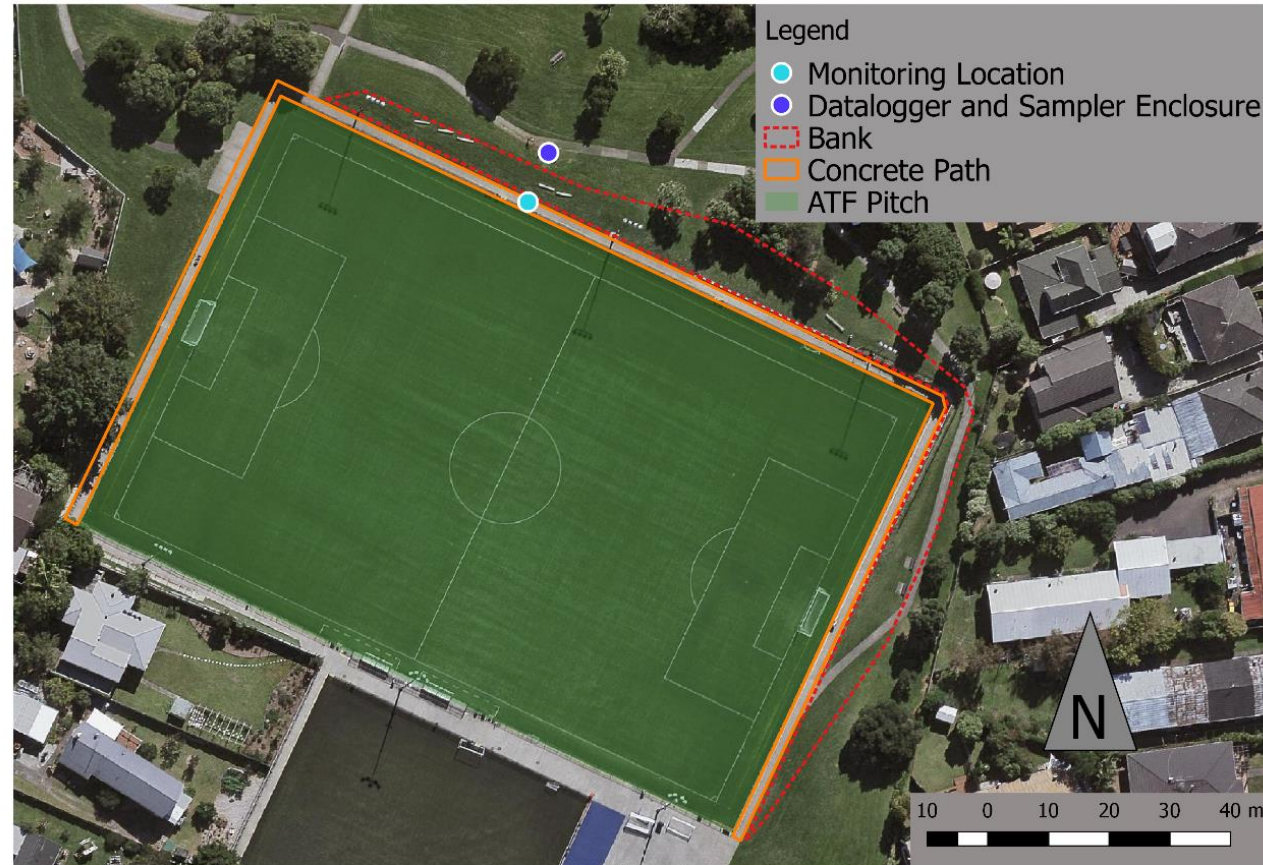
Figure 2. Contributing catchments for the Michaels Ave ATF (aerial photo from Auckland Council)

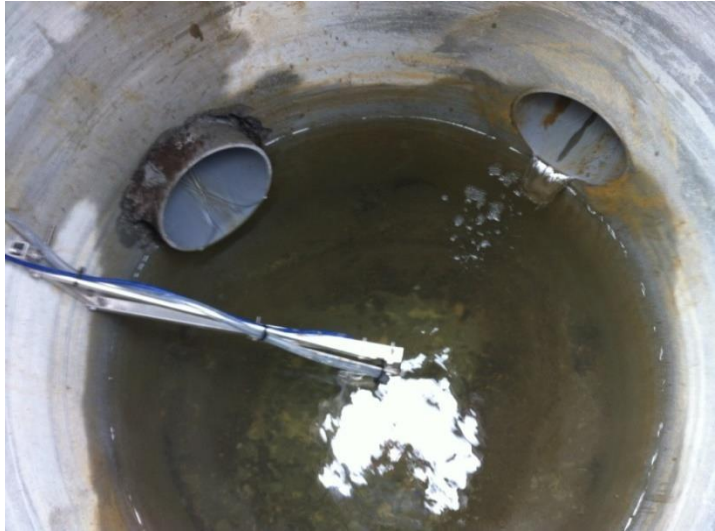
Plate 1 (left): View inside the manhole where monitoring equipment was located. Exit pipe orifice is top left, one sub-surface drain can be seen entering at top right.

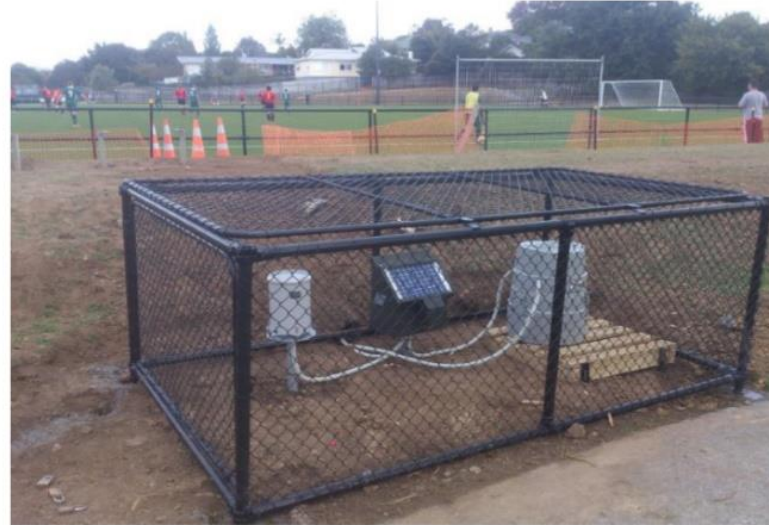
Plate 2 (right): Datalogger, rain gauge and sampler equipment one week after installation

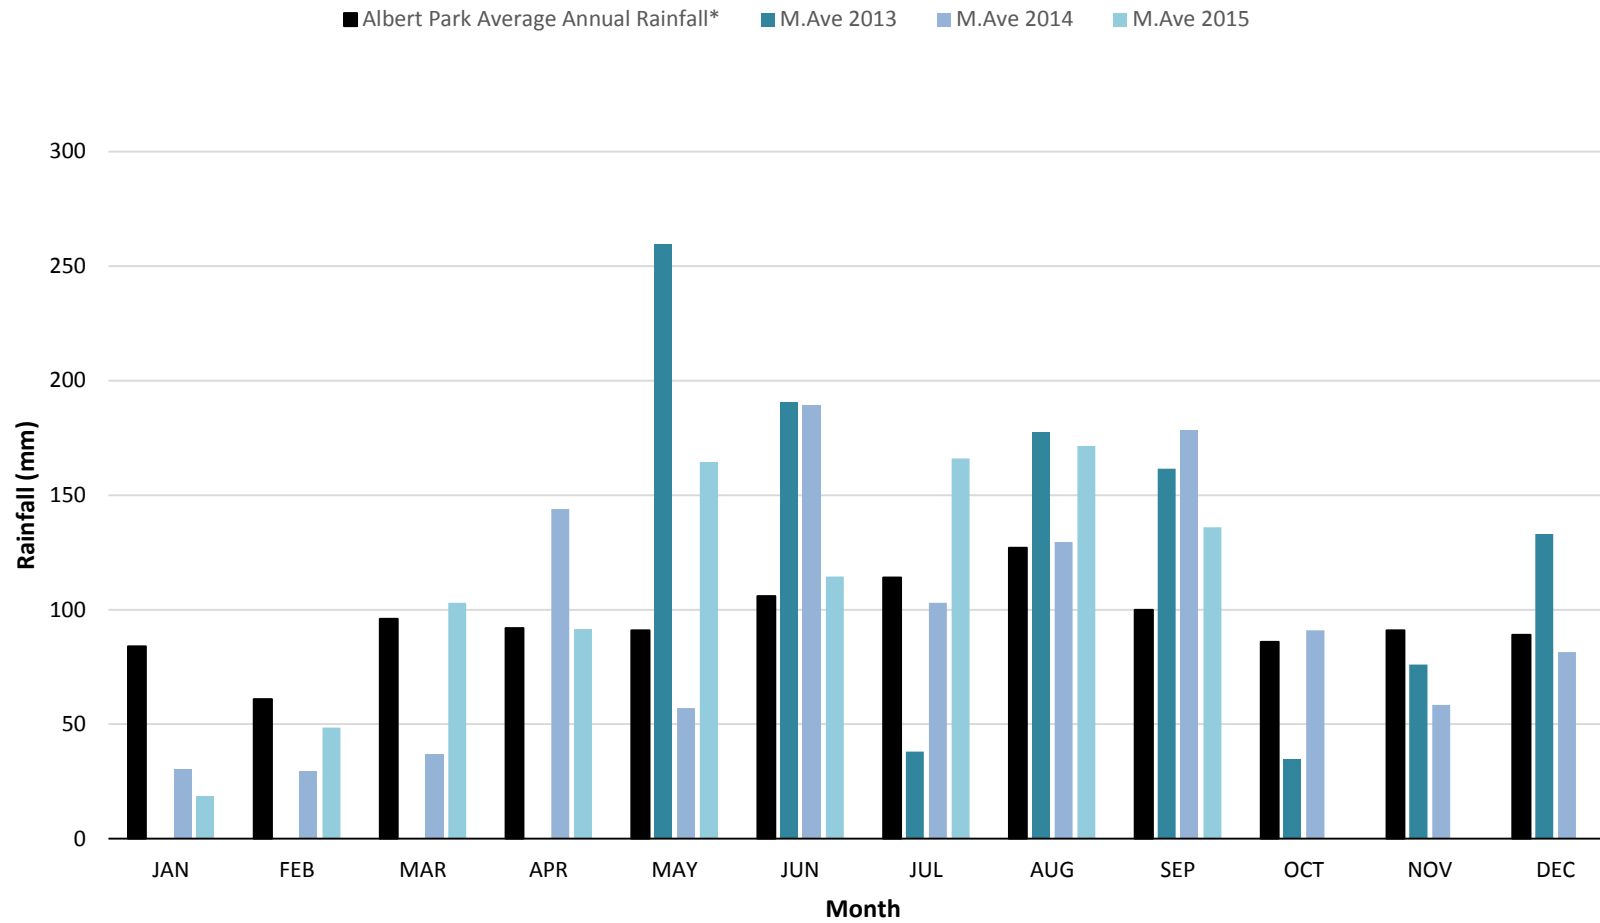
Figure 3. Rainfall by month

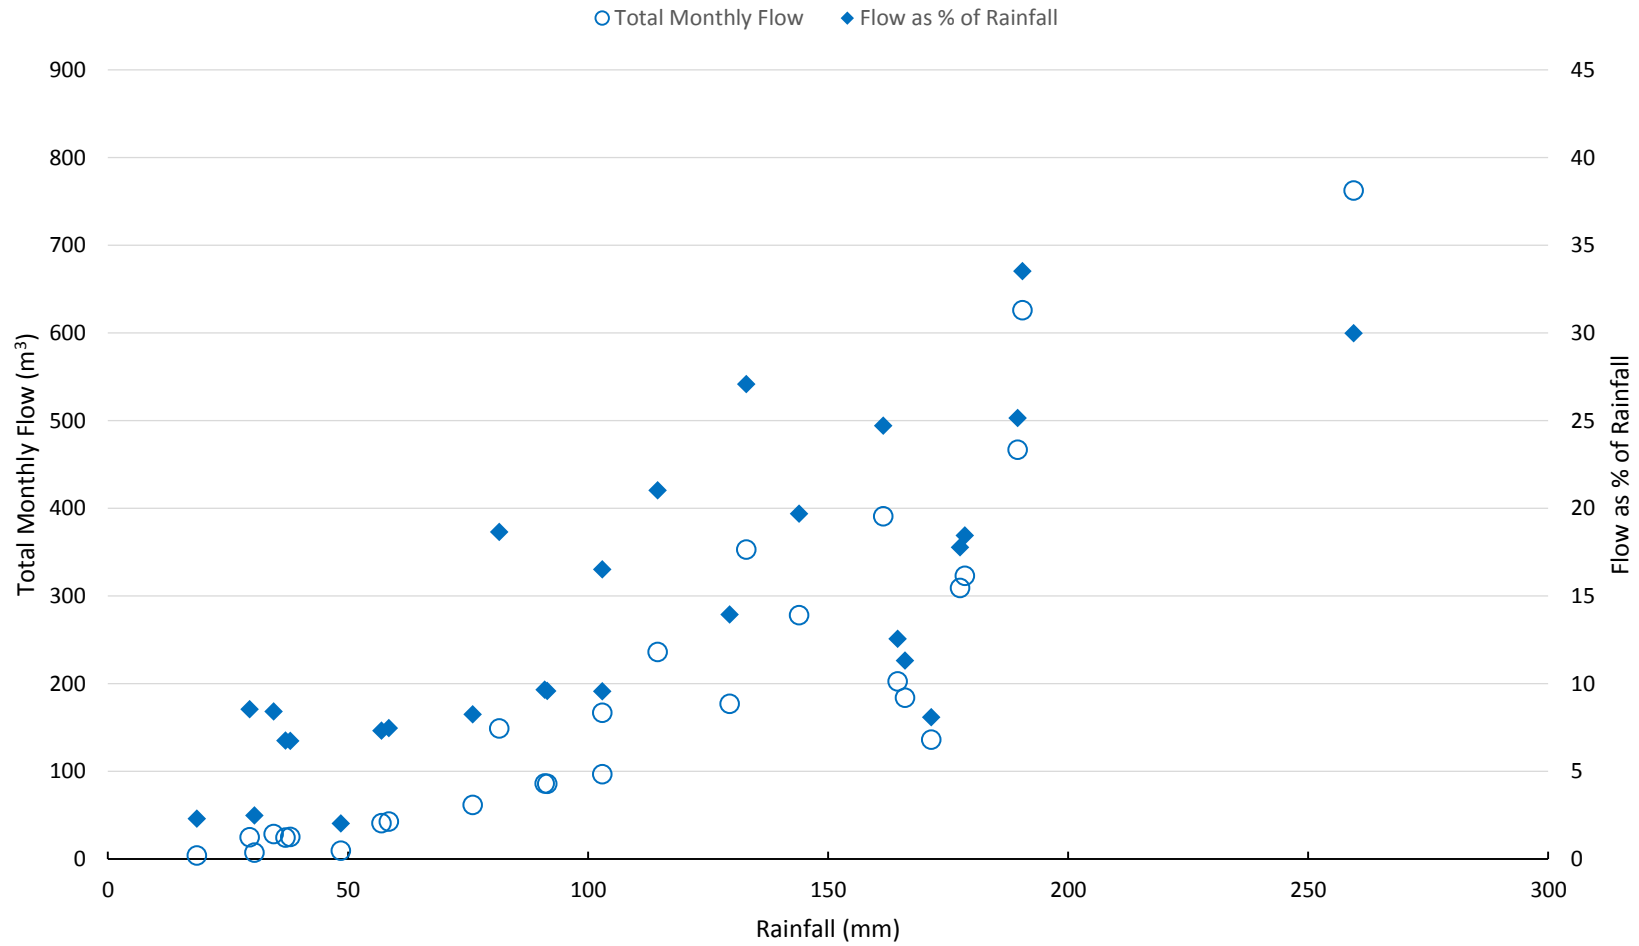
Figure 4. Total monthly flow and flow as percentage of rainfall

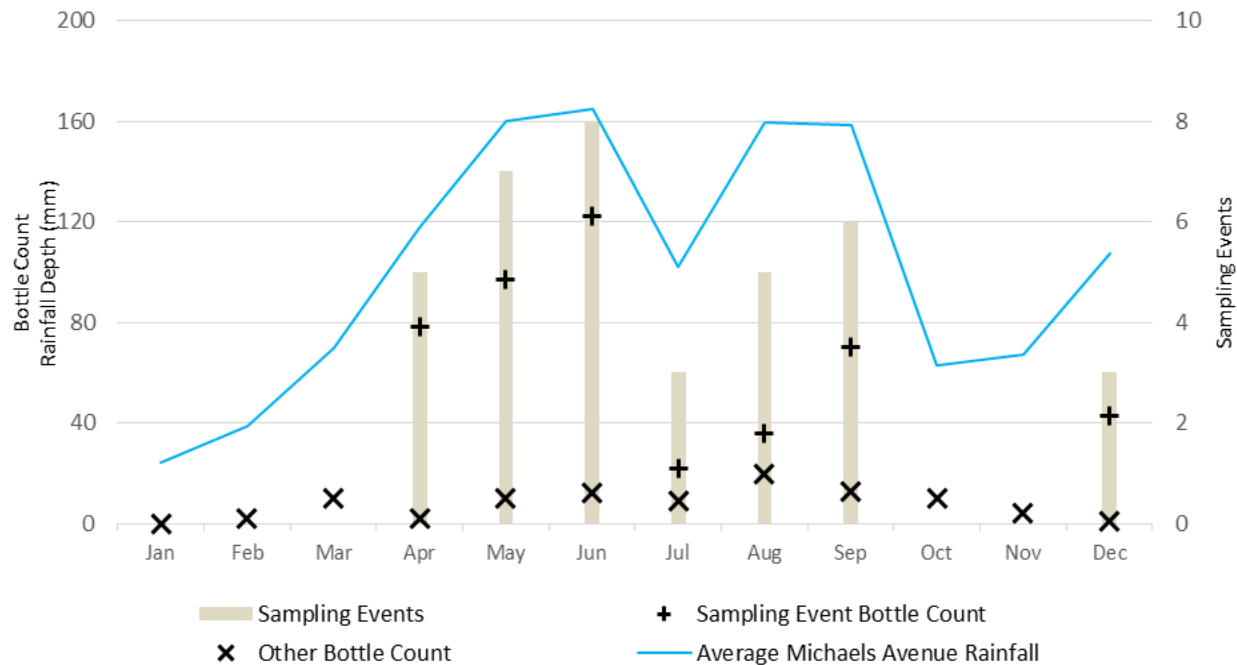
Figure 5. Sampling Event occurrence, number of samples collected and rainfall depth observed at Michaels Avenue by calendar month

- Thirty-four 'Sampling Events'

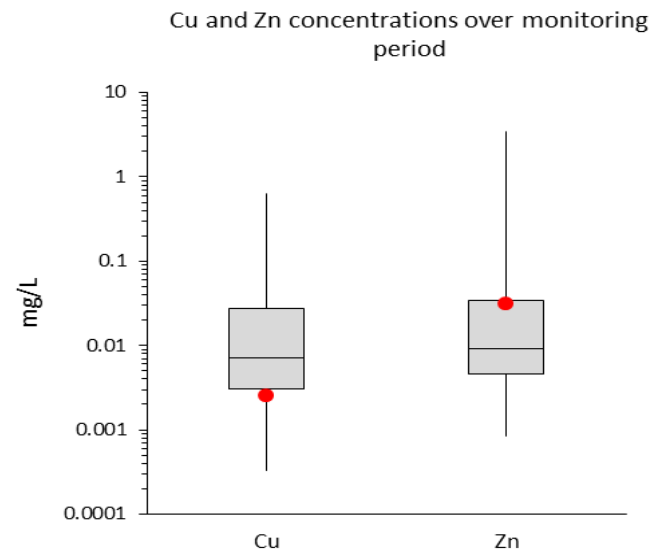
Figure 6. Cu and Zn concentrations over the monitoring period (box plots) with respective ANZECC 80% species survival marked (red dot). Box plots indicate maximum, minimum, median and upper and lower quartile values.

- 87% of Cu & 26% of Zn samples exceeded ANZECC 80% species survival

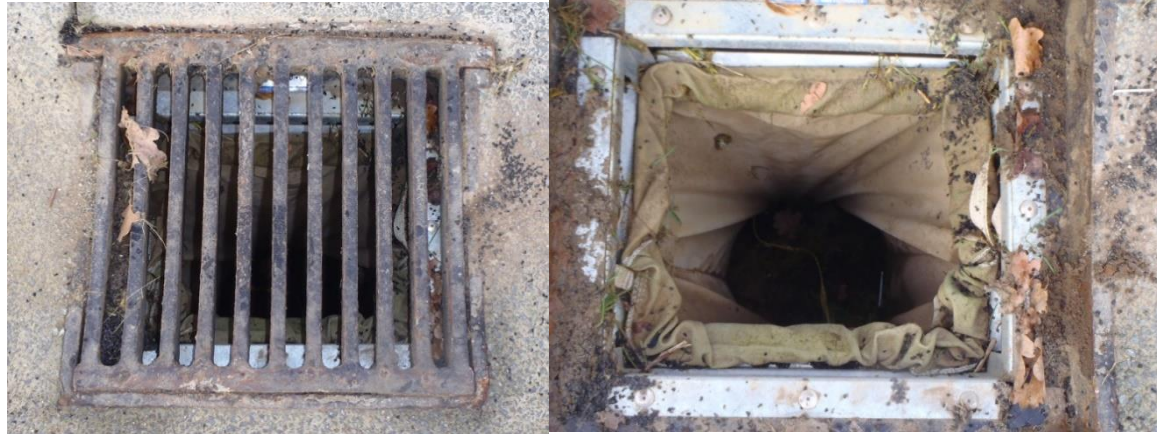
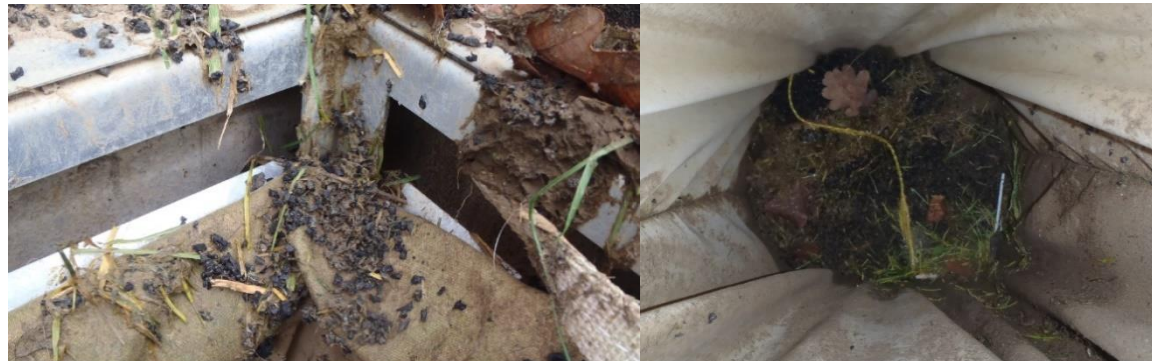
Plates 3-6. Above, a catchpit grate on the concrete path (left, Plate 3) and the Enviropod filter bag (right, Plate 4). Below, crumb rubber deposited within the Enviropod filter bag overflow (left, Plate 5) and in the bottom of the bag (right, Plate 6)

- Crumb rubber mobilised from the field

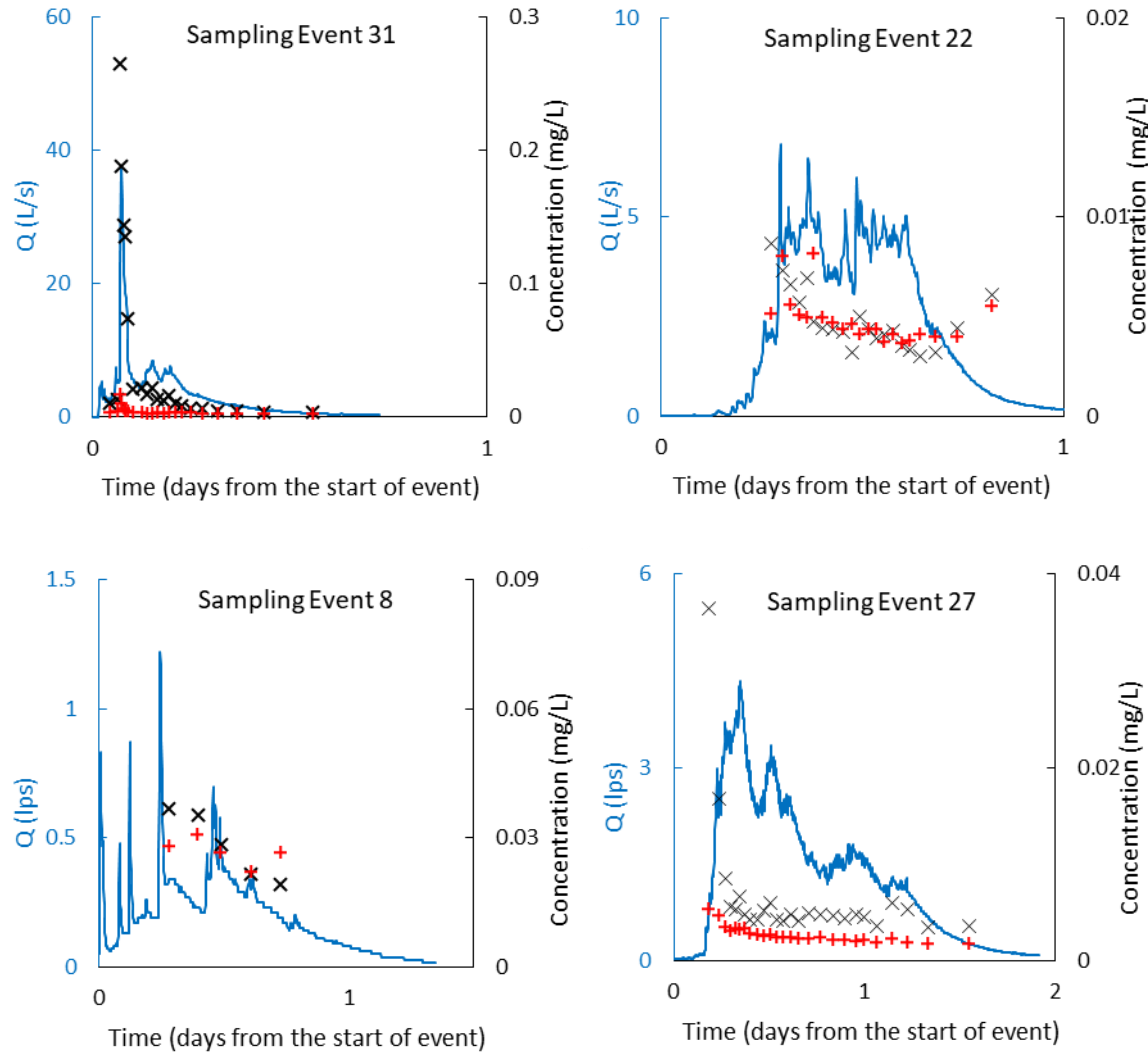
Figures 9 – 12, clockwise from top left: Large Sampling Events with a runoff spike (Figure 9) and without a runoff spike (Figure 10), a medium Sampling Event showing Zn exhaustion (Figure 11) and a small Sampling Event showing Zn exhaustion (Figure 12), both with no runoff spike sampled.

For all Figures flow rates are marked by blue lines, Zn concentrations with black crosses and Cu concentrations with red plus symbols.

- Two different pathways of site discharge
 - Infiltration (through the ATF pitch)
 - Runoff (from concrete path, bank and infiltration excess)
- Discernible in hydrograph
- Pollutant concentrations varied with flow pathway
 - Zn source limited
 - Cu flow limited

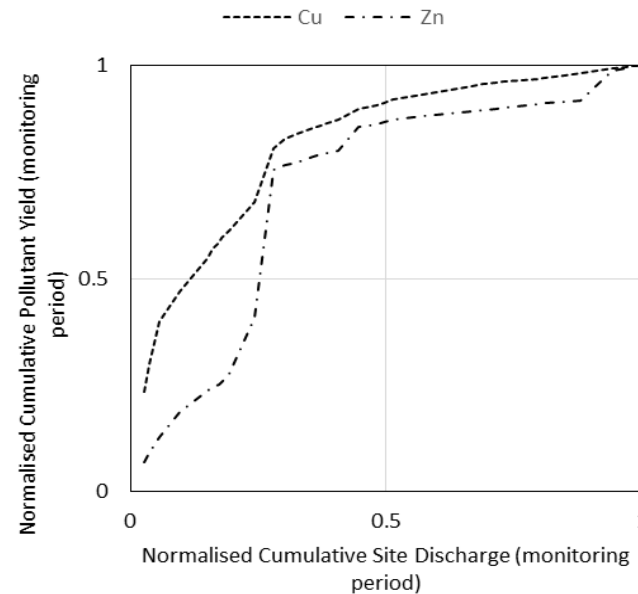
Figure 15: Land-Use First Flush for Cu and Zn

- Michaels Ave ATF demonstrates 'Land-Use First Flush'
