RESTRUCTURING A RENEWALS PROGRAMME TO DELIVER LONG TERM VALUE

Peter Evans, Harrison Grierson and Andrew Corbett, Pipeline & Civil

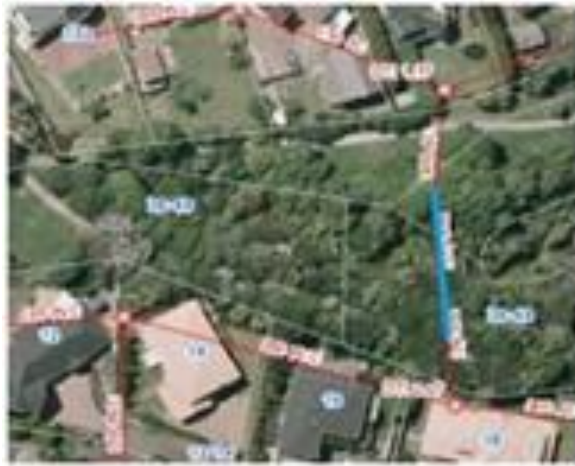
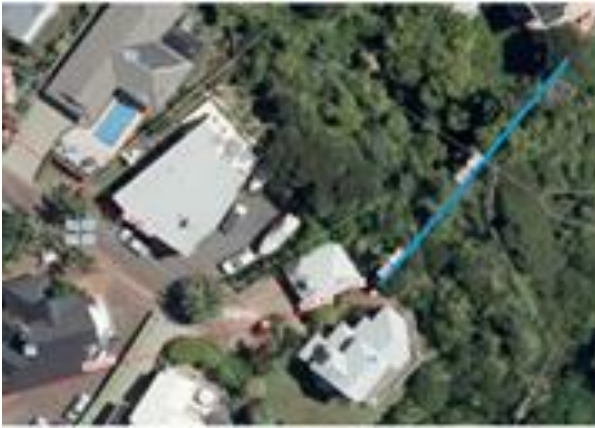
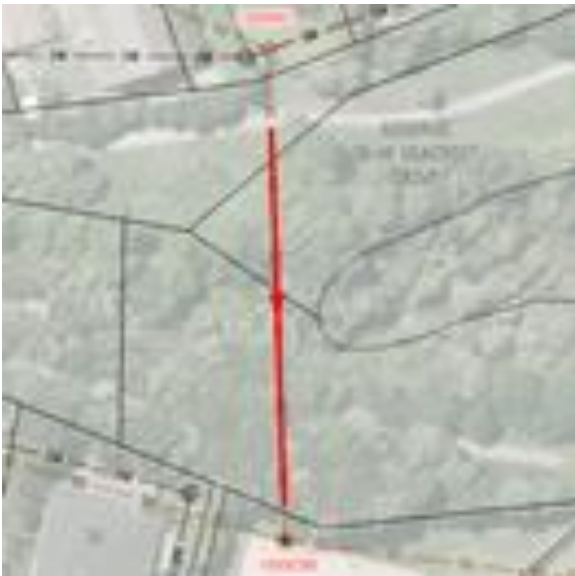
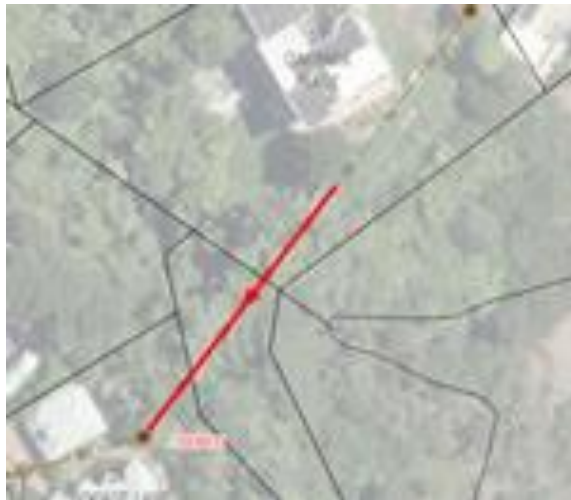
Name of project	West Harbour Pipe Bridges
Summary	The physical works are scoped based on brief initial assessments carried out by third parties. In this case, errors in the scope resulted in additional consenting, delays and a significant additional cost.
Cost Variance (\$+/-)	+\$83,000.00
Programme Variance	Uncertainty due to consenting, 3 months before works could be started.
Original Scope	<p>From the project definition sheet:</p> <p>Pipe Bridge Details: Length 10m and 24m, Material CLS, Diameter DN300</p> <p>Description: Replace pipe bridge</p> <p>Background: Coating has failed, large areas of exfoliation</p> <p>Justification: Pipe bridge visual inspection has condition grade 4 or grade 5</p> <p>Additional information: NIL</p> <p>Issues to be aware of: NIL</p>

Pipe Bridge Details: Length 46m and 38m, Material CLS, Diameter DN300

The original project definition sheet significantly underestimated the length of pipe bridge to be replaced and this was reflected in scheduled quantities resulting in a \$83,000.00 difference to contract price. Complex access arrangements were not identified in the initial definition sheets. Helicopter works are required for both of these replacements. This methodology had a follow on impact on the consenting for works in a Reserve and the programme order of works.

1. Initial investigations should be carried out by the contractor and agreed with the client.
2. The pipe bridge replacement items should be lump sums.

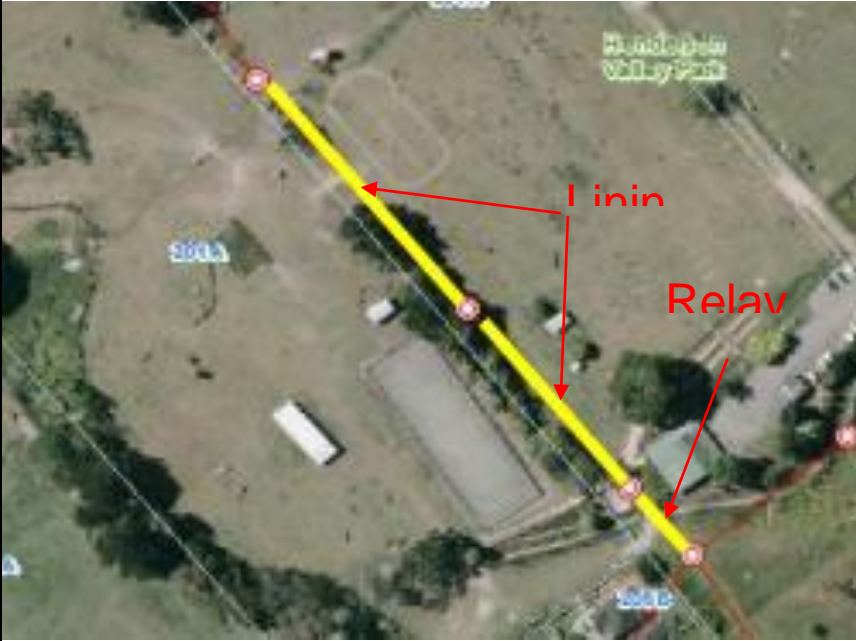
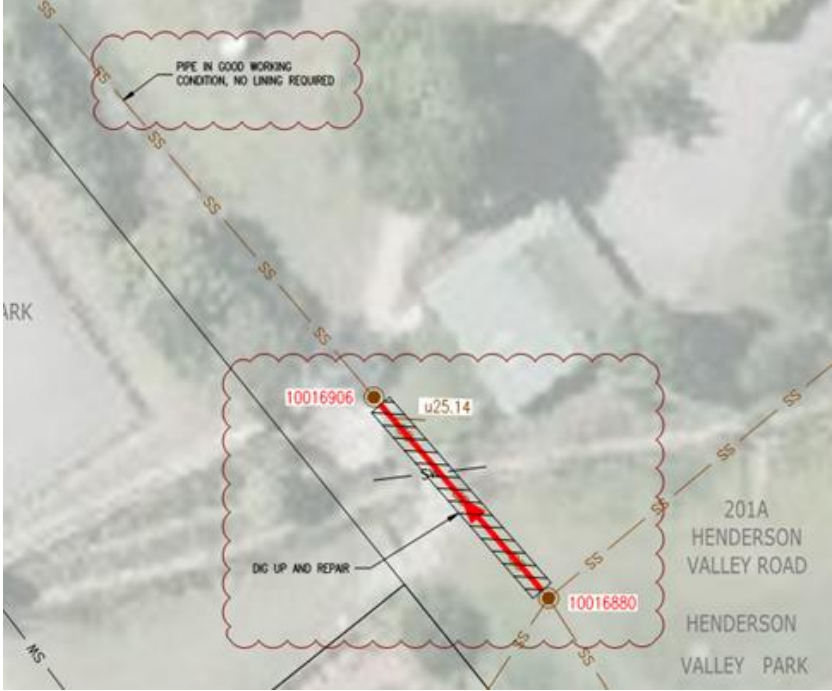
Name of project	Valley Road
Summary	The true scope of the project could not be assessed until after jetting and root cutting works had taken place. As a result incorrect works were scheduled. If consenting assessments and contamination of the site were addressed earlier cost and programme variance would be removed.
Cost Variance (\$+/-)	-\$28,000.00
Programme Variance	- 1 week no lining required. Delay to start of works due to potential contamination.
Original Scope	<p>From the project definition sheet:</p>

<p>Rehabilitation Details: Lining Length 192m, dip repair Material EW, Diameter DN150</p> <p>Description: Relay dipped section then line.</p> <p>Background: Major dip & displaced joint in first line & root infiltration issues in general.</p> <p>Justification: Identified by Operations as causing regular overflow and excessive maintenance cost >200 properties affected. (Ops Priority 1).</p> <p>Additional information: None identified.</p>

Issues to be aware of: None identified.
Final Scope of works	<p>Open cut repair only: Length 32m, Material EW with existing patch repair, MH repairs (not originally identified).</p> <p>Consenting checks identified the site as potentially contaminated and additional sampling was undertaken. This came back positive for low level contamination but did not require consent.</p>

Effect on Project	A more thorough investigation identified that only an open cut dip repair was required with the rest of the line in good condition and not needing lining. The low level contamination identified during the consent evaluation did not require a consent but caused considerable delay while this was assessed and testing was conducted.
Areas identified for improvement Likely outcomes:	<ol style="list-style-type: none"> 1. Initial investigations should be carried out by the contractor and agreed with the client. 2. Contamination testing should be carried out during these investigations <p>The lining works would not be included in the contract as they are not required. The dip repair is required but would have been priced as a lump sum after initial investigations. The length of the dip and type of replacement would have been identified..</p> <p>Cost variance would have been reduced significantly.</p>

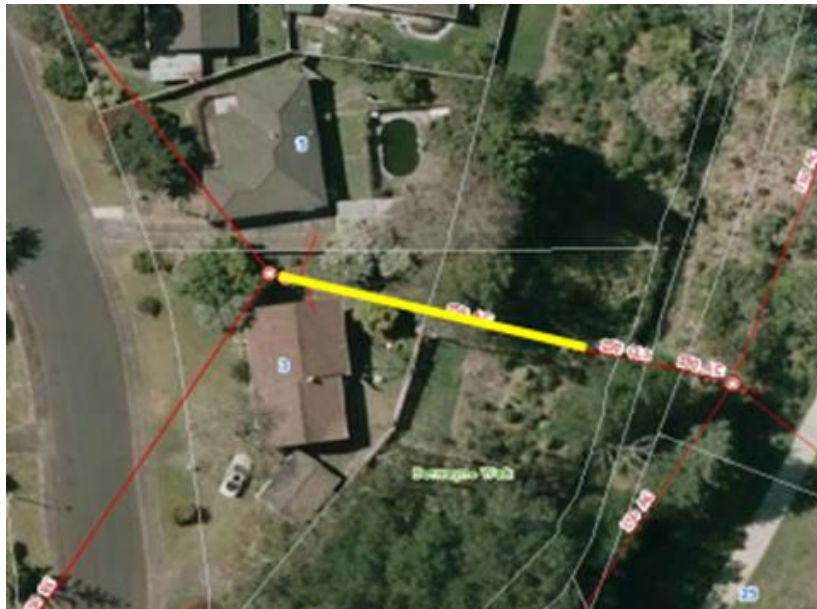
Name of project	3 Stencil Place
Summary	The works were assessed as a lining project. However the overflows were found to be the result of a dipped pipe bridge. A contractor could have proceeded with the lining works without solving the problem leading to an unsatisfactory result for Watercare and a future project to address the pipe bridge. The collaborative approach and agreed principal's requirements during initial scoping would have solved this problem.
Cost Variance (\$+/-)	+\$50,000
Programme Variance	Extension of Time due to increase in scope. Procurement lead time of 4 weeks for pipe bridge materials.
Original Scope	<p>From the project definition sheet:</p> <p>Rehabilitation Details: Lining Length 30.7m, Material AC, Diameter DN150</p> <p>Description: Structural rehabilitation of existing 2x 150mm pipe between the pipe bridge and manhole.</p> <p>Background: Root infiltration through joints.</p> <p>Justification: Identified by Operations as causing regular overflow and excessive maintenance cost.(Ops Priority 1)</p> <p>Additional information: None identified.</p> <p>Issues to be aware of: None identified.</p>

<p>Final Scope of works</p>	<p>Pipe Bridge Replacement: Length 13m, Material CLS. The change of scope was only discovered when a thorough pre-lining jetting and inspection was carried out. After jetting of the pipe it was decided that no lining of the pipeline was required. The regular overflows were identified as actually being a result of a significant dip in the pipe bridge and not as a result of root intrusion or other issues within the pipeline sections.</p>
<p>Effect on Project</p>	<p>As a result additional CLS pipe had to be procured welded and coated, a four week lead time. A consent is required for the pipe bridge replacement. Because this was not part of the original consenting programme it is not possible to slot it in to one of the existing consenting bundles which had already been submitted. A separate consent and submission was required.</p>
<p>Areas identified for improvement</p> <p>Likely outcomes:</p>	<p>1. Initial investigations should be carried out by the contractor and agreed with the client.</p> <p>2. Consenting assessments should be undertaken based on the concept design and methodology.</p> <p>Items with a lead time such as fabricated pipe spools would be ordered and coated in advance of the physical works programme. The distribution of works will be improved resulting in less strain on both Contractor and client resources at the end of the programme. The works can undergo an accurate consenting assessment earlier and be programmed accordingly.</p>

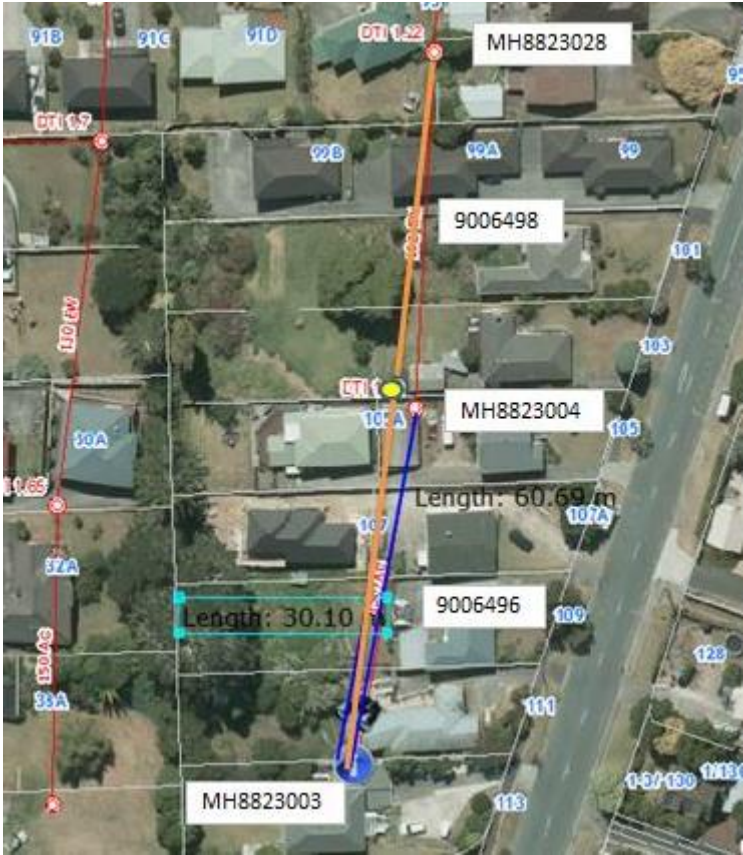
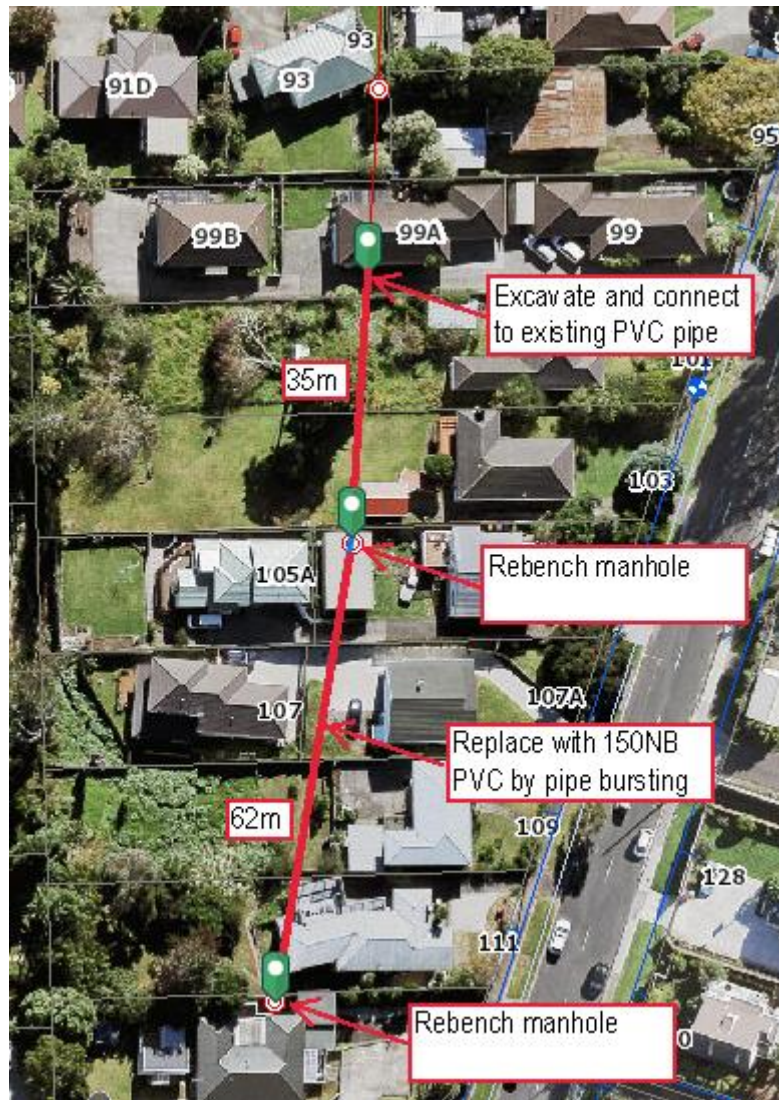
<p>Name of project</p>	<p>Wastewater Renewals 2017 - Blockhouse Road</p>
<p>Summary</p>	<p>A 150NB pitch fibre sewer laid during the 1970s had completely failed resulting in blockages and overflows to the stormwater network. Incomplete CCTV information was available and laterals had not be located. The Principal assessed the works would require the replacement of a 91m section of the pipe, and had assessed that directional drilling would need to be used due to the position of the houses.</p>
<p>Original Scope</p>	<p>From the project definition sheet:</p> <p>Drill new 180 O.D PE line from boundary of 99 and 101 to head of line at 113 Blockhouse Rd.</p> <p>Install new house connections and connect to existing laterals.</p> <p>Install new manhole.</p>

Investigation	The investigation involved review of house plans, service locations, manhole inspections, CCTV, source detection, push cam and topographic surveying.
Scope	<p>The investigation revealed several critical aspects:</p> <ol style="list-style-type: none"> 1. The pipe had completely collapsed in one location and sewerage was seeping into a stormwater catchpit 2. The pitch-fibre pipe extended further downstream to manhole 9006498 (where it became PVC in good condition) 3. A new retaining wall was located very close to the available corridor that would need to be used if the pipe was replaced by HDD 4. Access to the work sites was difficult - many properties had no access to the rear of the sections <p>The concept design was to replace the pipe with a new 150NB pipe downstream MH 8823003 and connect to the recently constructed PVC pipe under the house - a total of 97 metres, and reconnect 7 laterals.</p>

Design solution	<p>The detailed design solution was to replace the existing sewer with a 150NB PVC pipe using pipe bursting.</p> <p>This was selected for three reasons:</p> <ol style="list-style-type: none"> 1. The existing manholes could be retained and just rebenched - a proposed manhole was not required 2. The risk to houses was minimised 3. Service relocation risk was minimised 4. Equipment could be easily mobilised to site

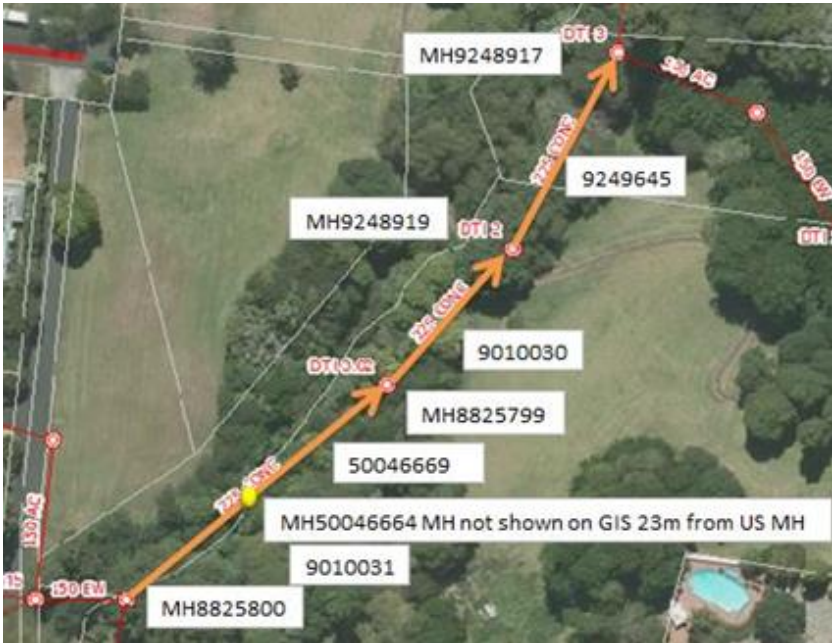
Name of project	Wastewater Renewals 2017 - Waiata Reserve
Summary	<p>A 225NB sewer cast insitu concrete sewer, constructed in 1921 had significant root intrusion, a history of overflows and had started to fail resulting in tomos. The sewer was located in heavily vegetated sections of the Waiata Reserve and access was restricted by the stream. Initial CCTV information provided by the maintenance contractor indicated that three sections had becoming partially blocked with grout. They had assessed that the works would require the replacement of a 130m section of the pipe, and had assessed that pipe bursting would be necessary due to the obstructions and vegetation which restricted clearing.</p>
Original Scope	<p>From the project definition sheet:</p> <p>Replace 4 pipelines, from MH8825800 to MH9248917 installing a 250mm diam PE wastewater pipeline, 0 Laterals. Need to rehabilitate or replace 1 manholes.</p>

Investigation	<p>The investigation involved a site visit, manhole inspections and CCTV.</p>

Scope	<p>The investigation revealed several critical aspects:</p> <ol style="list-style-type: none">1) One of the manholes had been buried2) A tree consent would be required in order to clear trees for access to be able to excavate the pipe bursting pits3) The pipeline appeared to be shallow in places <p>The concept design was to rehabilitate the pipe using a structural liner and repair the manholes.</p>
Design solution	<p>The detailed design solution was to rehabilitate 130m of the existing sewer with a Expanda spiral wound PVC liner and repair the five manholes by hand, instead of using pipe bursting.</p> <p>This solution was selected for four reasons:</p> <ol style="list-style-type: none">1. By eliminating the need for excavation, the effects on the vegetation and park users could be minimised, simplifying the consent and parks approval process2. The grout obstructions were carefully assessed and we were confident they could be removed using a robotic cutter3. The risk of ground heave in shallow sections was eliminated4. PVC lining was significantly cheaper than bursting (delivered approximately \$40,000 of savings to the client)

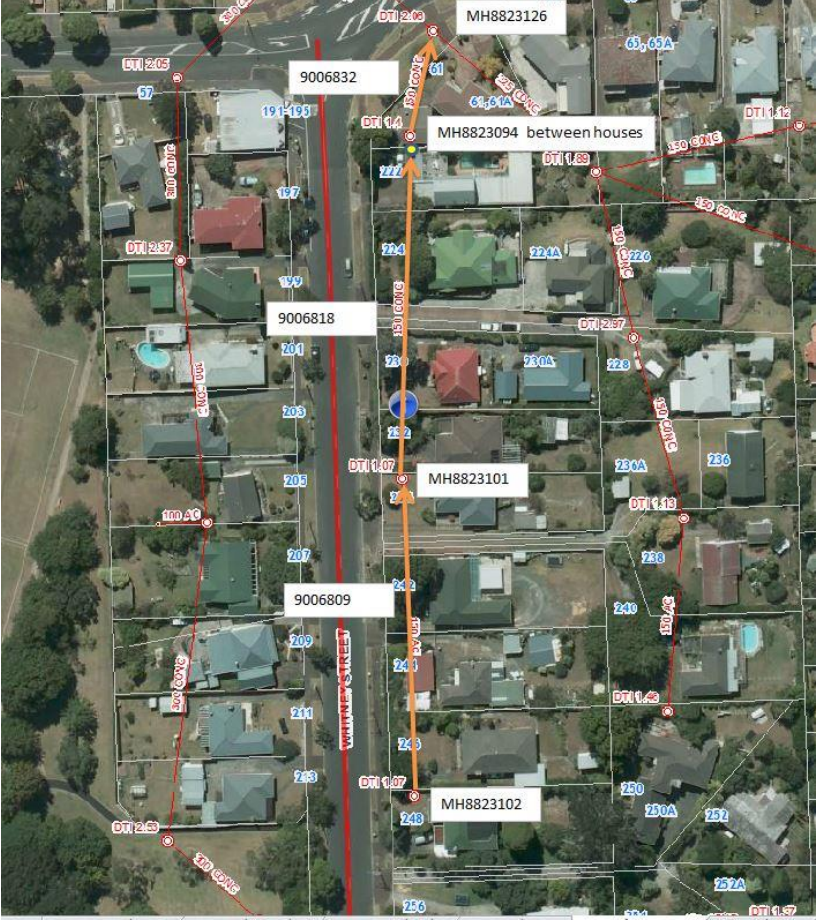
Name of project	Wastewater Renewals 2017 - Whitbey Road,
Summary	A 150NB pitch fibre sewer laid during the 1970s had significant deformation failed resulting in regular blockages. Due to the deformation it was not possible to CCTV large sections of the pipe. The Principal assessed the works would require the replacement of a 176m long sewer line by HDD or open cut.
Original Scope	<p>From the project definition sheet:</p> <p>Relay 176m of existing pitch fibre pipeline by open cut or drilling, installing 3 new manholes.</p>

Investigation	The investigation involved review of house plans, service locations, manhole inspections, CCTV, source detection, arborist assessment, push cam and topographic surveying.

Scope	<p>The investigation revealed several critical aspects:</p> <ol style="list-style-type: none"> 1. The downstream section of the sewer (17m) had been replaced and was in good condition 2. Open cut would be difficult and expensive given the trees and reinstatement costs. 3. For a HDD alignment, the pipe depth would need to be increased, resulting in lateral connections over 3m deep <p>The concept design was to replace the pipe with a new 150NB pipe between the head of the line and the existing manhole MH88230094 - a total of 159 metres, rehabilitate three manholes and reconnect 8 laterals.</p>
Design solution	<p>The design solution was to replace the existing sewer with a 150NB PVC pipe using pipe bursting.</p> <p>This was selected for three reasons:</p> <ol style="list-style-type: none"> 1. The existing manholes could be retained 2. The risk to houses was minimised 3. Service relocation risk was minimised 4. The overall cost was lower than HDD due to the elimination of new manholes and grouting
