THE BATTLE OF WATERLOO

Laurence Edwards (Wellington Water), Rob Blakemore (Wellington Water)

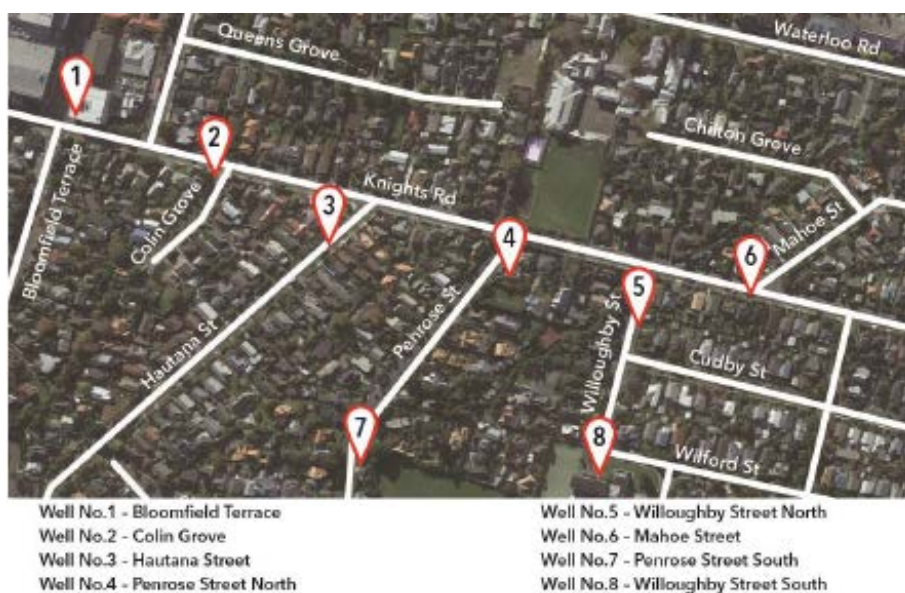
Figure 1: Location of Waterloo wellfield bores

Eight supply bores drawing from the aquifer were installed along Knights Road in Lower Hutt between 1980 and 1989, supplying the Waterloo water treatment plant (WTP) via a single collector main. The bores are located in an urban environment, and all bore heads are below ground level. All of the wells are double cased and their construction complies with the requirements of NZS 4411.

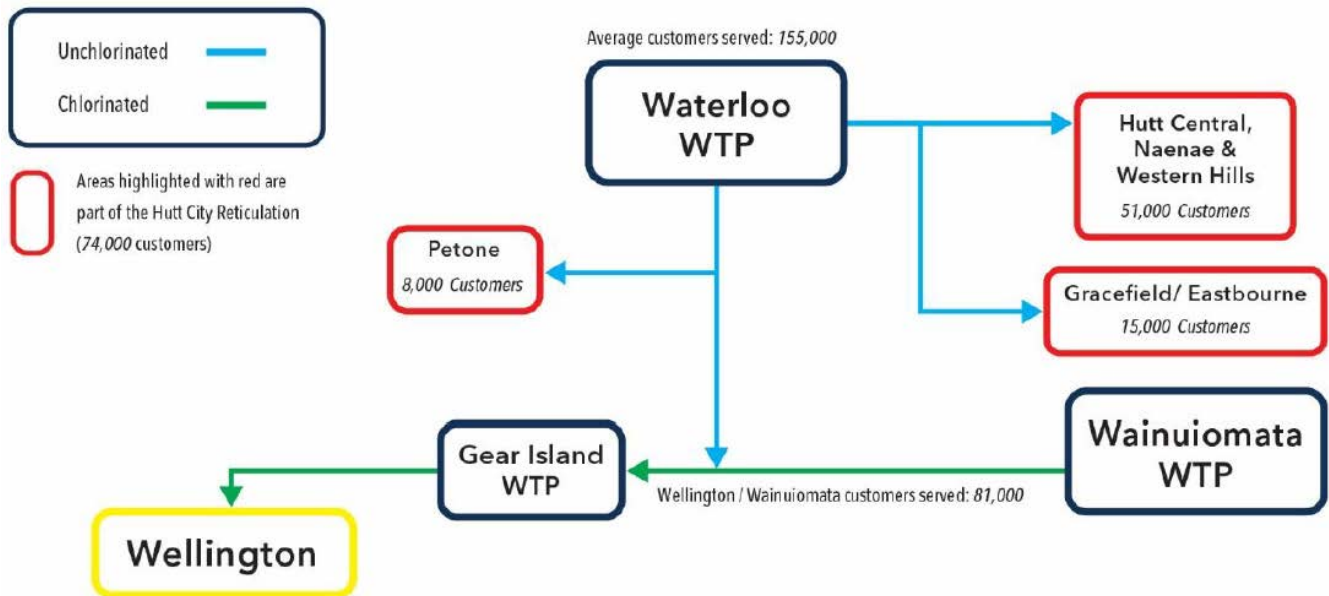
Figure 2 – Chlorinated and Unchlorinated Supplies from Waterloo WTP

The water drawn from the Waiwhetu aquifer that is distributed to much of Hutt City was not normally treated at the Waterloo water treatment plant (WTP) for waterborne pathogens. This is because the aquifer's natural filtration processes and confined environment were relied upon to remove or inactivate them. Water supplied to Wellington from the WTP was treated with chlorine, as indicated schematically below.

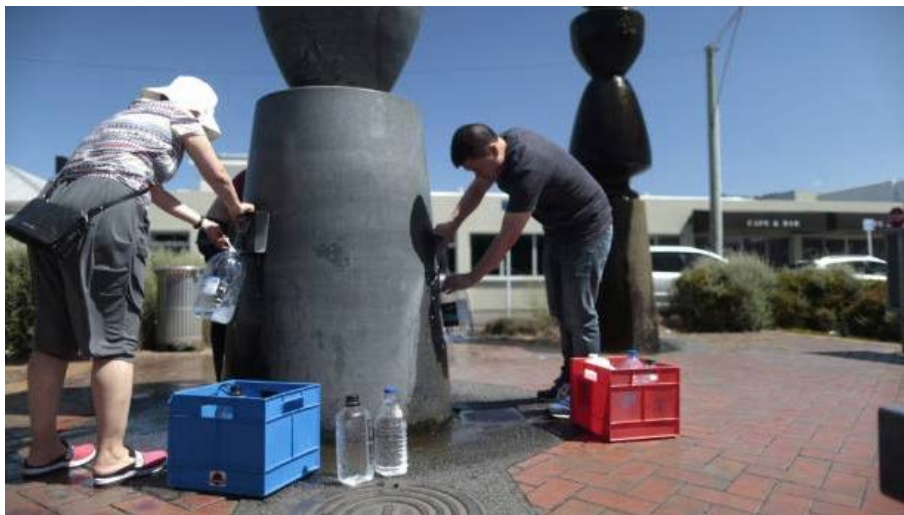
Figure 3 – The Buick Street unchlorinated water supply bore, Petone

Like many areas of New Zealand, residents of Lower Hutt are very proud of their 'pure' unchlorinated aquifer water. Residents are often seen filling bottles from unchlorinated water bores at Buick Street in Petone and Laings Road at the Dowse in Lower Hutt (see Figure 3).

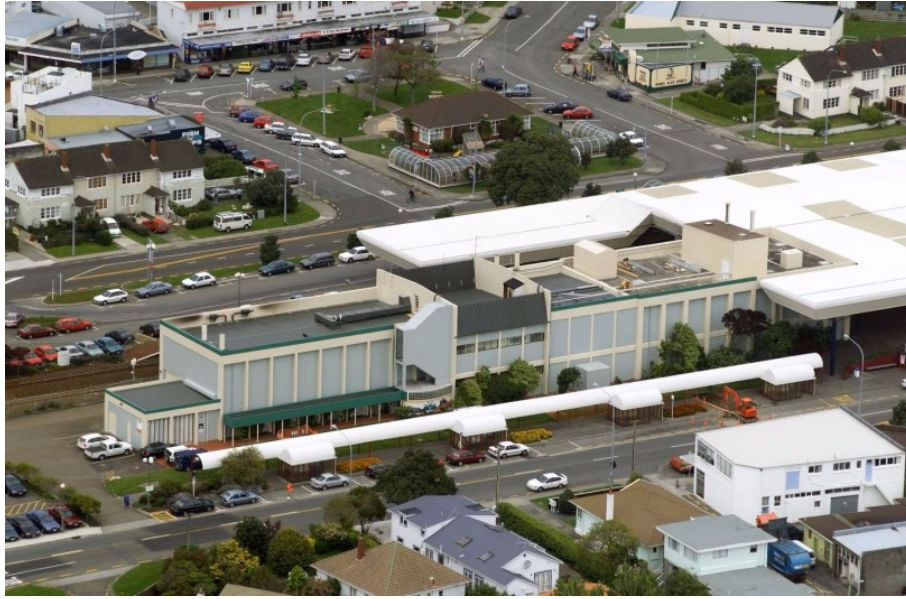
Figure 4 – Waterloo Water Treatment Plant

The Waterloo WTP is immediately adjacent to the Waterloo railway station. The plant is split into twin streams, in which the raw water is aerated and dosed with lime to adjust its pH and reduce its aggressiveness to pipework and fittings.

The two streams allow one stream to be taken offline for maintenance while continuing to supply via the other stream, although at reduced capacity.

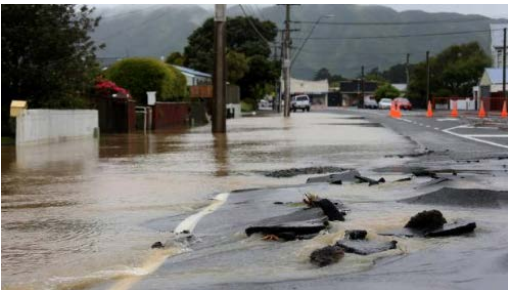
Figure 5 – Udy Street Petone, 15 November 2016

The 14 November 2016 M7.8 Kaikoura earthquake caused significant shaking throughout the Wellington region, resulting in damage to infrastructure including buildings for which repairs are still ongoing. The following day, a significant rainfall event caused flooding in Lower Hutt, including areas around the Knights Road bore field.

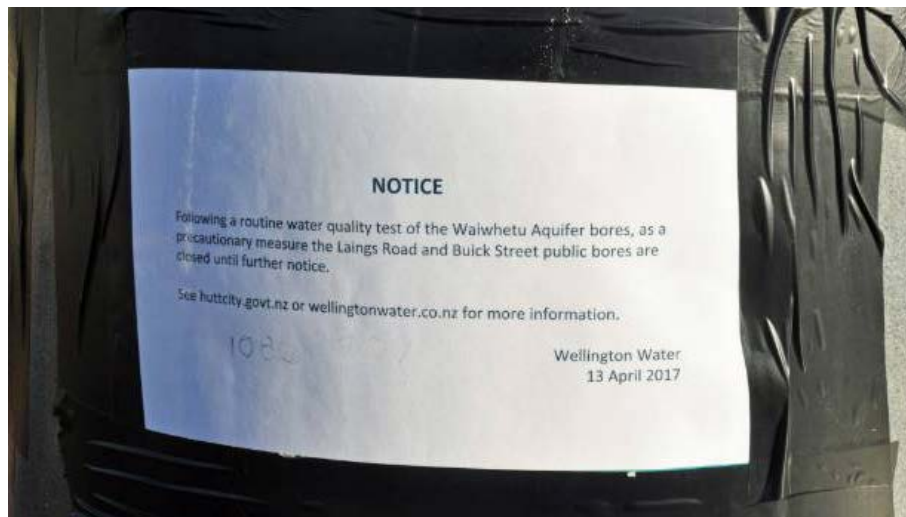
Figures 7 –Buick Street Raw Water Supply Bore and Closure Notice

Positive total coliform test results were received for the public raw water supply wells at Buick Street and the Dowse, which received no treatment. As there was a risk that the water in the Waiwhetu aquifer was contaminated, both well supplies were shut down as a precaution following discussion and agreement with HCC.

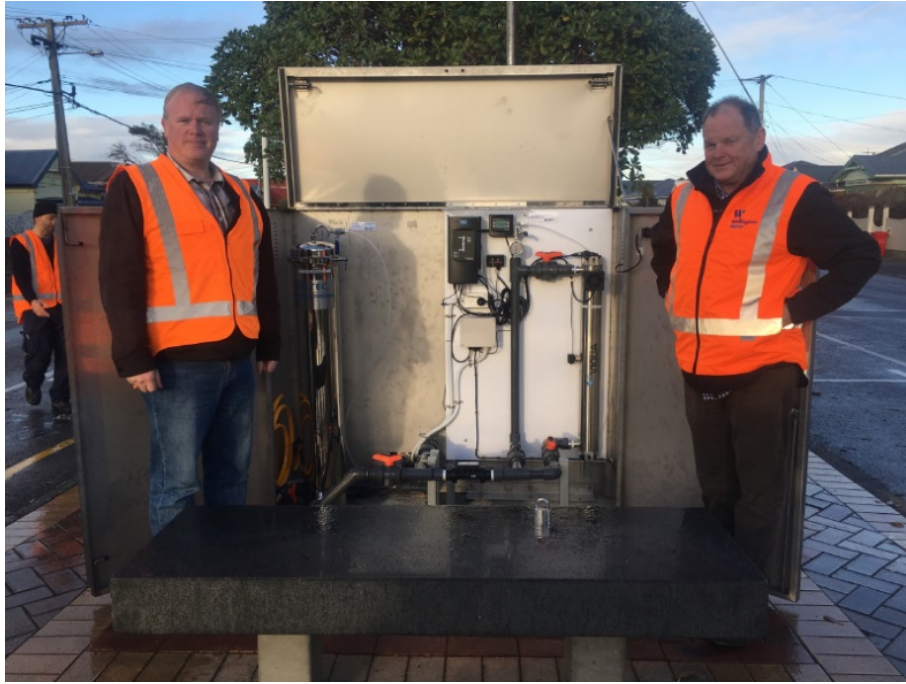
Figure 10 – Package Treatment (UV and filtration) installed at Buick Street

Safe and healthy water could be provided without the need for chlorine from these package treatment plants as there is no distribution network requiring a disinfection residual in case of post treatment contamination.

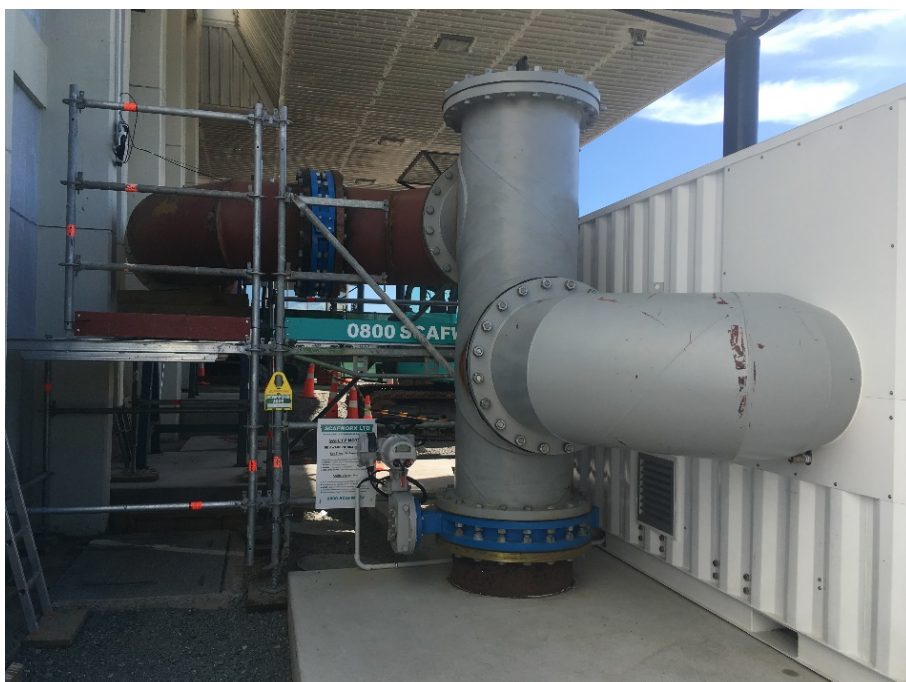
Figure 11 – Installation of UV1 at Waterloo WTP

Providing adequate protection for protozoa risk at the Waterloo WTP then became the focus of our attention. Due to the constrained nature of the site, location of inlet and outlet pipelines, and the need to install and commission at least one UV unit in the shortest possible timeframe to mitigate this risk, a design was developed allowing for containerisation of the first unit, to be located close to the existing inlet pipework.

This concept also allowed for a second UV unit to be installed in another container above the first UV unit in a relatively short timeframe.

Each unit would provide for up to 60 MLD flow capacity, to ensure adequate supply to meet the region's summer demand.
