# ICE PIGGING: A NEW APPROACH TO CLEANING PRESSURISED PIPELINES

*Graeme Berriman, Operations Manager – Ice Pigging (Suez Water)*

Ice Pigging is an innovative technique used for cleaning pressurised water and wastewater pipelines.

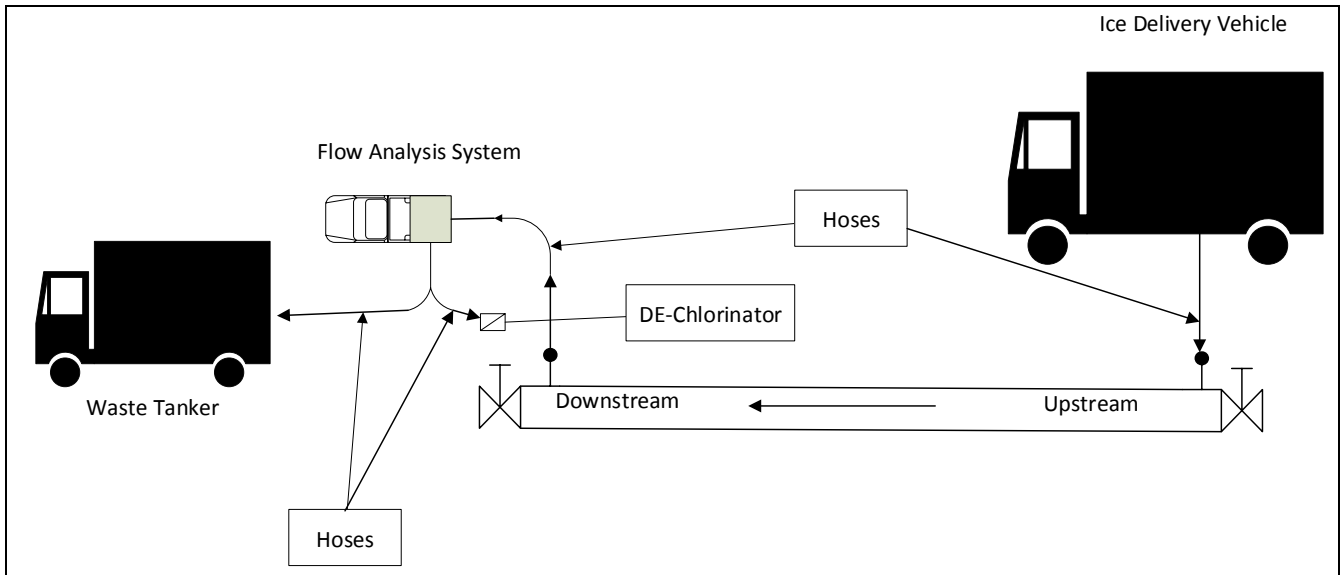
Firstly, the section of main to be cleaned is isolated from mains pressure but kept full of water, the ice is then inserted at one end, whilst the displaced water is discharged from the other end. Once the insertion is complete, both insertion and discharge fittings are closed, and the upstream valve is fully opened, this compresses the ice to form a solid pig and provides the pressure which will propel the ice through the main. The discharge fitting is then opened to discharge the water allowing for the pig to move through the main. *see figure 1.*

Figure 1: Ice Pigging Potable Water Reticulation System

The pipeline is isolated and readied for cleaning. Ice is injected into a Hydrant, once the correct amount of ice has been inserted the upstream valve is opened to repressurise the line to form the pig. The downstream valve located on the flow analysis system is opened and the pig moves through the line, *see figure 1*. At the outlet we measure pressure, temperature, turbidity, and conductivity, salt in the ice.

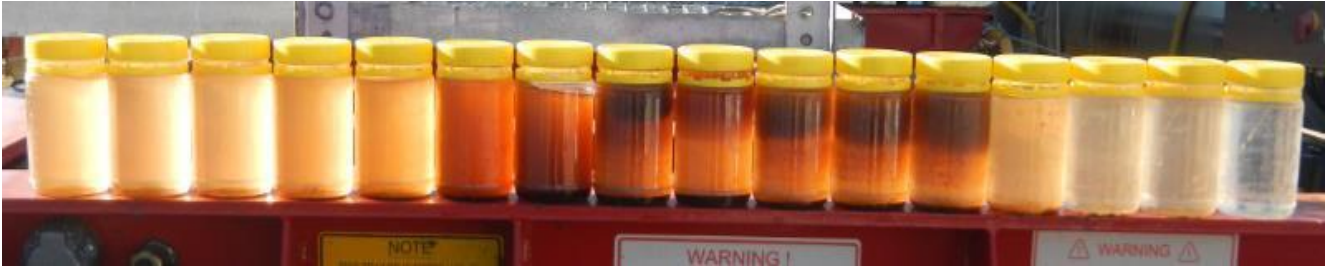
Photograph 1: Samples taken for Operation 1.

As can be seen by the samples above, removal of sediment for this run was substantial. However, this was not an isolated main and the sample are on average consistent with what we found across the system. The samples are then dried out and weighed to give an average amount of sediment per kilometer, allowing the client to get a holistic picture of the condition of the network. As part of the final report we supply the customer with the following type of information, refer table 1.

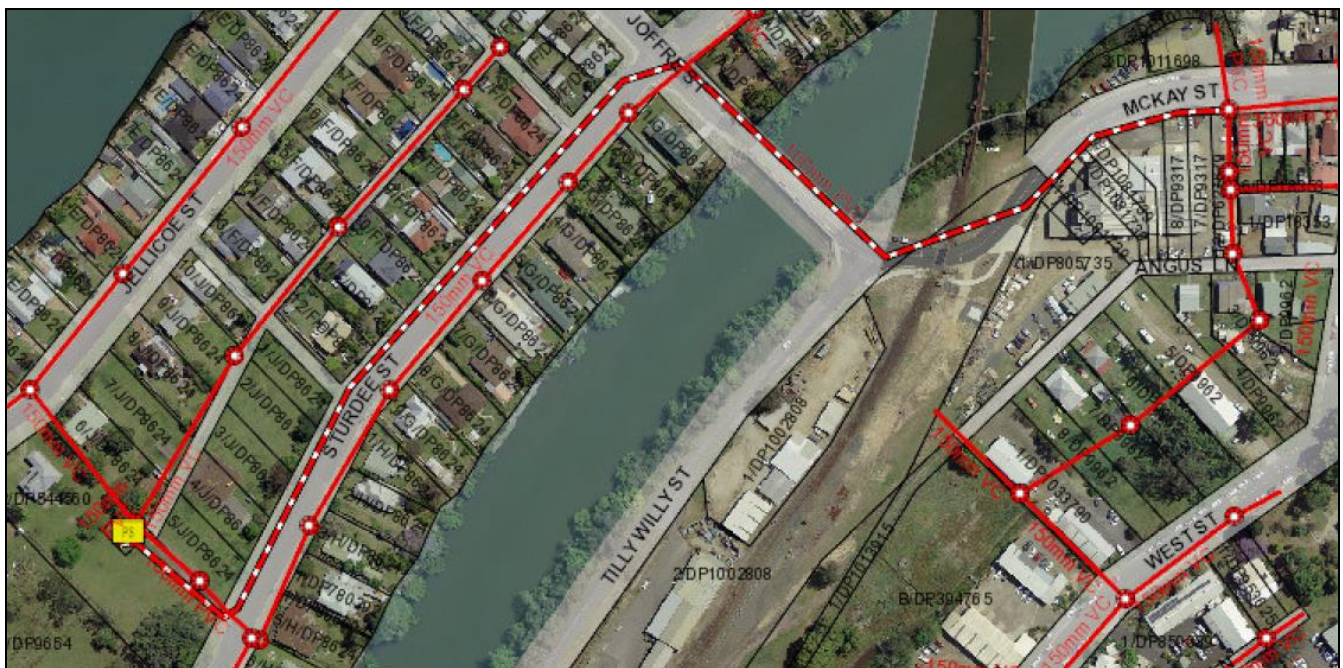
Photograph 2: Red and white, denotes Sewer Rising Main.

As you can see from photograph 3 the pipeline suffered from considerable blockage. The low flows caused by this only exacerbated the situation. We arrived on site and setup to inject the slush ice. As can be seen in photograph 2 there was a section of rising main that crossed Tilly Willy Creek, this was also of concern as the connection points either side of the bridge were made from older galvanized iron fitting. These were heavily corroded, and we decided to have a person station at the creek crossing in case of an incident. Nambucca Shire Council had put a crew on standby in case of a break.

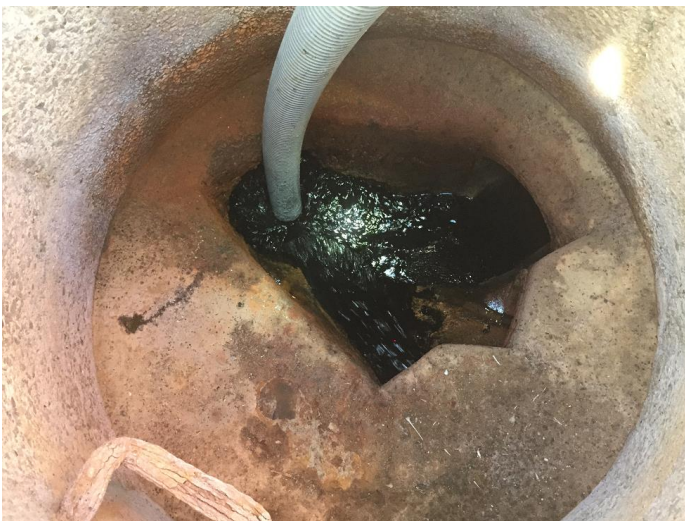
Photograph 4: Ice and sludge arriving at the discharge manhole.

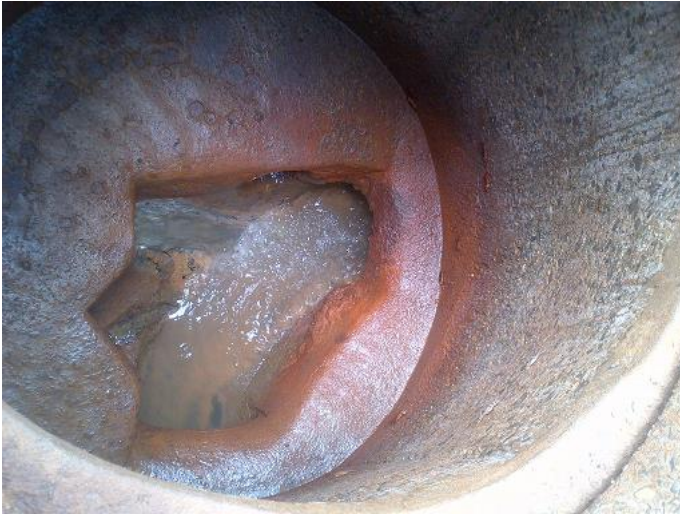
The ice continues to flow through the discharge manhole until it comes clean this shows that the rising main has been cleaned.

*Photograph 4: Clean ice at the discharge manhole.*
