DIGESTER 8 – LESSONS LEARNT CONSTRUCTING NEW ZEALAND’S LARGEST MESOPHILIC WASTEWATER DIGESTER

Andrew Blow (CH2M Beca), Garry Macdonald (CH2M Beca), John Robson (Watercare), Chris Turner (Brian Perry Civil)

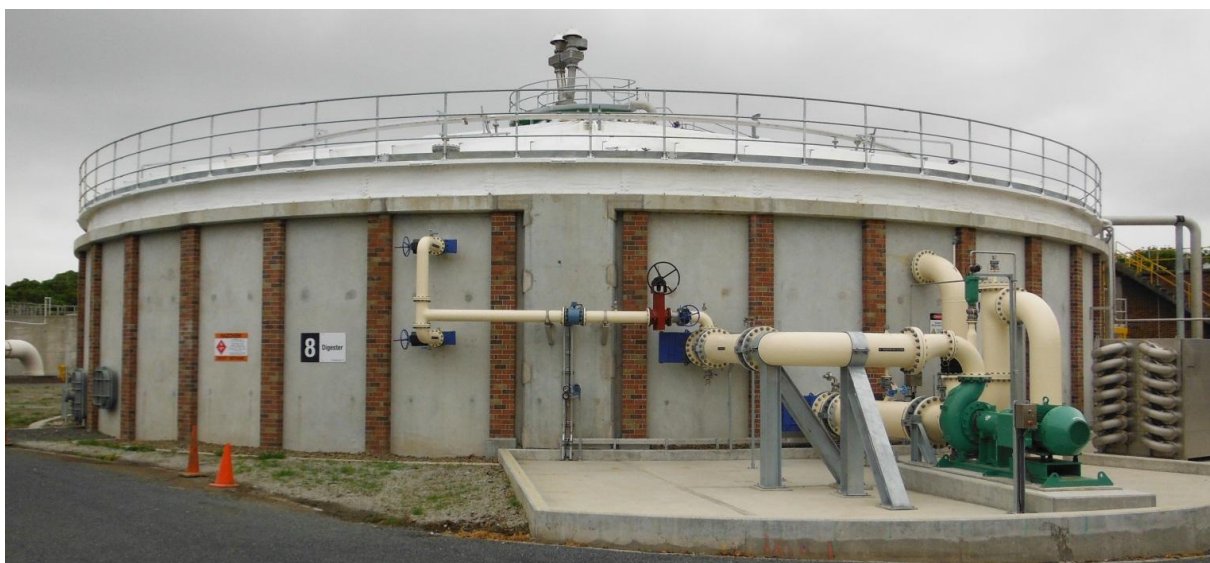
Figure 1 – Digester 8

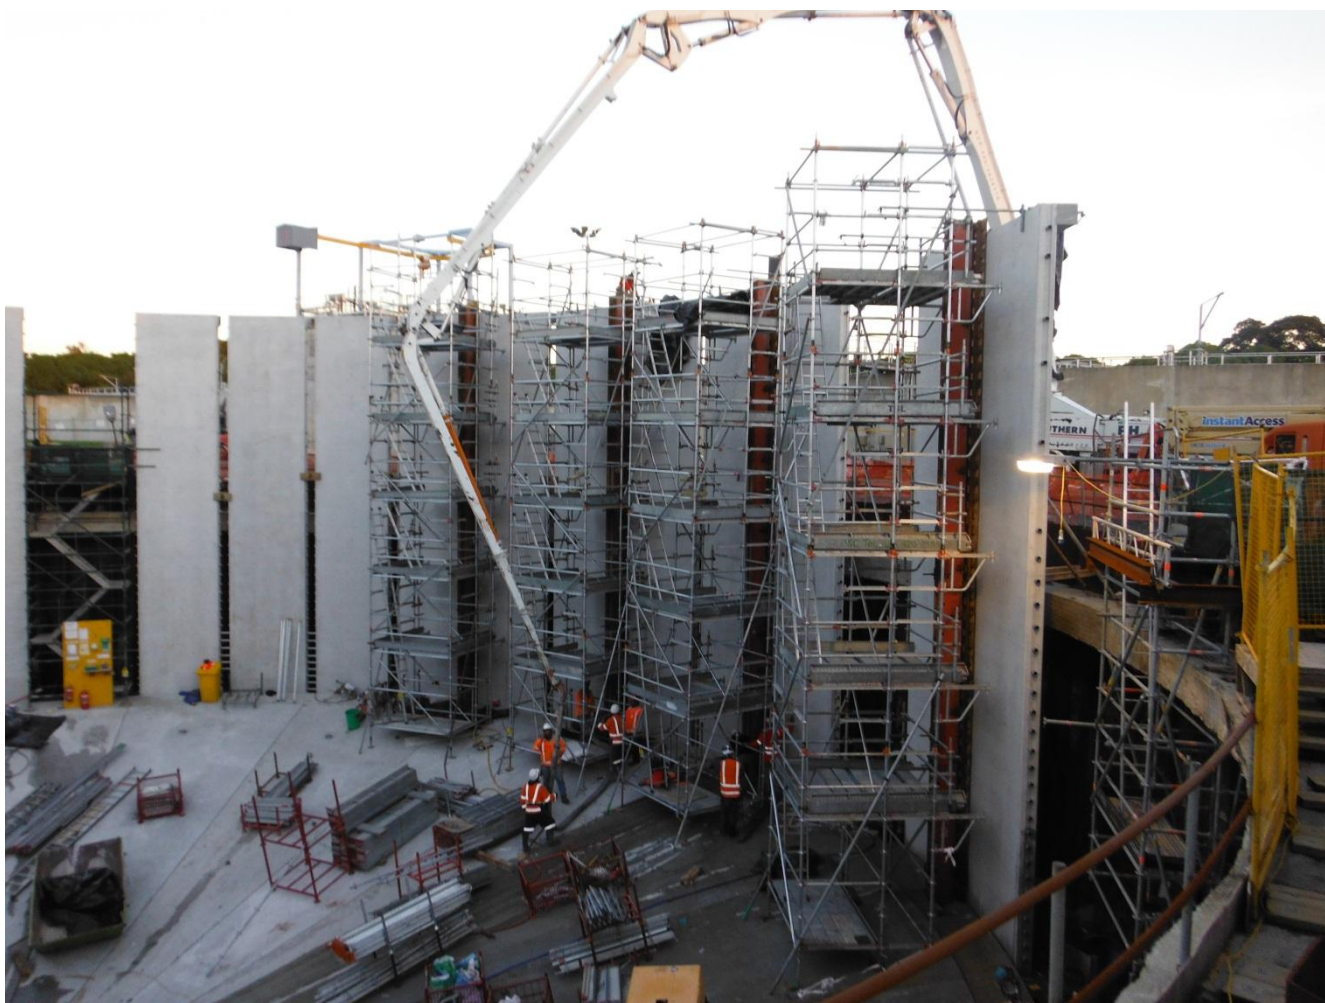
Figure 3 - Wall Stitch Joint Formwork and Concrete Placement. Note: Concrete Enters Near the Stitch Bottom

To undertake the single lift, reinforcement and post-tensioning tendon ducting would be installed, along with Hydrophilic sealing material within the stitch detail, as well as formwork consisting of two large I-beams with a timber facing clamped over the stitch between each panel. Self-compacting concrete would then be pumped to a valved inlet at the bottom of the I-beam clamp and concrete would be placed bottom-up into each stitching.

The constructor's methodology detailed pouring the stitch joints in a single lift to complete these wall panels. A traditional approach is to construct these stitches in two lifts, though this is inefficient with multiple formwork and concrete-placing operations required. A single lift not only meant a reduced overall construction period but it also simplified much of the detail involved, such as eliminating the construction joints between separate lifts.

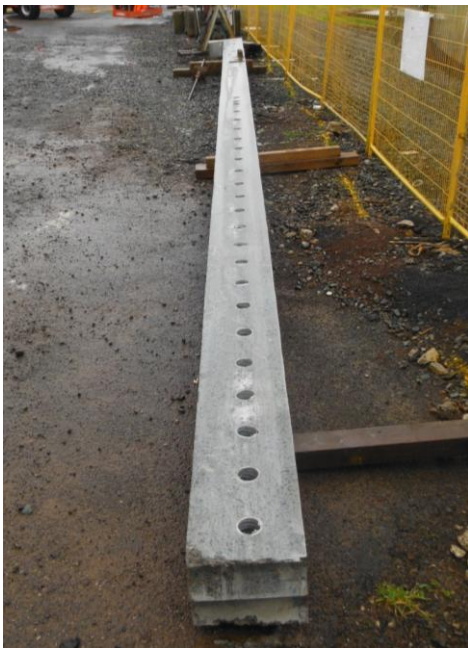
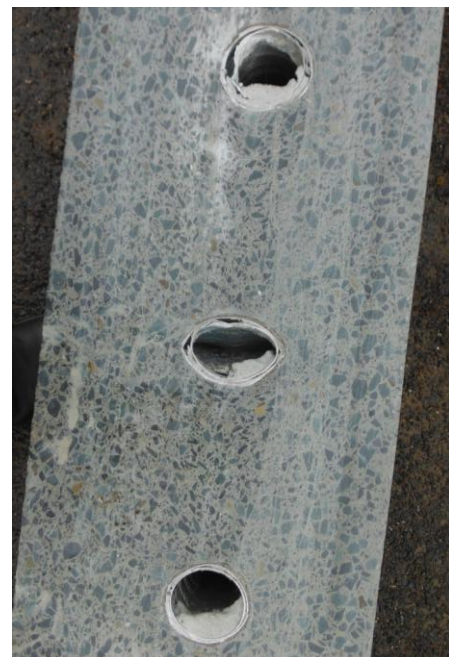
Once two-thirds of the panels were stitched together, installation of post-tensioning strand was trialled. It was found that a number of ducts had deformed or crushed completely, resulting in it being impossible to install post-tensioning tendons.

Extensive CCTV investigations were then undertaken to determine the scale of the problem. As far as practicable (where ducts had crushed it was not possible to CCTV beyond these points), all of the internal ducting was CCTV surveyed to determine the condition. It was estimated that 15 to 20 per cent of the ducting had been severely deformed or crushed. The first eight stitches poured had no duct failures.

Figures 4A and 4B - Saw Cut Removed Stitch Showing Duct Deformities

After trialling of various experimental remedial methods, it was decided that saw-cutting and removing the affected stitch joints (Figures 4A and 4B below) and recasting them was the best-for-project remedial solution.

Through further investigation it was determined that a change to the tendon ducting installation methodology during construction resulted in failure of the ducts due to hydrostatic pressure during placement of the concrete. Ducts were meant to be installed as a solid tube; however, it was found that splitting these tubes lengthways and ‘clamping’ these over the tendon ducting spigots installed in the wall panels enabled significantly more straightforward construction. Splitting of the tubes also could have the detrimental effect of substantially reducing structural strength.

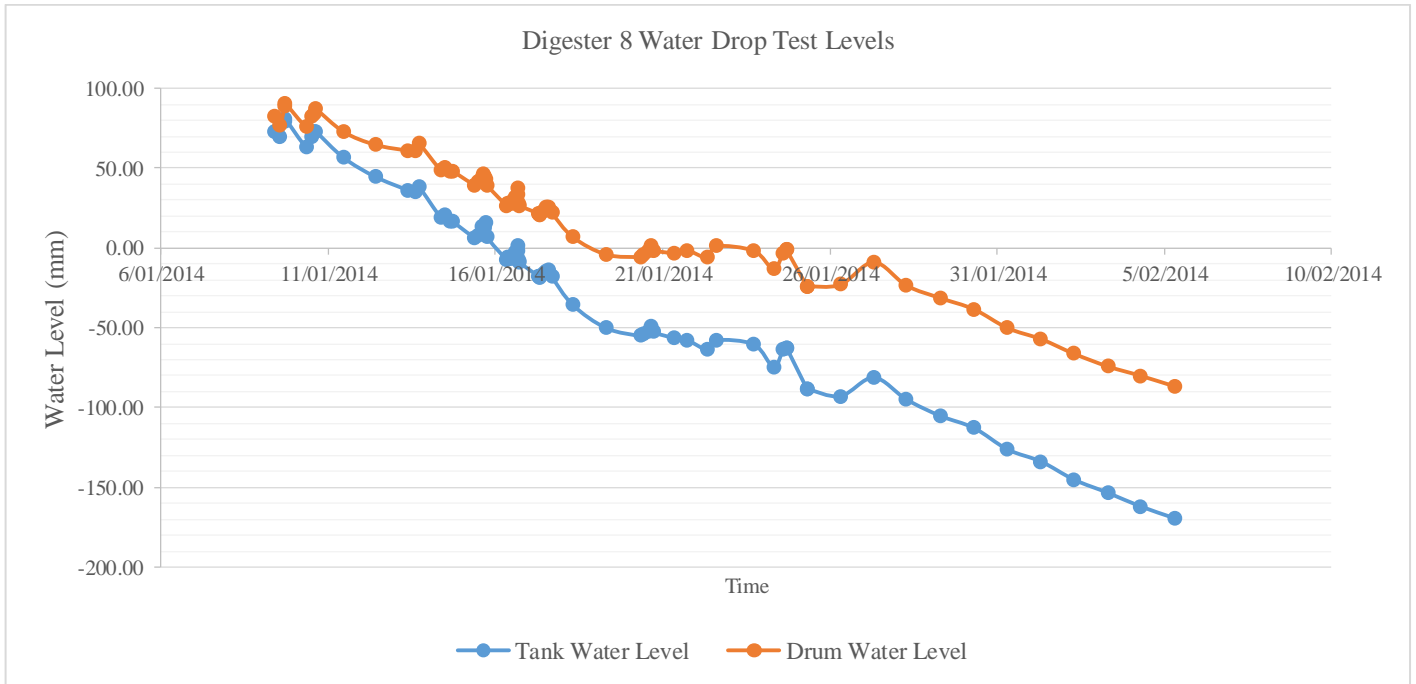
1. Large fluctuations in water levels, and determining whether these could be attributed to evaporation from the open-air tank (see Figure 6)
2. Accounting for precipitation

Figure 6 - Digester 8 Water Drop Test Levels

A reliable and satisfactory method to determine these factors was unable to be realised during the testing period. NZS 3106:2009 is lacking in any stipulated method for accounting for items 1 and 2 above, though significant research and specifications were found to be available internationally. After approximately a month of testing, the specification limits for the drop test were reached, and testing subsequently ceased. The authors suggest that is an area where additional research would be valuable.

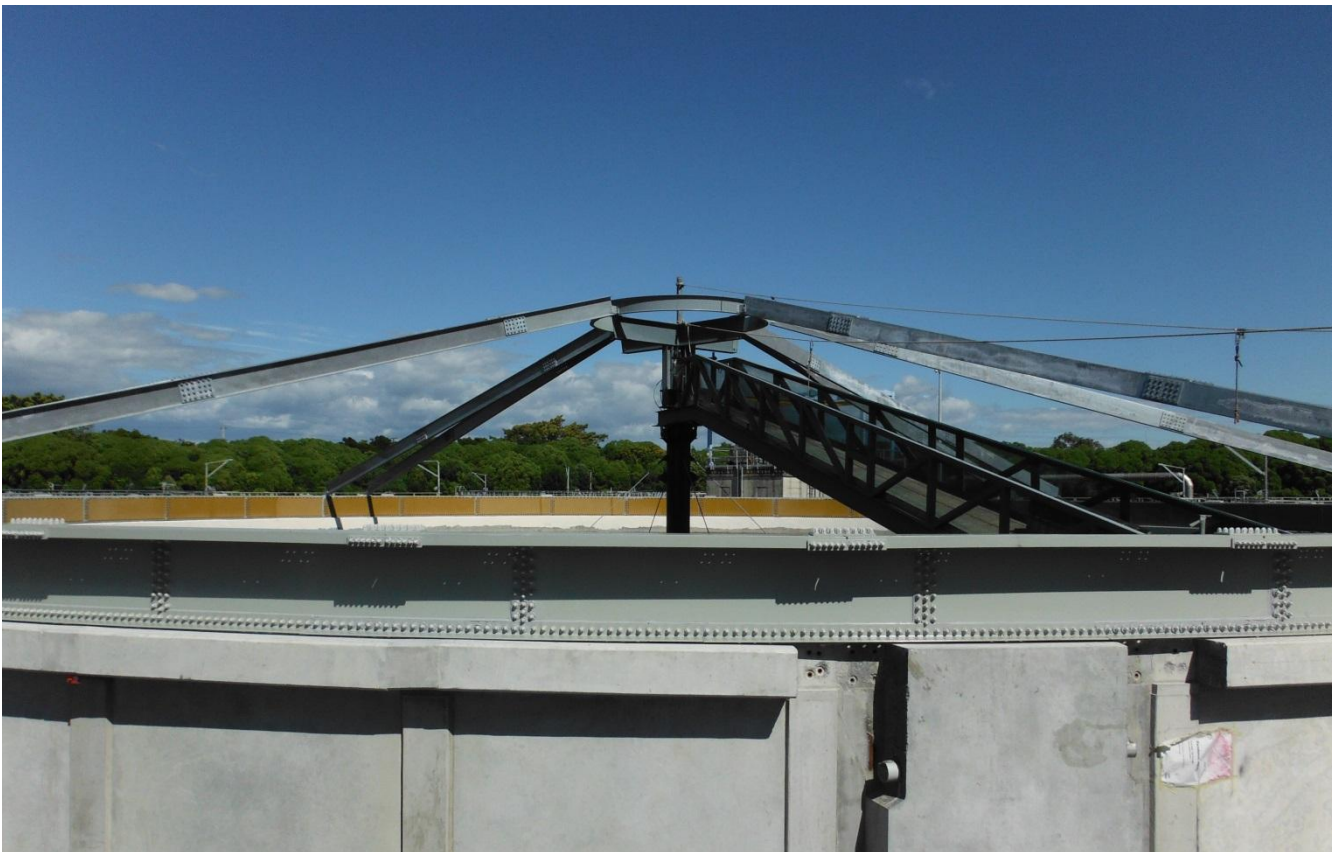
To facilitate installation, the roof specialist's local agent developed an innovative gantry structure. This gave a moving platform that could revolve within the digester to enable installation of roof components.

Figure 8 - Gantry Structure Used to Assist Roof Installation
