DREDGING TO RESTORE RESILIENCE TO A CRITICAL CHRISTCHURCH WATERWAY

B, Peters, S. Woods & A. Park (Stantec New Zealand) , P. Christensen & B. Pasco (Christchurch City Council)

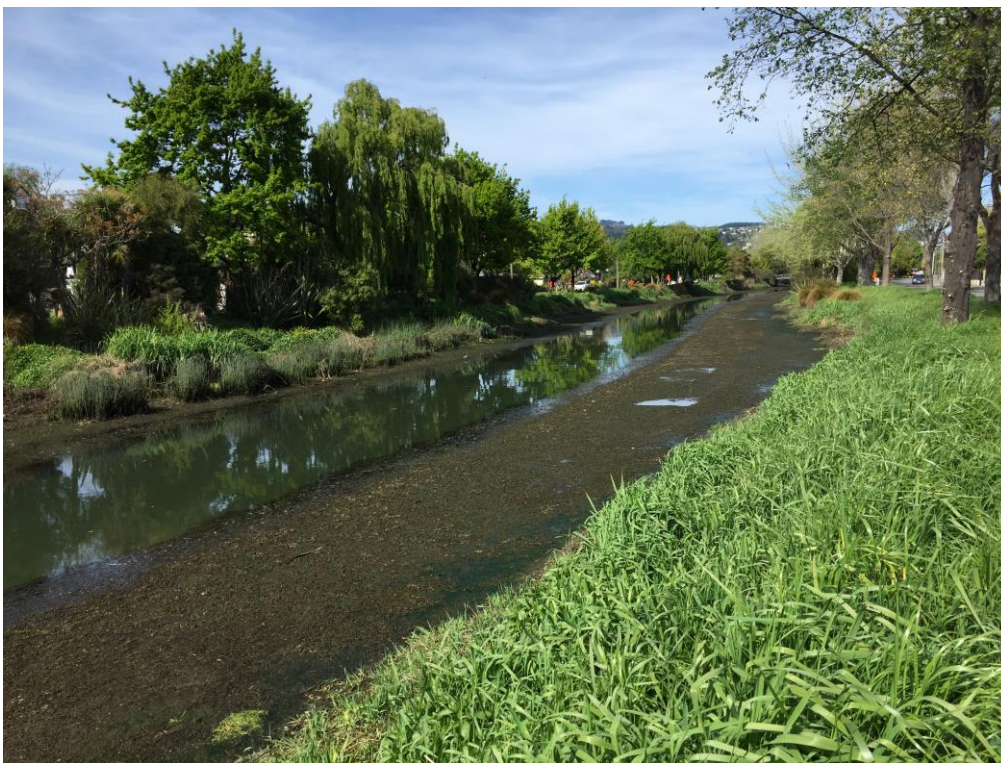
Photograph 1: River Sedimentation in the Heathcote River (low tide)

The CCC, through the LDRP, has initiated a series of investigations and ensuing projects into floodplain management in Christchurch, including in the Ōpāwaho / Heathcote River. The river has a long history of flooding, and the severity and frequency of flooding have both increased as a result of the CES.

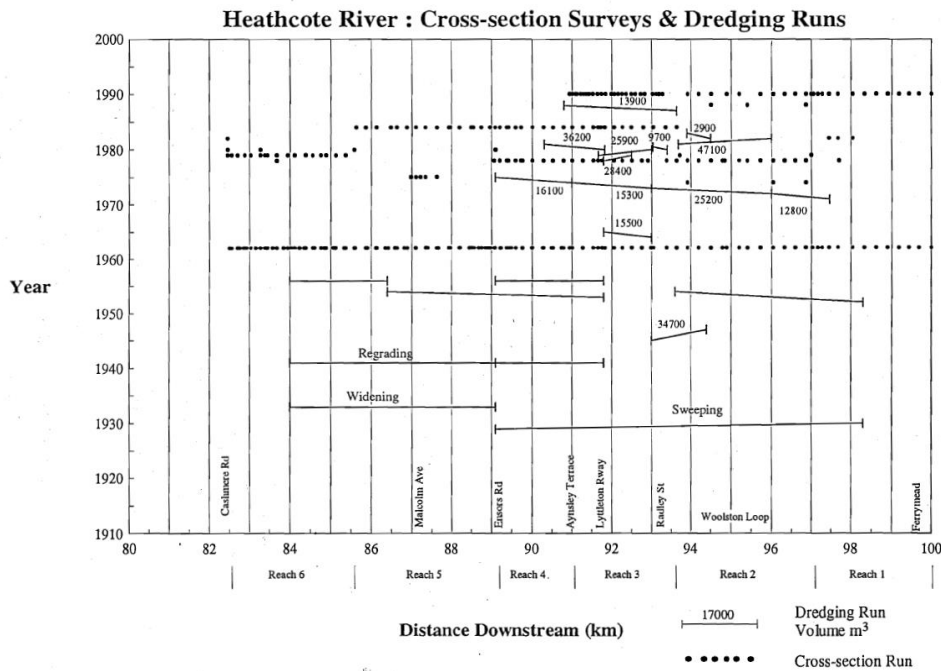
Dredging had previously been undertaken up until approximately 1989, and managed by the Christchurch Drainage Board (CDB). Based on records, regular dredging was undertaken between the late 1920's and 1989. Specifically, the reach between Radley Street and Opawa Road has been dredged frequently (Stage 2), referred to as Reach 3 in Figure 2 below (Hicks, 1993). Figure 2 depicts historical records of the Heathcote Dredging, including longitudinal lengths and volume of dredging.

Figure 2: Historical records of the Heathcote Dredging (Hicks, 1993)

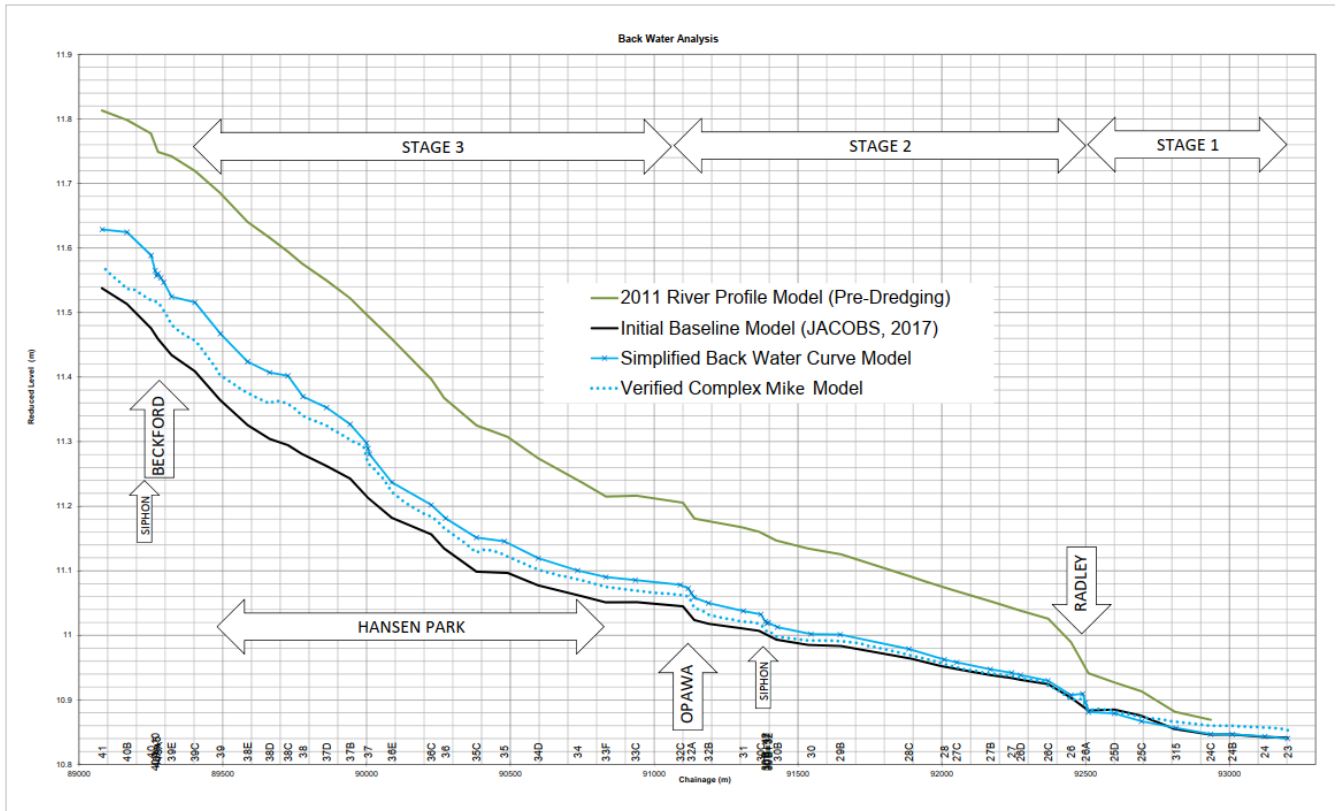
An example of hydraulic comparison of the two model types is shown in Figure 3, and indicates that water level reductions are a close match with the Mike 11 model showing improved reduction in water level over the simplified backwater model.

Figure 3: Comparison between Simplified Backwater Model and Verified Mike 11 Model

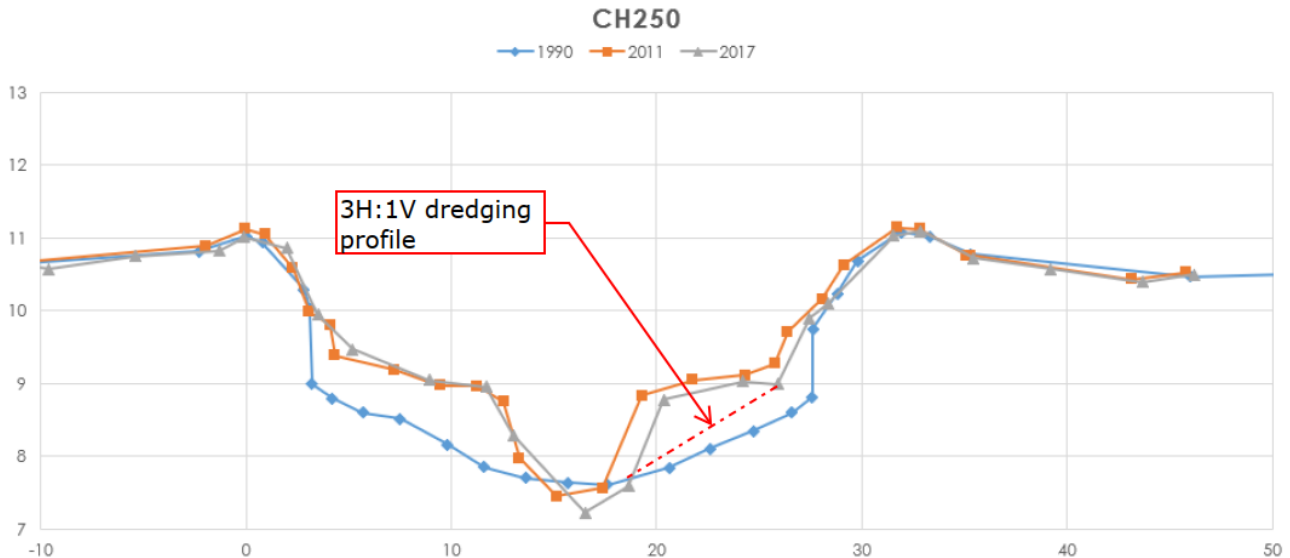
Figure 4 shows the development of sediment accumulation since 1990 at one location (Clarendon Terrace/ Stage 2). The profile appears consistent with what is inferred to be

an accumulation of sediment on the river bank moving the bank toe further towards the river centerline, and a significant thickness of sediment at the current bank (i.e. the vertical distance between the grey and blue lines). The sediment accumulated on the river was found to be soft/loose from site inspection and was determined not to contribute significantly to stability of the natural river bank. The 3H:1V nominal dredging slope is therefore often wholly within river sediments.

Figure 4: Sedimentation since 1990 in the Heathcote River (Clarendon Terrace)

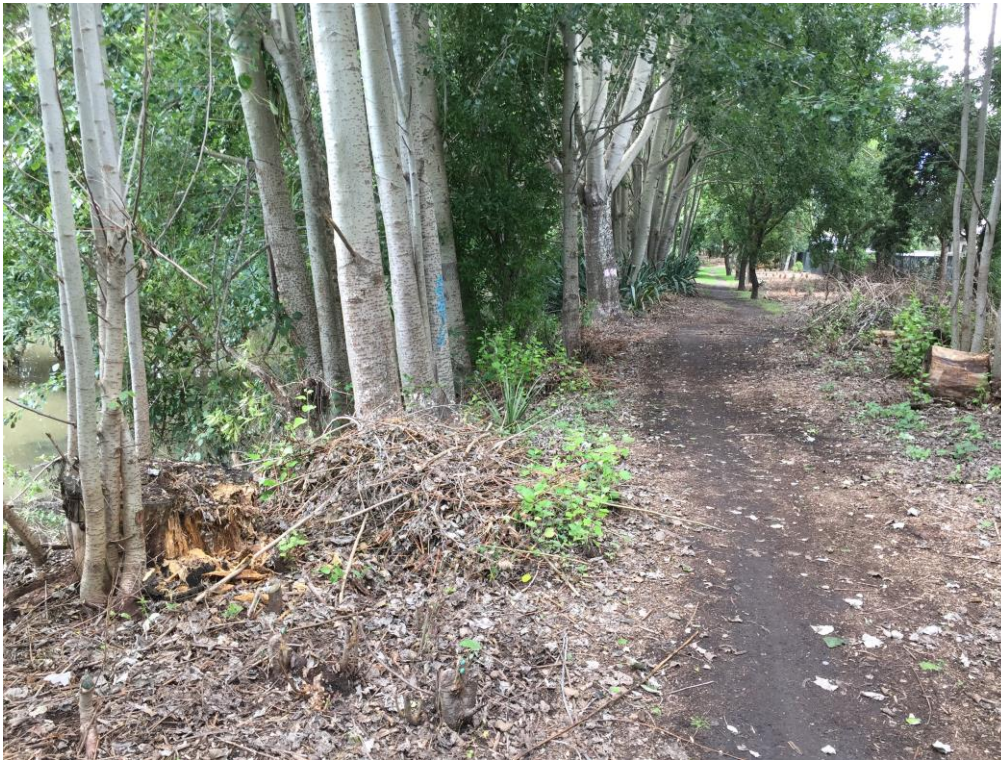
Some areas within the proposed dredging reach are densely vegetated with native and exotic plants along the bank (particularly the Stage 1 area). The established vegetation limits access for dredging and transportation equipment / plant due to narrowness between the vegetated area and the cadastral boundaries. Early engagement with community groups and potential contractors identified an opportunity to combine the access needs of the dredging project with an eradication exercise of a large portion of the problematic white poplar trees. Tree removals were able to be progressed while considering the interests of river access along with landscape amenity and ecological enhancement.

Photograph 2: Access limited by established dense vegetation (Stage 1)

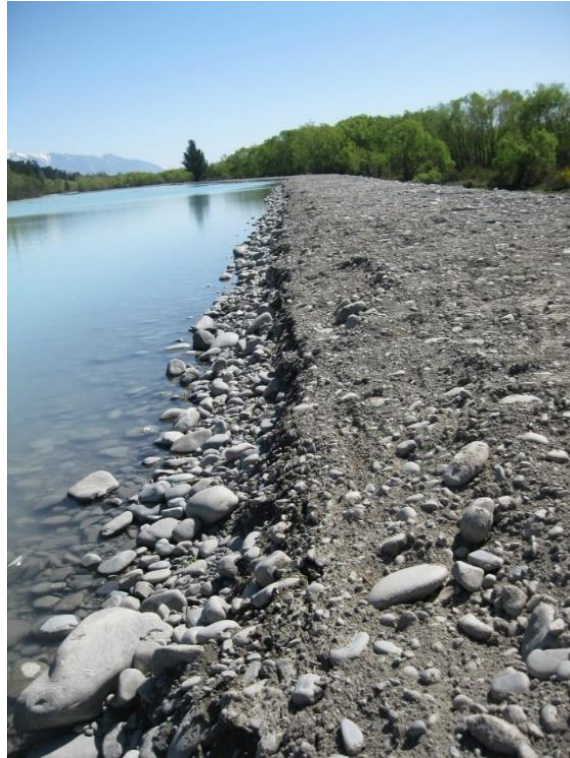
In order to address this erosion potential, a protection layer composed of gravel is applied on the dredged slopes in stretches where the proposed works will expose fresh soil within the tidal range as shown in Figure 5. The gravel layer is tamped into the dredged slope (loose silt sediment) until the surface of gravel layer ceases to exhibit observable movement. Vegetation, that would otherwise provide erosion protection, will not grow below RL 9.6 m based on operational experience and this has, therefore, been adopted as the upper most vertical extent of the erosion protection. The expected behaviours of the erosion protection material is for erosion of the fine fraction to occur leaving behind a 'beach' of larger (> 10 mm) material that is erosion resistant as illustrated in Photograph 3. However, placing a single-sized gravel (i.e. railway ballast) layer was suggested by the contractor due to constructability and availability, and this option was ultimately adopted.

Photograph 3: Beach formed in sandy gravel protection layer (example – not from Heathcote River)

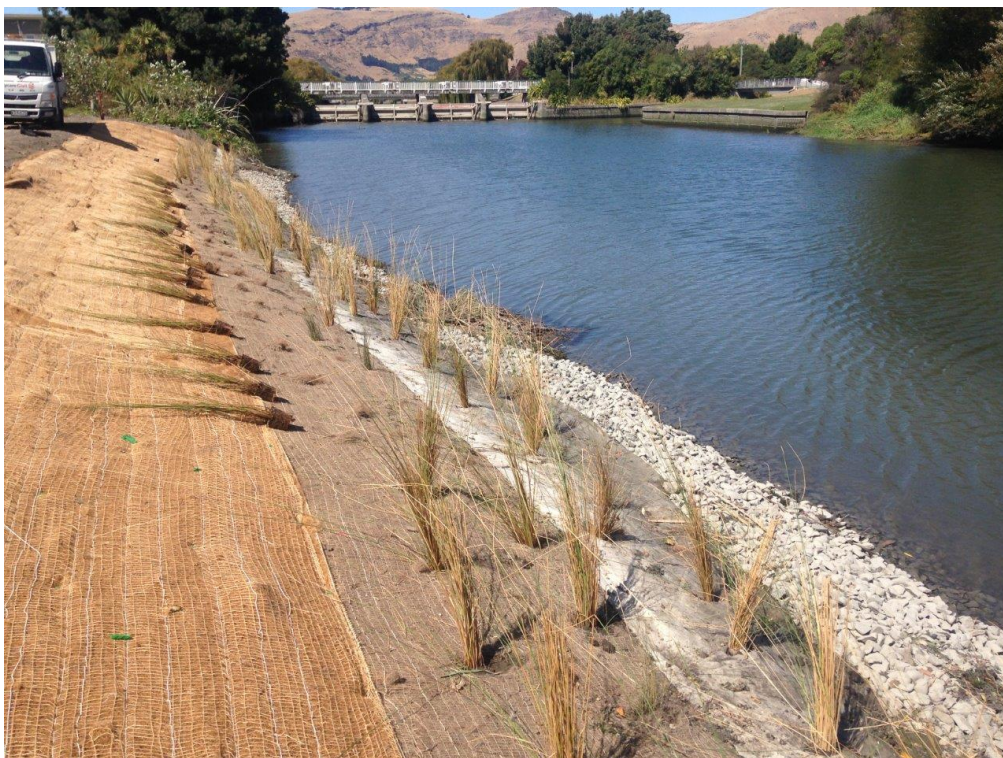
Installing riparian plants above the erosion protection layer will provide ecological habitat, and may potentially encourage inanga spawning. Removing existing trees and re-profiling with milder slope will result in an wide open space on the bank and this is hoped to attract community members to the water edge, encouraging recreational and cultural activities in the Heathcote River.

Photograph 4: Open space on river bank with riparian plants (Connal Reserve)
2019 Stormwater Conference & Expo

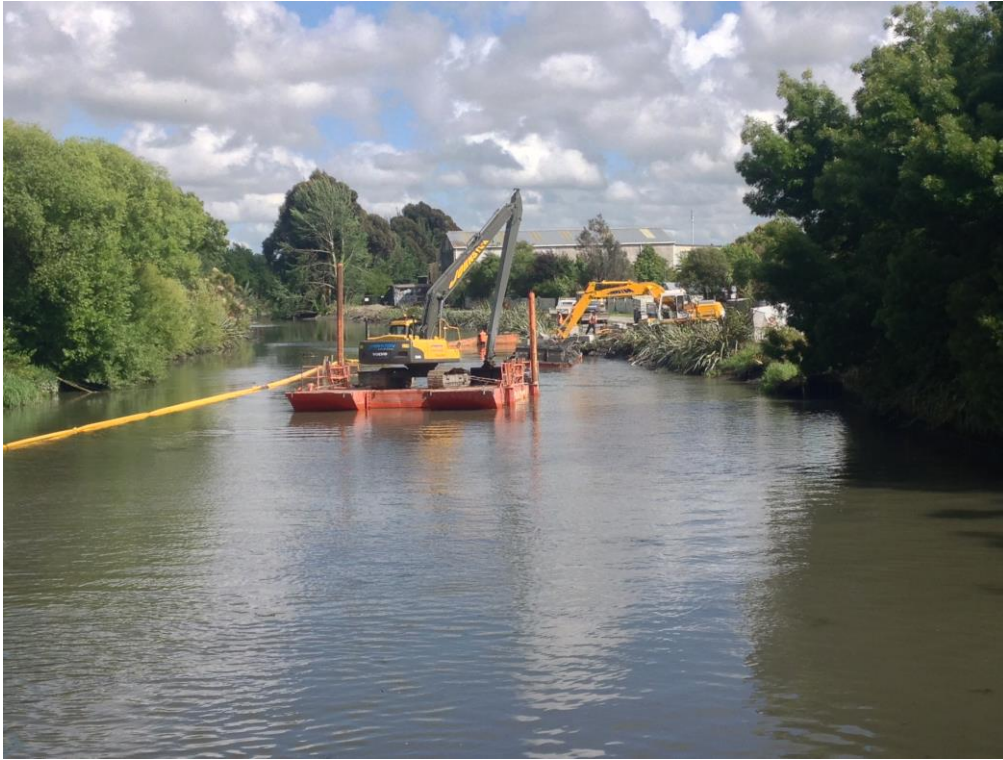
Site works have been primarily driven by access and river characteristics. For the Stage 1 reach, the early identification of tree removals meant good working areas could be established at the upper and lower limits of the dredging reach and dredging by barge with dedicated load-out areas was possible.

Photograph 4: Dredging by barge operation (Stage 1)

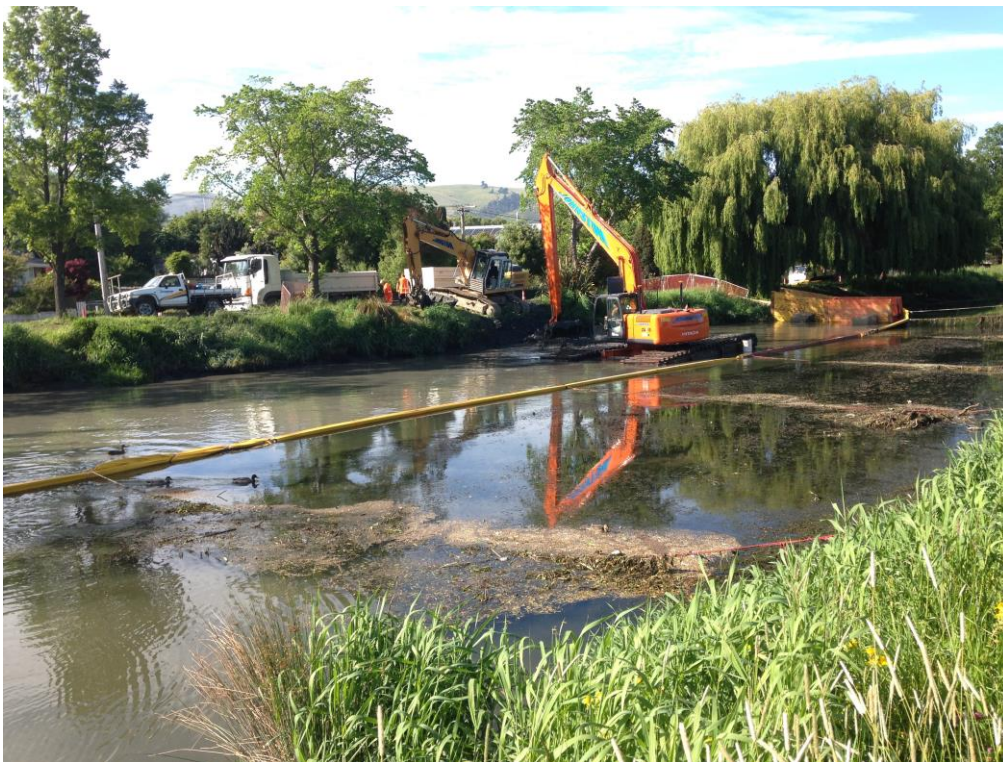
For the Stage 2 reach, access is readily available from adjacent public roads so a moving option of excavation by long reach and/or amphibious excavator was ultimately adopted by the contractor.

Photograph 5: Dredging by long reach and amphibious excavators (Stage 2)
