ADDINGTON BROOK – A CATCHMENT APPROACH TO IMPROVING THE HEALTH OF AN URBAN WATERWAY

J. Watters (Environment Canterbury), M. Stevenson (Environment Canterbury),

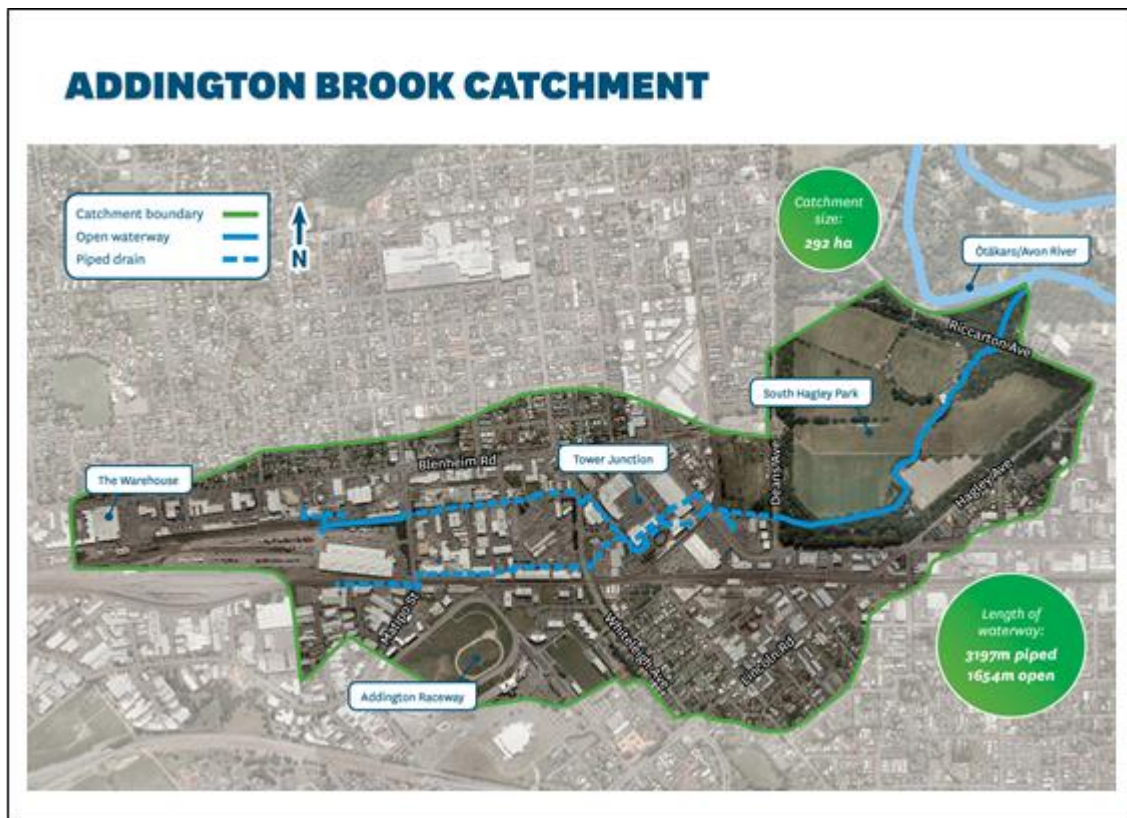
Addington Brook catchment is situated in the south west of Christchurch, fed through spring and stormwater sources (Figure 1). Only a few sections at the top of the catchment are above ground with most of the brook flowing via an underground network of pipes. The brook reemerges to daylight travelling through Hagley park (see Figure 2), undertaking the last leg of its journey through the Botanical Gardens before joining the Ōtākaro / Avon river.

Figure 1. Addington Brook stormwater catchment boundary

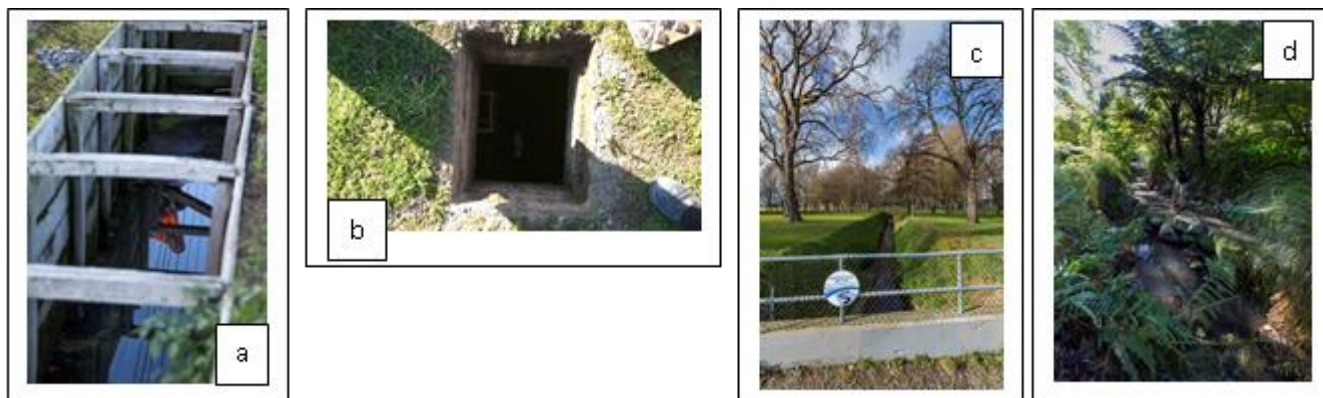
Figure 2. Photos of Addington Brook throughout the catchment
(a) timber-lined box drain upstream of Matipo Street stormwater ponds
(b) view down stormwater sump to the piped brook in mid-catchment
(c) stream as reemerges through Hagley Park
(d) section of stream through the Botanical Gardens

Financial Year	Project / activity Description	Principle
2014 / 15	<ul style="list-style-type: none"> • Three new public signs (Figure 2c) to raise awareness of stream through Hagley Park and the Botanic Gardens • Catchment specific communications material (leaflet and poster) • Full catchment scoping and awareness raising of all drains in catchment leading to Addington Brook • Pollution prevention visits to 32 high risk businesses • Additional monthly instream catchment monitoring and data analysis 	Awareness raising Awareness raising Knowledge gaps / Awareness Raising. Knowledge gaps and Awareness raising Awareness raising Knowledge gaps
2015/16	<ul style="list-style-type: none"> • Autosamplers installed and data analyzed (O’Sullivan and Cochrane, 2017) • CCC Botanic Gardens stormwater visitor display (housed for a year) • SCIRT staff drain stenciling volunteer morning • MEDUSA commissioned in the catchment and initial findings reported (Charters, 2016) • Targeted investigations at O’Shannessey Place as directed by additional catchment monitoring 	Knowledge gaps Awareness raising Awareness raising Knowledge gaps Awareness raising

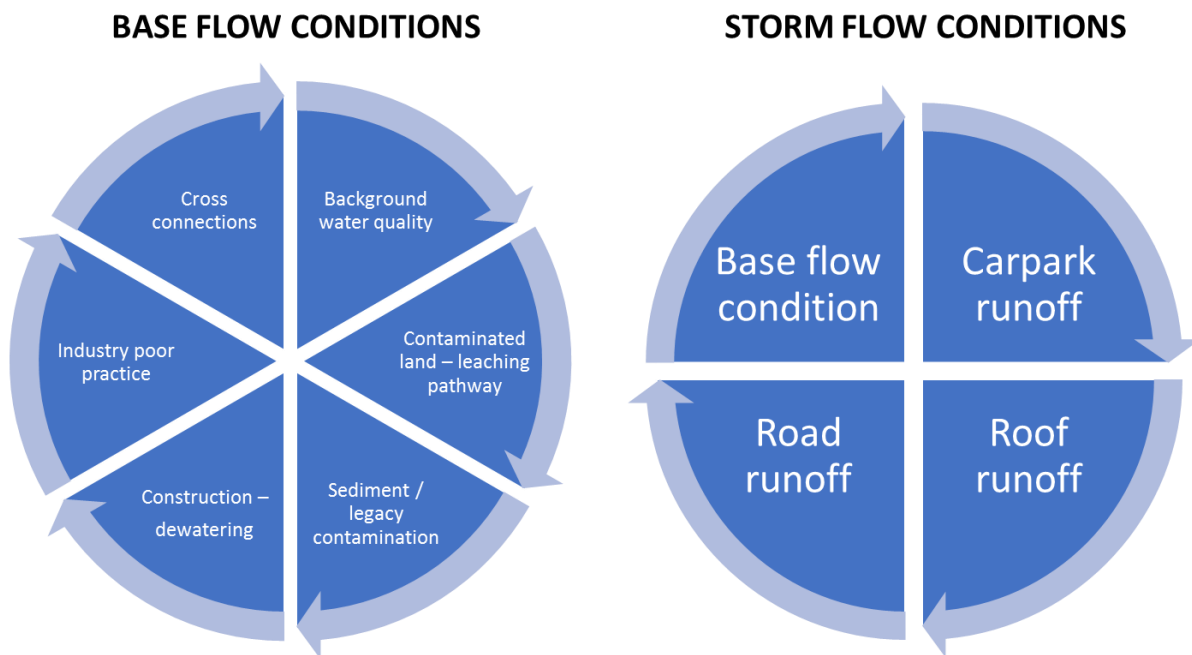
In 2013-14 CCC's water quality data highlighted that Addington Brook had elevated levels of dissolved zinc, dissolved copper, dissolved lead, total ammonia, total suspended solids (TSS), biochemical oxygen demand and *Escherichia coli*, based on consistently recording results well above guideline values and/or recording a number of high one-off events compared to other sites (Margetts 2014). Sampling for CCC's monthly instream water quality monitoring programme typically occurs during dry weather and is limited to one site in the lower reaches of Addington Brook. Therefore, to further investigate the water quality issues we required more detailed catchment monitoring and research for Addington Brook, especially since it is a combined spring and stormwater-fed catchment. A key realization was that the water quality condition of the stream during baseflow and stormflow conditions was impacted by different factors. These are summarized in Figure 3.

Figure 3: Conceptual diagram of the complexity and different factors influencing water quality in base flow and storm flow conditions in an urban stream

In baseflow conditions there can be a diverse range of activities occurring within a mixed land use catchment that can result in contaminants entering a stream. These include cross-connections between the wastewater and stormwater networks, poor site management practices such as washing down of hardstand surfaces into a stormwater sump, and dewatering of construction sites resulting in sediment-laden discharges. Additionally, legacy contaminants may be mobilized from instream sediments or from leaching from contaminated land. All of these factors may be having an influence on top of the existing background water quality, which in the case of a spring-fed stream is driven by the quality of the groundwater in shallow aquifers. It is very difficult to determine the relative importance and contribution of these factors on the instream water quality that we measure.
