AN INNOVATIVE APPROACH TO CONDITION AND DAMAGE ASSESSMENT OF LAND DRAINAGE ASSETS

J. Scott-Hansen and L. Foster

Opus International Consultants, Christchurch, New Zealand

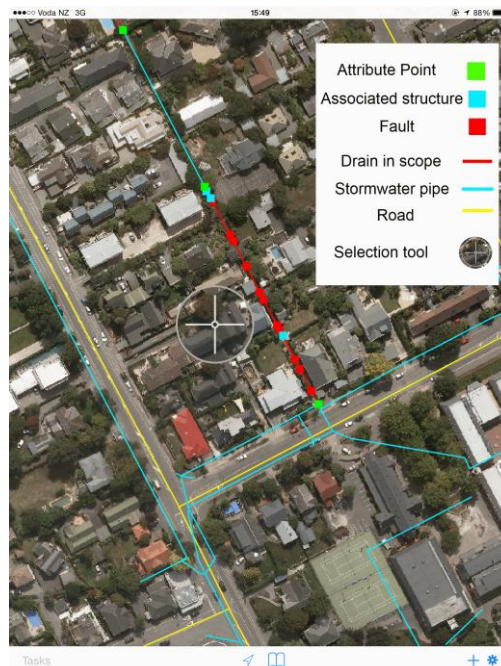
A screenshot of the tablet GIS application can be seen in Figure 2. The image shows the prepopulated GIS information (roads, stormwater pipes and drains), and condition assessment data points (attributes, associated structures and faults) that have been added in the field.

Figure 2: Screenshot of tablet map application showing GIS data and data points captured in the field.

Condition assessment data points could be added in the field in exact locations on the GIS plot of the drain. Adding a new point would trigger a popup window with a template that was then filled out with the required data. Points were added to unique layers depending on their type: attribute, associated structure or fault. The separate layers made post-processing simpler and more efficient as the different types of points could be automatically sorted and separated on download.

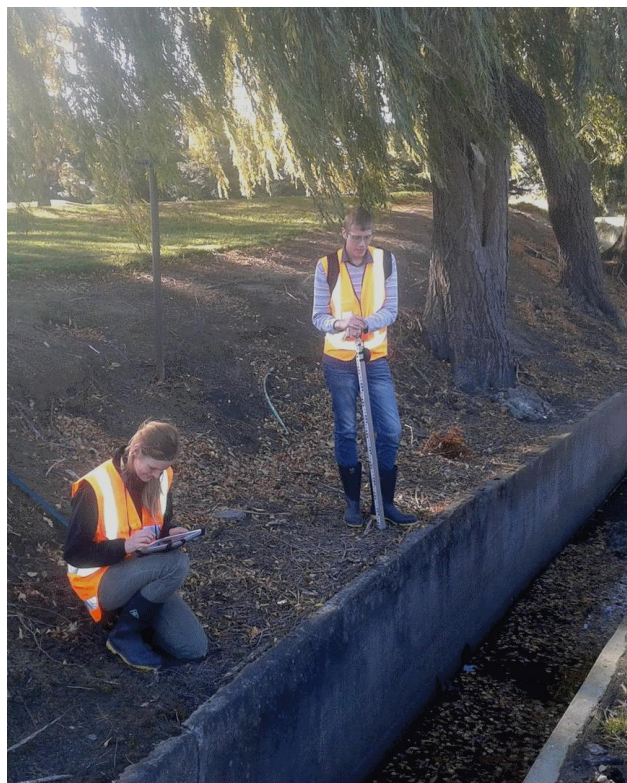
Photograph 1: Field staff collecting condition assessment data on a tablet.

Two people were required to do the field collection, for health and safety reasons, and to make the data collection more efficient. One person would operate the tablet and the other person would focus on measurements and identifying attributes, structures and faults to be collected. Photograph 1 shows field staff capturing asset condition data on the tablet.

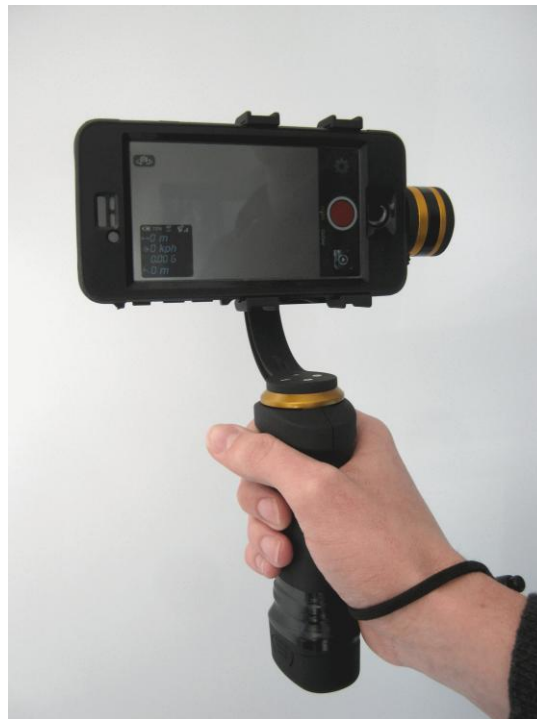
Photograph 2: Setup of geo-referenced video camera on handheld stabilising gimbal.

As with the tablet for the asset data collection, a process of research and development was undertaken to select the appropriate equipment for the video survey. Using drones to capture the footage was considered, however this was discounted due to the difficulty of capturing sufficiently detailed shots, as well as the risk of low flying amongst multiple crash hazards (such as trees). Drones could also potentially generate complaints regarding privacy when flown near private properties. A trial which involved walking along a drain with a handheld camera was conducted. After the trial, it was determined that walking in or along the drain was the most effective method of capturing the video. However, the movement created while walking resulted in the picture being too unstable. As a solution, the camera was mounted on a handheld gimbal to stabilise the footage. The setup of the camera on the gimbal is shown in Photograph 2.

The requirements for the camera included GPS tracking, long battery life, excellent video quality and the capability to support video-capture applications. The latter was particularly important as this allowed capture of the camera position and direction during the recording process along with the video. This information could then be used to calculate other information such as walking pace and distance covered.

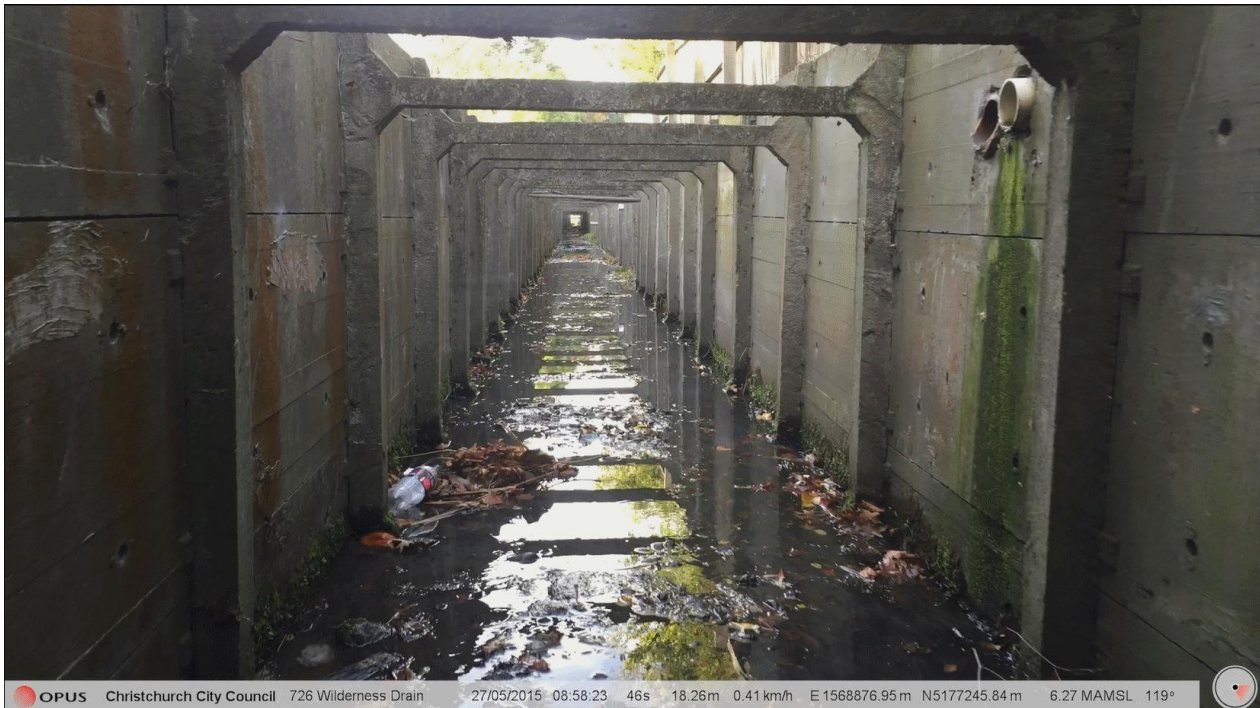
A screenshot from a video of a concrete lined drain can be seen in Figure 3. The data field on the bottom of the screen was added during post-processing of the videos. The field details relevant information such as drain ID and name, time into video (s), distance from upstream point (m), speed (km/h), GPS location, approximate elevation above sea level (MAMSL), and direction.

Figure 3: *Geo-referenced video screenshot. The field on the bottom identifies data in the video such as distance from the upstream point, speed, GPS location, elevation (estimate), and direction.*

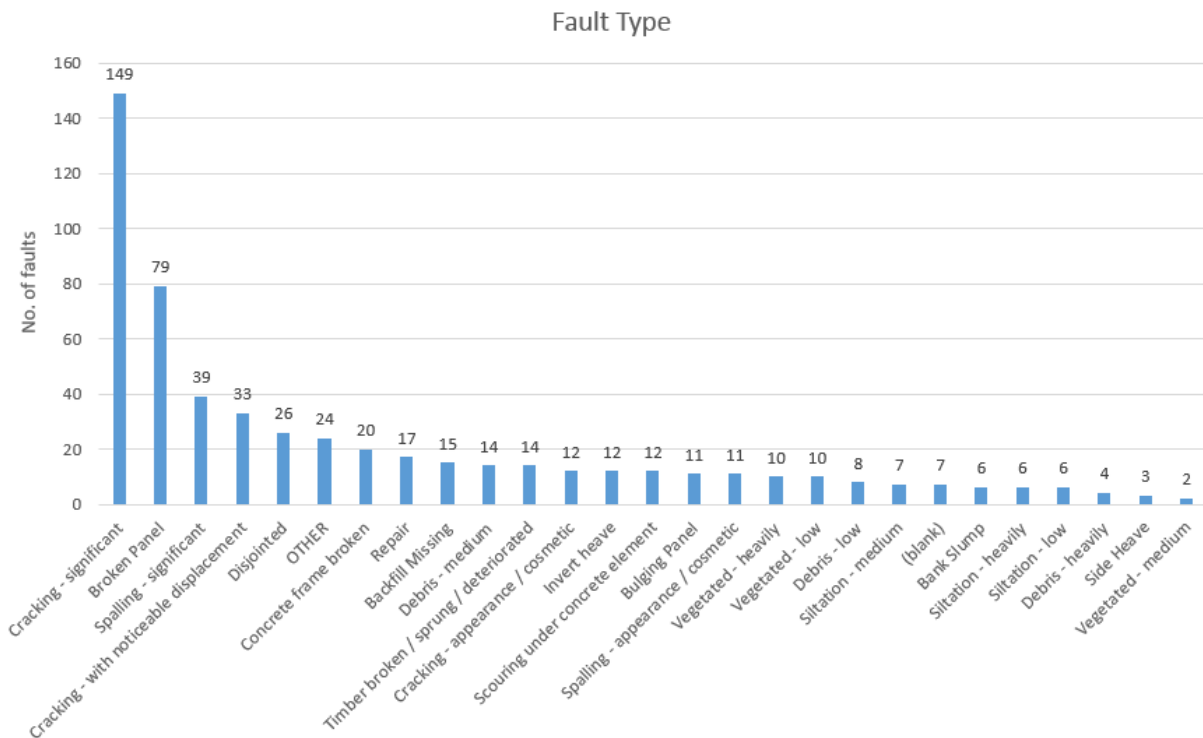
The asset condition data captured in the field were collected into a spreadsheet where attribute data, associated structures and faults were automatically separated into different tabs. The spreadsheet organised all the information in one place and analyses could then be made depending on what output was needed. For example, pivot tables could be generated to examine the most prevalent faults, as shown in Figure 5.

Figure 5: Pivot table result of fault types logged in condition assessment.

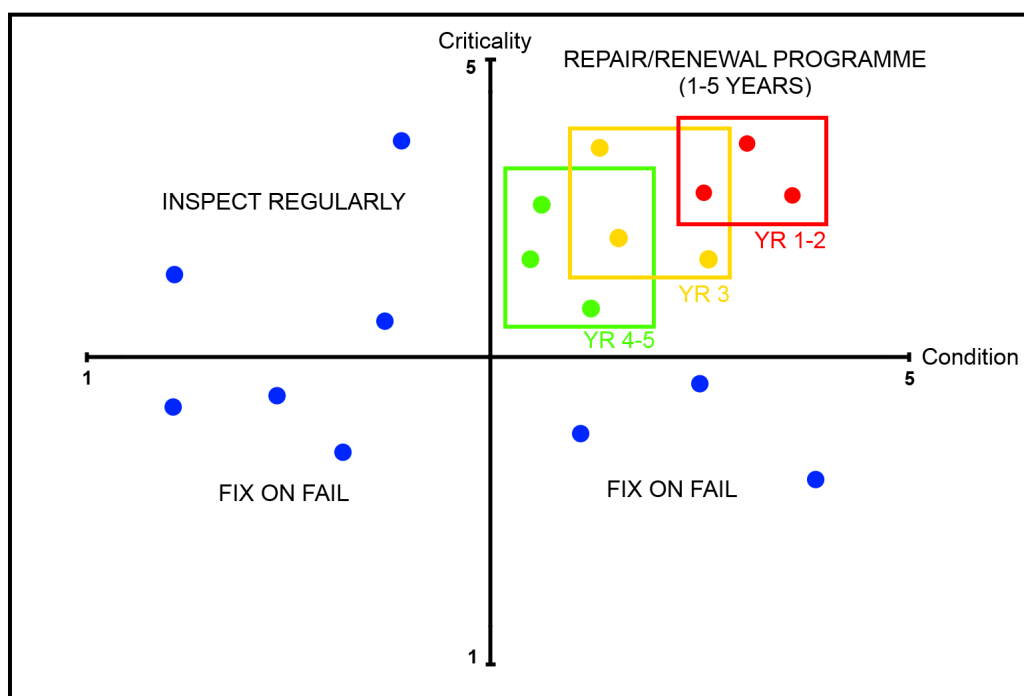
A high-level representation of how the prioritisation can be structured is shown in Figure 8. The figure shows an example of how the prioritisation scores can be divided into different strategy-quadrants. For example, assets that are critical and in poor condition can be arranged into a renewal and repair programme over a set number of years. Regular inspections can be implemented for assets that are critical but in good condition, and assets that are not critical and in good condition can be dealt with at failure or as part of more extensive upgrade programmes.

Figure 8: Example of repair prioritisation programme based on asset criticality and condition scores.

The prioritisation of renewals would be based on the product of the criticality score and the average condition score. Both elements were scored from 1 to 5, with 1 being not critical/good condition, and 5 being highly critical/very poor condition (ie a prioritisation score of 25 signifies a highly critical and very poor condition drain section).
