Collaborative Experiences in Effective Water Network Improvements

September 2019

Zoran Pilipovic and Mike Dunstone

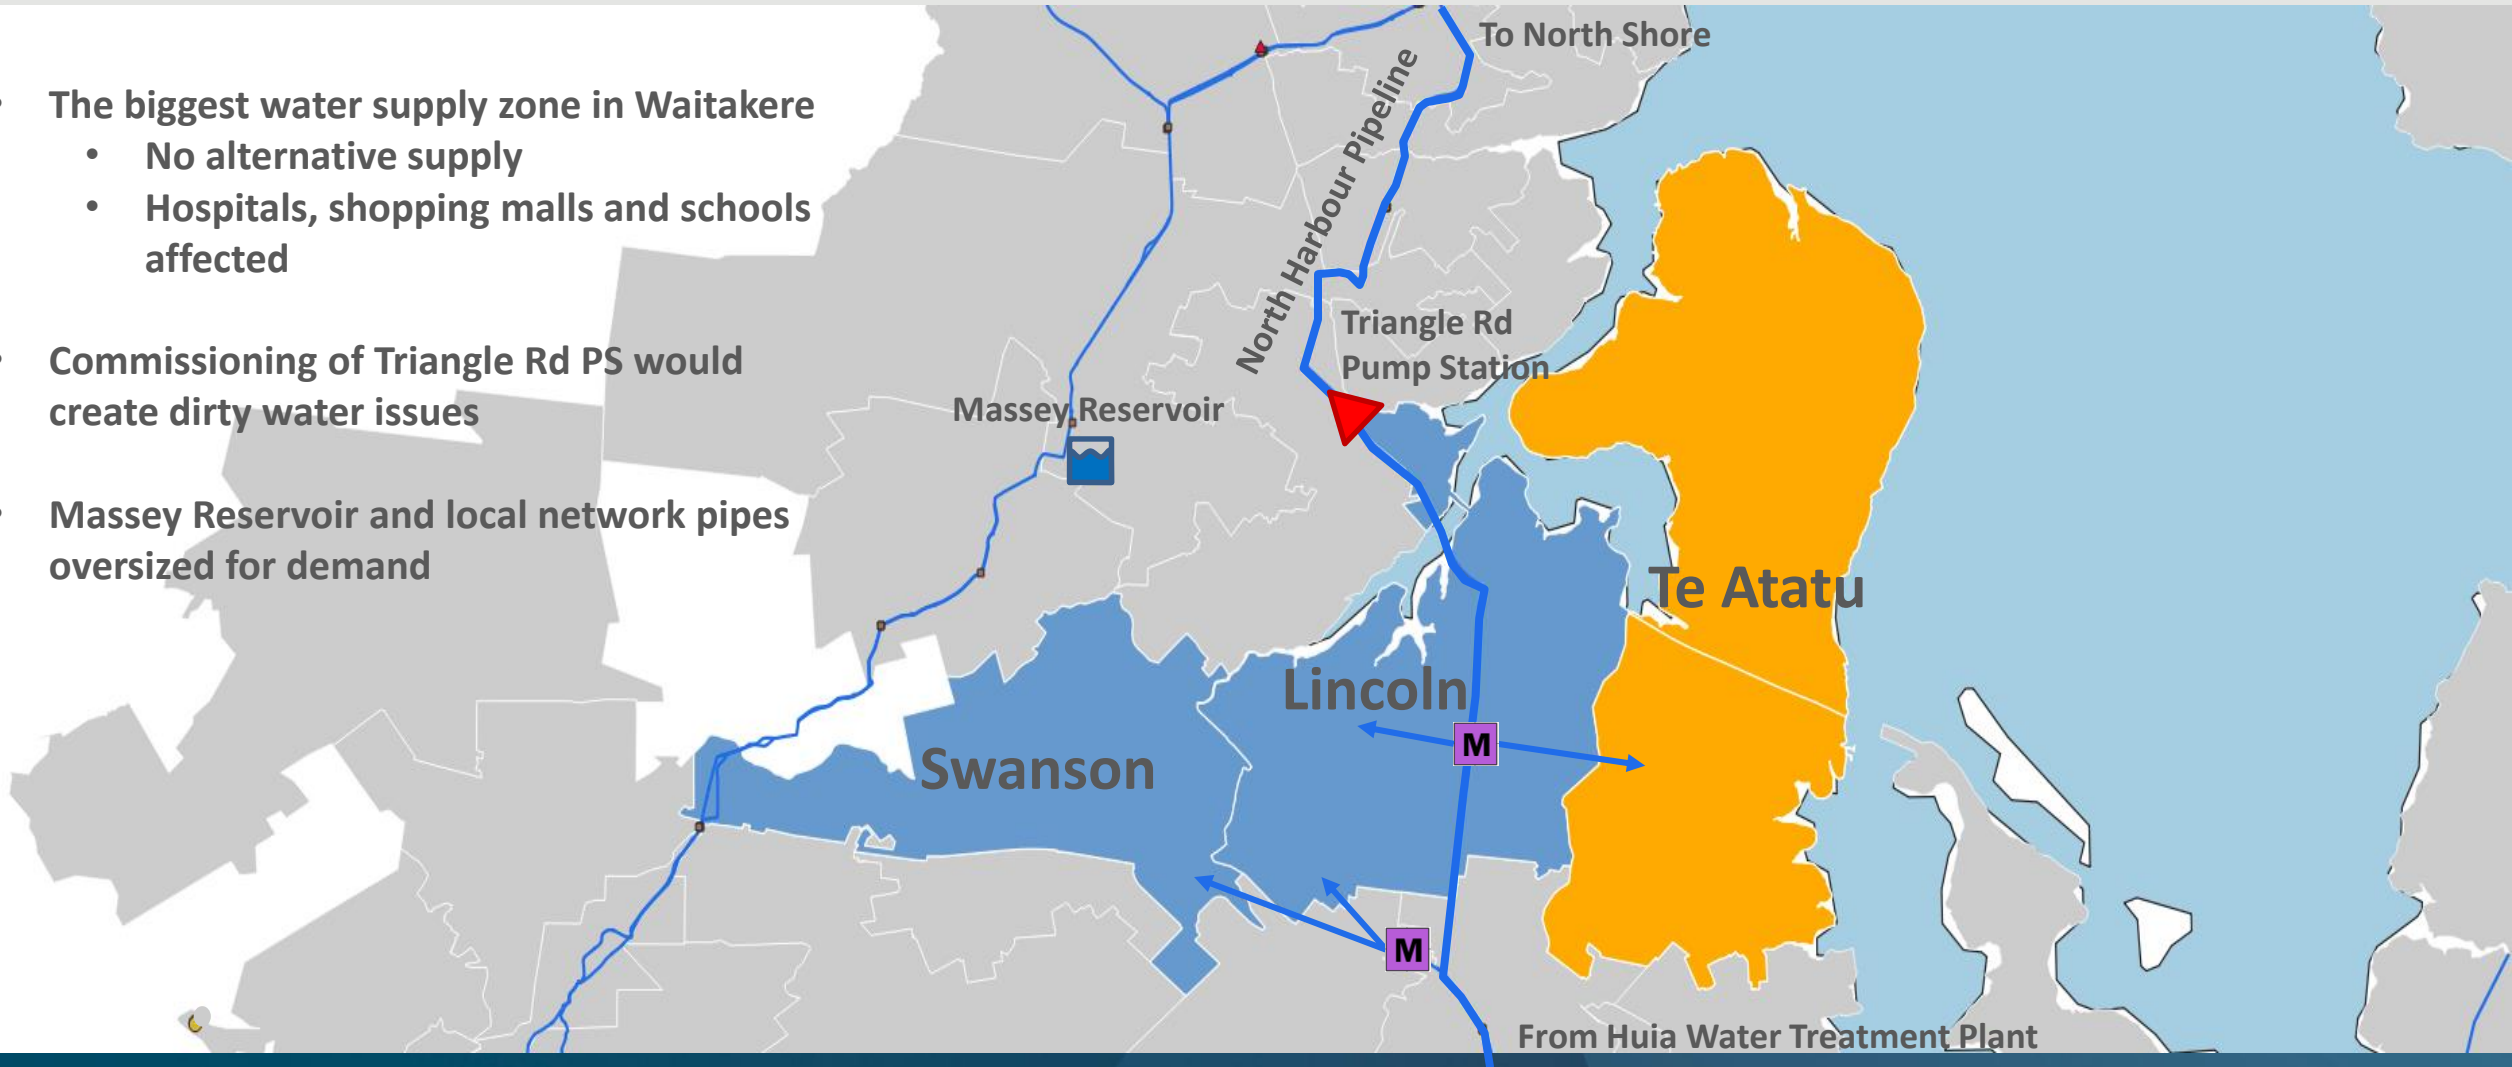
Case Study 1 – Lincoln Swanson - Issues

- The biggest water supply zone in Waitakere
 - No alternative supply
 - Hospitals, shopping malls and schools affected
- Commissioning of Triangle Rd PS would create dirty water issues
- Massey Reservoir and local network pipes oversized for demand

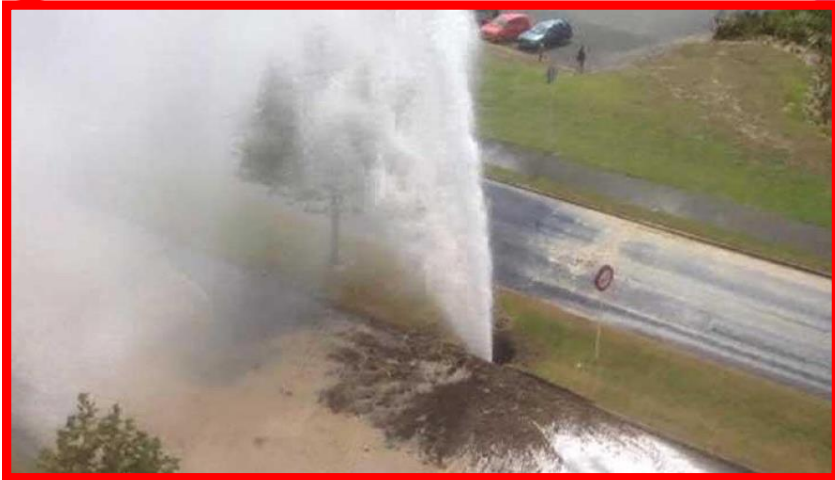
Case Study 2 – Albany - Issues

- Burst water main in Albany required a bulk supply point to be shut
- No alternative supply
- Approximately 3,500 customers affected
- Shopping centre shut down for over 24 hours

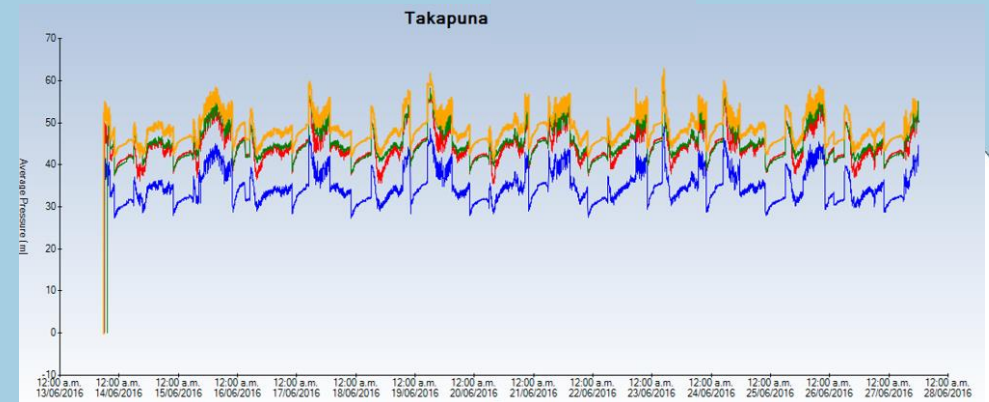
Case Study 3 – Takapuna and Northcote - Issues

- Over 20,000 customers experiencing high and unstable water pressures
- Large numbers of breaks, leaks and complaints

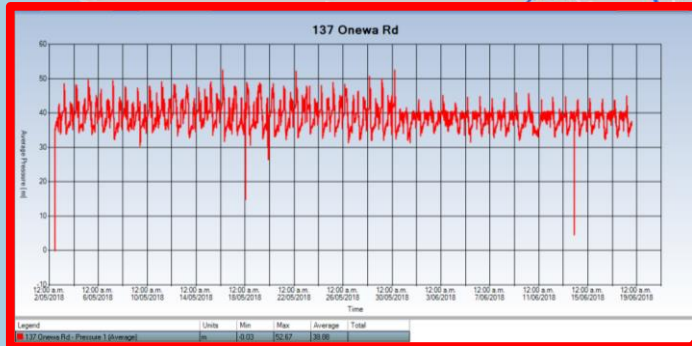
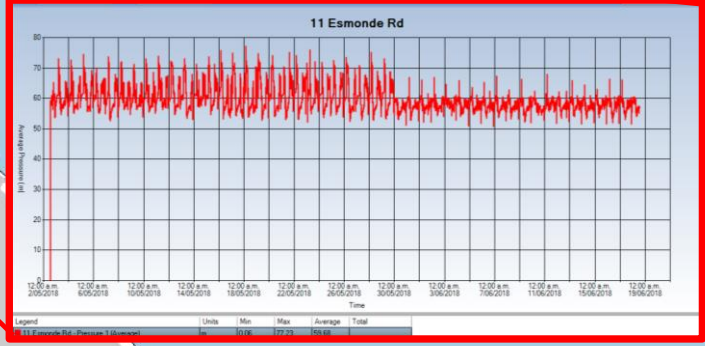
Case Study 3 – Takapuna and Northcote - Solution

- Pressure reducing valves installed at 6 bulk supply points
- Number of water main breaks reduced by 46%
- Water Jobs reduced by 31%
- Reported leaks down 25%
- No customer complaints received
