# **PRACTICALITIES WHEN APPLYING AS/NZS4853 FOR AC LOW FREQUENCY INDUCTION RISK ASSESSMENT**

*Tony Auditoré VOLTONI LTD*

This paper reviews the risk assessment process and the practical limitations for calculating steady state impressed voltages. It also proposes an alternative to calculating these voltages. The paper presents a practical case study along the Watercare (Auckland) Huia No.1 & Niho No.1 replacement watermain. Included in the paper is a discussion regarding the limitations when applying AC measurements as a replacement for calculations.

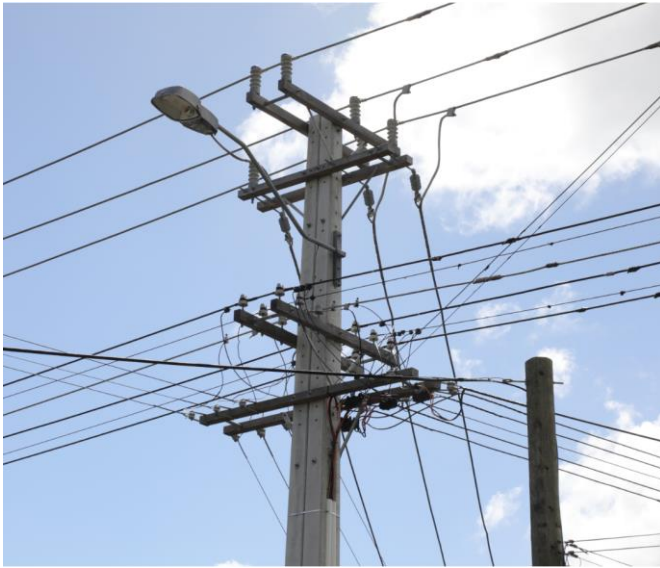
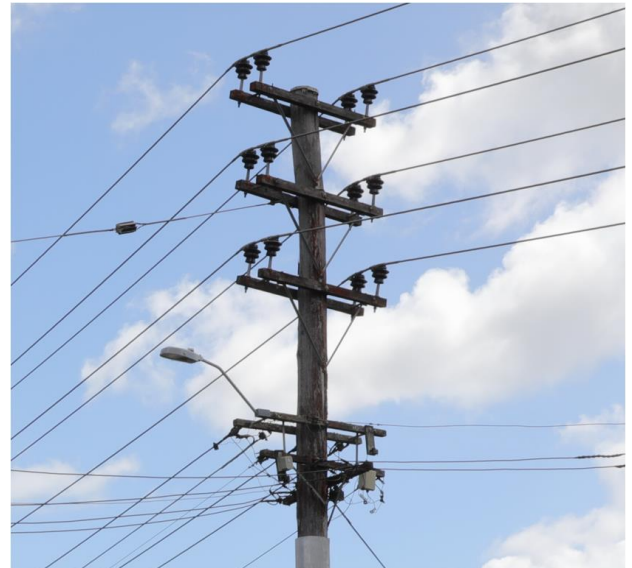
*Figure 2: Distribution low voltage and medium voltage multi-circuit power lines*

The water pipeline is installed within an urban area which contains numerous urban distribution overhead lines and underground cables. These distribution power lines consist of both MV & LV multi-circuits and are typically illustrated in Figure 2. In addition to the former multi-circuits, the following five transmission lines are considered in this electrical hazard assessment:

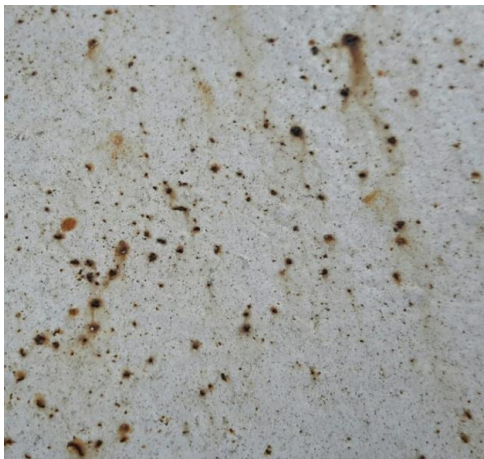
(a) Pinholes<sup>1</sup>

(b) Holiday<sup>2</sup>

*Figure 3: Pipeline defects*

Metal pipelines provided with high resistant coatings are subject to alternating current (AC) induction from parallel overhead and or underground electrical sources. AC corrosion is the metal loss that occurs from an AC current source transferred along a metallic pipeline at a defective point in the protective coating. A defect is commonly named a 'holiday'. A holiday may include lack of bonding, pinholes, cracks in coating and insufficient or excessive film thickness. Pinholes and holidays are illustrated in Figure 3. These defects expose the unprotected metal surface to either the atmosphere for above ground, or soil for underground installed pipelines.
