# WAIOHINE RIVER

**GEOMORPHIC TRENDS ASSESSMENT AND ITS APPLICATION TO RIVER  
MANAGEMENT**

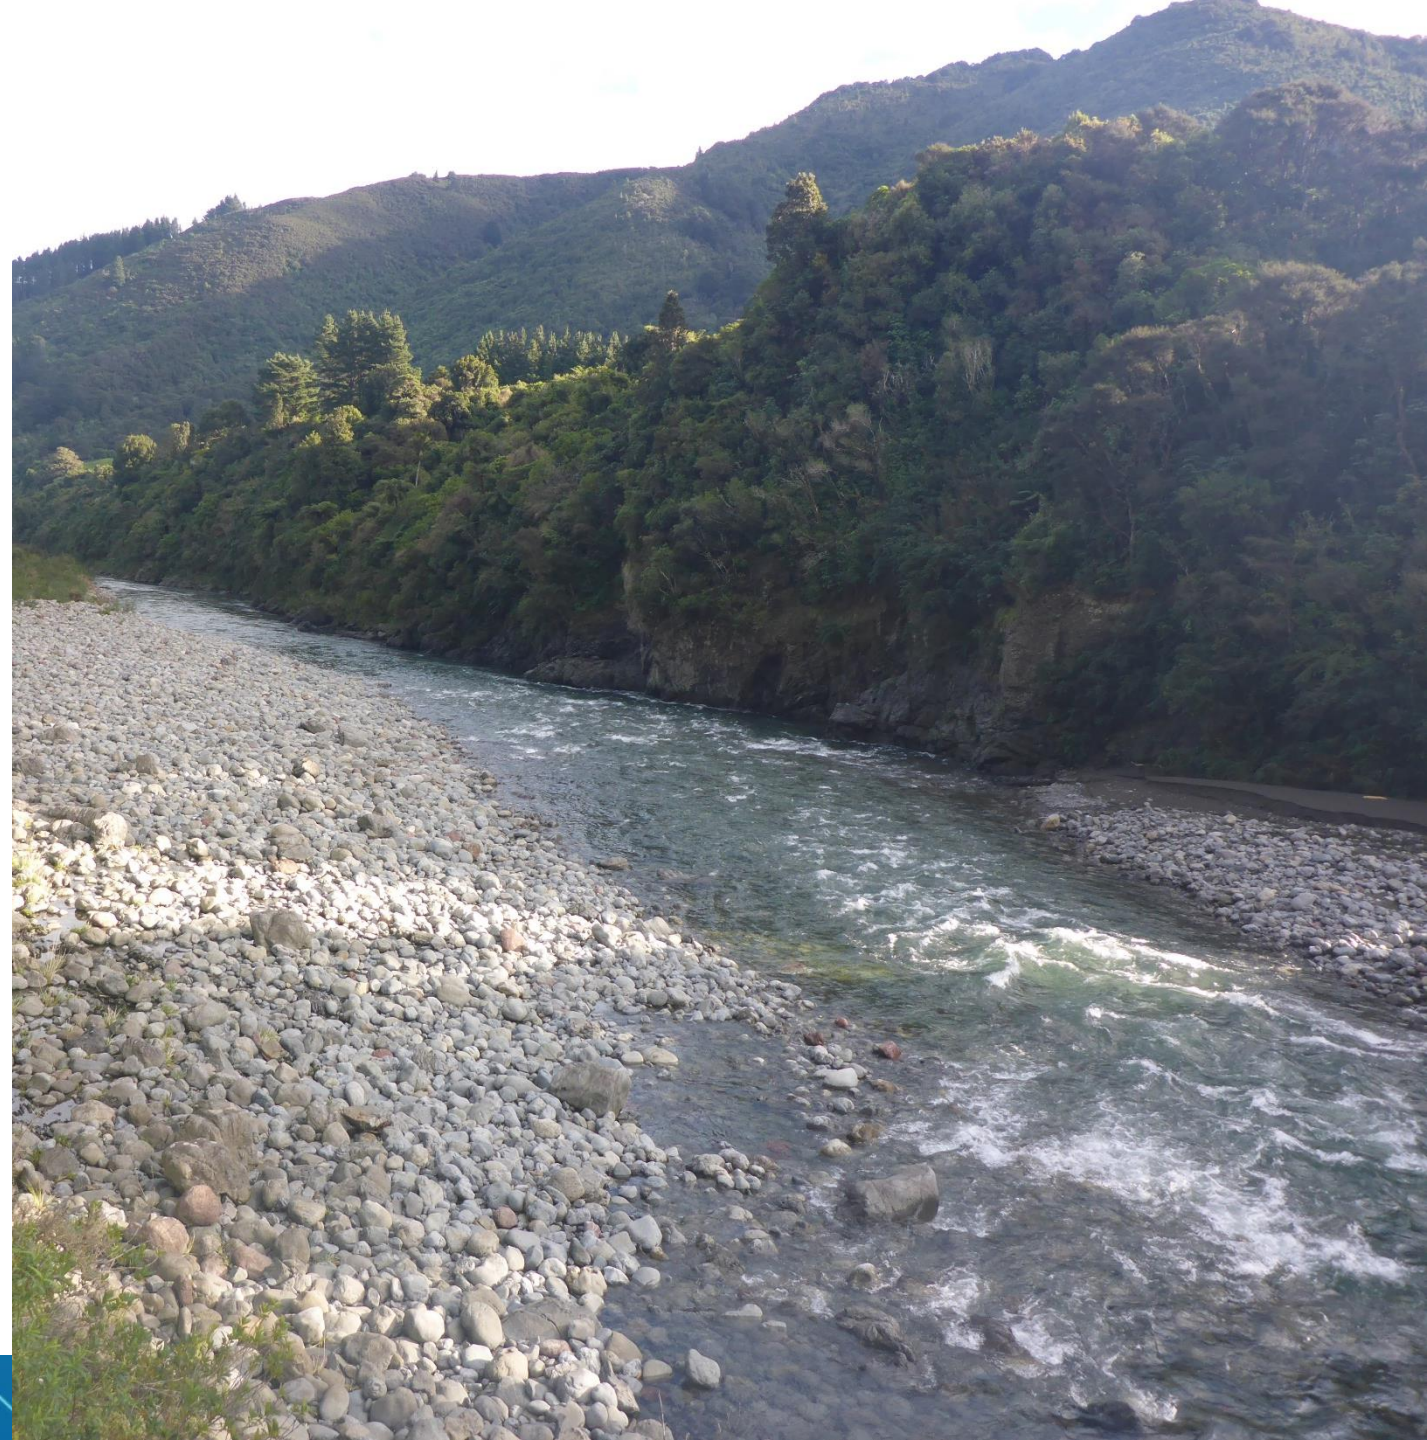
# Drivers of change

- Climatic change
  - Sediment availability
  - Vegetation changes
  - Large magnitude rain events
- Episodic events
  - Tectonic (earthquakes)
  - High intensity rainfall
- Human induced change
  - Gravel extraction
  - Active channel confinement
  - Vegetation changes

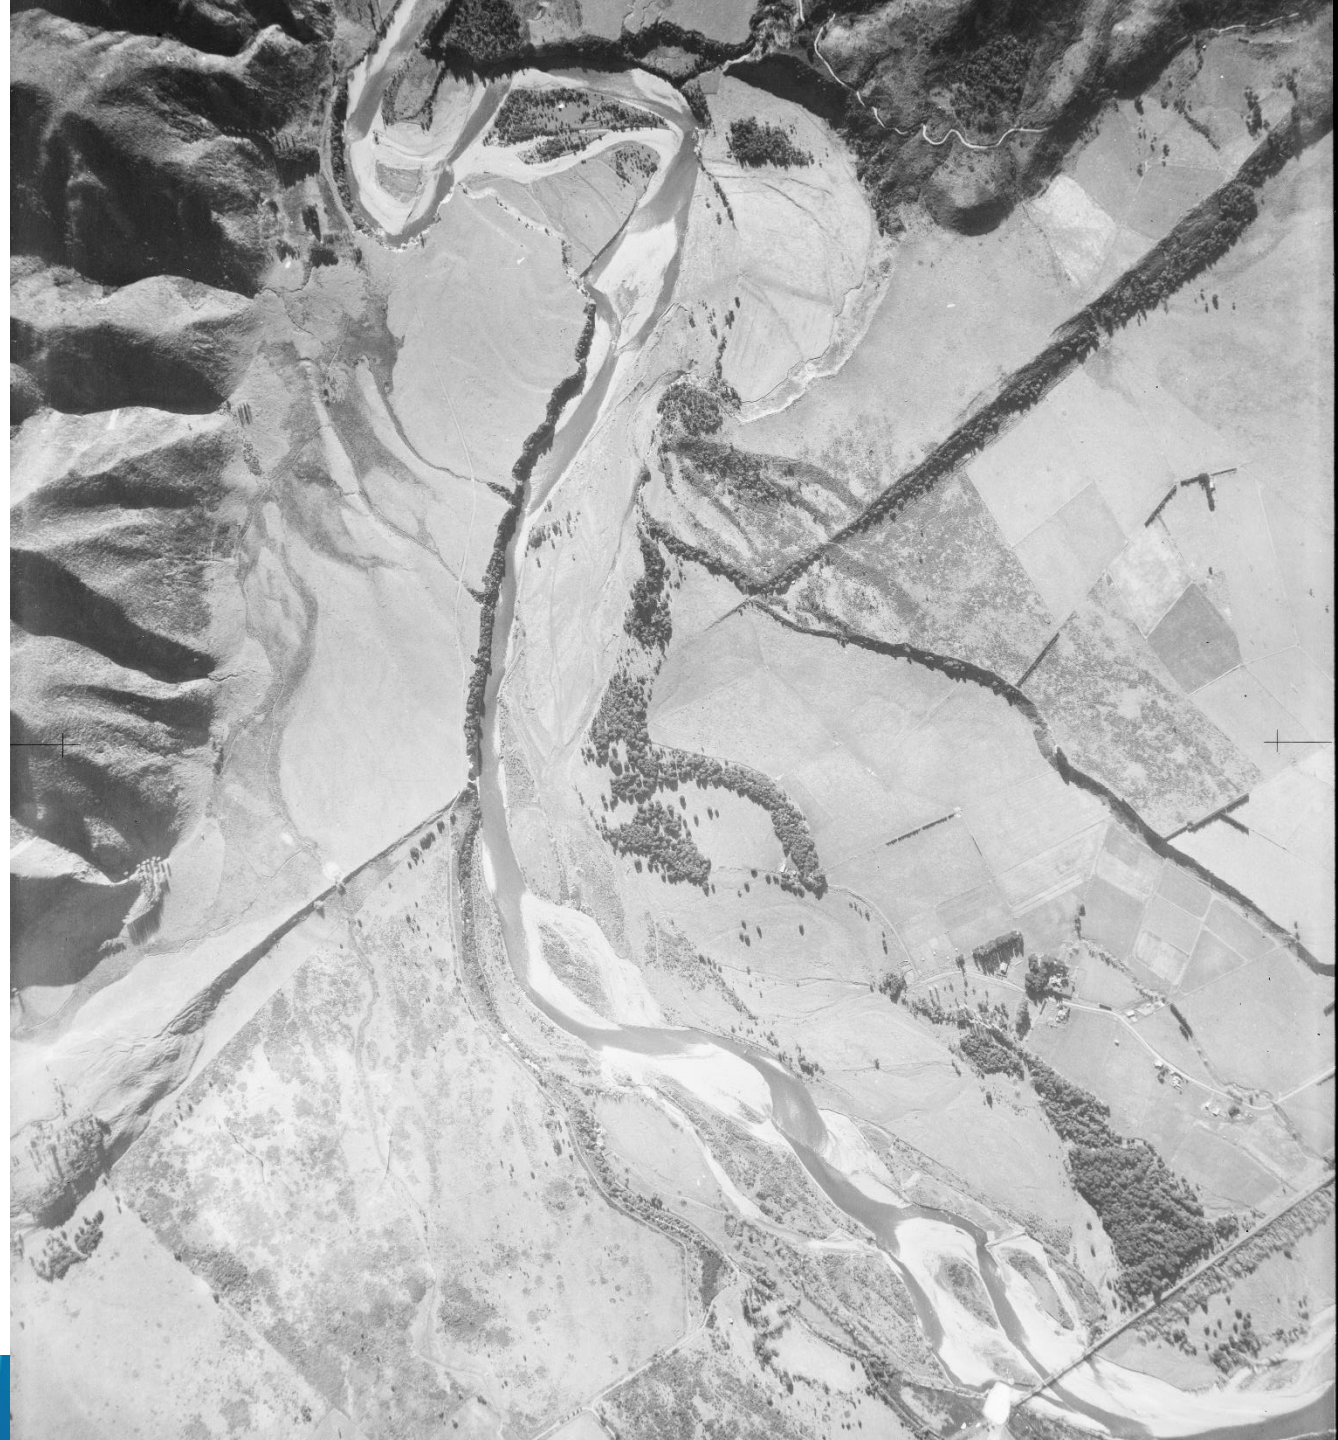
# Long term trends

- High sediment load at end of 'cold' periods
- Two alluvial fans (10-25,000 and 0-10,000)
- Multiple terrace sequences
- Evidence of large scale fault rupture between 110 and 430BC
- 1855 fault rupture

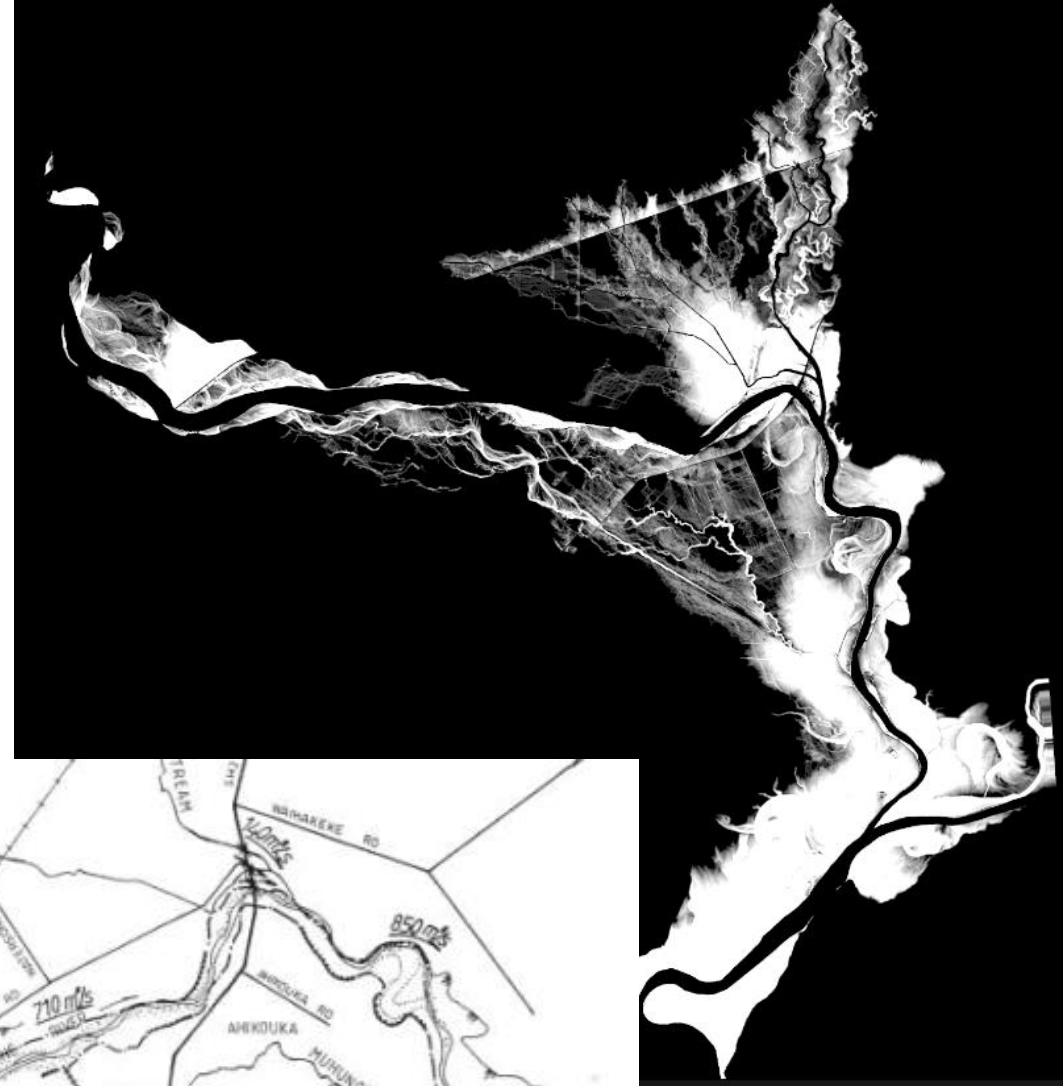
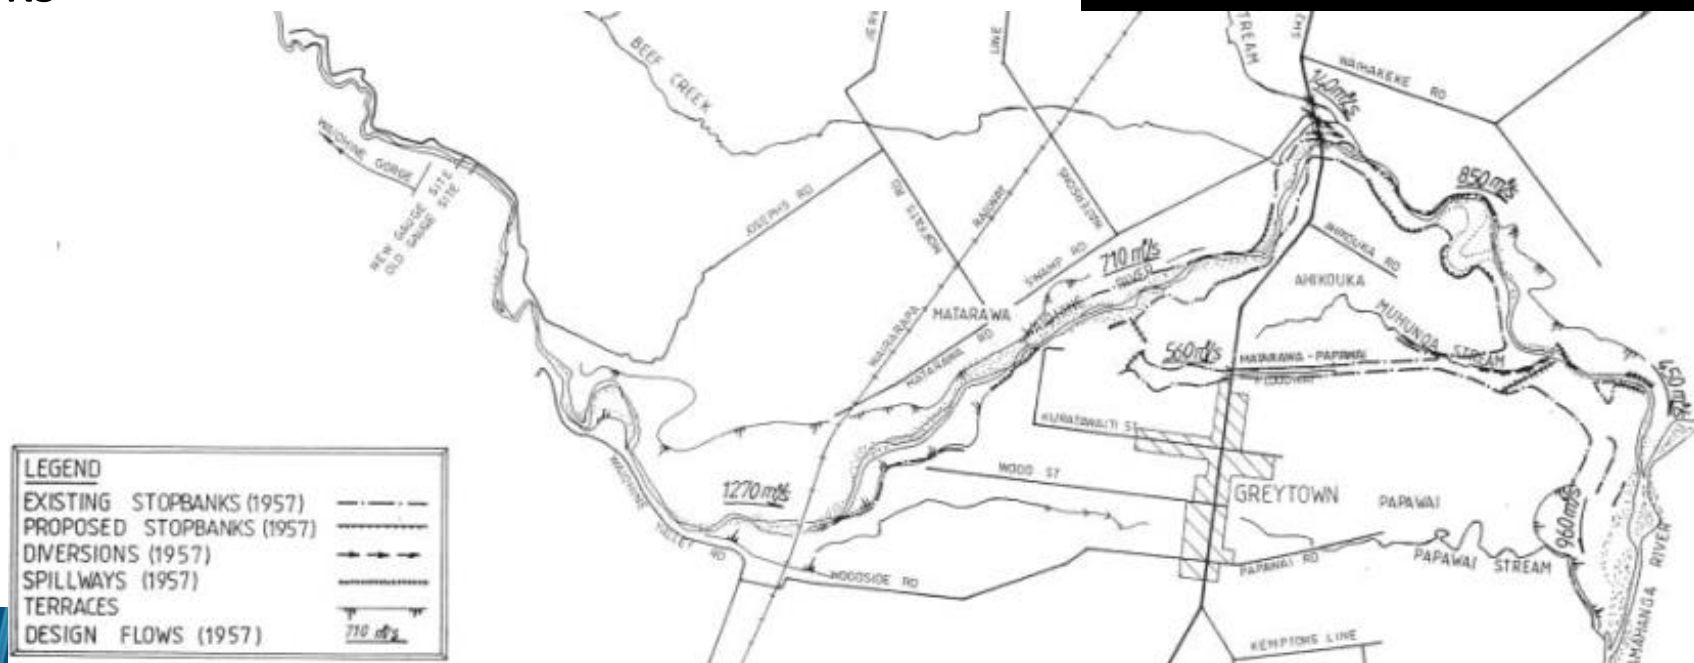
# Current trends

- Current position dictated by river management
- Gravel management
- Willow and rock groyne training
- Informal and formal but infrequent stopbanks

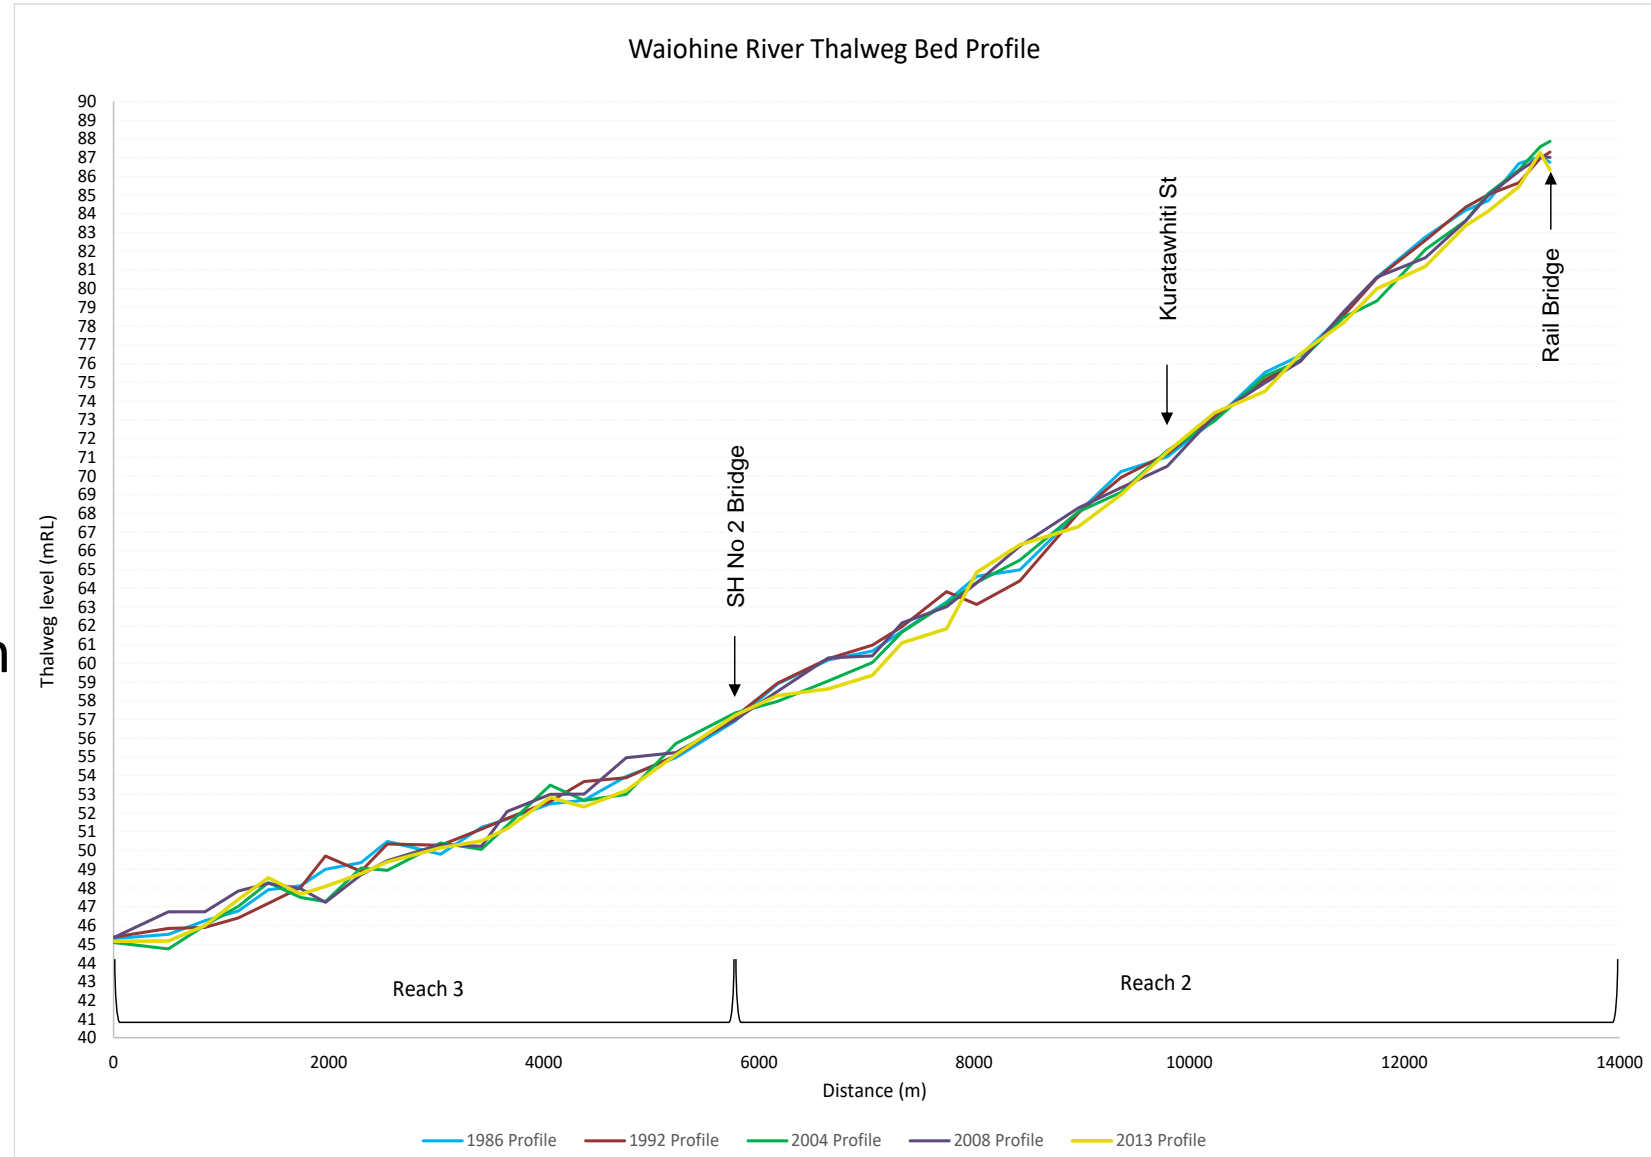
# Current trends

- Slight degradation trend
- Pulses of sediment (sediment slugs)
- Limited change over 27 years upstream of Kurtawhiti Street and immediately downstream of SH2 bridge
- Localised change, gravel management, channel straightening

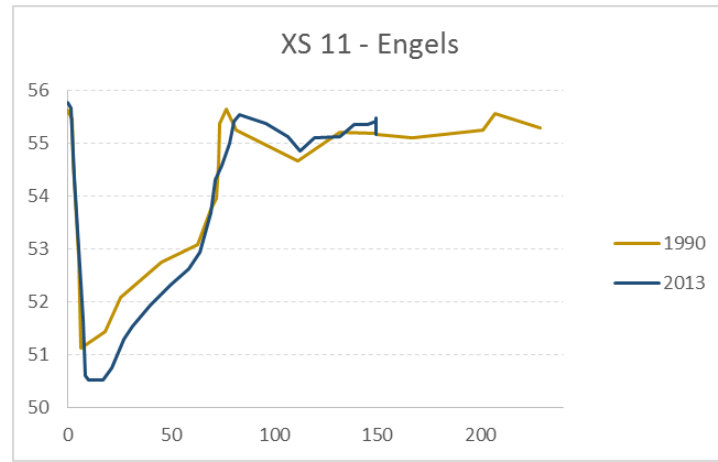
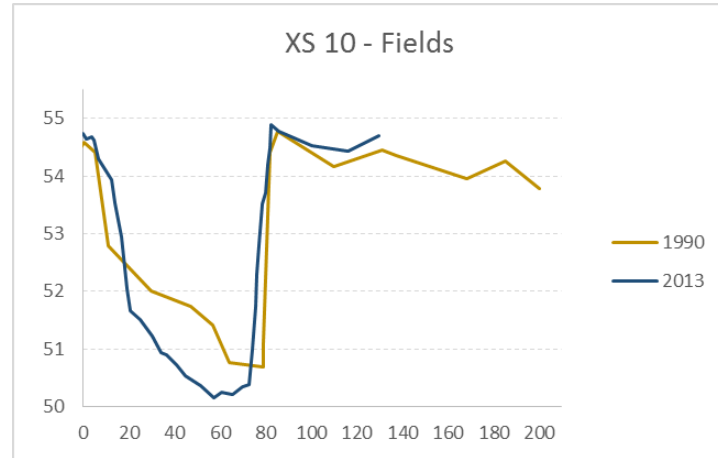
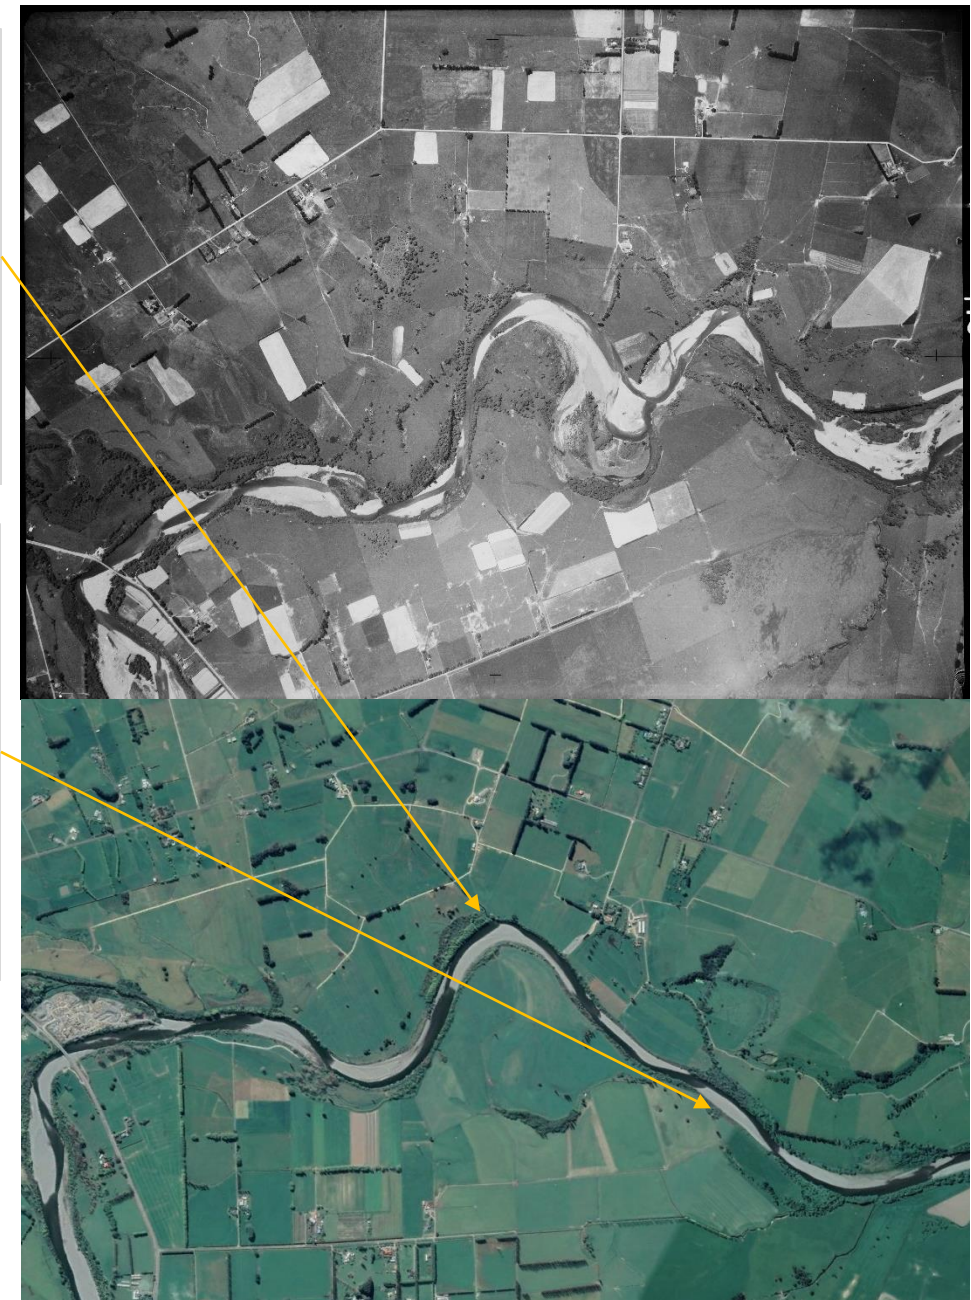
# Current trends

- Changes in morphology downstream
- Linked to reduction in sediment supply and increase in transport capacity
- Result of river management, as well as natural processes
- Changes in flood dynamics from rail bridge?
