Water NZ Conference 2019

Dredging to Restore Resilience

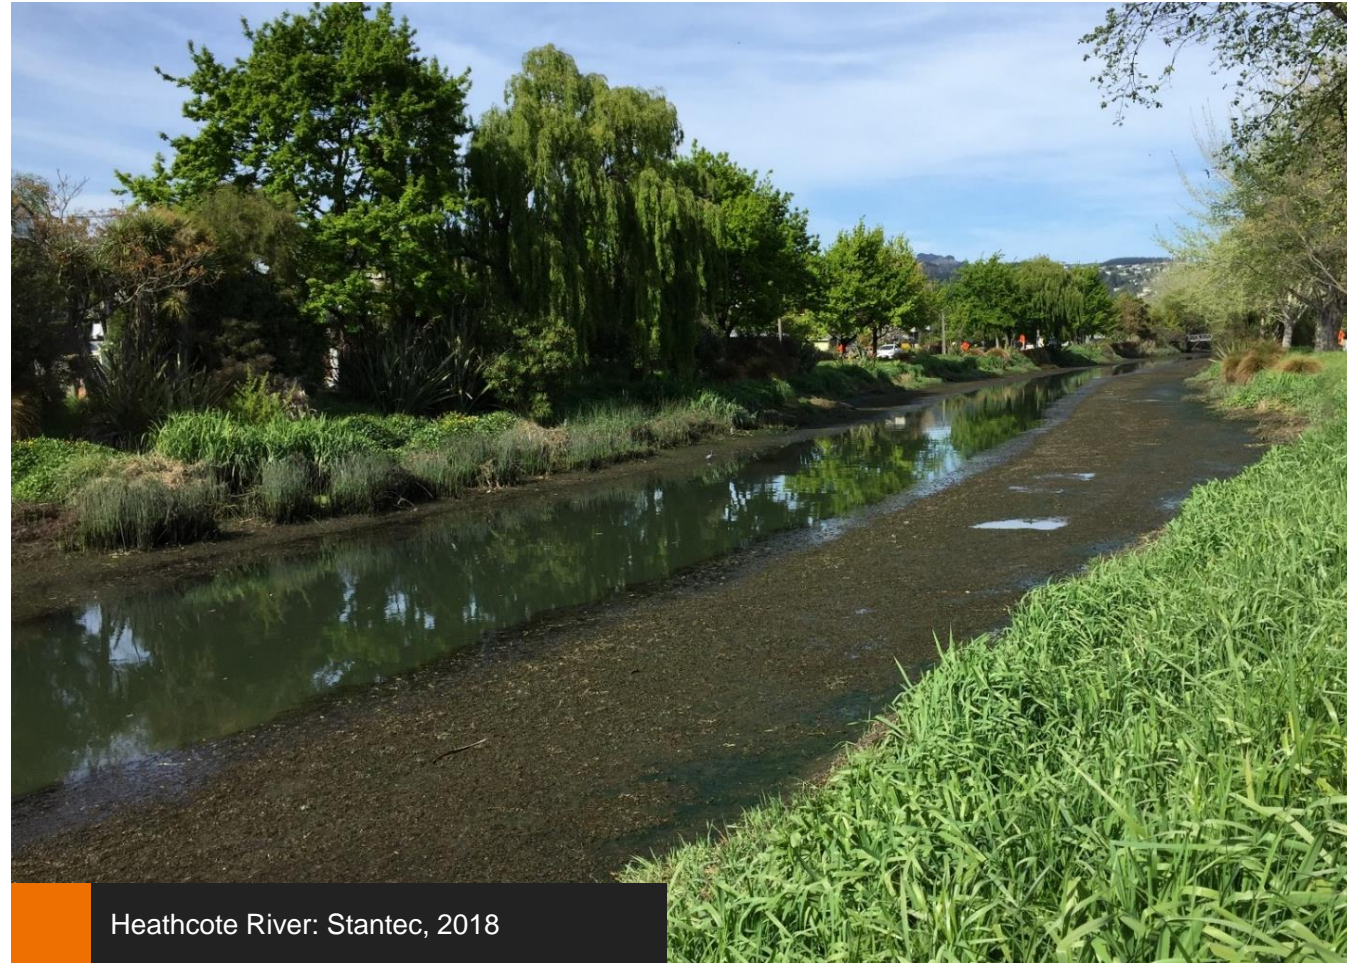
Heathcote River: Stantec, 2018

The 2011 Earthquakes caused:

- Bank Collapse
- Lateral Spread
- Bed Heave
- Sediment

Resulting in:

- Less Flow
- Less Habitat
- More Sedimentation
- More Flooding

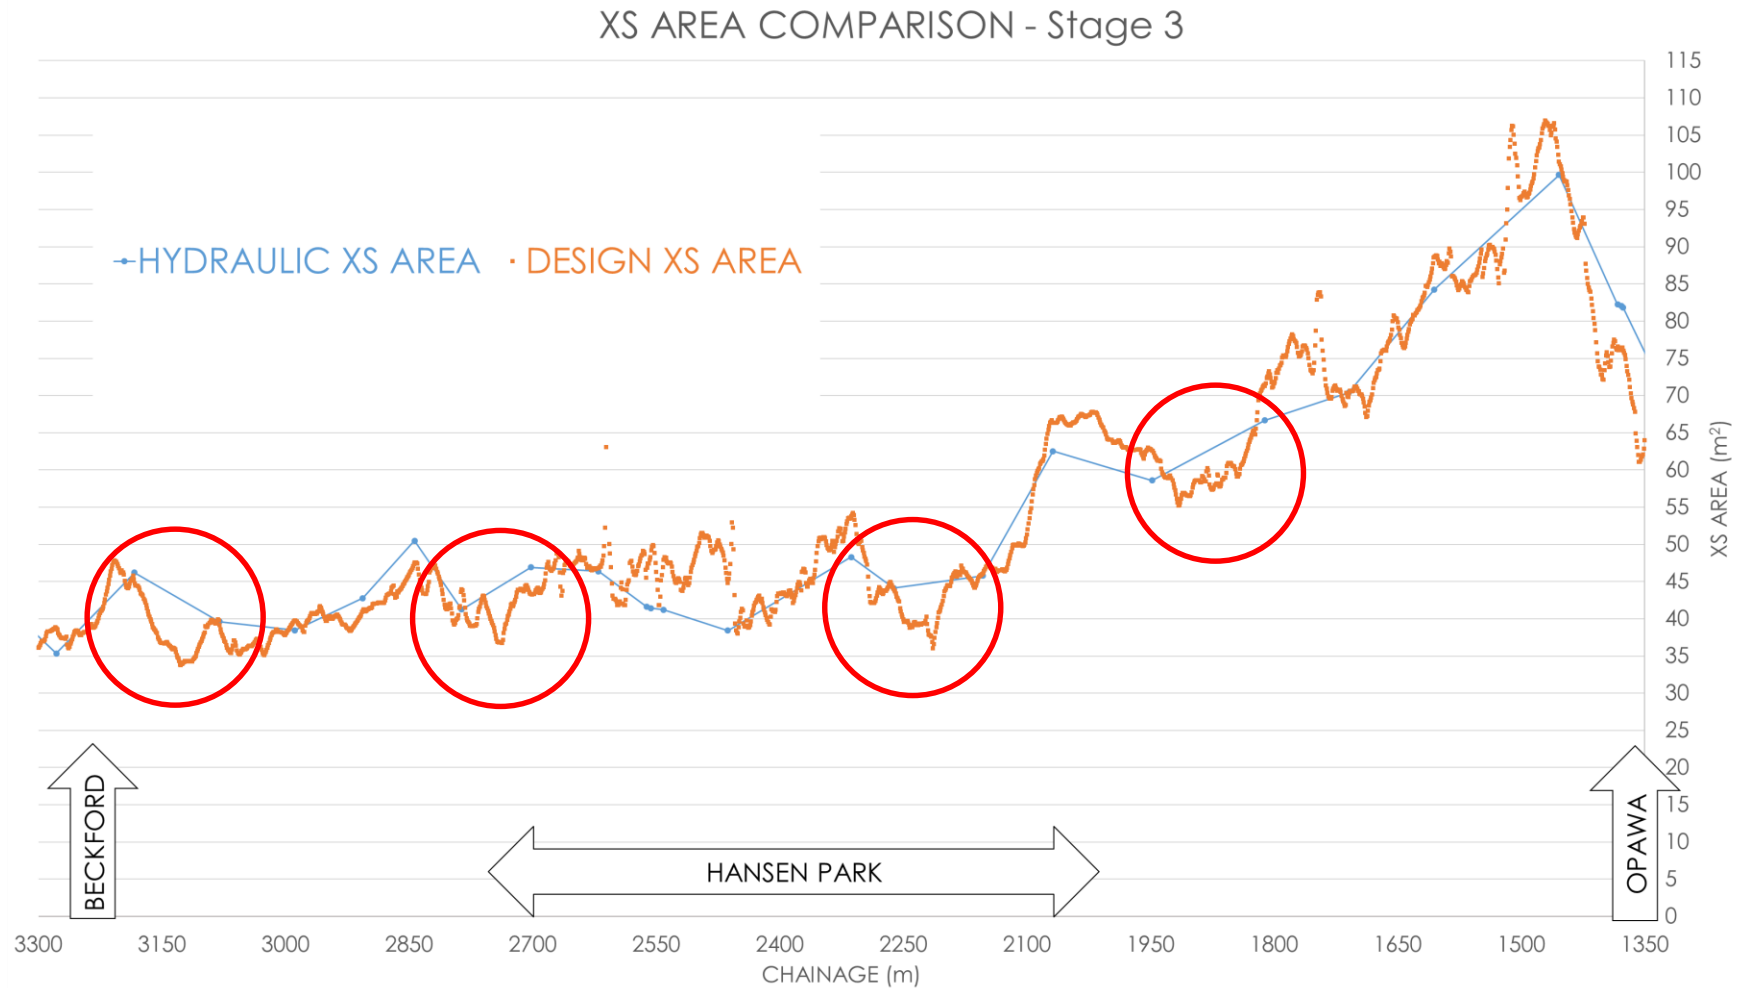
Stage 3

- Backwater calc
- X-section analysis
- Targeted Areas

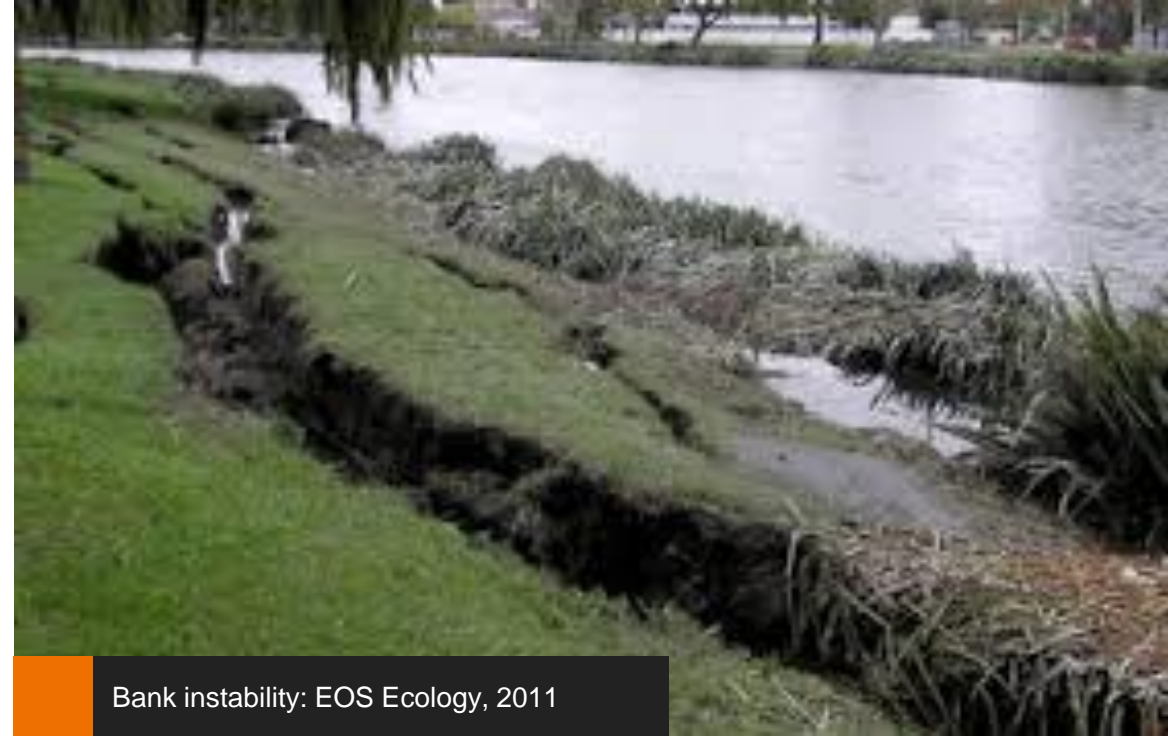
Bank instability: EOS Ecology, 2011

Seismic Stability

Check movement
(pre and post-dredging)

No liquefaction

- Pre-dredge - tens of mm
- Post-dredging similar

Significant Liquefaction

- Pre-dredging - hundreds of mm
- Post-dredging plus 20%
- Similar levels of damage

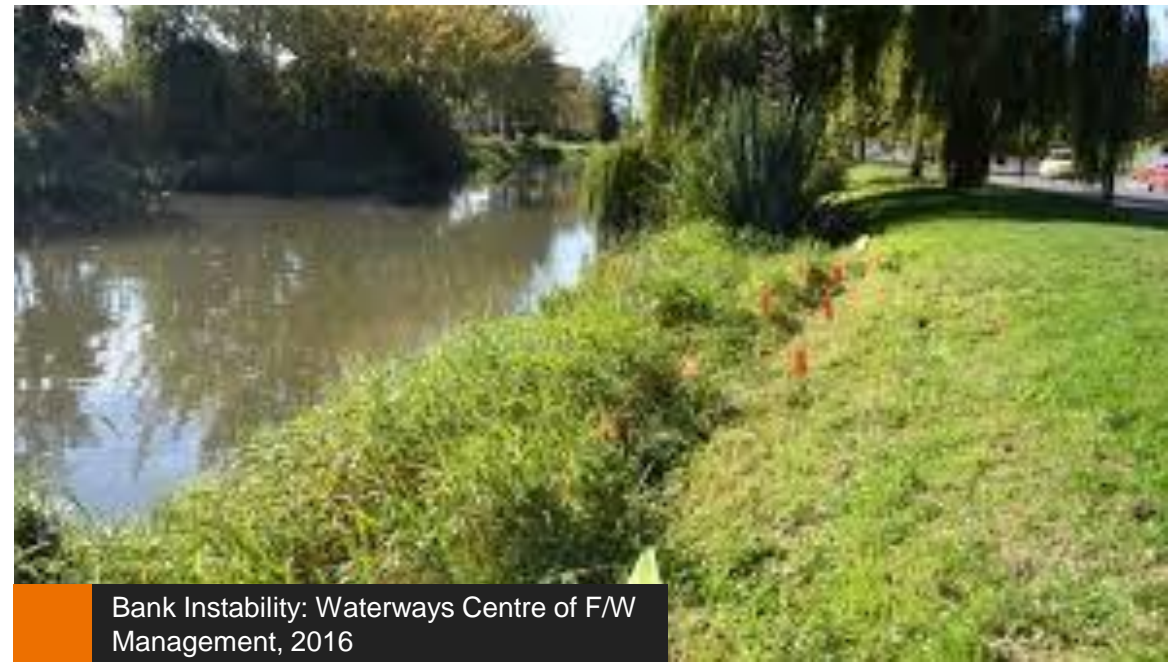
Bank Instability: Waterways Centre of F/W Management, 2016

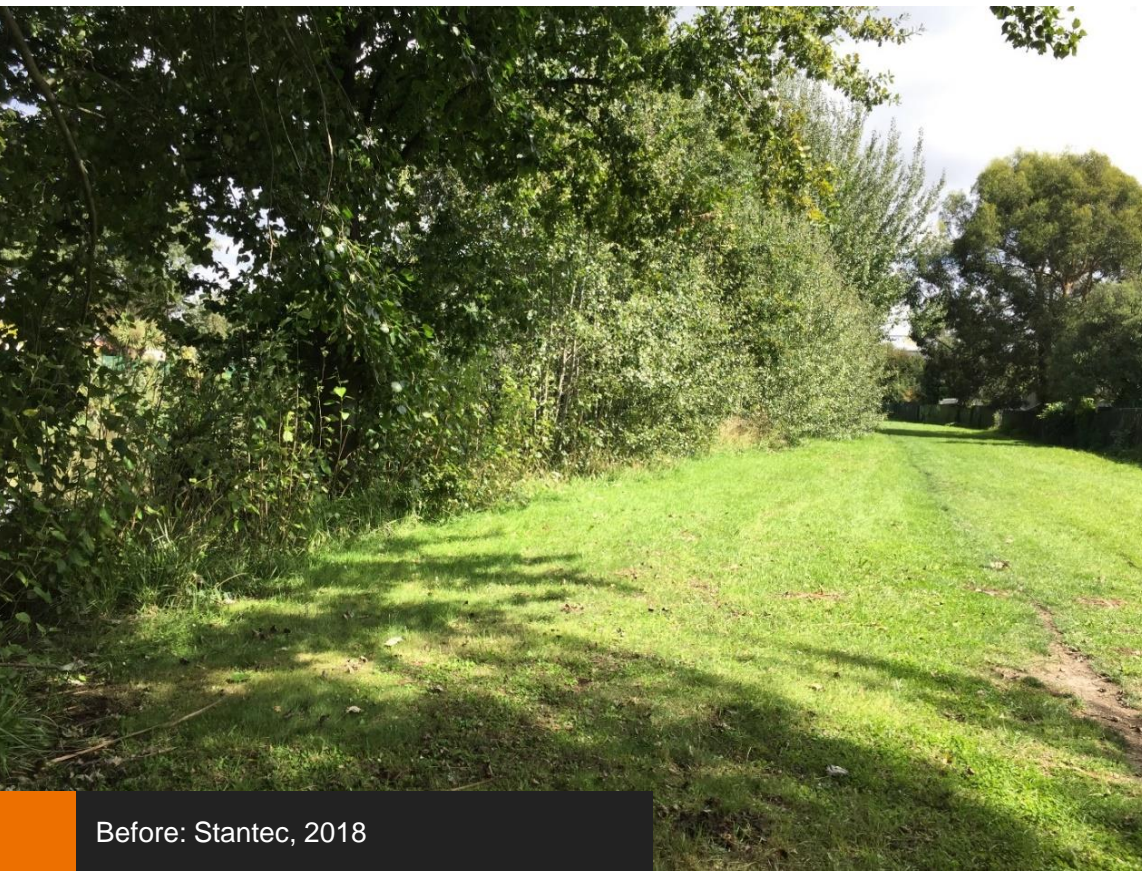
Before: Stantec, 2018

Significant planting post construction

- River's edge
- Top of bank
- Trees/canopy
