HUNUA 4 WATERMAIN TRENCHLESS CROSSING OF STATE HIGHWAY 1

M. Boyd and D. Jovanovic
GHD Limited, Auckland, New Zealand

ABSTRACT

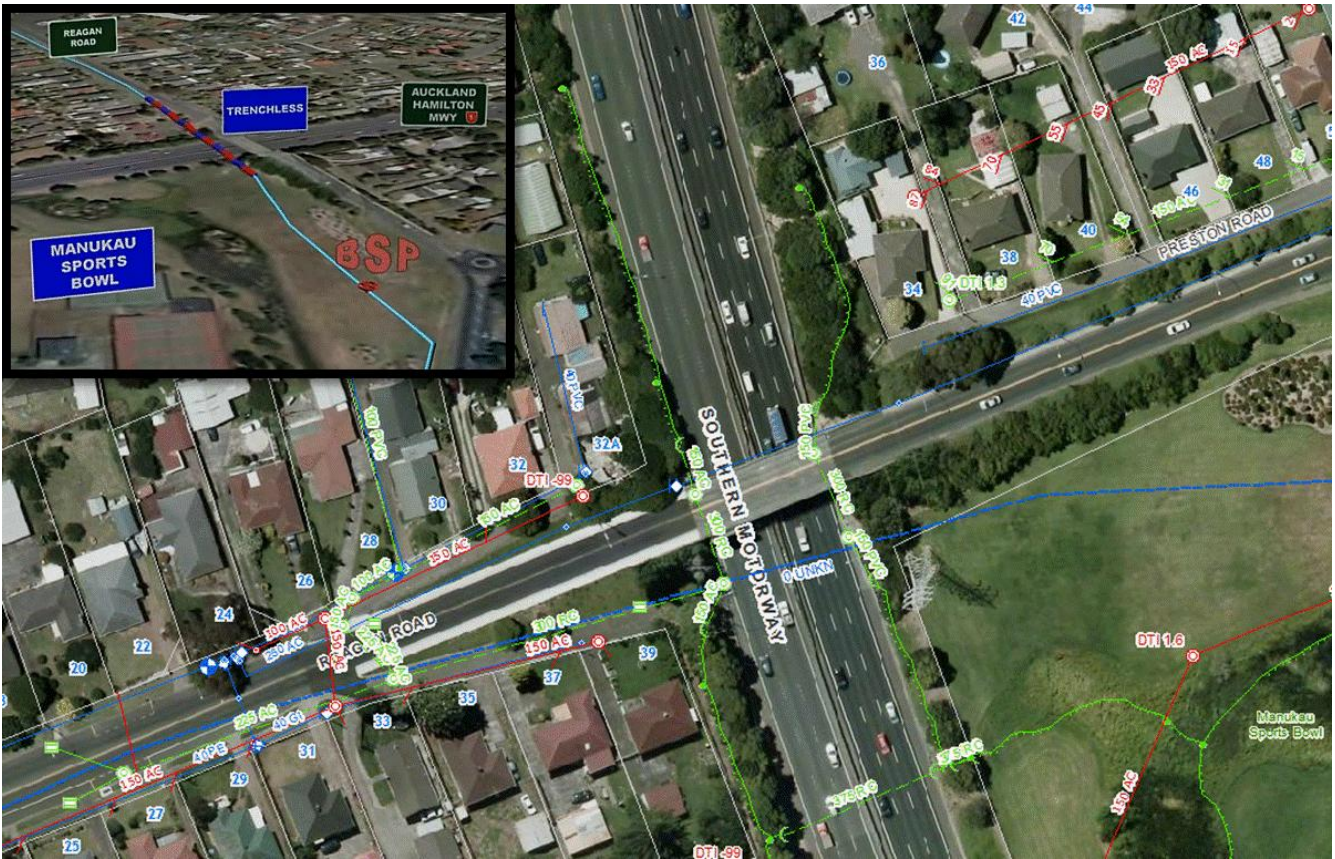
Figure 1: SH1 Crossing Location

A second criterion for the pipeline routing was that Watercare preferred to route the pipeline along publicly owned road corridors in preference to private land. As a result of those criteria, the pipeline heads west and crosses SH1 near the Reagan Road highway overbridge (Figure 1).

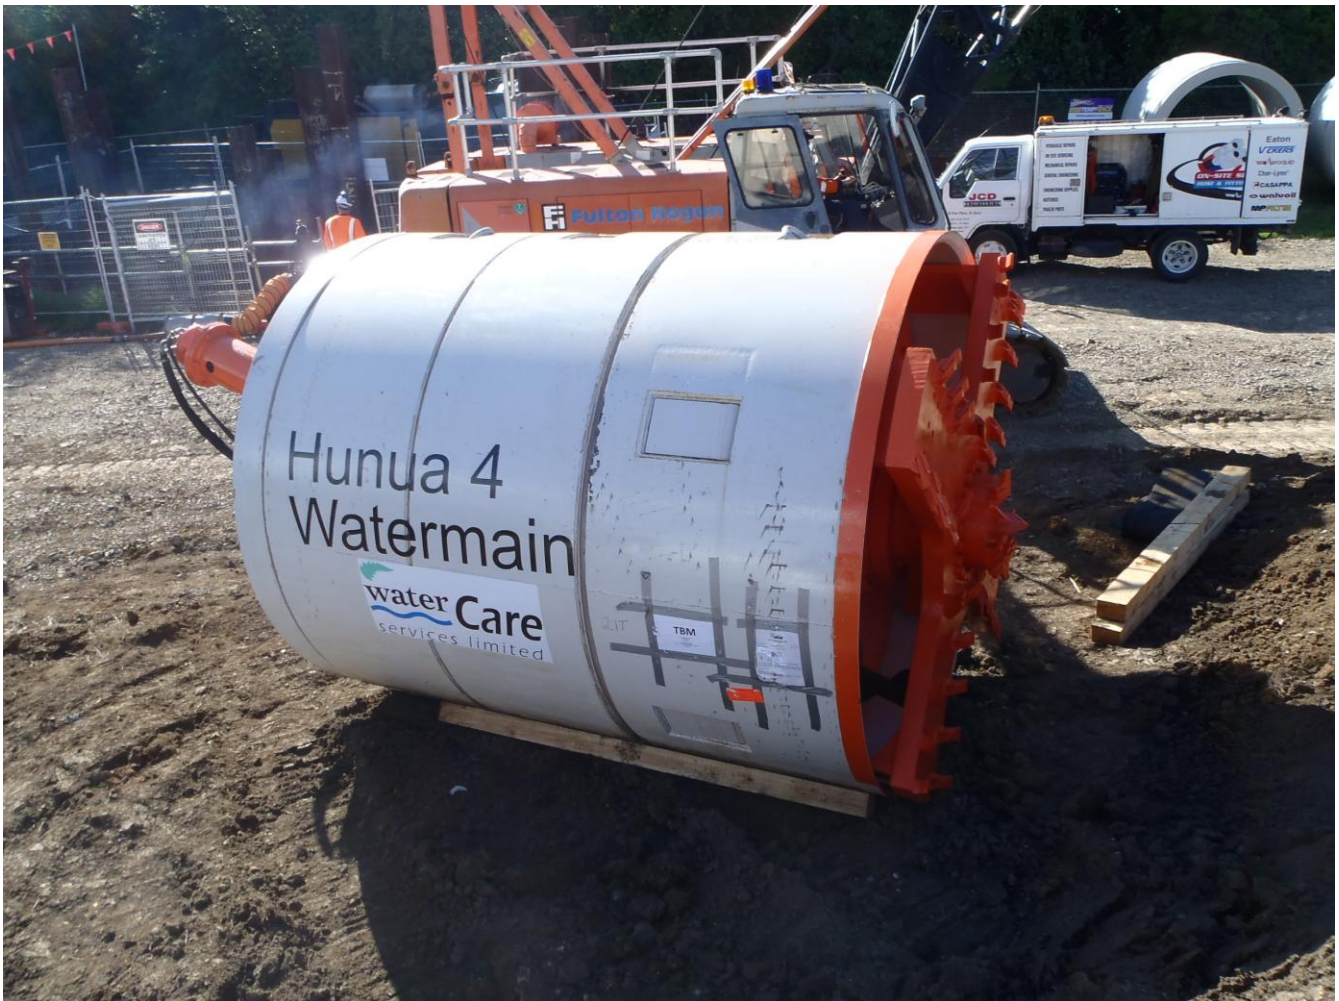
Photograph 1: SH1 Crossing 2.75 m diameter EPB TBM

An Earth Pressure Balance (EPB) Tunnel Boring Machine (TBM) was considered most suitable for the ground conditions, whilst controlling face pressure to limit settlement. An EPB machine can be either closed face or a partially closed face machine with the capability of adjusting the pressure in its front compartment to match the outside pressure of ground water. Such technology limits groundwater drawdown and therefore limits consolidation settlement.

Bothar Boring Ltd decided to use a partially closed faced 2,756 mm diameter earth pressure balance (EPB) tunnel boring machine (TBM), as they estimated the ground conditions to be stable enough to not require a fully closed face TBM. The pipe jacking utilised a 2.7 m outside diameter, 2.25 m inside diameter carrier pipe with a custom coupling without a strapping band, resulting in a minimised overcut.

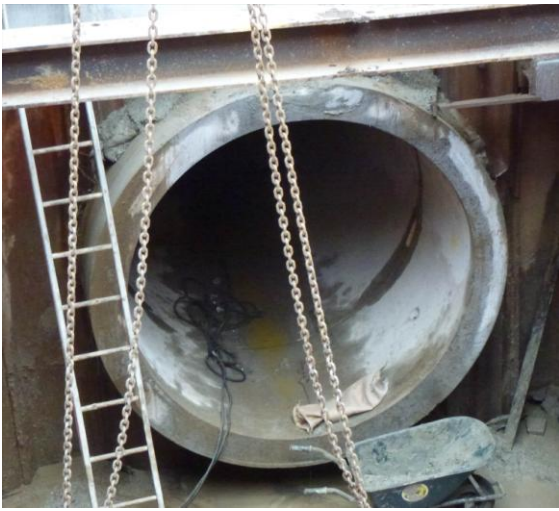
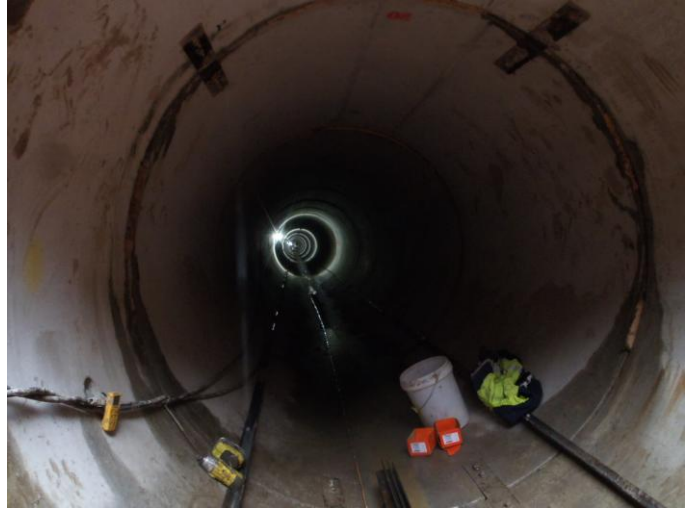
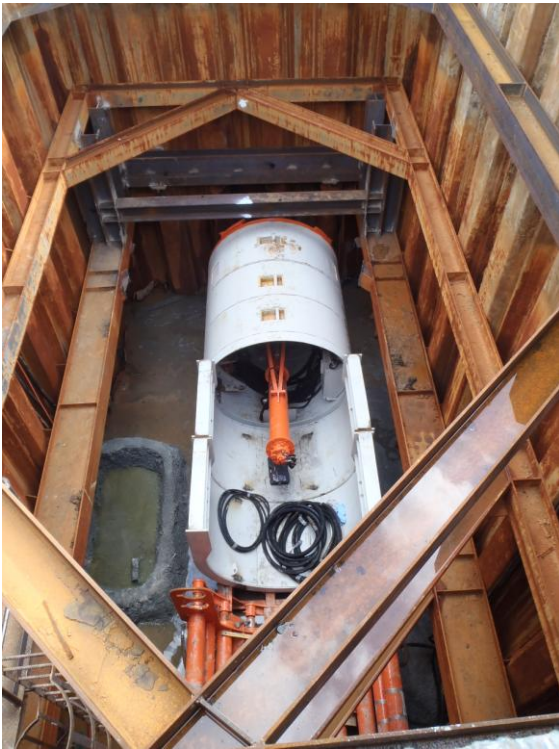
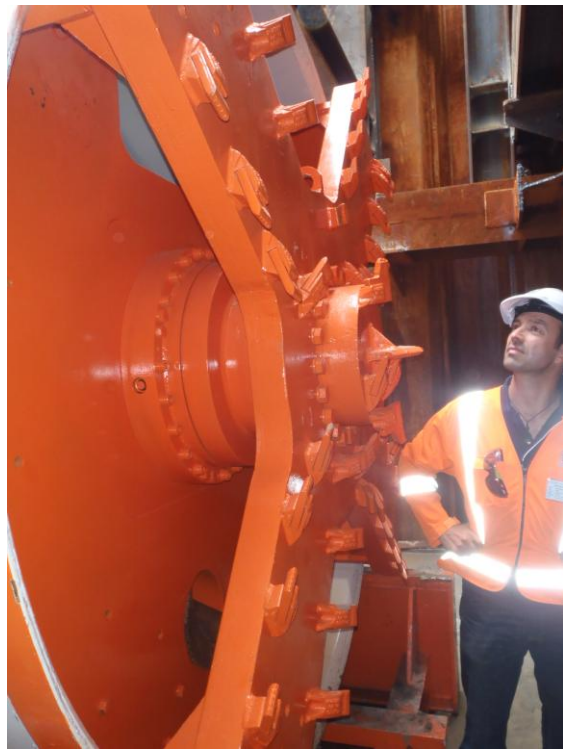
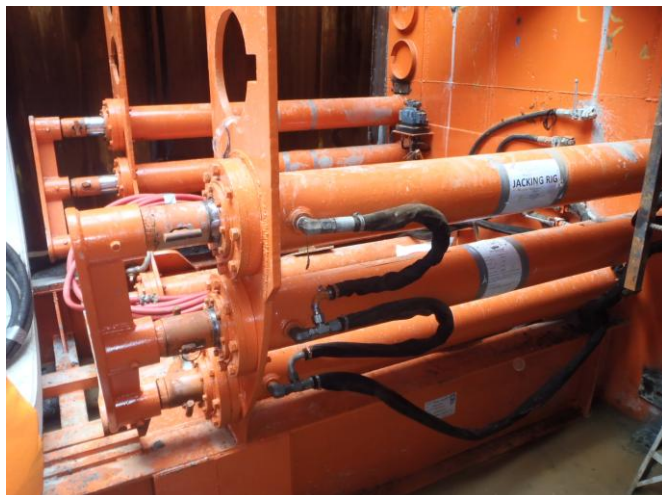
Photographs 2-6: Construction Photos of the completed bore and the general construction setup.

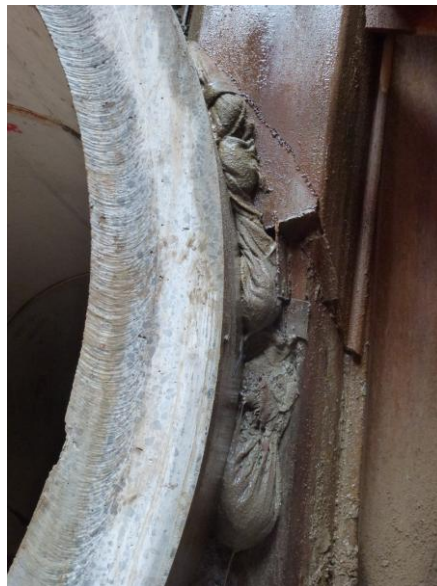
Bothar Boring Ltd had envisaged that the annulus, if not significantly overcut, would be able to be sealed against ground and water influx with sandbags and packing. Groundwater influx was significant, and the steady flow migrated fine soil material into the launch shaft. Several attempts were made to grout and pack the annulus to restrict the flow (Photograph 7), which were partially successful; however around the 9th of April and for a few days following, a series of “bursts” of disturbed ground entered the shaft. This influx of soil resulted in a settlement crater immediately in front of the launch shaft as see in Photograph 4. The progression of the slump was monitored and the hole eventually backfilled with site concrete. In hindsight, the lesson learnt would be to install a soft eye to control local ground influx near the shaft.

Photograph 7: Annulus Packing – welded plate and sand bag to seal the annulus from ground ingress

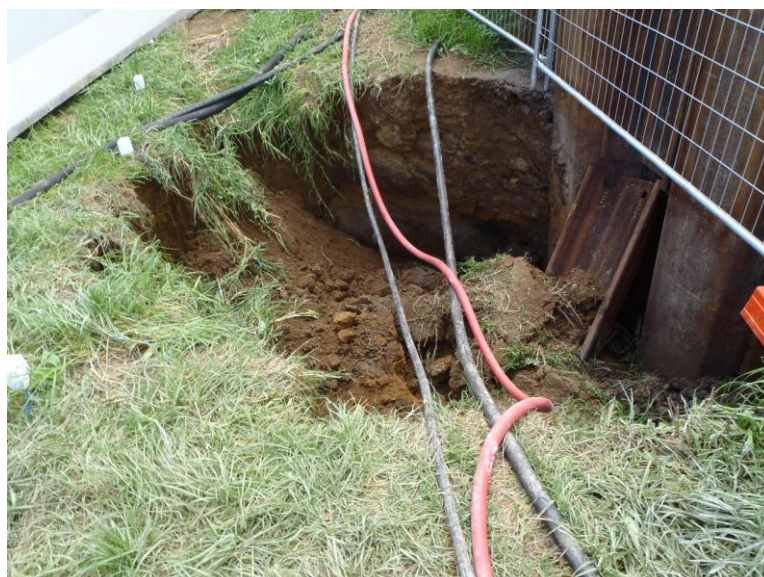
Photograph 4: Settlement hole.
