# ORAKEI MAIN SEWER REHABILITATION MH1-MH3 UTILISING SPIRAL WOUND PVC LINING

*Máire Lenihan, Watercare Services Limited*

*Maurice Lubbock, AECOM*

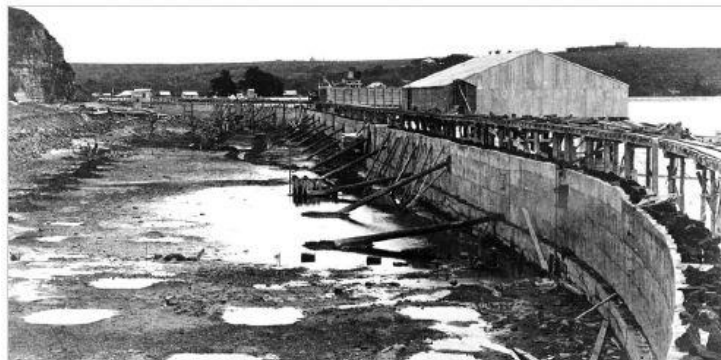
*Photograph 1: Wastewater storage tanks under construction in Orakei in 1911*

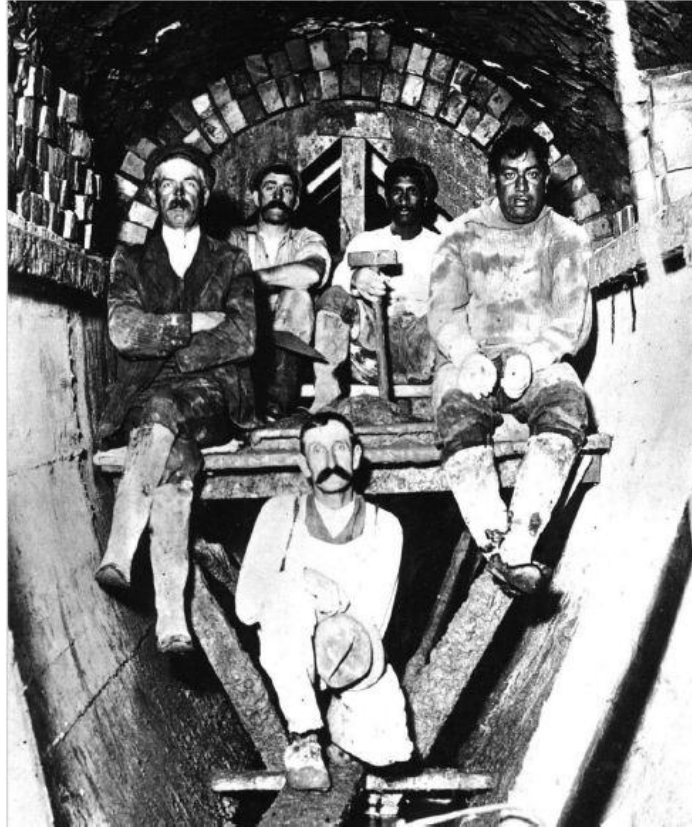
*Photograph 2: Construction of the Hobson Bay Sewer*

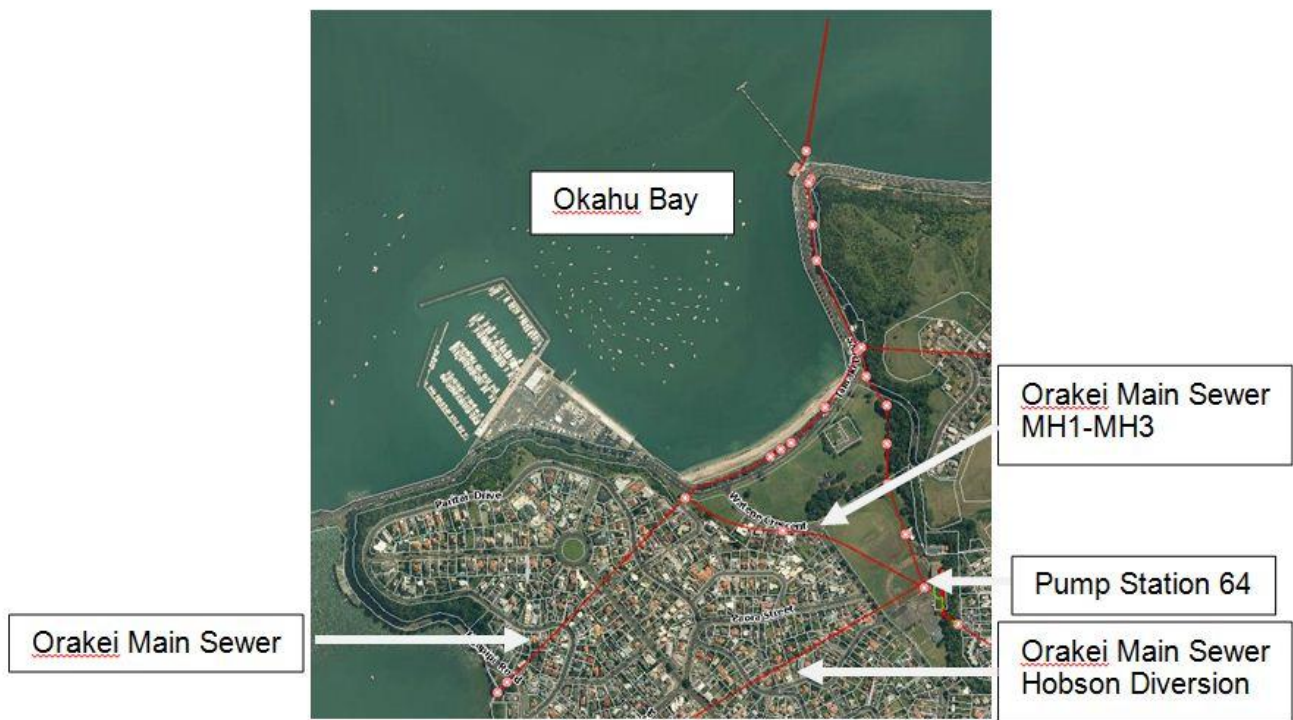
Figure 1: Orakei Main Sewer Infrastructure

In 2010, Watercare undertook a further significant upgrade in the area, which included the construction of Pump Station (PS) 64 and the Orakei Main Sewer Hobson Diversion. The Orakei Main Sewer MH1-MH3 was no longer required to operate as a trunk sewer, and is now utilised as storage, network reticulation and a pumped emergency overflow from PS 64. An overview of the network is illustrated on figure 1 overleaf.

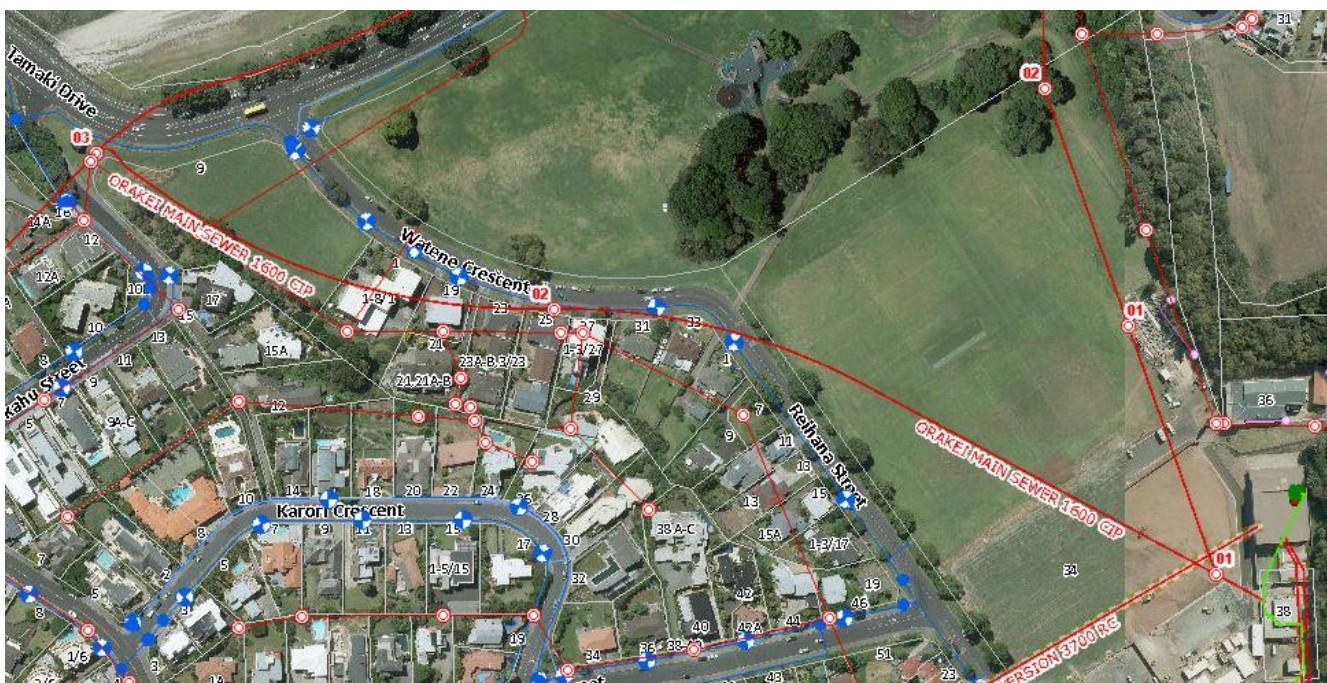
Figure 2: Orakei Main Sewer MH1-MH3

The greatest loading on the pipeline is the soil and hydrostatic load at the south western end, adjacent to PS64, but it also runs under local roading (Watene Crescent) and grass reserve areas as illustrated on Figure 2 below. Heavy vehicle traffic does use this road on occasions, and even the grass areas are subject to truck loads during community events.

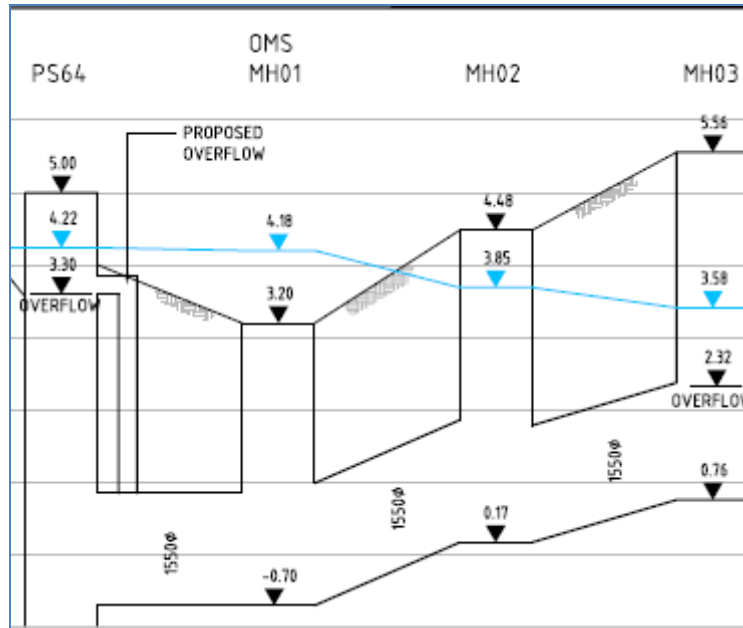
Figure 3: Orakei Main Sewer MH1-MH3 Hydraulic Grade Line

This pipeline is also very unusual in that it must function as a pumped overflow when inflows to the PS64 Pumping Station exceed capacity of the downstream sections (approximately 4 times per year), as well as being a gravity sewer in normal service. This feature required that the rehabilitation process should also provide for the line to be able to serve as a pressure main when operating as the pumped overflow.

Although the pressure required to drive the pumped overflow is not great when compared to the pressures in rising mains, the requirement for internal pressure capacity is not a common one facing designers of rehabilitation projects in wastewater conduits of this size. Figure 3 overleaf shows an excerpt from the Watercare Hydraulic plan for the sewer section.

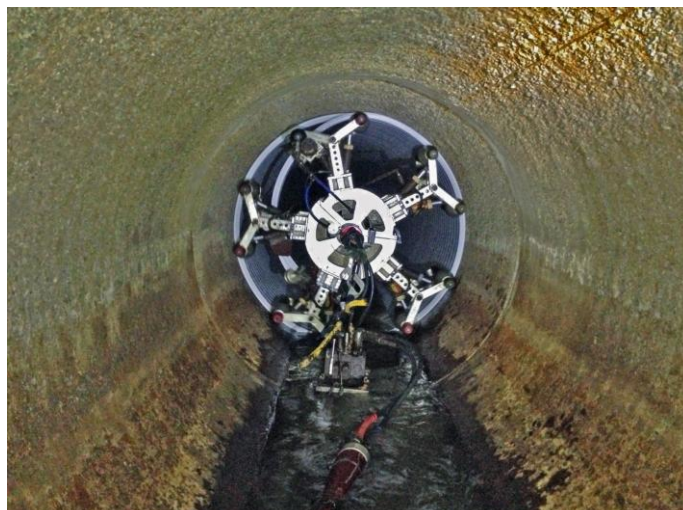
Figure 4: Rotaloc Standard Profile Strip

The principal advantage of the Rotaloc system for this project was that it allowed for the lining to be installed without any major flow management, as well as meeting the requirement to provide a fully structural rehabilitation, capable of withstanding internal pressure, and maintaining hydraulic capacity in the diversion section. Figure 4 below illustrates the Rotaloc standard profile strip. Photograph 4 below shows the Rotaloc installation in the live sewer.

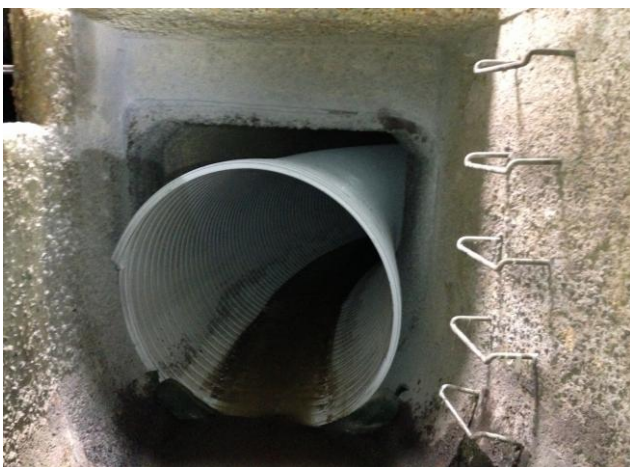
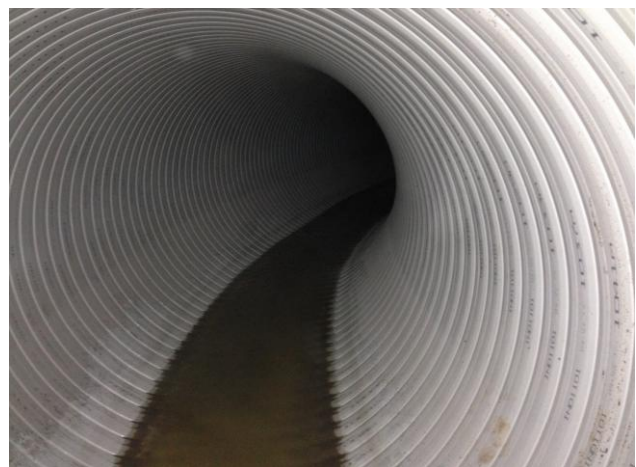
Immediately downstream of MH3, there was a curved section, including a 10m length of rectangular culvert, which presented a further challenge for this project. The standard Rotaloc liner would not have been suitable for lining this curve, and the original intention was to rehabilitate this section by conventional reconstructive techniques, using reinforcement replacement and shotcreting with calcium aluminate cement mortar. However, Interflow proposed a newly developed variant of the Rotaloc® profile for this section, which allowed for the same rehabilitation process to be used throughout. For the flat top section, the lining was continued into the manhole, and the void space was filled with grout, so that the circular profile was installed continuously from MH03 to MH02. The bend profile strip utilized is illustrated on figure 5 below and shown in photographs 5 and 6 overleaf.

*Photographs 5 & 6: Rotaloc installation in the Sewer Bend MH2-MH3*
