CAPACITY AND CONDITION – THE CRITICAL ELEMENTS FOR INFRASTRUCTURE PLANNING

*Brett Eaton, Amy Smith, Simon Cartwright – Cardno BTO
Arno Benadie, Kritzo Venter – Wanganui District Council*

This paper presents how Wanganui District Council (WDC) commissioned a 30 Year Master Plan for the Beach Road Pumping Station (BRPS) and the tools Cardno BTO used to prepare this Plan. This Plan forms an integral basis of WDC's long term infrastructure planning strategy.

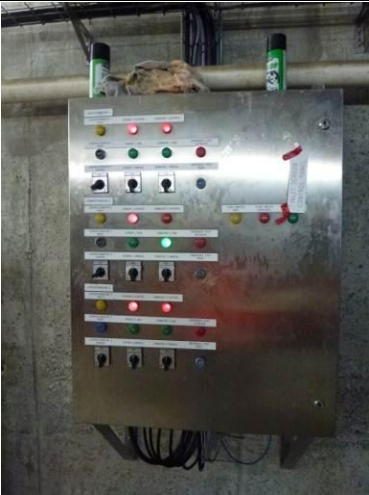
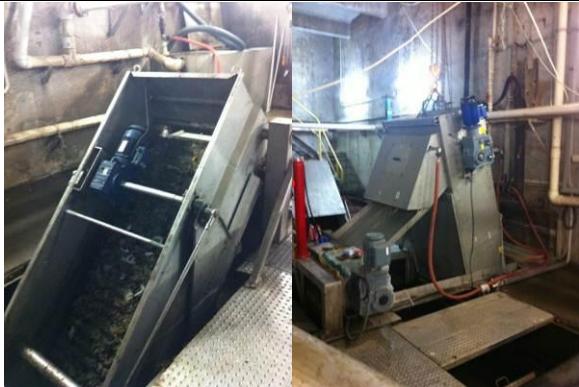
Table 2 – Example: Electrical condition assessment of inlet screens

Asset Description: Inlet Screens General Condition: Grade 1 – Very Good Exceptions: Old rake screen and ancillaries and cable containment. Refer to photos and notes below

<u>Inlet Screens</u> Inlet screens control panel is in very good condition, however labels need to be secured.	<u>Inlet Screens</u> Inlet step screen and new rake screen motors in good condition.

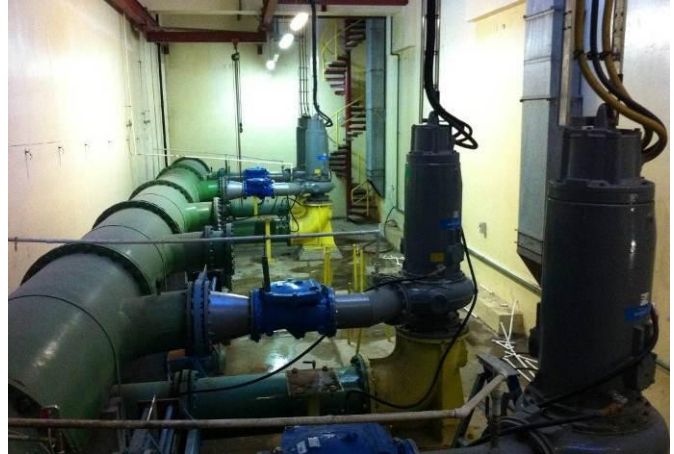
Picture 1 – Beach Road Pumping Station dry well and pumps

The BRPS consists of five (including one spare) Flygt dry mounted submersible centrifugal pumps, operated in parallel and on variable speed drives (refer to Picture 1). The pumps were installed in 2006, and have the following specifications: Flygt model C3312.765, a 560mm impeller diameter, and an 180kW motor.

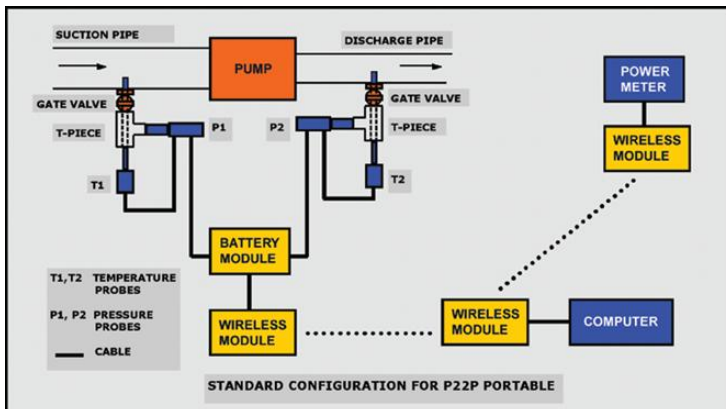
Figure 2 – Schematic of P22 portable pump performance monitor

Each P22P pump monitor system has two temperature probes, two pressure probes, one power meter and a software program. These are connected together using digital network technology that can utilise radio transmitters to allow the computer terminal to be situated away from the noises of a pump room. Figure 2 shows a schematic of a standard testing equipment configuration, and Picture 2 presents the portable testing equipment (discharge side only) installed during an in-situ pump performance test.

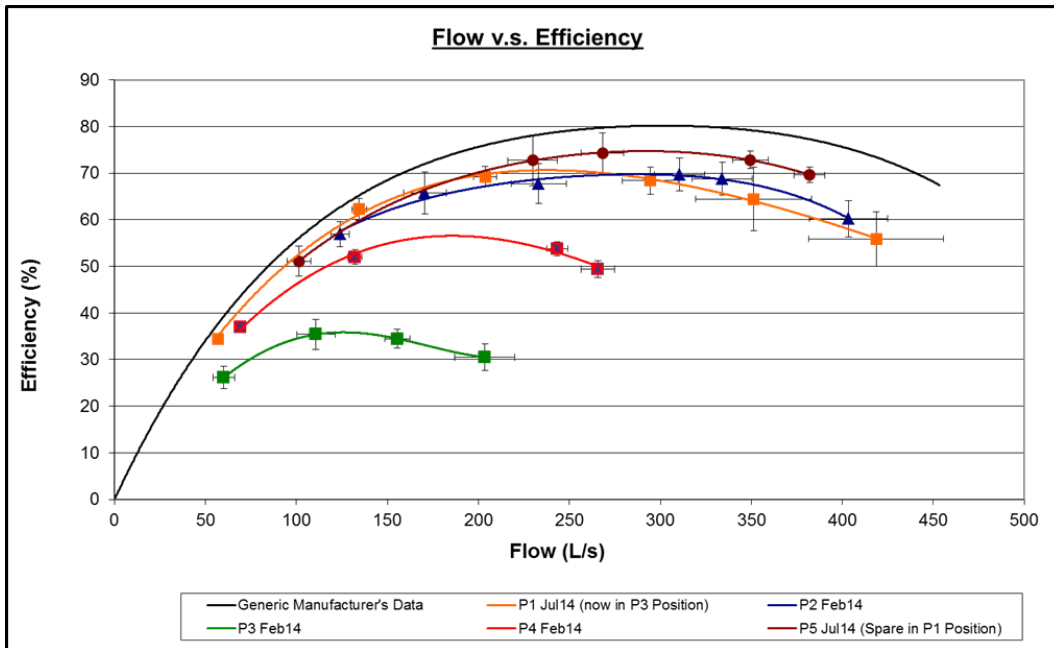
Figure 3 – All pumps' efficiency vs. flow (at 75% of full speed)

The latest performance tests for each of the five BRPS pumps are compared against each other. All curves have been standardised to 75% of full speed. Flow variation was achieved by modulating the newly installed discharge valves.

Figures 3, 4 and 5 show the efficiency, head, and power respectively of the four BRPS pumps. The data points presented in these figures contain error bars that represent the uncertainty, by means of a 95% confidence interval.

Pump 3 is the most deteriorated pump; it now has approximately half the efficiency of Pump 2. This is consistent with observations by operations staff; who have observed that the flow through Pump 3 has declined significantly. Possible reasons for Pump 3 deteriorating further than the other pumps could be due to the following: the suction pipework to Pump 3 favours pumping debris accumulated in the wet well, higher total pump run hours than the other pumps.

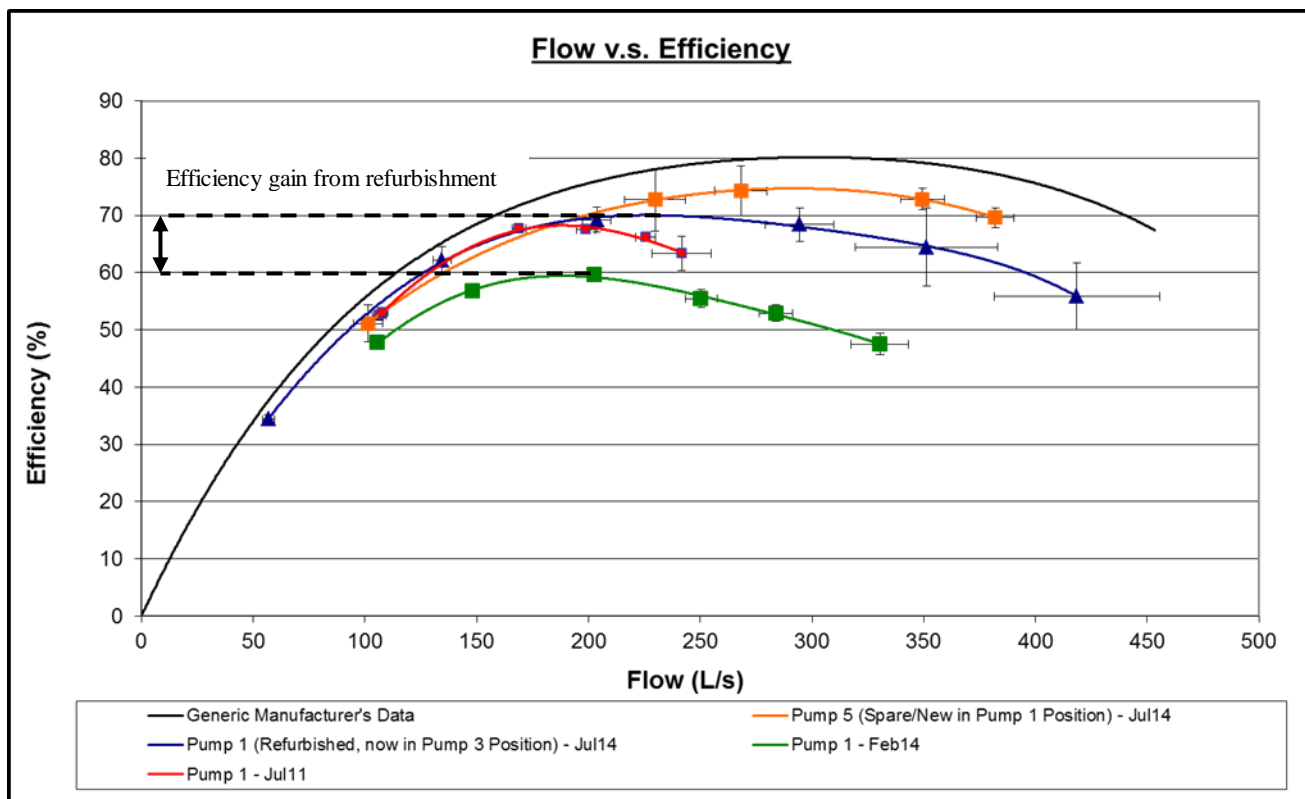
Figure 6 – Pump 1 pre and post refurbishment efficiency (at 75% of full speed) compared to various benchmarks

Figure 6 presents the refurbished Pump 1 performance, compared to various benchmarks (generic manufacturer’s data, Spare Pump 5, and previous performance tests).

The refurbishment of Pump 1 yielded an increase in efficiency of around 11.7% compared to the performance measured in February 2014. Refurbished Pump 1 has a BEP that is 4.3% less than that of Pump 5 (the spare/new pump), and 8.8% less than that of the generic manufacturer’s data. This is in our opinion, a realistic outcome from such a pump refurbishment.

- Freight
- Dismantled and cleaned
- Replacement of the following parts is also required: bearings, wear ring, mechanical seal and all other rubber sealing parts..
- Setting the pump ‘wear ring’ tolerance back to the manufacturer’s specifications (where the most pump performance benefit will be gained)
- Shaft repair and balancing
