INITIAL RESPONSE IN AN EMERGENCY: CHRISTCHURCH WWTP FIRE

Dr Becky Macdonald – Principal Wastewater Engineer, Jacobs NZ Ltd

Adam Twose – Operations Manager, 3 Waters, Christchurch City Council

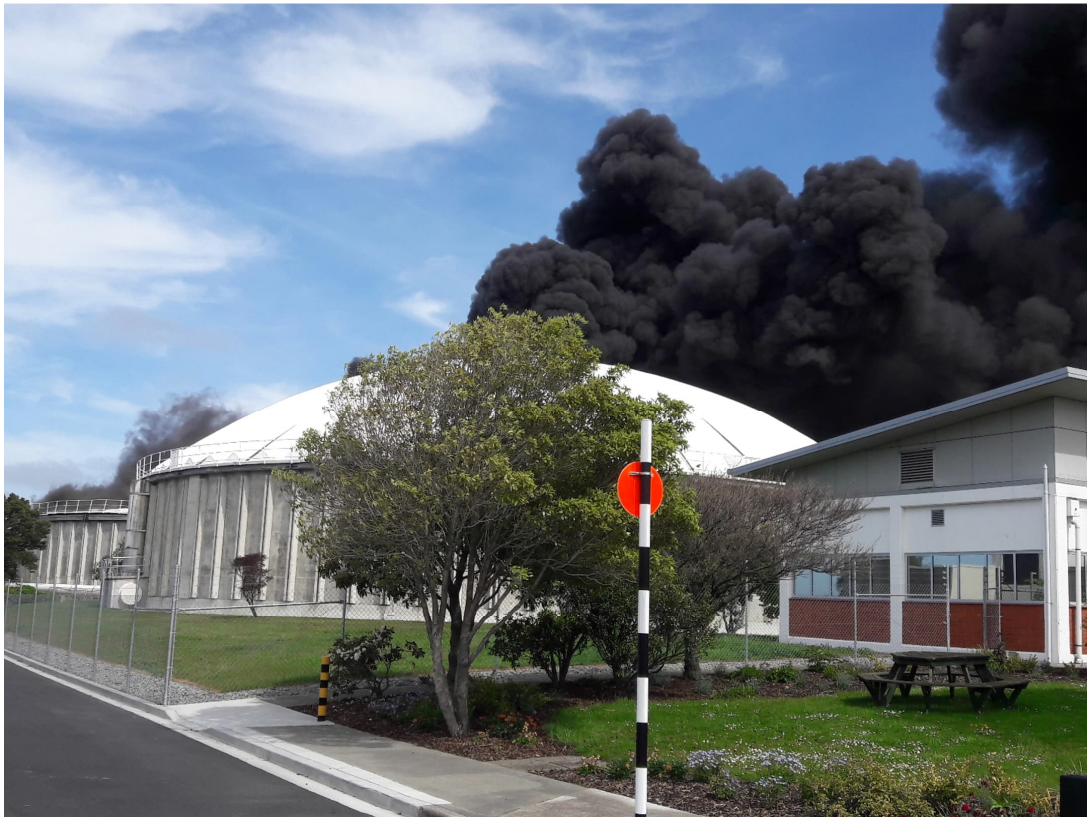
Figure 1: Trickling filters during the fire event

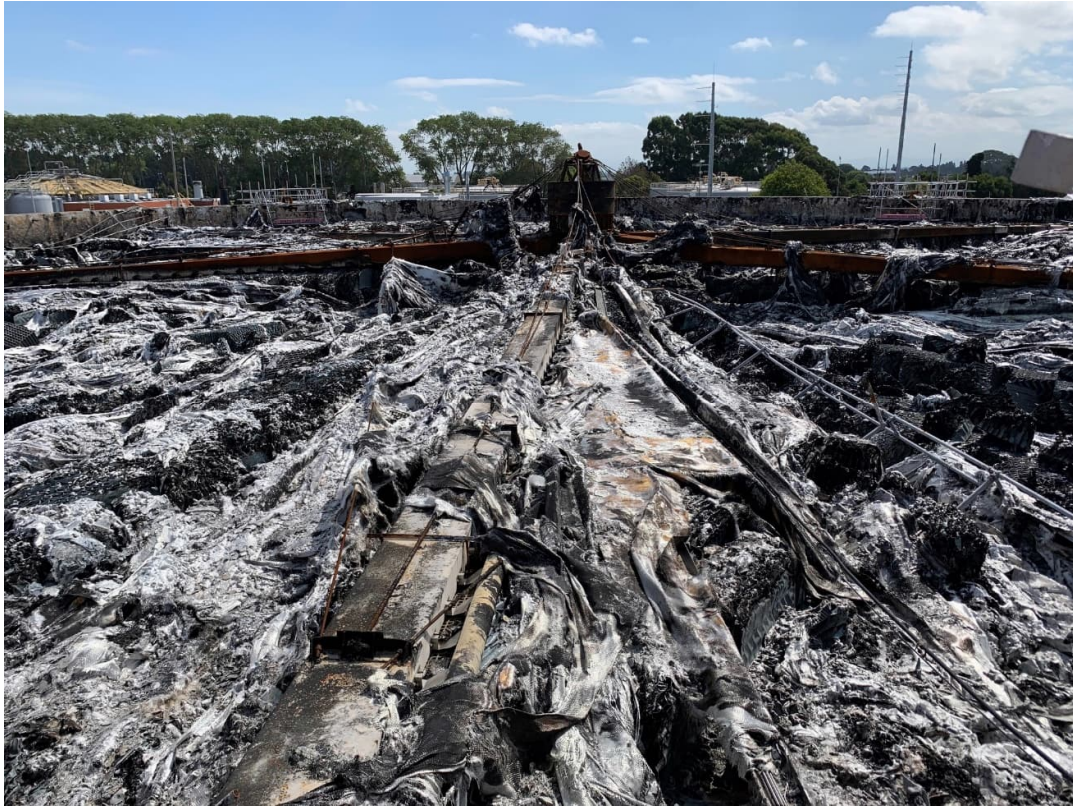
Figure 2: fire damaged trickling filter

For the last 50 years the powerhouse of the CWTP treatment process has been two trickling filters, operating in parallel, which provided the majority of the BOD removal. The 2021 fire caused catastrophic damage to the trickling filters (rendering them unusable), damaged the odour management in the screen room, and disabled the wastewater flow path through the trickling filters to the SCTs, isolating Pump Station A from the process. Pump Station B remained connected and operable, which allowed a portion of the flow to bypass directly from the PSTs to the SCTs and then on to the secondary clarifiers.

- The trickling filters were rendered inoperable due to the direct damage caused by the fire, essentially removing all of the secondary treatment process and significantly reducing the BOD removal capability of the process.

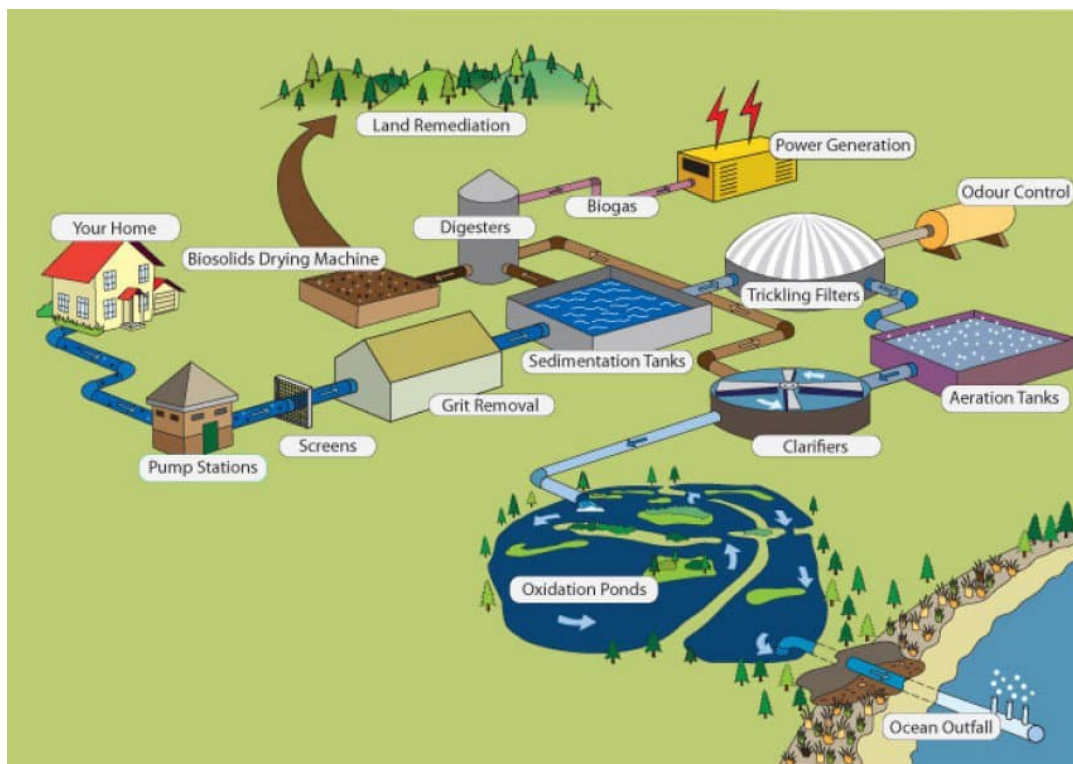
The general process description for the liquid stream at CWTP, pre fire, is shown in Figure 1 and includes:

- Screening to removal larger particulate contaminants in the raw wastewater
- Grit removal to remove of grit and sand
- Primary sedimentation (PST) removes the readily settleable “primary solids” which are transferred to an anaerobic digester for treatment.
- Trickling filters (TF) which biologically converts about 80% of the soluble BOD converting it to “secondary solids”
- Solid Contact Tanks (SCT) where air is bubbled through the TF effluent, providing some further biological treatment but mainly secondary solids flocculation
- Secondary clarification to remove the secondary solids which are transferred to an anaerobic digester for treatment
- Polishing ponds which provide some nutrient removal but primarily disinfect the wastewater (pathogen removal) using natural sunlight

Figure 3: CWTP prior to the 2021 fire event

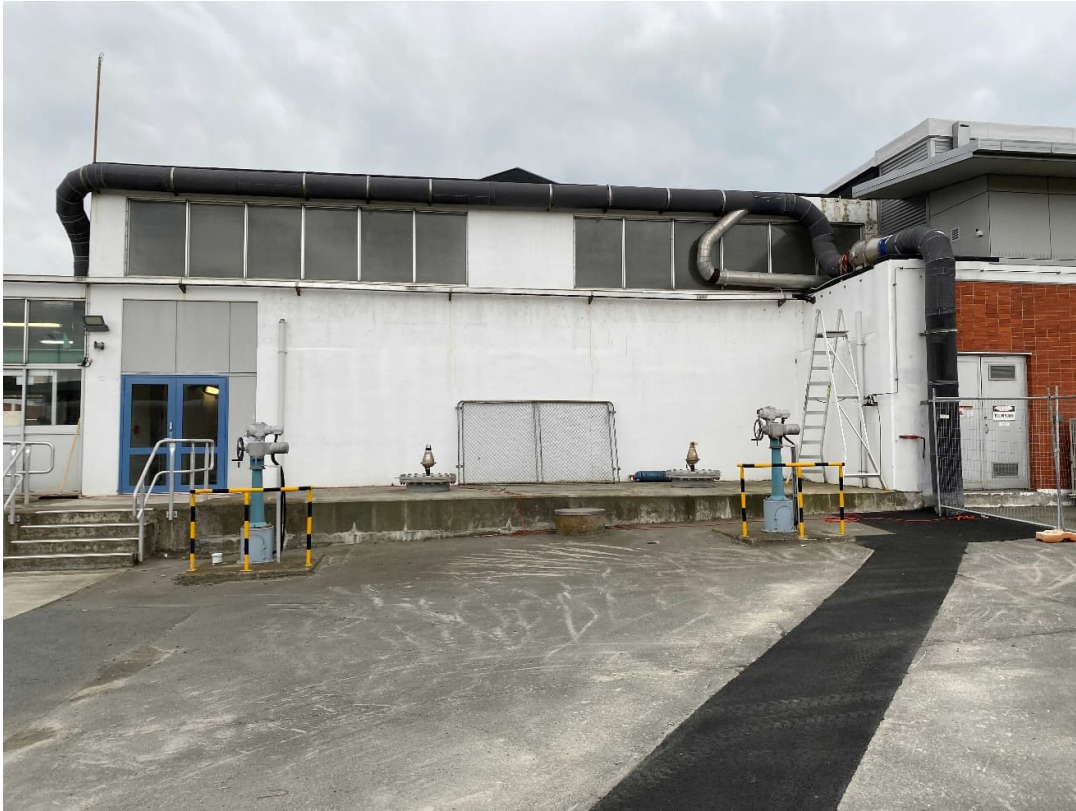
Foul air ducting from the inlet screen room was connected to the trickling filter foul ducting. The fire damaged the trickling filter foul air ducting and fans. Biofilter 1 including the biofilter fans, were not damaged and continued to provide treatment of air from the gravity belt thickener building which was separately conveyed to the biofilter.

Figure 4: new foul air ducting from the inlet screen room

In the weeks following the fire, new ducting was installed to convey foul air from the screen room to the foul air handling system for the gravity belt thickener building. From here the air is combined with the foul air from the gravity belt thickener building for conveyance to Biofilter 1 for treatment.

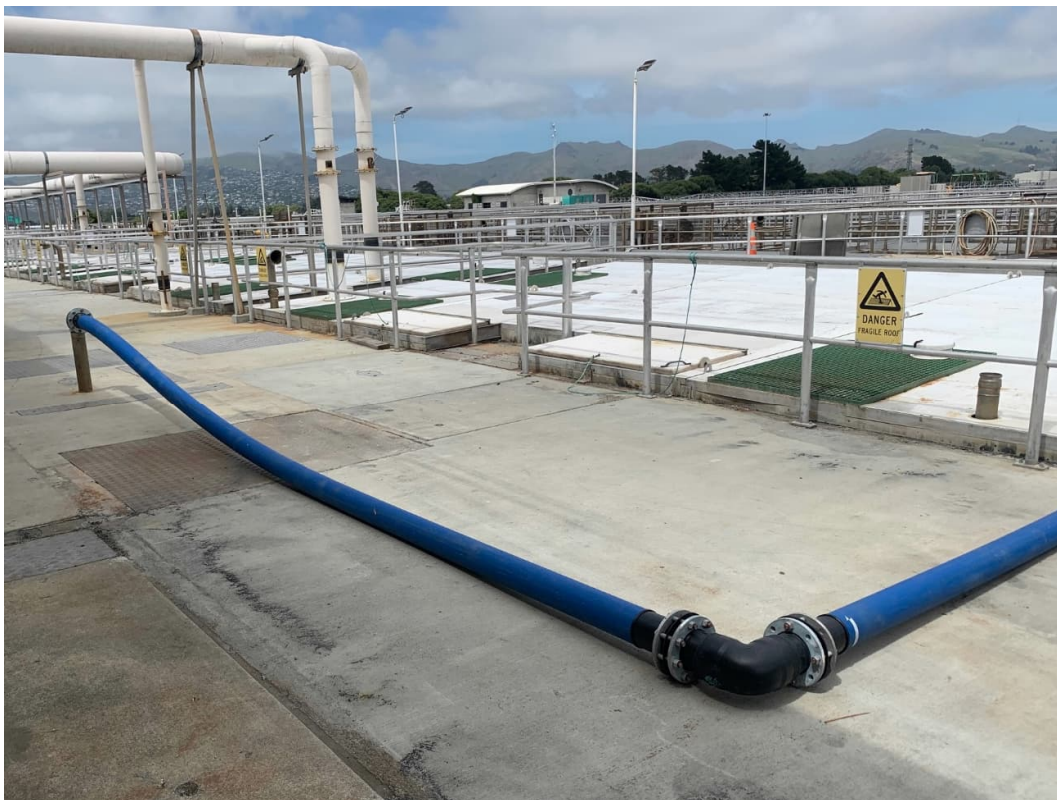
Due to the potential for WAS to generate odour, the only feasible, short-term option for the management of the contaminated WAS, was disposal to landfill. However, there was no existing mechanism to collect the WAS and dewater it for transport. The existing WAS is thickened using gravity belt thickeners ahead of digestion. The belt presses are only connected to the digested sludge and are located over 100m across site from the thickened WAS hopper.

Figure 6: temporary connection from the gravity belt thickeners to the belt presses

Temporary modifications were made, running flexible pipe across the ground to connect the thickened WAS to the belt presses. Dewatered WAS from the belt press was deposited on the biosolids pad, where was collected and trucked to the landfill. Once the trickling filters were isolated, and the source of contamination removed, WAS was again conveyed to the digesters for treatment.

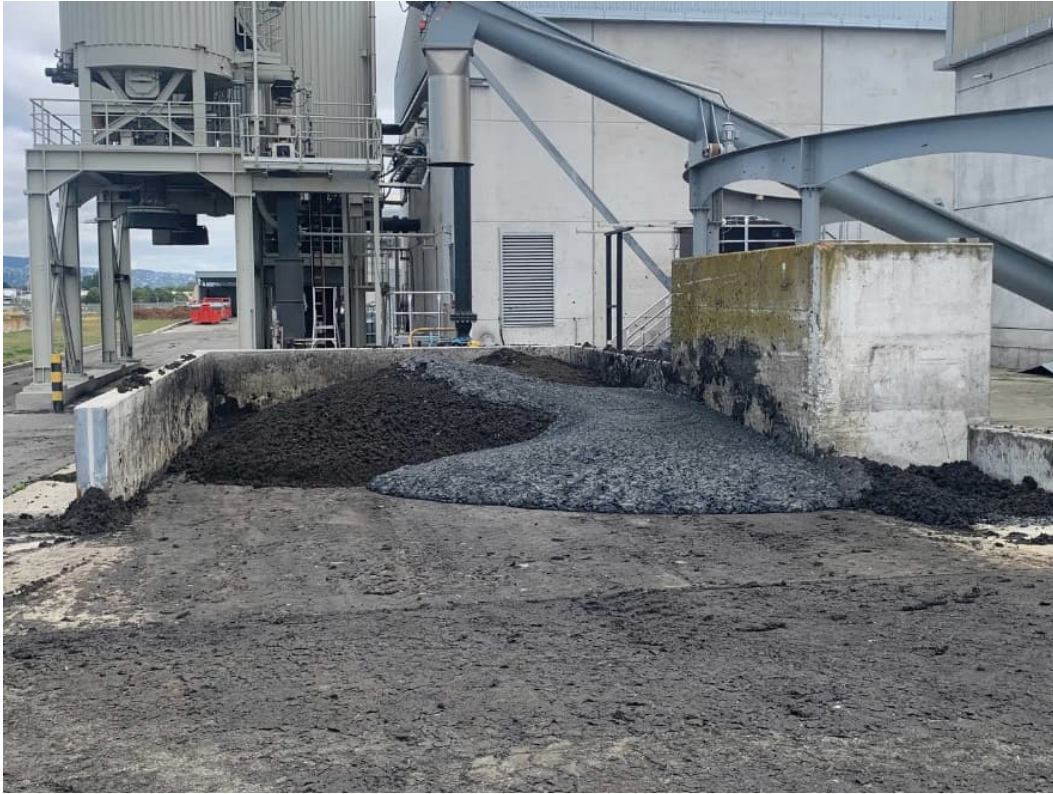
Figure 7: dewatered WAS awaiting transport

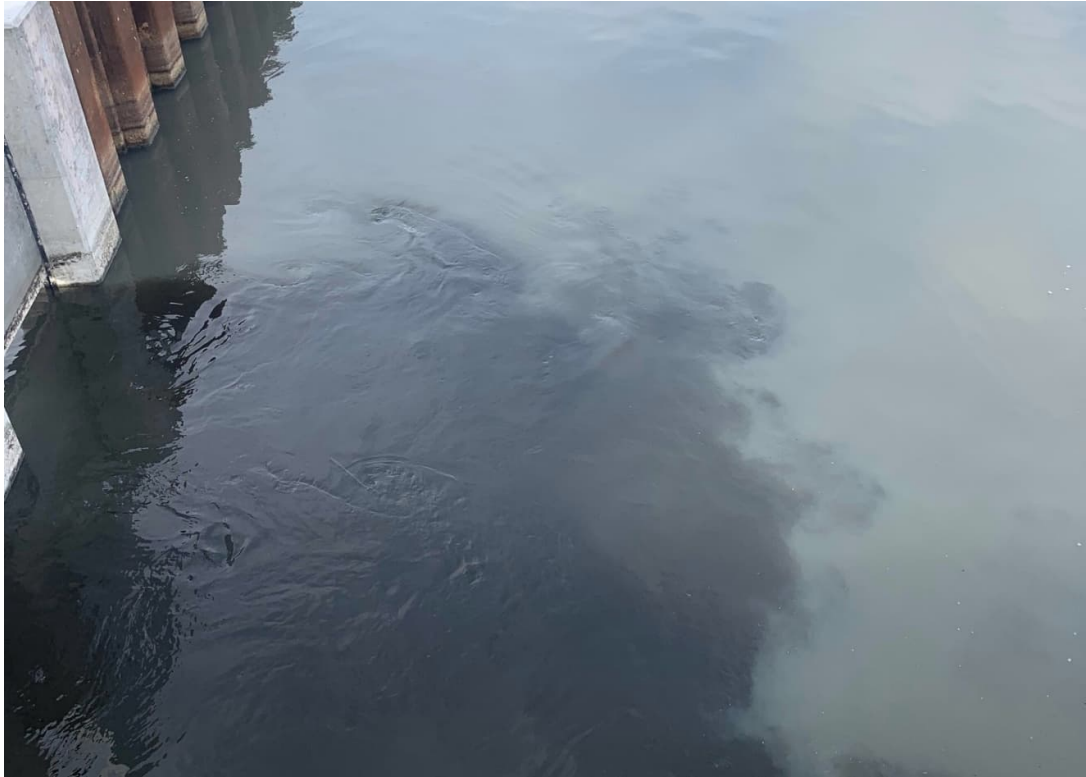
Contaminated wastewater flowed into the ponds changing the colour from green (algae) to black.

With the loss of the trickling filters, the BOD of the plant effluent increased from normally stable 10 g/m^3 and 20 g/m^3 (filtered BOD) to fluctuating between 30 g/m^3 and 150 g/m^3 (average 133 g/m^3). This corresponded with a reduction on the dissolved oxygen in Pond 1 to below 1.0 g/m^3 . This indicated that the ponds had changed operation from operating as maturing / polishing ponds for low strength secondary treatment wastewater, to operating as a highly loaded oxidation pond receiving primary treated wastewater. This creates a risk of anaerobic conditions forming across the full depth of the pond, resulting in odours from the ponds. Due to the large pond surface area, odour could be significant.

Figure 8: contaminated wastewater mixing in Pond 2

Increasing the available oxygen in the ponds was essential in order to enable BOD treatment of the wastewater in the ponds. An immediate mitigation was to introduce chemical oxygen to the ponds. Hydrogen peroxide dosing (H_2O_2) was installed at the inlet to the ponds to achieve a set point of 4.0 g/m^3 dissolved oxygen at the inlet to Pond 1. However, this additional oxygen was quickly depleted with the outlet from Pond 1 remaining at below 1.0 g/m^3 .

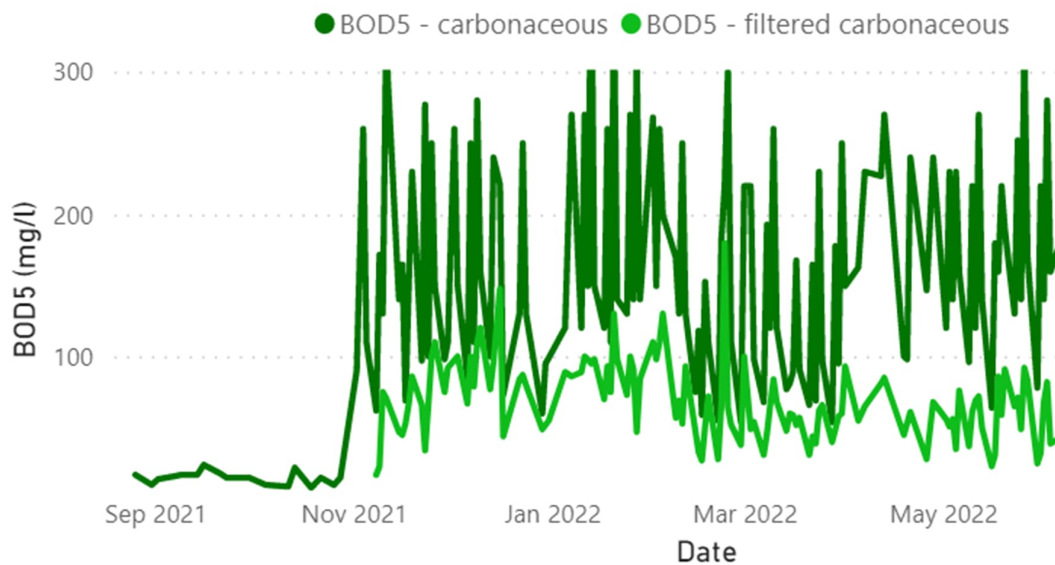
Figure 9: Plant effluent BOD₅ (filtered)

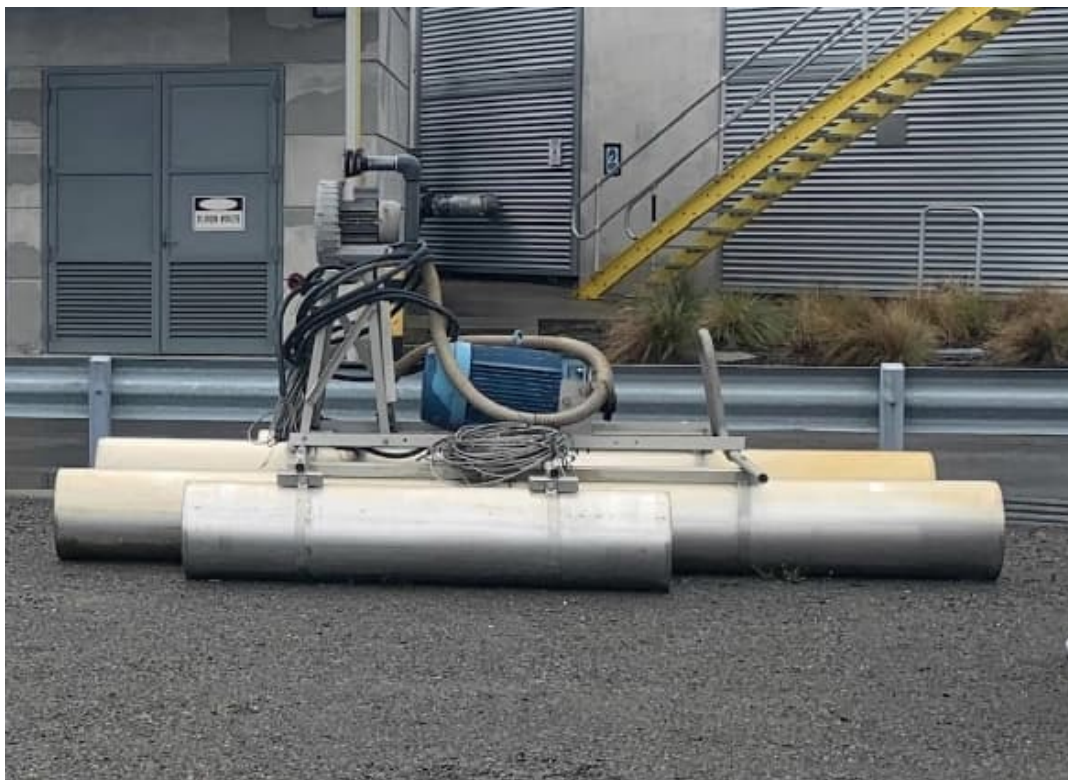
- One aspirating aerator owned by Fonterra and operated by Tasman District Council at the Takaka Wastewater Treatment Plant. This aerator is generally only used 3 months of the year when the milk flows are at the highest.
- Two directional surface aerators owned by Invercargill City Council that had been mothballed at the Invercargill Wastewater Treatment Plant.

Figure 9: one for the direction aerators from Invercargill

All three aerators were relocated to CWTP and refurbished at the CWTP maintenance workshop. These aerators were installed close to the inlet of Pond 1. However, due to the very high BOD loading, the ponds rely on the production of oxygen by algae in the ponds. In winter when algae growth slows considerably, due to the lower temperatures and reduced sunlight, the current aeration is not sufficient to maintain aerobic conditions and odours are a nuisance.

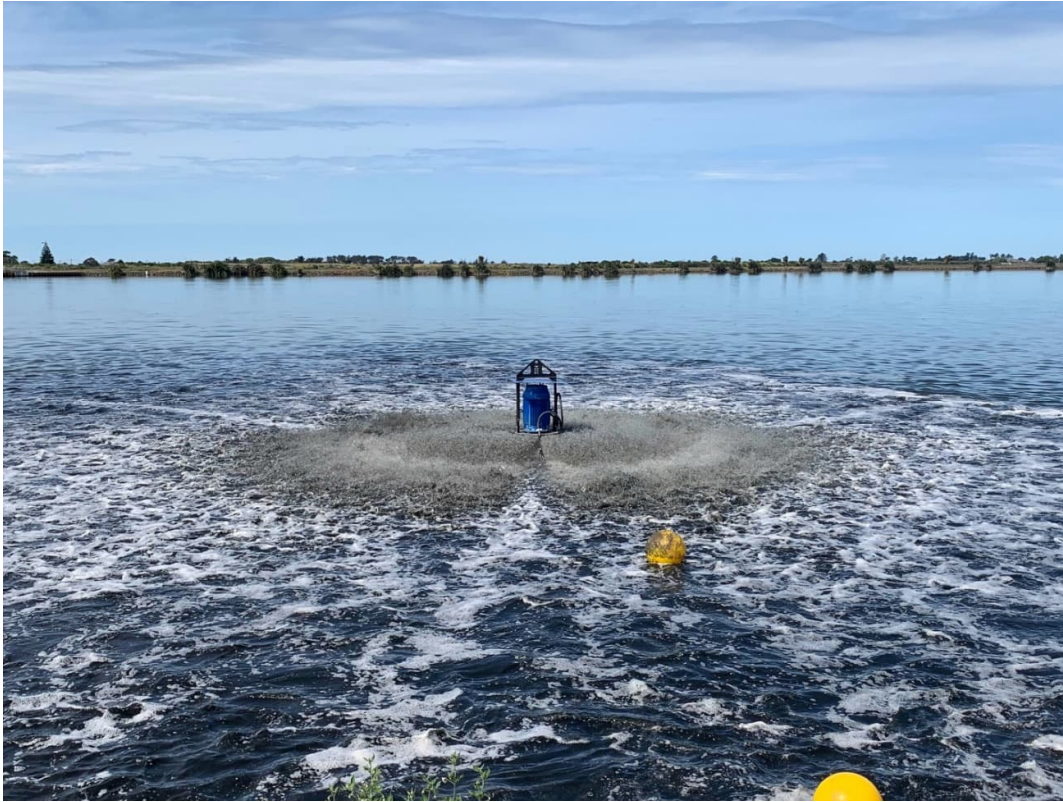
Figure 10: The aspirating aerator from Takaka
