PRESSURE PIPE CONDITION – RIGHT PIPE, RIGHT TEST

Aaron Prince – Assetlife Alliance

ABSTRACT

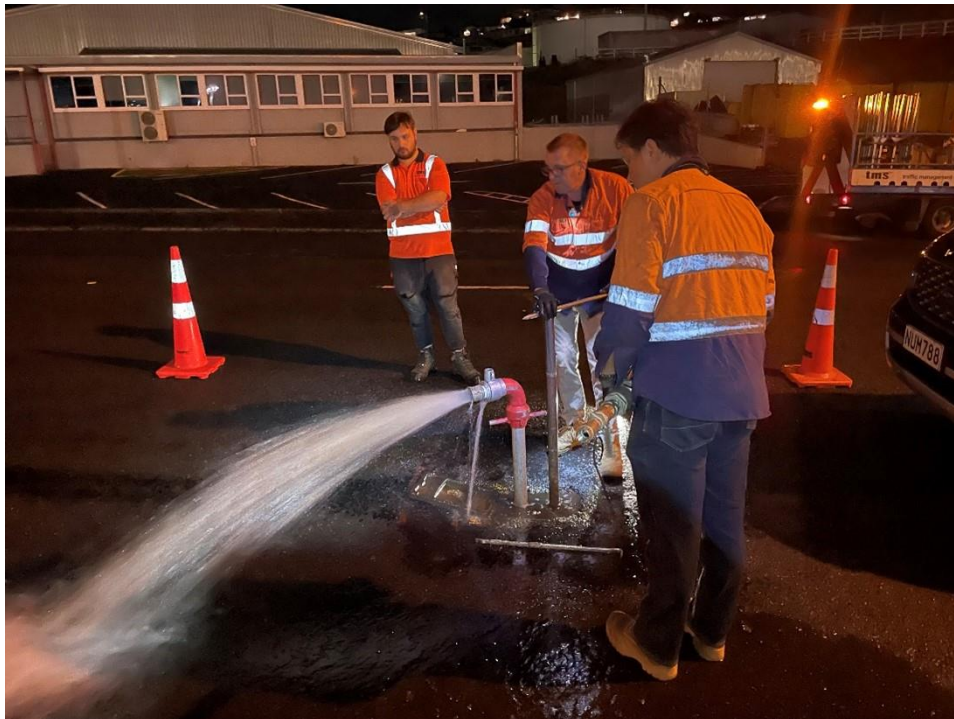
Figure 3: Flushing a hydrant in New Plymouth before connecting p-CAT test kit to the riser

Access points can be spaced reasonably far apart, typical access points are air valves, hydrants, flush valves, permanent pressure monitoring tappings, blanked off tees or as a last resort specially constructed tapping points.

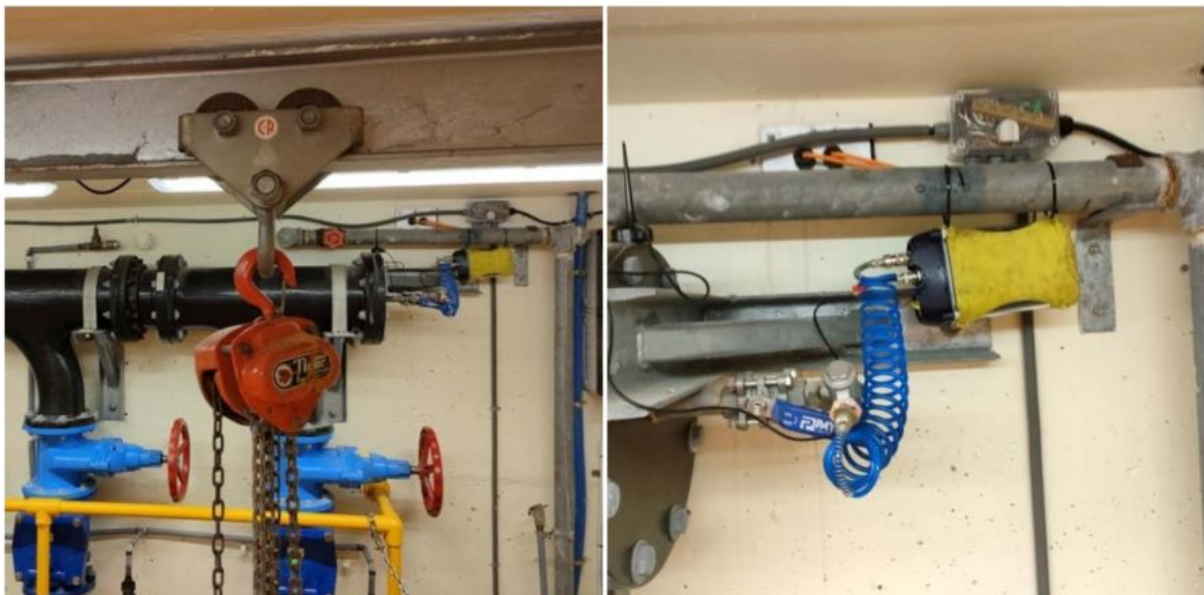
Figure 4: PT Monitor is the yellow unit, installed in a wastewater pumpstation in Seatoun Wellington.

PT Monitoring measures the internal stresses induced on pipes, which combined with information on the pipe wall condition allows calculation of the factor of safety of the pipe. They can be placed on both fresh and wastewater pipes.

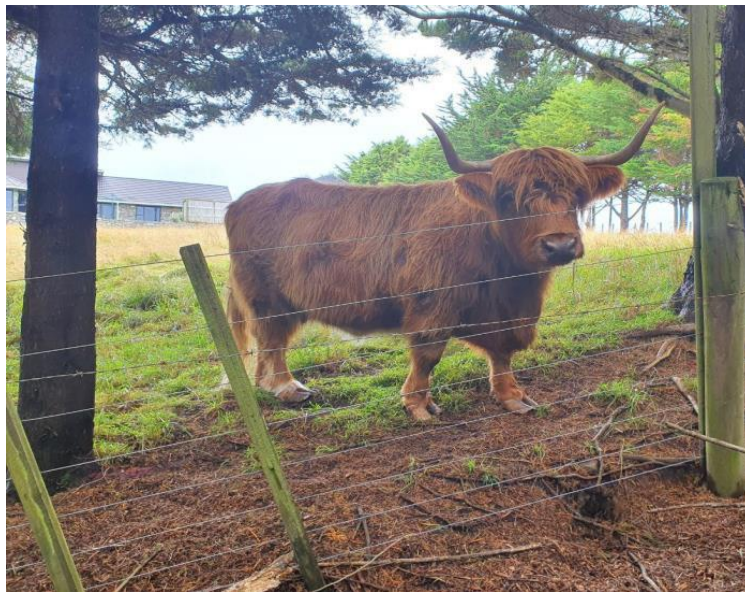
Figure 6: A local restricting access to a VHCA pipe across private farmland in Wellington. Photo courtesy Chris Newton

Most testing will require minor civil works such as potholing, asset location and opening buried or seized chambers that could not be accessed during the pre-inspection. There will invariably be traffic management planning and access to private land may need to be arranged.

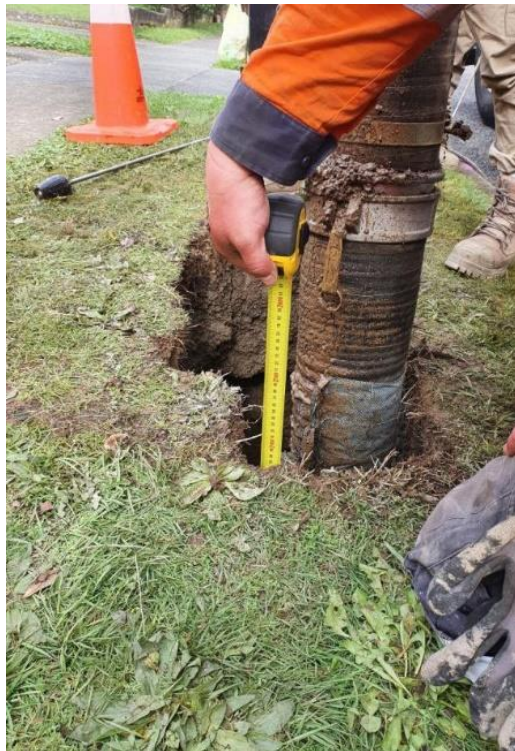
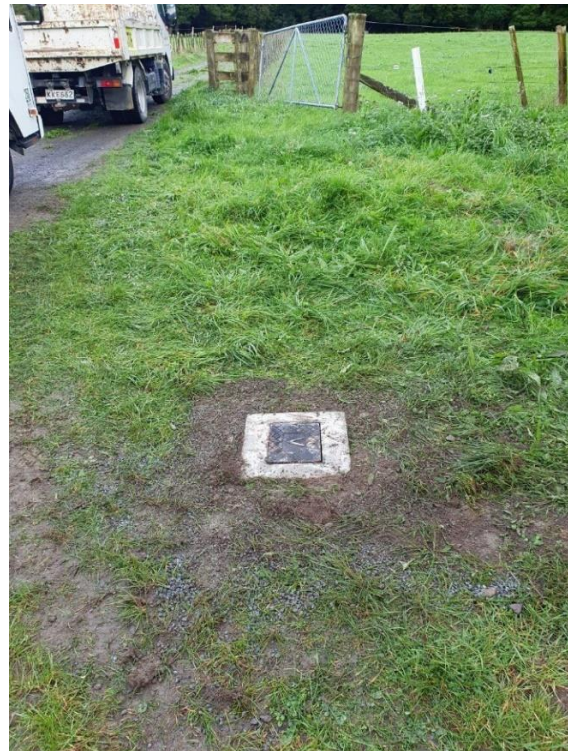
Figure 8: Typical inspection shaft being hydro excavated and finished with cover (courtesy Intergroup and Wellington Water)
