# REMOTE MONITORING TO REDUCE WASTEWATER OVERFLOWS IN OUT-OF-SIGHT PLACES

*Heather Kikkert (Hamilton City Council)*

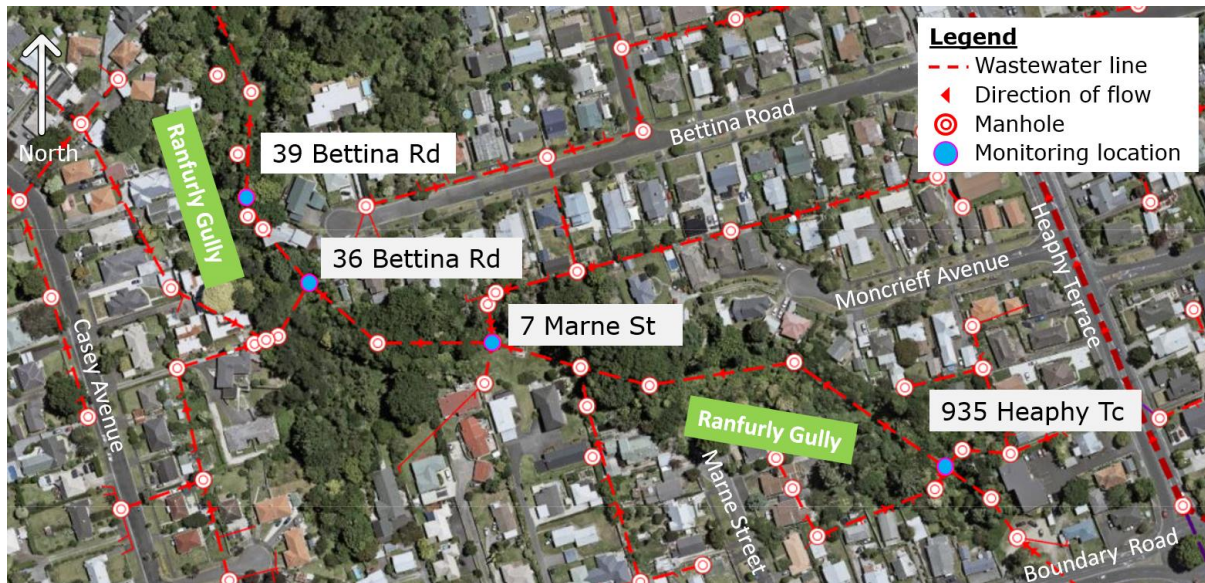
Figure 1: Ranfurly Gully showing location of wastewater network and monitored manholes

The monitoring locations were selected based on known previous overflows, all of which were due to network blockages. Four locations were selected along the main pipeline (*Figure 1*), based on the chance that a drop or increase in level would be picked up. Once the hydraulic interaction between the selected locations was better understood, the number of sensors would be reduced. The removed sensors would then be redeployed and reinitiated to monitor elsewhere.

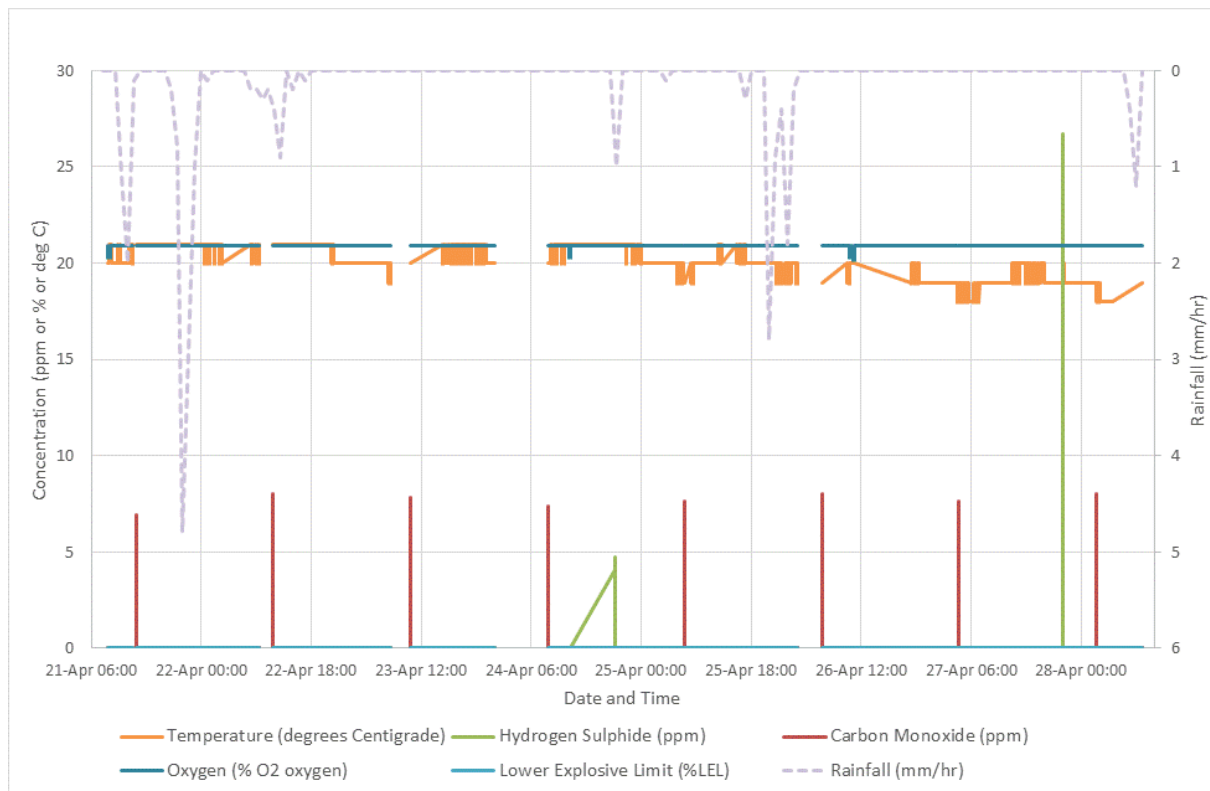
The gas measurements showed no obvious changes over the weekend (23 and 24 April 2022), with the exception of a spike in hydrogen sulphide (*Figure 2*). The maximum reading was 4.7 ppm. Levels of 5 ppm are considered low.

A larger spike in hydrogen sulphide was observed on 27 April, peaking at 21:00 at 26.7 ppm (*Figure 2*). The hydrogen sulphide level rose from 5 ppm to 26.7 ppm in 1 minute and dropped back to 4.1 ppm over 4 minutes. The cause of this spike to medium levels is unknown and is assumed to be something passing along the pipe.

Figure 2: Gas monitoring at a wastewater manhole in Ranfurly Gully over a week

The gas logging also indicated a cycle of carbon monoxide spikes at fairly regular intervals, with the peak level observed at a low 8.0 ppm (Figure 2). The cause of these spikes is unknown.

Rainfall was plotted to compare with the gas levels, in case this was the cause of spikes in gas concentrations. As shown in Figure 2, rainfall did not seem to impact the gas levels.

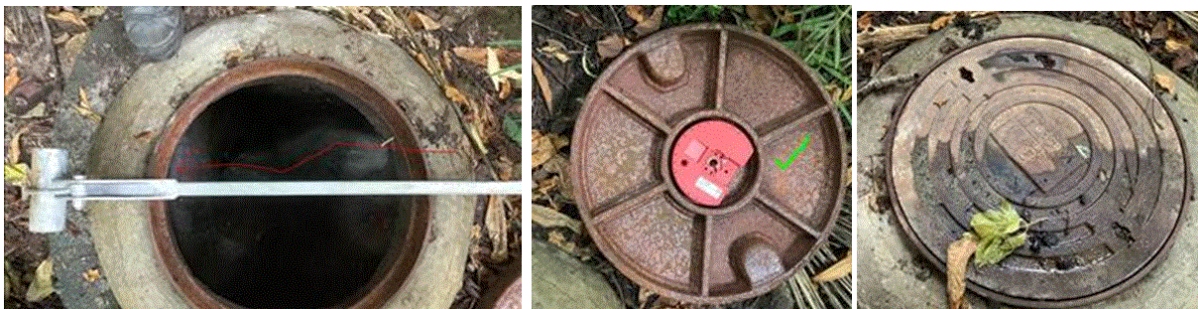
*Figure 3: Example 1 from preliminary site survey: photos showing, from left to right, alignment of channel, sensor placement, manhole surface*

At each site the alignment of the channel under the lid was also checked (e.g. central versus off-set, see *Figure 3* and *Figure 4* for examples) to determine whether it may be possible to measure water level within the channel in addition

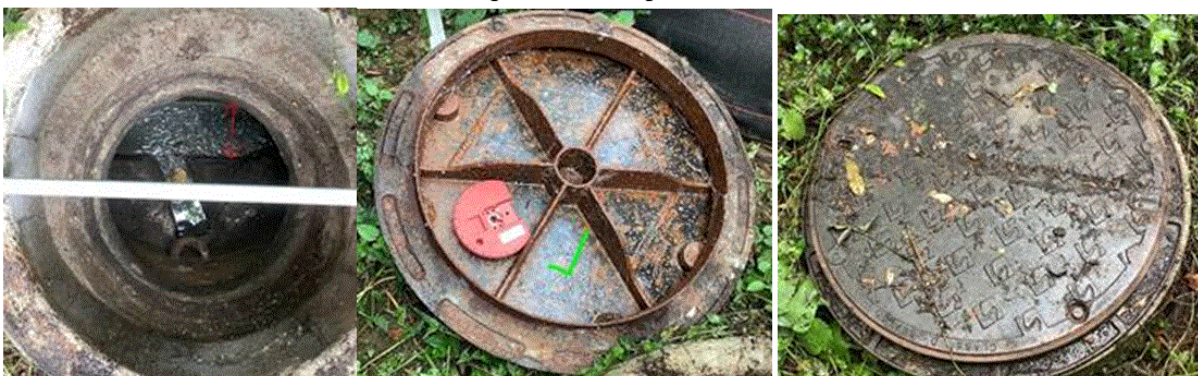
*Figure 4: Example 2 from preliminary site survey: photos showing, from left to right, alignment of channel, sensor placement, manhole surface*

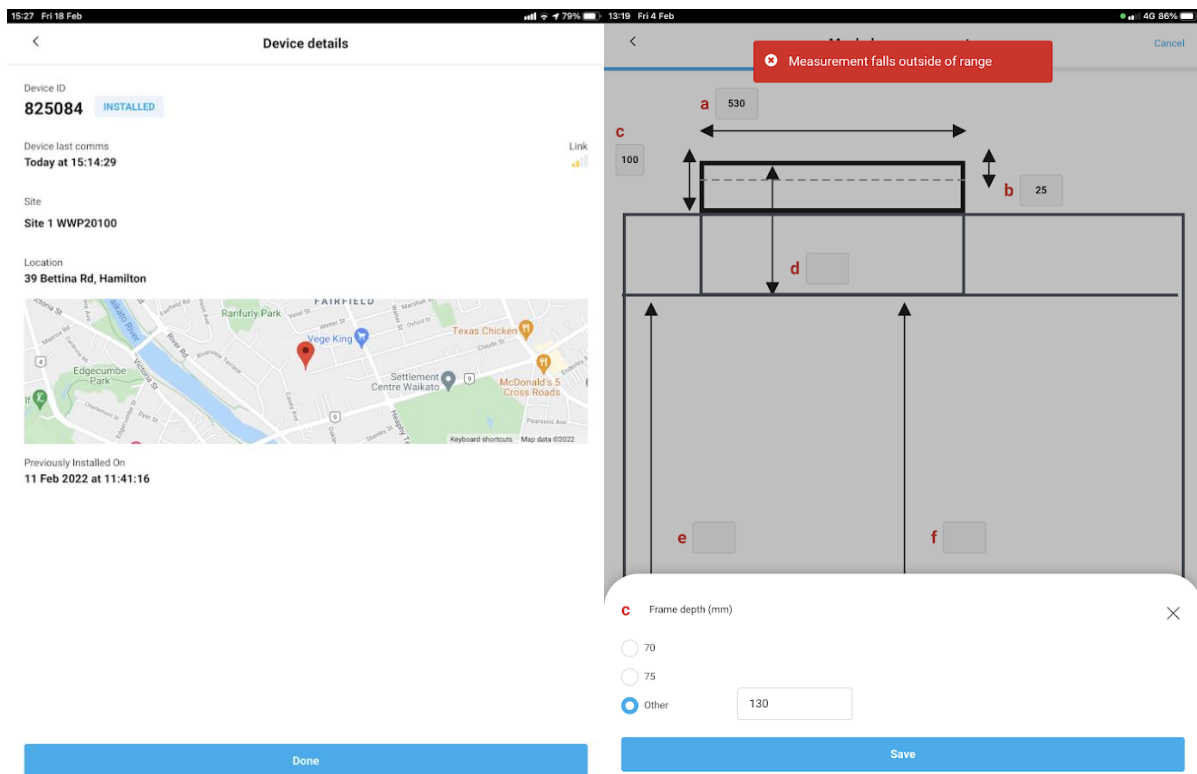
*Figure 5: Two screenshots from the Hynds Aquanect installation app*

Each sensor was set-up using a prototype app. The app stepped through set-up of the devices, prompting the user for data required to set-up the device, such as depths (see *Figure 5* for screenshots). This data was forwarded to Hynds to complete the device setup remotely. At the time of installation, the app was only available for Apple devices. The app was easy to use, and the feedback staff provided was able to feed into further development of the app, such as Android capability.

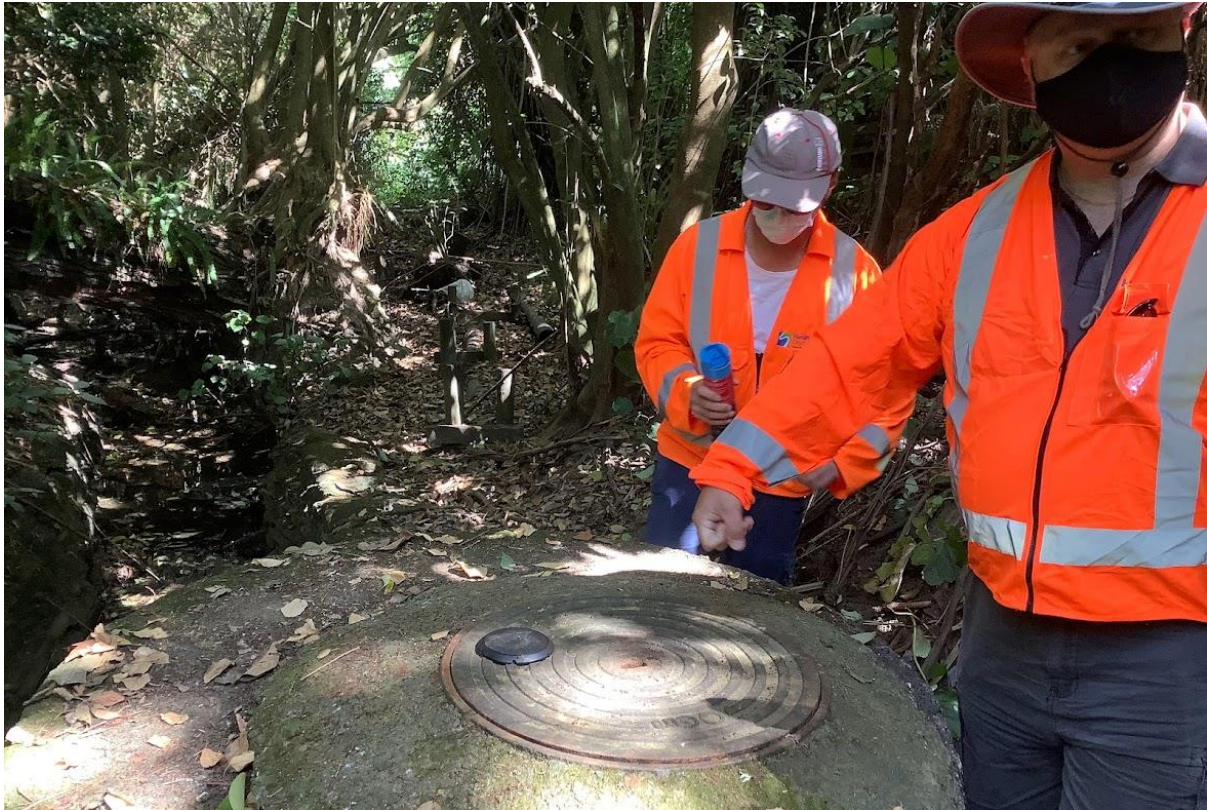
*Figure 6: Manhole with sensor installed and staff preparing to mark manhole alignment. Note uneven terrain and dense vegetation in the background.*

The manhole lids and frames were marked with blue spray paint to denote the correct orientation of the lid within the frame (refer to *Figure 6* and *Figure 13*). The correct alignment is essential as the sensor learns the shape of the manhole chamber and uses this to measure when the level is rising in the chamber. If the manhole lid is rotated, the sensor loses its benchmark bearings and resulting in false readings.

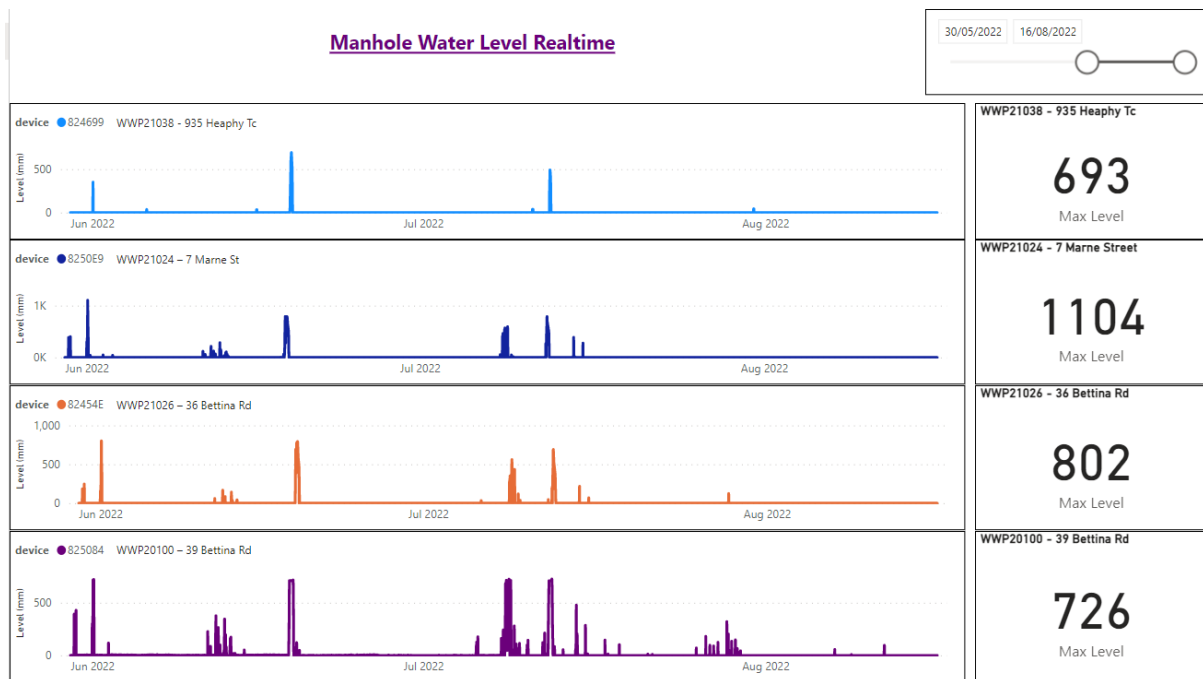
*Figure 7: Screenshot of the monitoring dashboard main page showing the four trial sensors*

The dashboard showed a timeline of all four sensors, with the maximum level reached within the time period selected (*Figure 7*). A second page allows the sensors to be overlapped to see their interrelationships more easily (*Figure 8*). If more locations were monitored in the future, the dashboard can be easily amended at minimal cost to show further sites, plus has the flexibility to add specialized pages for interrelated sites.

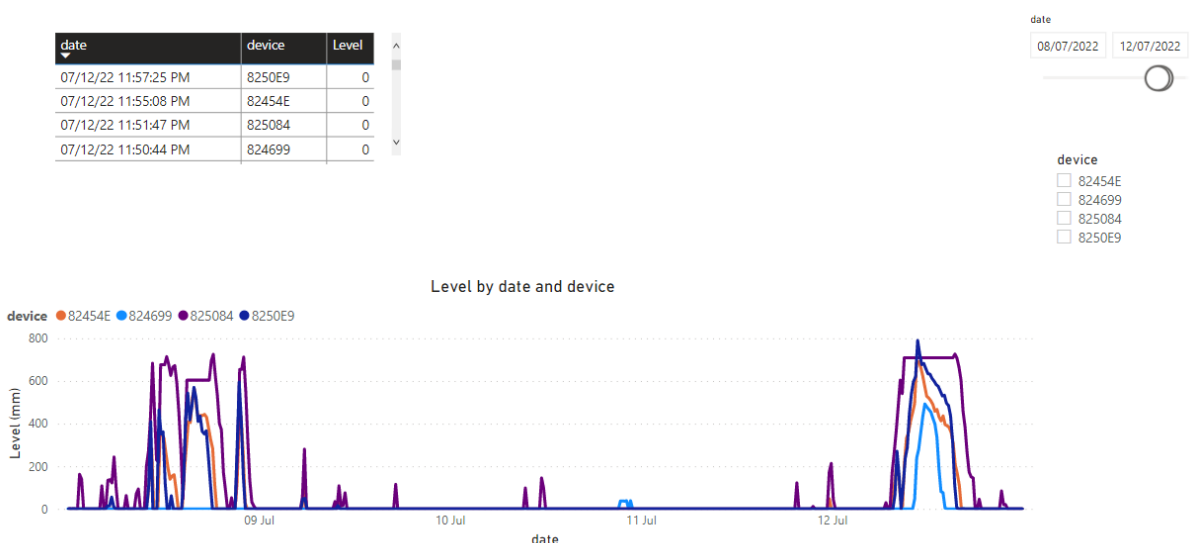
*Figure 8: Screenshot of the monitoring dashboard with sites in Ranfurly Gully overlapped and a summary table of the last call-in within the period*

The dry summer of 2021-2022 meant that initially the new dashboard showed a flat line of zero level. This caused some people to wonder whether the sensors were in fact reading at all. To alleviate that fear, the dashboard showed the date and time of the last call in for each sensor (*Figure 8*), showing that they were calling in every 15 minutes as programmed.

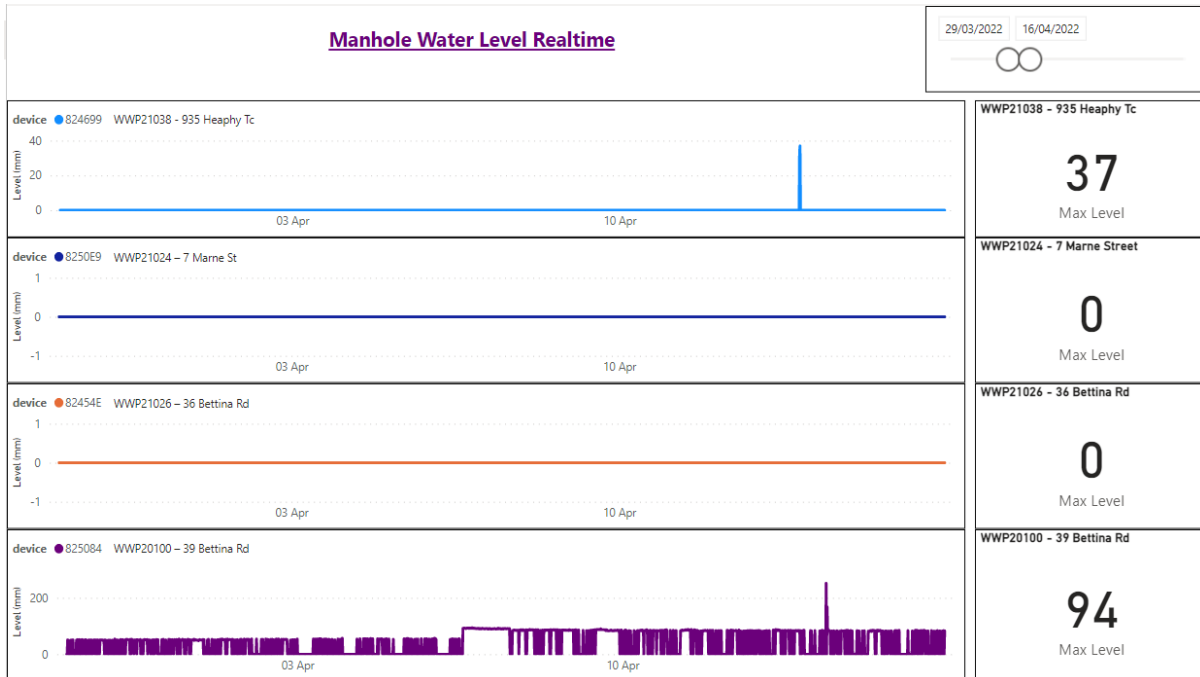
Figure 10: Screenshot of the monitoring dashboard showing false high readings at 39 Bettina Rd manhole (purple) due to incorrect sensor orientation

During the trial, data coming back from one of the manhole sensors started to read consistently above zero (*Figure 10*), though lower than the alert levels, suggesting that a block may have been forming. Investigation discovered that the programmed cleaning work had been started without approval from the Operations Team and this manhole had been accessed. The newly appointed contractor was still learning the correct procedures and had bypassed the opportunity for the Operations Team to inform them of hazards or monitoring equipment in the vicinity of their work. The manhole had not been put back in the exact same orientation, causing the false readings. This prompted the Operations Team to contact all internal and external contractors to proactively inform/remind them about these sensors.

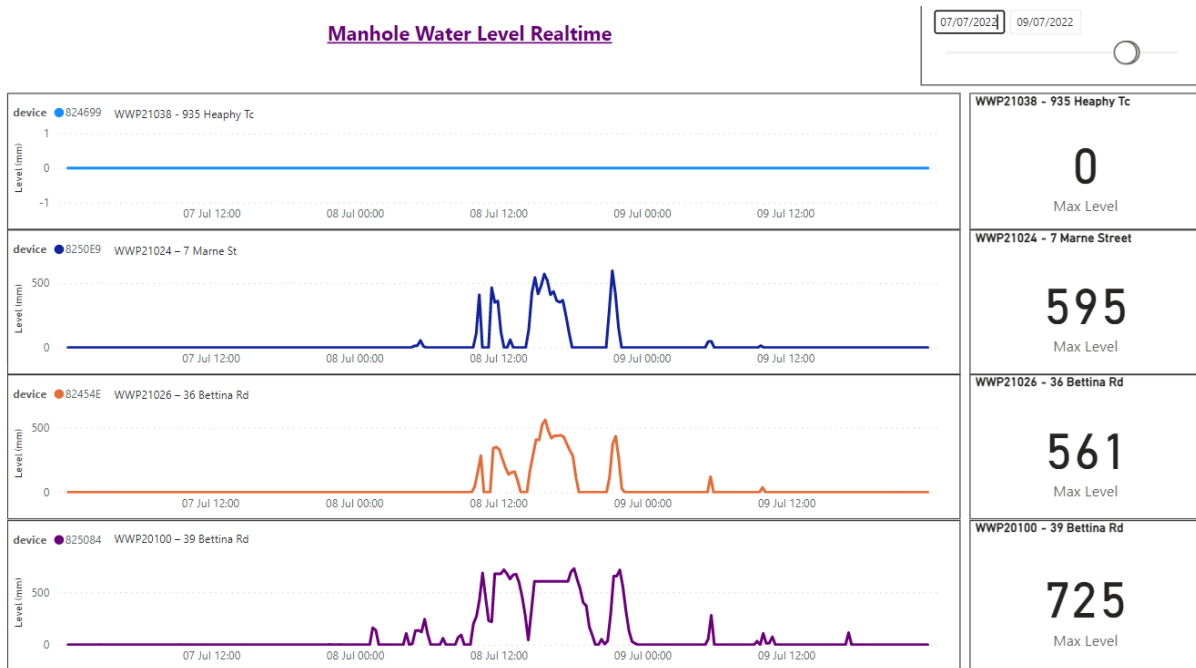
Figure 12: Monitoring dashboard readings during a wet day when an overflow was reported in the gully behind 7 Marne Street. Note overflow levels are greater than 1200 mm.

On 9 July 2022, a customer reported that a manhole in the gully behind 7 Marne Street was overflowing during wet weather. This manhole is two manholes upstream from the closest monitored site, yet the dashboard did not indicate an overflow or a concerning high level. Figure 12 shows the dashboard on that day, with all levels below 750 mm, indicating that the situation was 'green' and not being closely monitored.

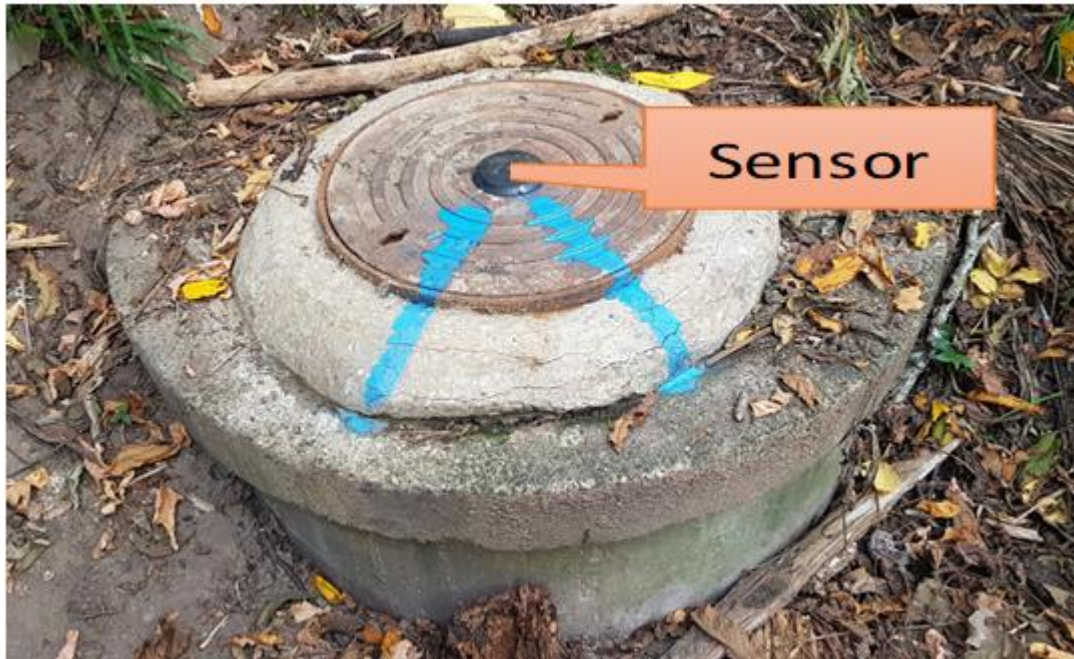
*Figure 13: Image sent to contractors to explain sensors and to request the correct alignment is maintained*

The trial showed that the sensors are very sensitive to orientation. The data sent back can become false if the manhole lid containing the sensor is not put back in the exact same orientation. To prevent future issues with this, maintenance staff

and contractors that may work in this area have been provided with information about the location of the sensors, what they look like, and the need to orientate the manhole lid according to markings on the lid and frame (*Figure 13*). Future reminders may need to be sent to cover changes in staff and ensure the integrity of data collection.
