# TAUPO DISTRICT LAND TREATMENT SCHEME - REVISITED

*Sarah Sunich Mott MacDonald New Zealand Ltd*

## ABSTRACT

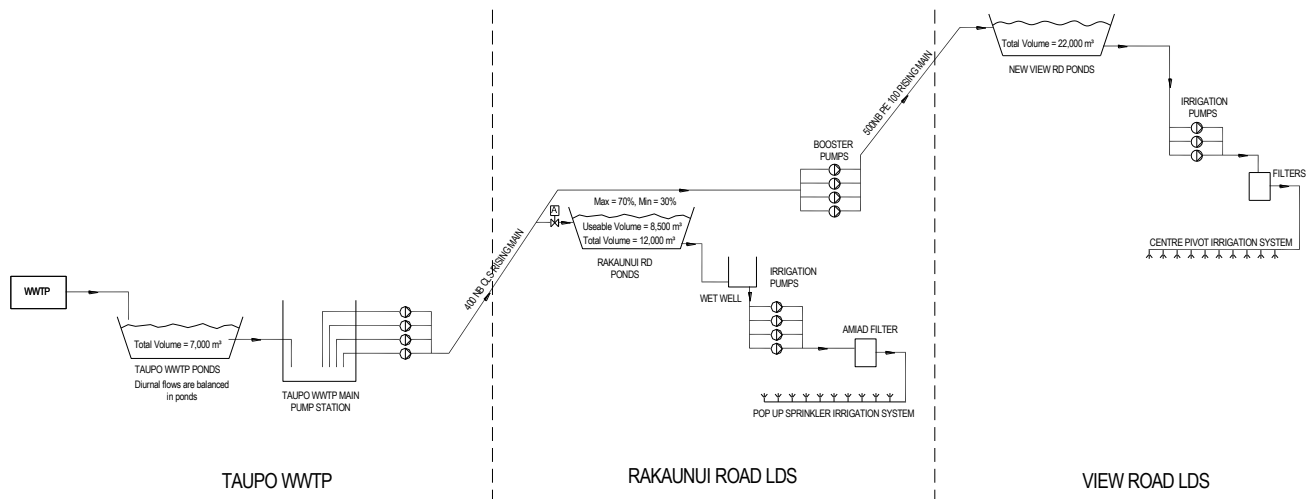
Figure 2: Schematic of Taupo effluent conveyance system post commissioning of View Rd LTS

From the plant, treated effluent is conveyed via a 4.6km rising main to the original LTS at Rakaunui Rd and a portion of the flow is on-pumped a further 4.5km to the new View Road LTS (refer to Figures 1 and 2 below for a scheme layout and conveyance system schematic).

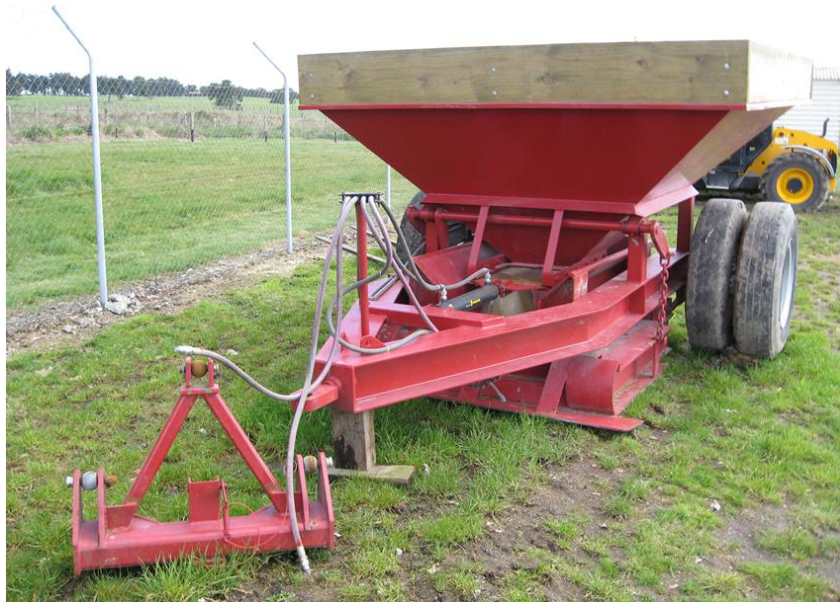
*Photograph 1: Rut Filler Trailer specifically designed by TDC*

Following scheme commissioning, rutting where the wheels from the centre pivots pass became an issue. The wheel rutting leads to uneven ground resulting in the locking of the wheels which could have led to gear box failure within individual drive units due to stresses on the spans. The uneven ground also caused problems for harvesting equipment. To overcome this problem, TDC built a bespoke rutt hopper that lays aggregate into the wheel track. As the centre-pivot rotates, the aggregate is compacted with time enabling it to compact flush with the ground allowing the harvesters to operate more effectively.

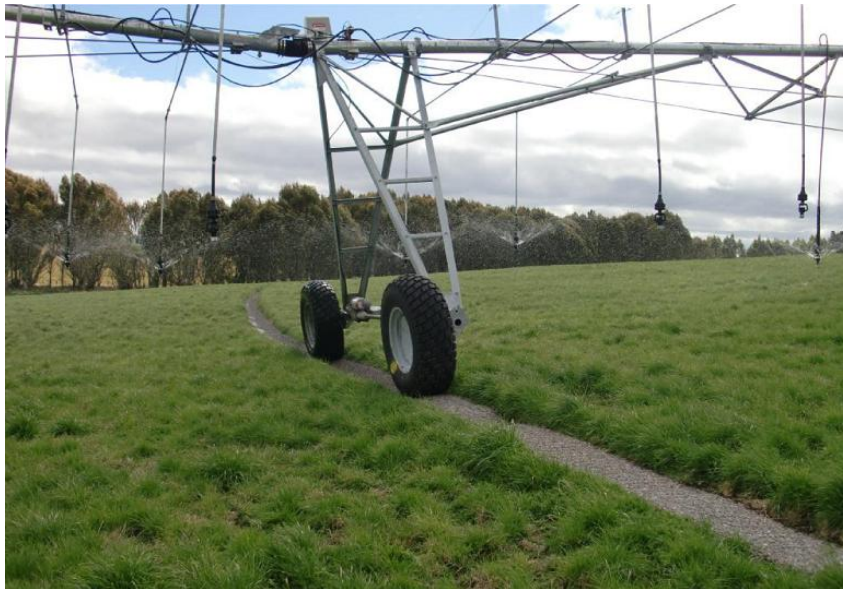
*Photograph 2: Wheel Tracks*

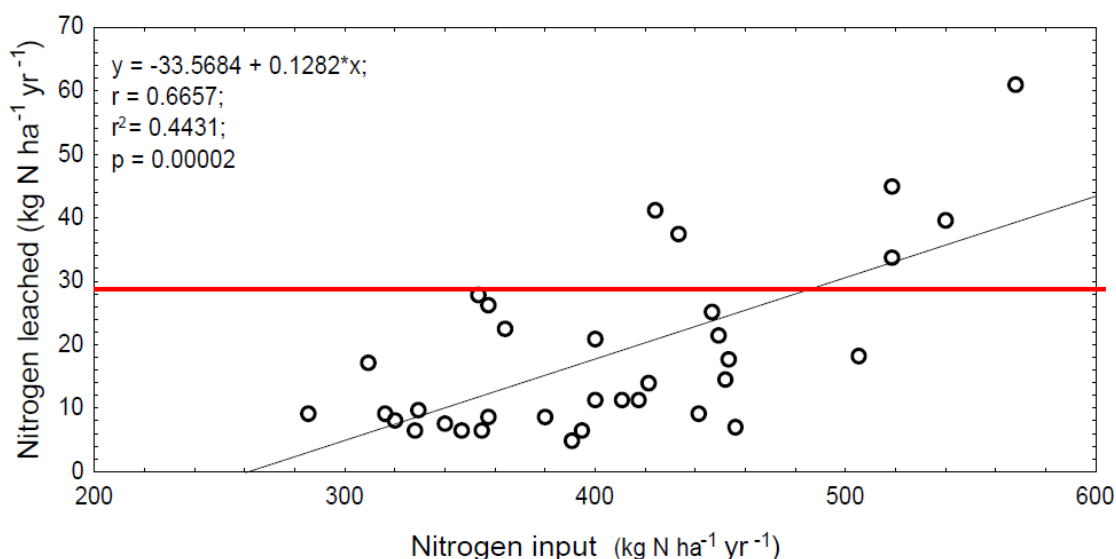
Figure 5: Relation between nitrogen leaching losses and nitrogen input (TDC, 2013a)

- Nitrogen leaching losses were found to be similar to that observed in the original trial with increasing leaching rates as loading rates are increased (control sites leached  $2.8 \pm 0.6$  kgN/ha, low-N treatment leached  $12.7 \pm 4.2$  kgN/ha, mid-N treatment leached  $16 \pm 7.2$  kgN/ha and high-N treatment leached  $28.6 \pm 10.1$  kgN/ha).

- The leaching rates measured therefore provided some evidence that applying wastewater at an application rate greater than 550 kgN/ha/yr would likely result in leaching of nitrogen in excess of 30 kgN/ha/yr (as prescribed by the consent).
